# Maryland Historical Trust State Historic Sites Inventory Form

historic Glickman's Service Station

and/or common Takoma Old Town Auto Service Center

street & number 7060 Carroll Avenue  not for publication

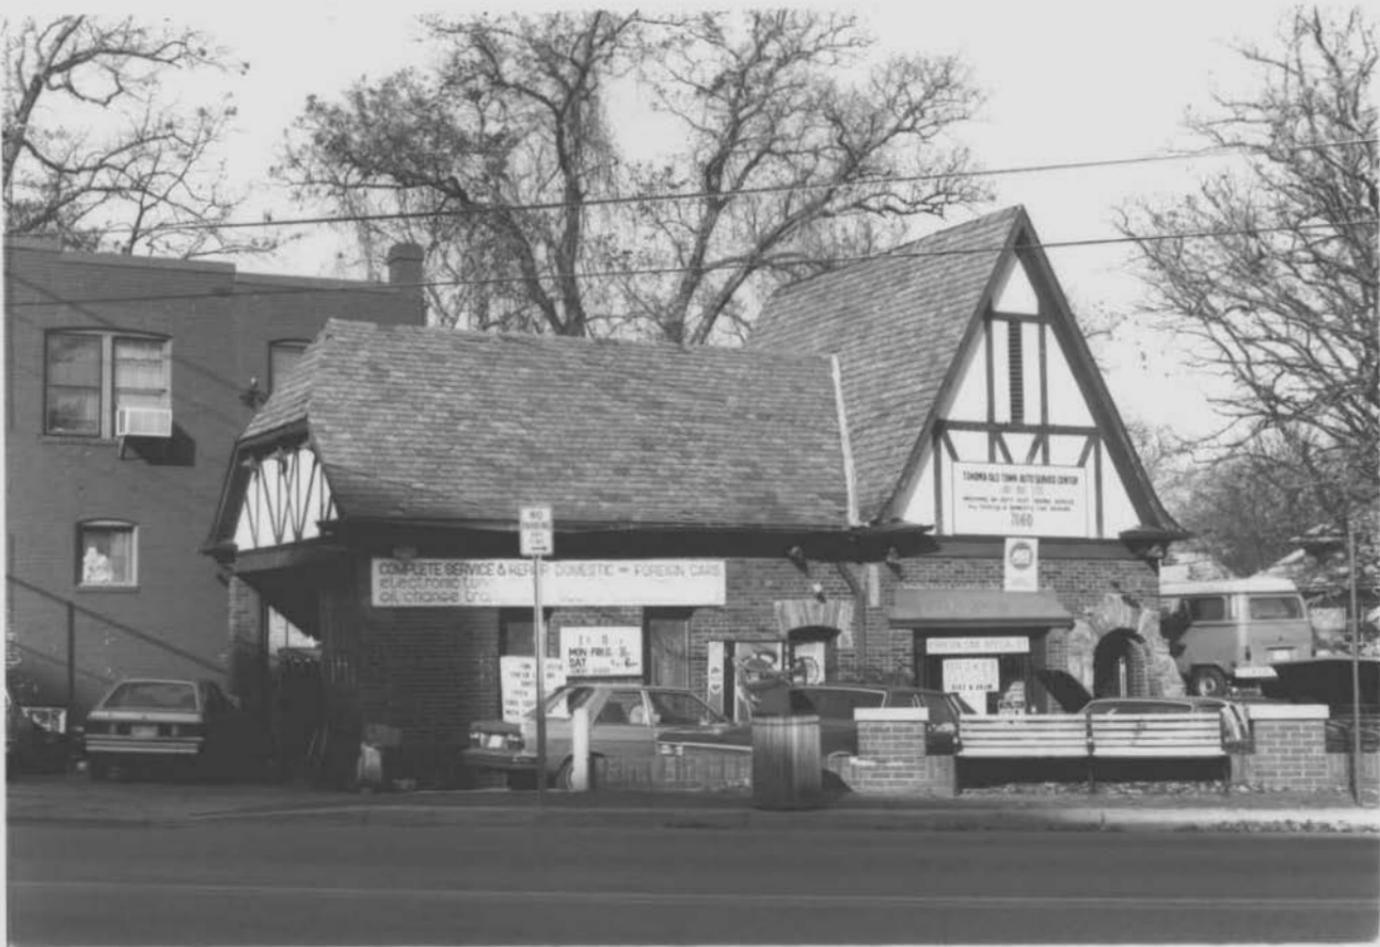
Southeast Elevation

The main elevation faces southeast onto Carroll Avenue, and consists of two windows and a door for the garage portion on the left, and a large show window and round-headed doorway to the office portion on the right. The show window consists of a single large pane of glass flanked on each side by a vertical row of several small lights. The sash is of wood. The window sits between two projecting brick piers which support a small, mansarded metal roof. The main doorway has its original round-headed, glazed, wood door set deep in a reveal. This reveal consists of a brick arch behind a massive surround of rough-cut stone of varying sized pieces, some of which form voussoirs for the arch. A tall, vertical, louvered vent in the half-timbered gable ventilates the attic over the office.
