National Register of Historic Places Registration Form

historic name Cedar Hill
other names/site number Long Farm S-195

street & number East side of Sign Post Road N/A not for publication
city, town Westover vicinity
state Maryland code MD county Somerset code 039 zip code 21871

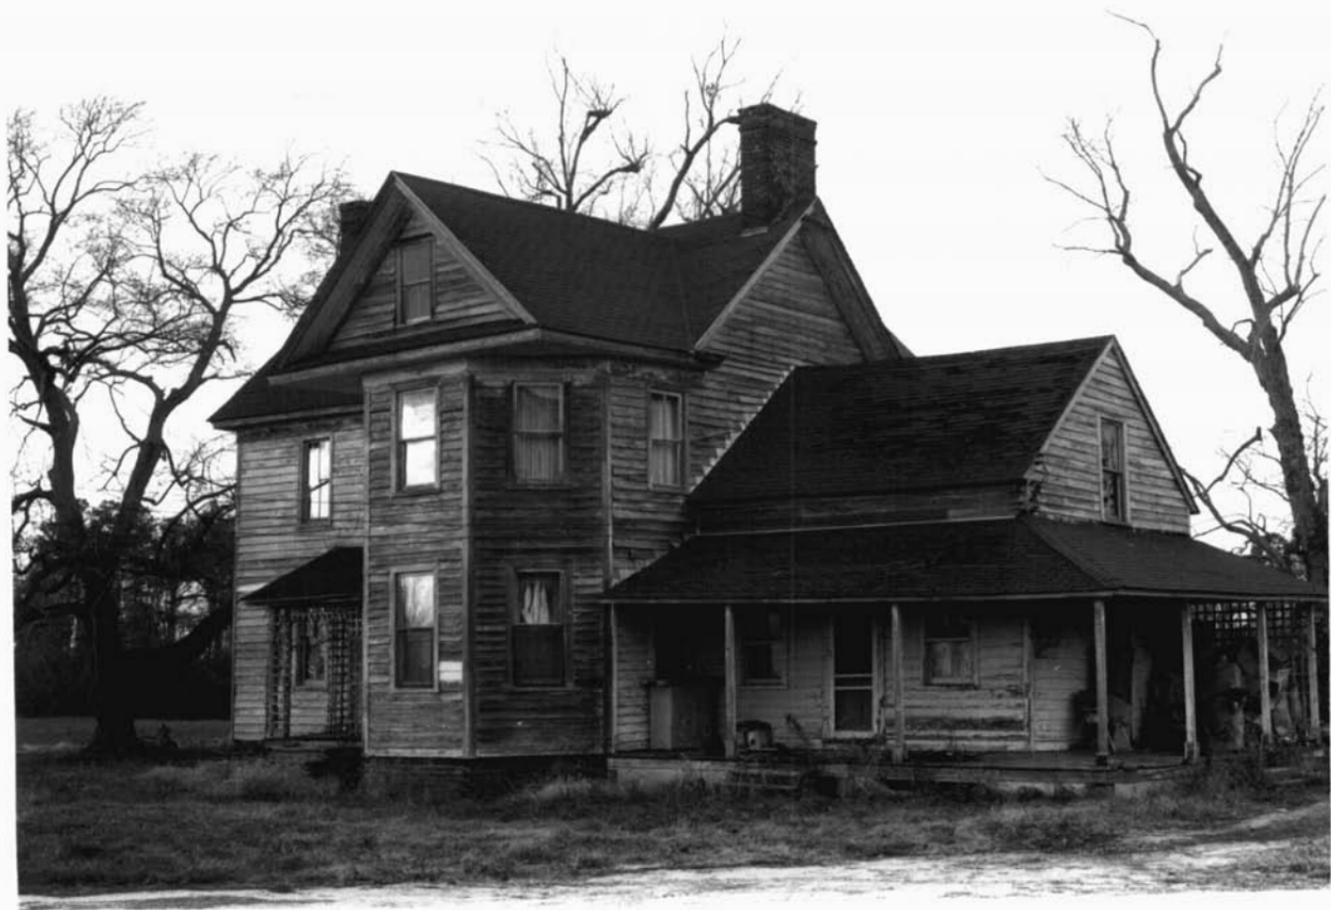
S-195

Long Farm
Near Westover, Somerset County
Southeast Elevation
2/84 Paul Touart
Neg./ Maryland Historic Trust

The south (main) elevation of the main house is an uneven three-bay facade with the projecting two-story five-side pavilion. The south face of the old house is the only wall surface that retains the original beaded weatherboards. The centrally located front six-panel door and the fluted, plain corner block surround date from the 1840s, however, the diamond-shaped muntin transom above is an original eighteenth century feature. Another original element is the diamond cross-sectioned foundation grill below the west side windows. A long two-over-two sash window marks the bay to the west of the entrance while the projecting pavilion, pierced by single-pane sash windows, dominates the eastern side. The second floor of the main house is lighted by two-over-two sash windows. Single-pane sash windows illuminate the second floor of the pavilion, and fixed within the gable end pediment is a small two-over-two sash window.

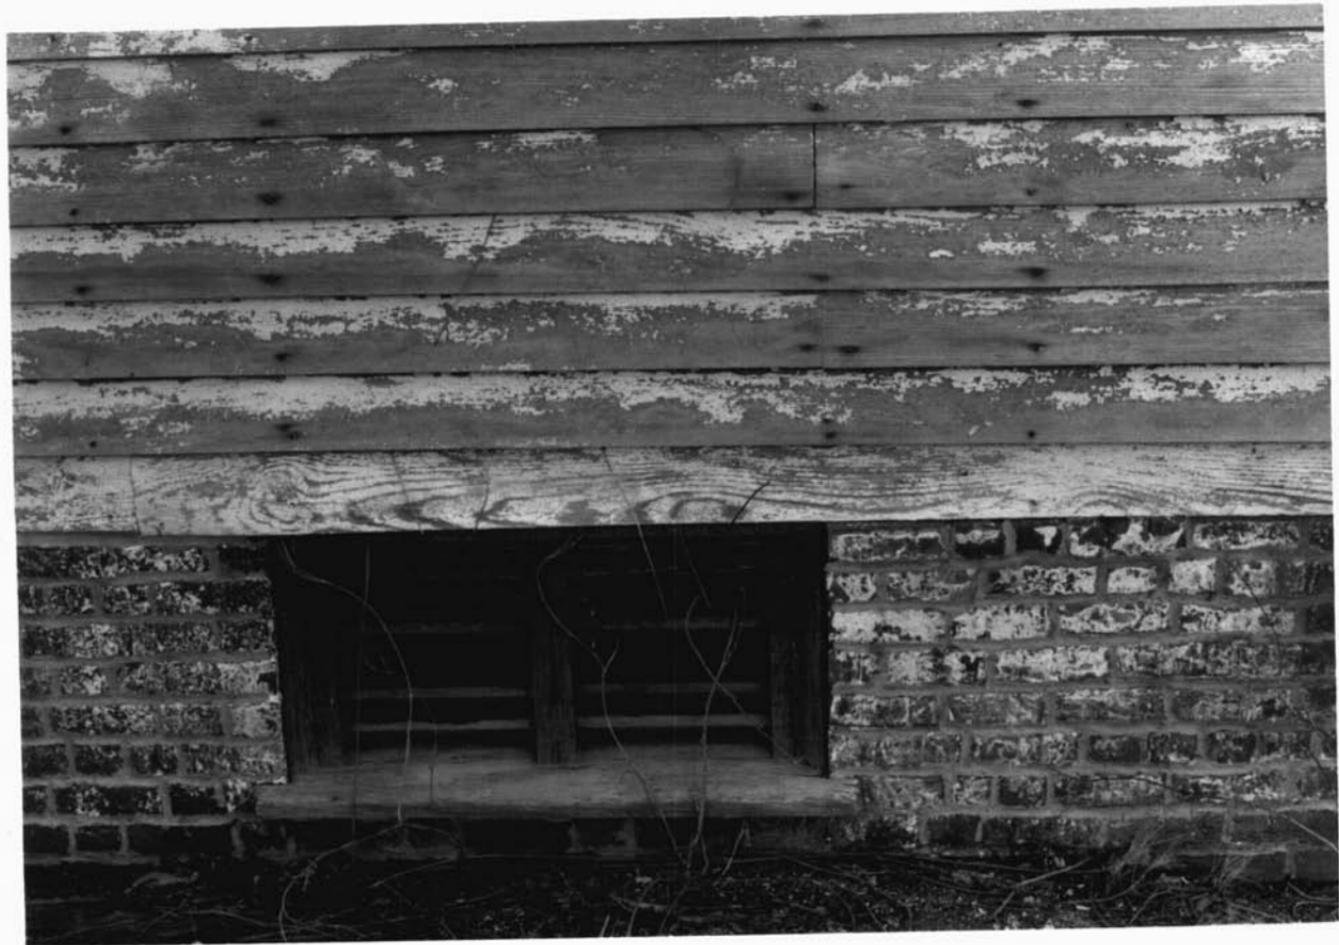
S-195

Long Farm
Cellar Grill
Near Westover, Somerset County
2/84 Paul Touart
Neg./ Maryland Historic Trust

The west gable end is a symmetrical elevation with pairs of two-over-two sash windows on the first and second floors, and small two-over-two attic sash. The second floor window openings retain original cyma-curve backband surrounds and molded sills. The pairs of windows flank an interior end chimney stack that is inscribed "1793" in the fifth brick course from the top. The eaves to the roof are extended and finished with short returns at the base of the roof. Piercing the foundation wall in the southwest corner is another diamond cross-sectioned timber frame grill.

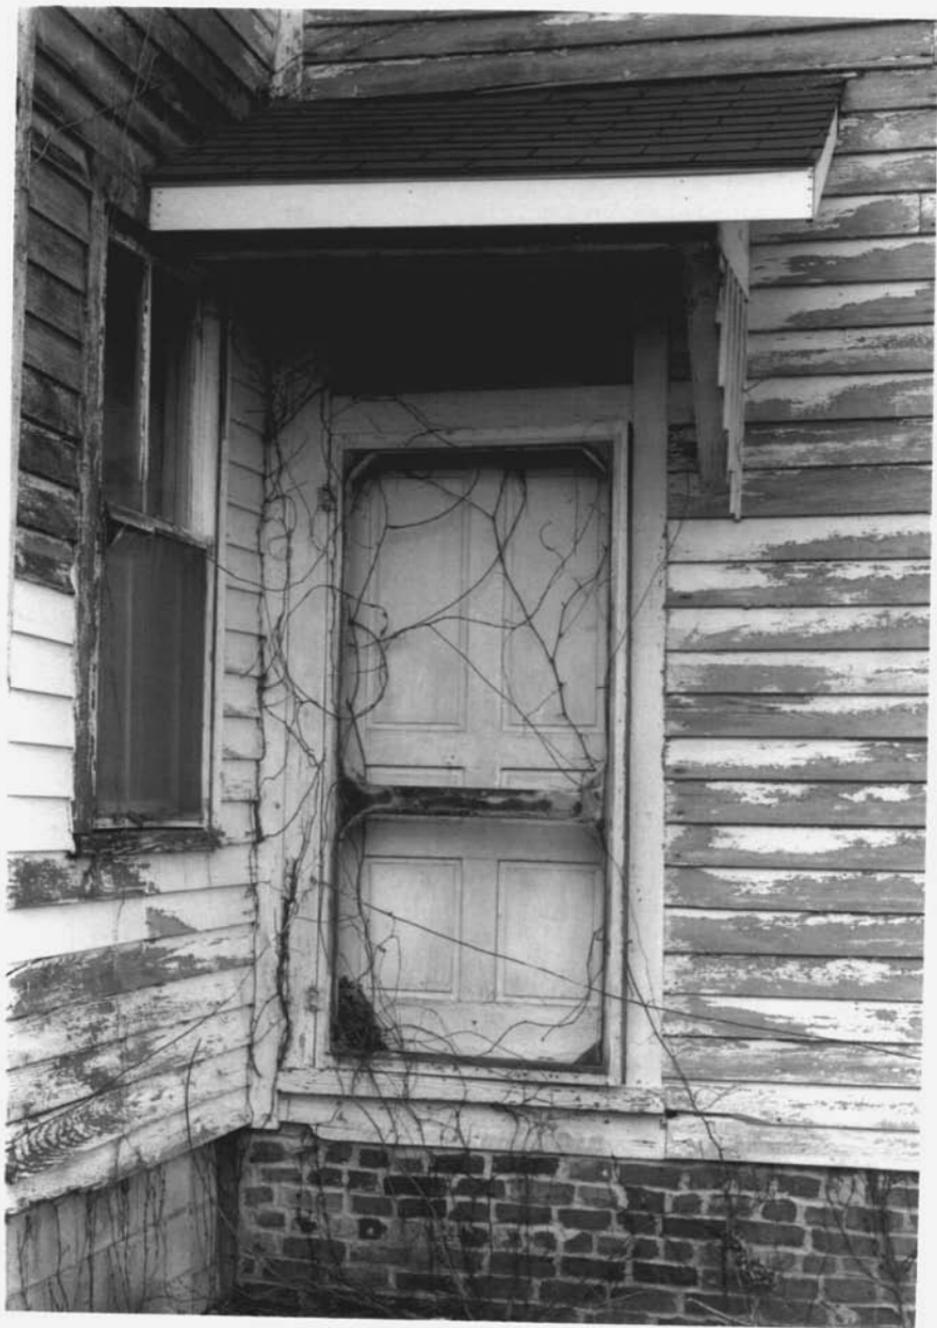
S-1945

Long Farm
Near Westover, Somerset County
Rear Entrance
2/84 Paul Touart
Neg./ Maryland Historic Trust
