National Register of Historic Places  
Registration Form

historic name EAST OAKS

other names/site number M:17-24

**United States Department of the Interior  
National Park Service****National Register of Historic Places  
Continuation Sheet**EAST OAKS  
Montgomery County  
MarylandSection number 7 Page 1**DESCRIPTION SUMMARY:**

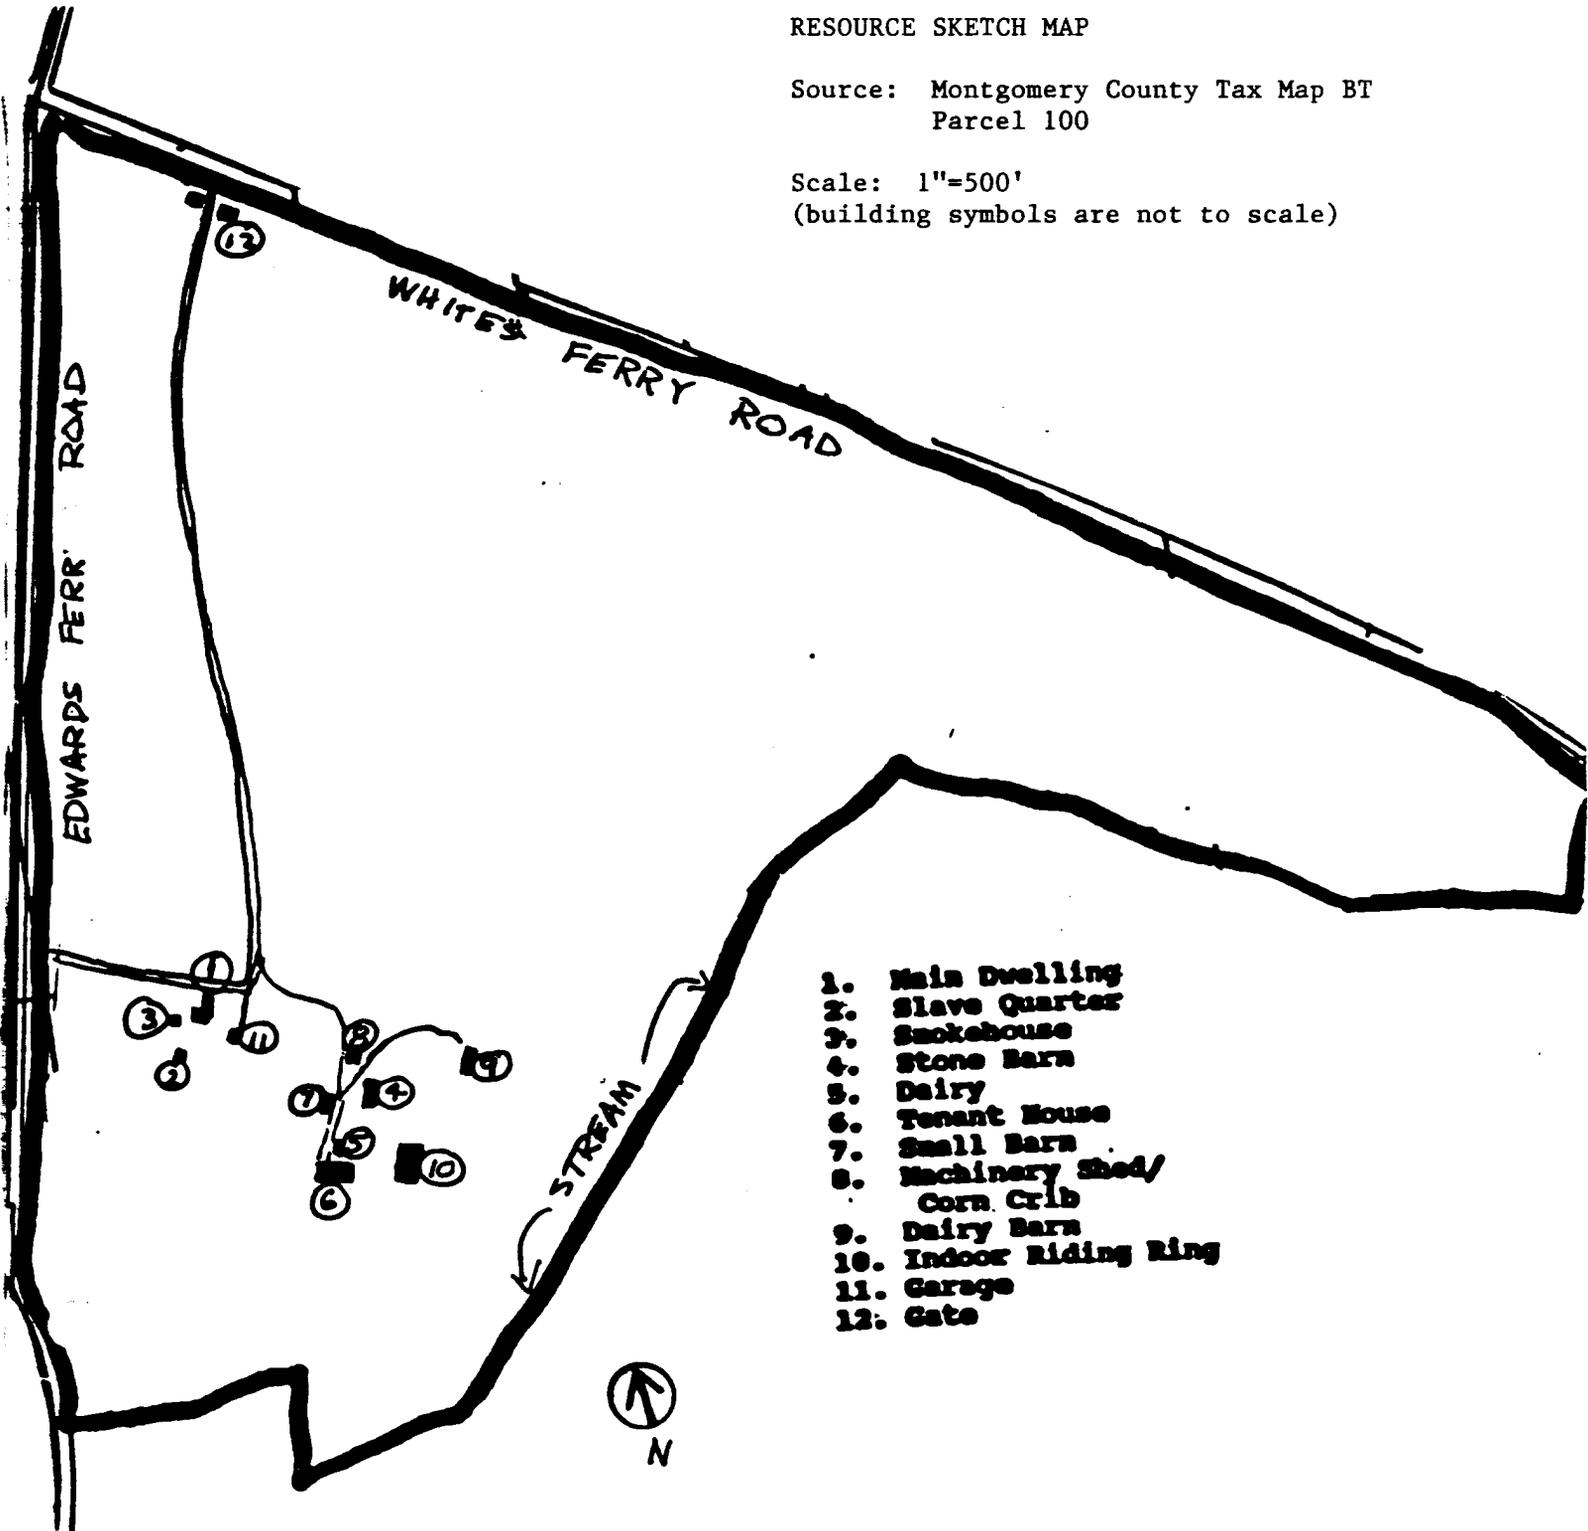
M 17/24  
EAST OAKS  
MONTGOMERY  
COUNTY, MD

Source: Montgomery County Tax Map BT  
Parcel 100

Scale: 1"=500'  
(building symbols are not to scale)

- 1. Main Dwelling
- 2. Slave Quarter
- 3. Smokehouse
- 4. Stone Barn
- 5. Dairy
- 6. Tenant House
- 7. Small Barn
- 8. Machinery Shed/  
Corn Crib
- 9. Dairy Barn
- 10. Indoor Riding Ring
- 11. Garage
- 12. Gate

The following descriptions of existing resources are keyed to the site plan which accompanies this documentation. Buildings 1 through 9 are considered contributing resources. These include the main dwelling (#1) plus outbuildings whose construction dates span over 100 years and document the history of agriculture in Montgomery County. This complex exhibits an unusually high degree of architectural and historic integrity.

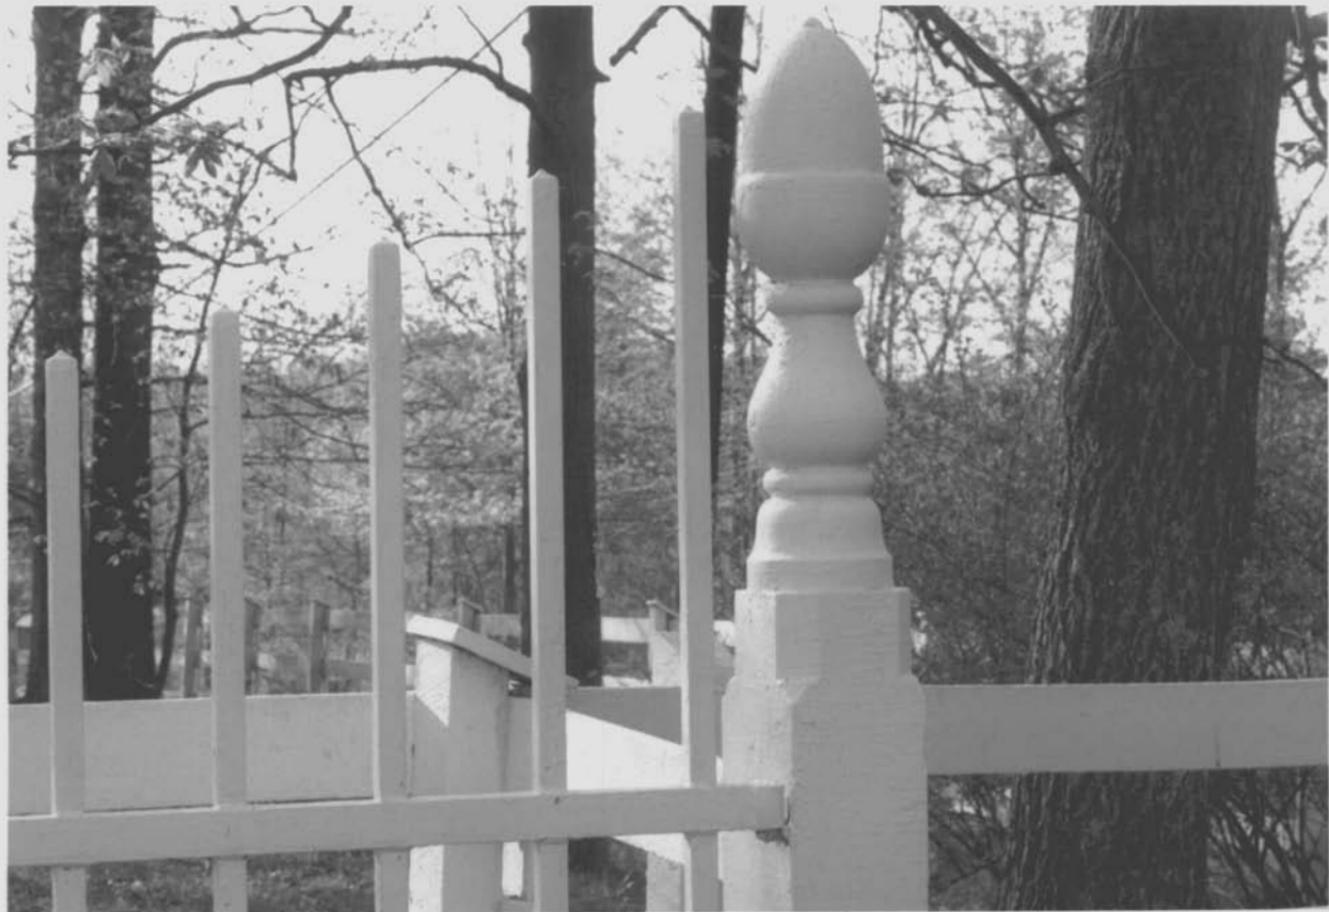
GATE POST W SIDE  
CAMERA FACING W  
PHOTOGRAPH NO. 2

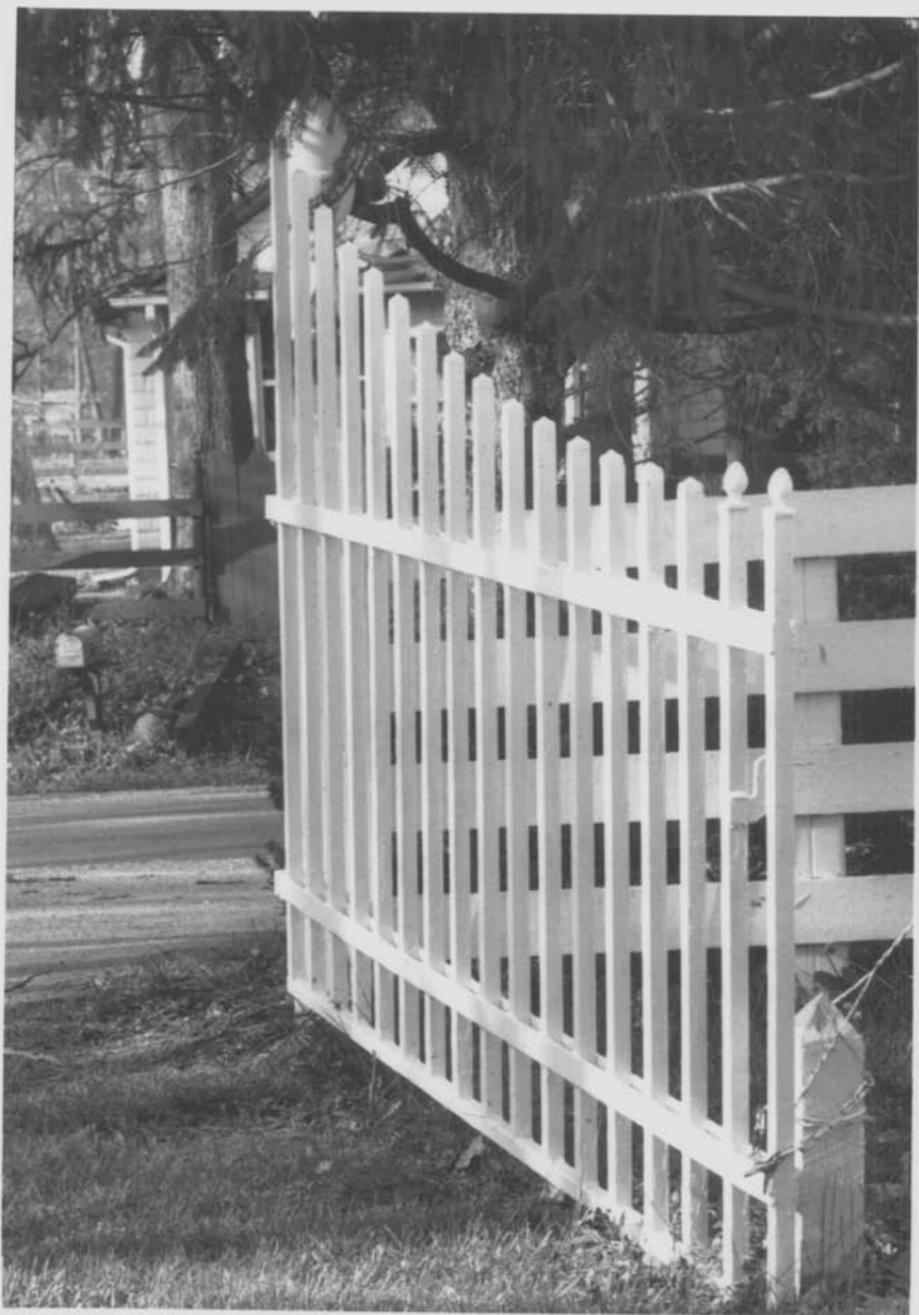
PHOTOGRAPH NO. 1

ENTRANCE GATE, E SIDE  
CAMERA FACING N

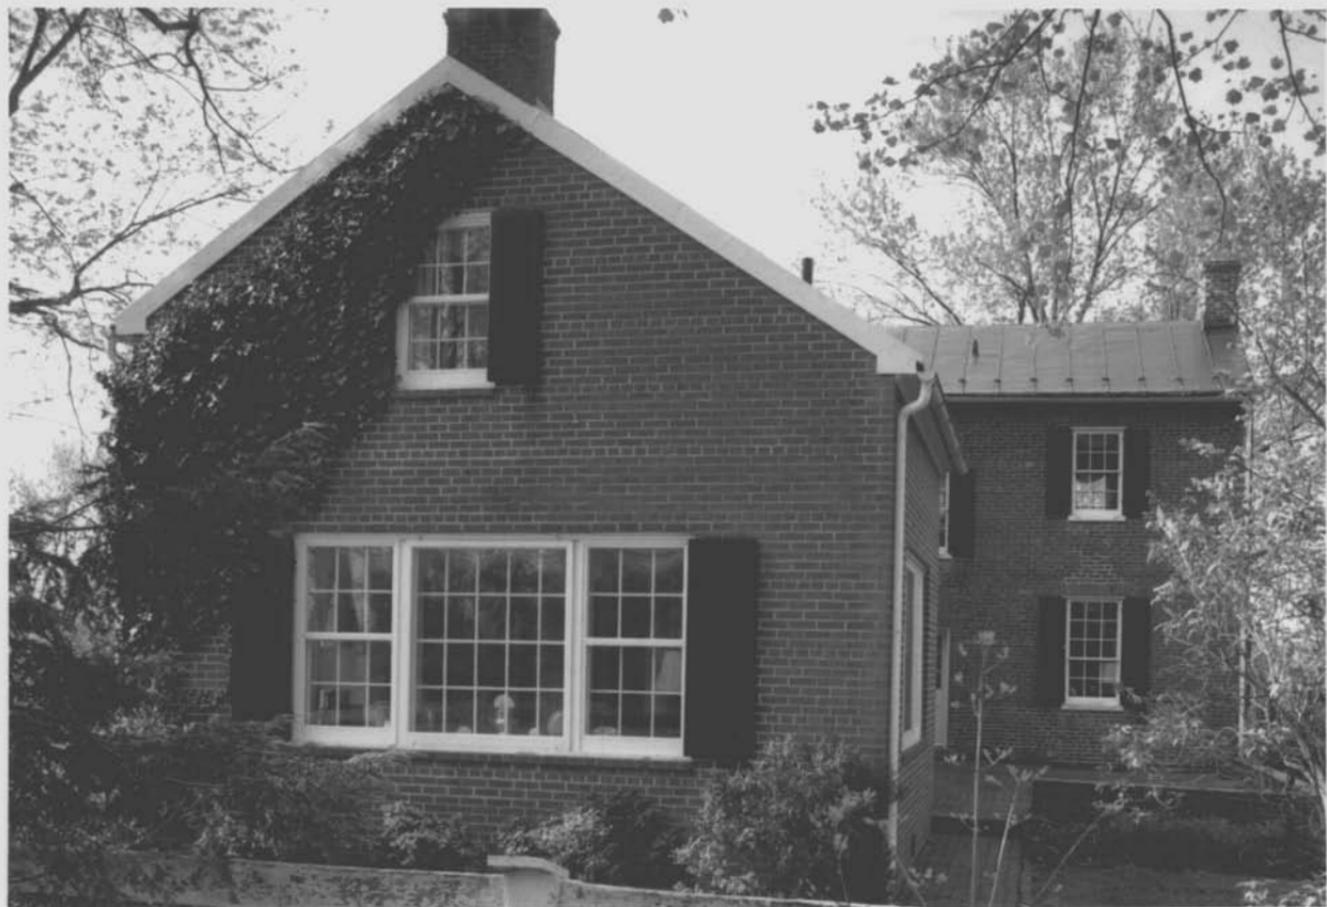
PHOTOGRAPH NO. 5

MAIN DWELLING 1942 ADDITION (LEFT)  
ORIGINAL W. WING (RIGHT)  
CAMERA FACING S.

On the north end of the main block a brick one-and-a-half story addition was built in 1942.

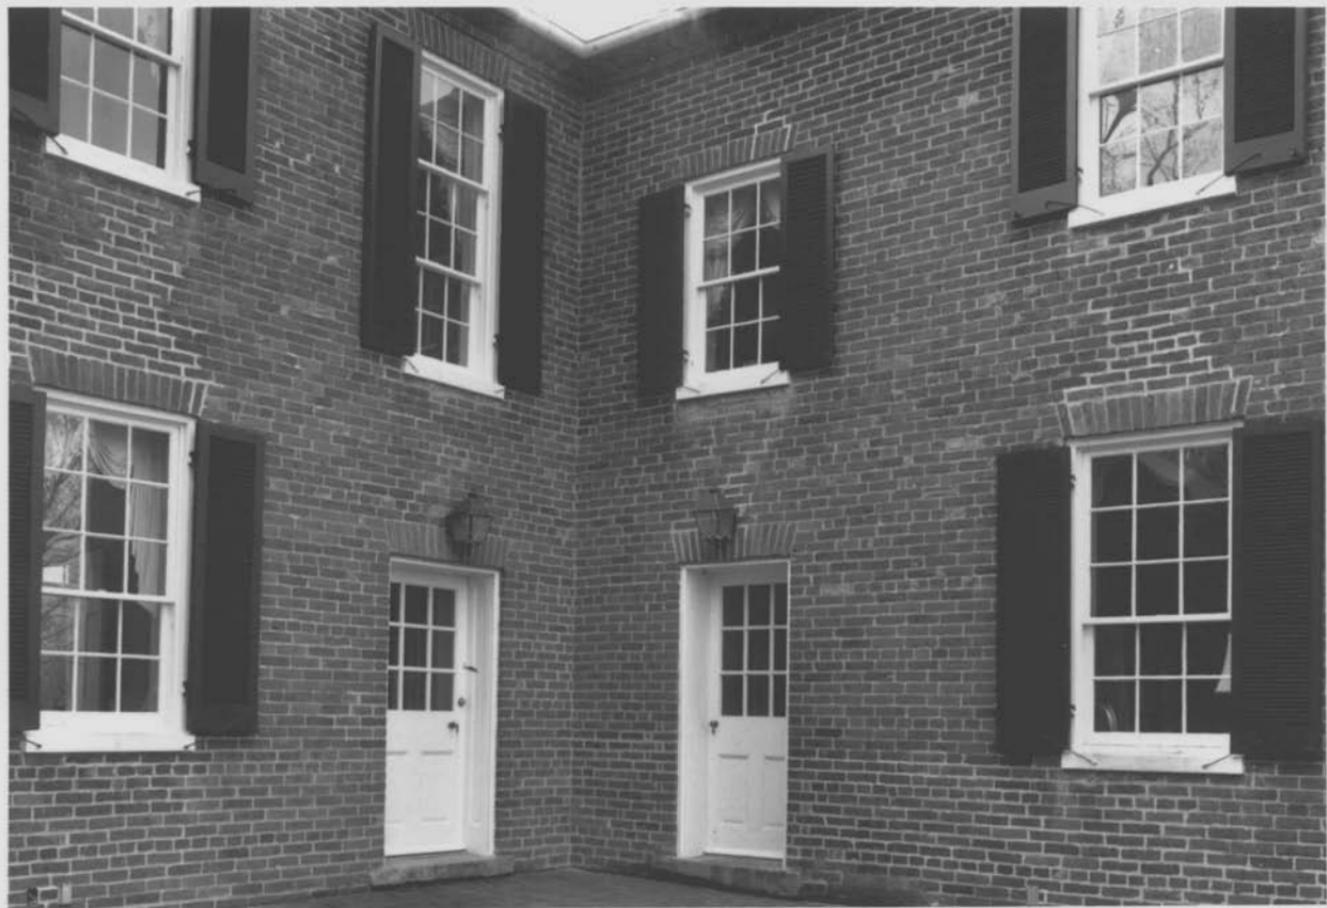
PHOTOGRAPH NO. 6

MAIN DWELLING  
WEST ELEVATION (LEFT)  
NORTH ELEVATION (RIGHT)  
CAMERA FACING S.E.

On the west facade, main block, first level, there are two nine-over-six light windows and a doorway to the right of the two windows. On the second level, there are two six-over-six light windows directly above the windows on the first level. There is one eighteen light, triple-hung window directly above the first level door. The doorway on the west wall is inset with 14" reveals with rolled moldings, has a stone threshold and, above the opening, a jack arch of gauged brick.

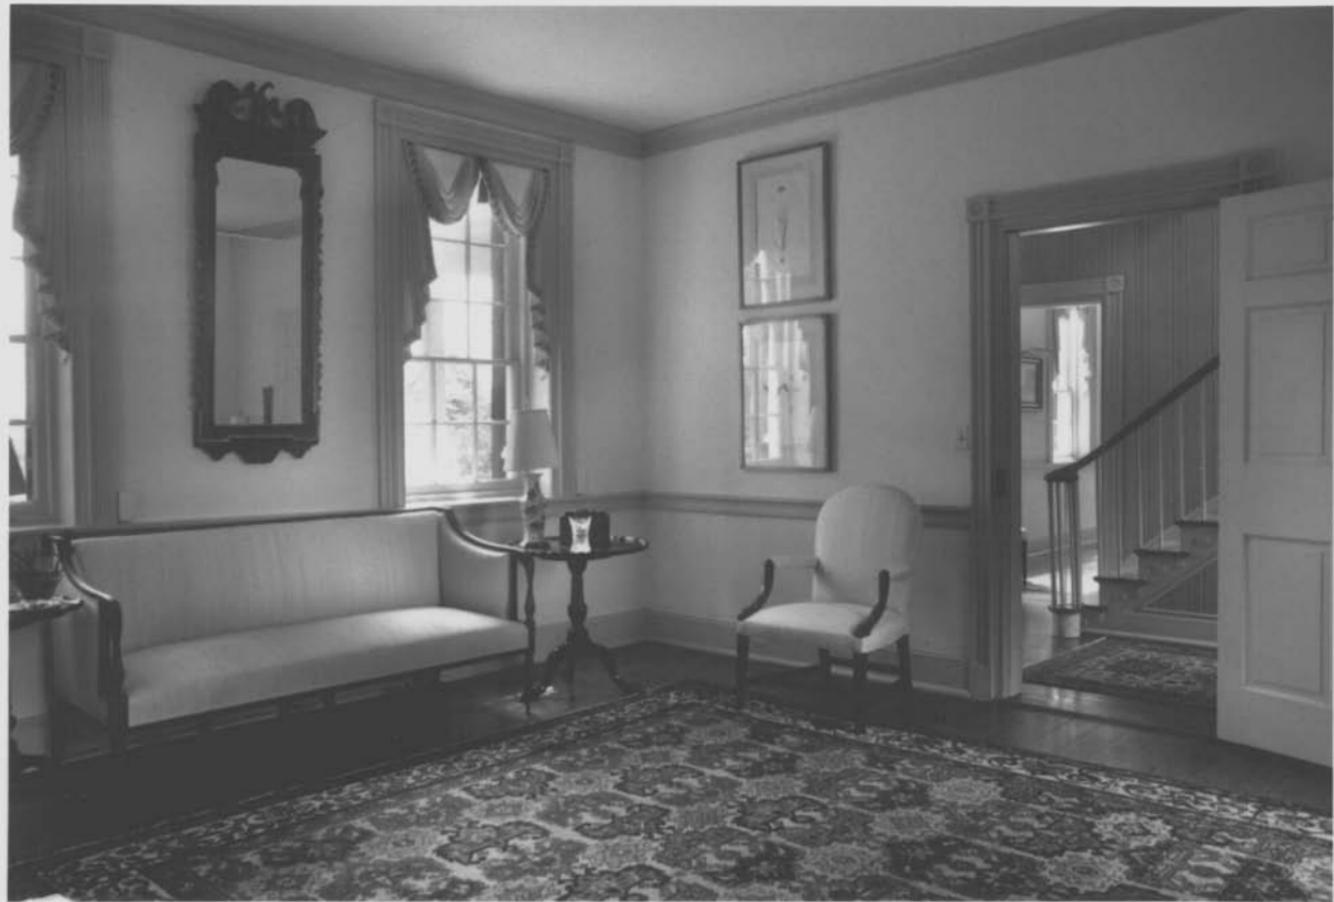
PHOTOGRAPH NO. 10

MAIN DWELLING INTERIOR  
LIVING ROOM, EAST AND SOUTH WALLS  
HALL AND STAIRWAY  
ORIGINAL FLOORING  
CAMERA FACING S.E.

The front door opens on a center hall which extends through the main block to the rear where there is another large doorway. A squared spiral stairway rises along the south wall to a landing, thence in half turns to the second floor. The landing between the first and second floors is lighted by a triple-hung, eighteen light window set in the west wall.

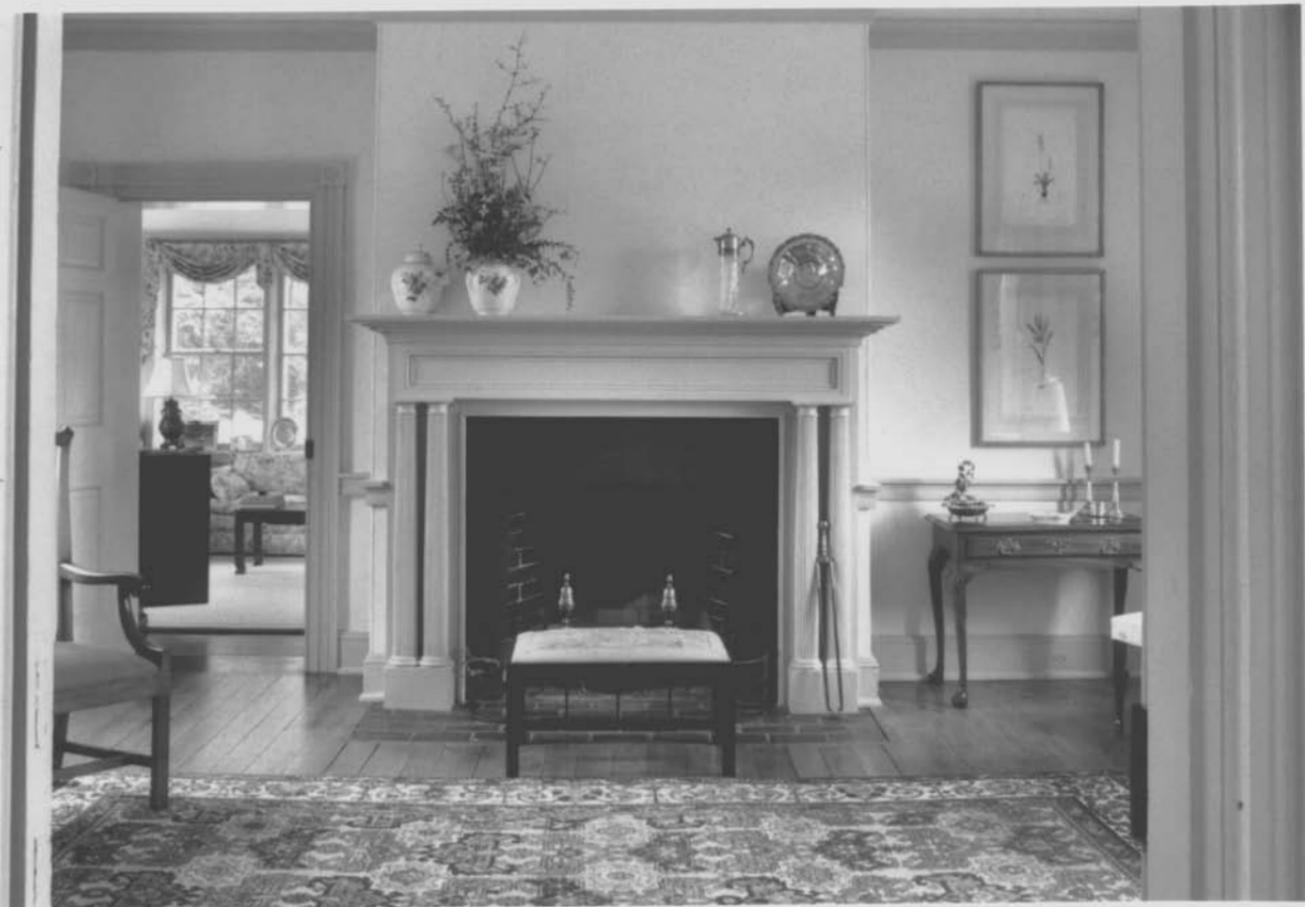
MAIN DWELLING, INTERIOR  
LIVING ROOM, NORTH WALL  
FIREPLACE SURROUND, ORIGINAL FLOOR  
BRICK HEARTH, WOODWORK, 1823-9  
N. WINDOW OF 1942 ADDITION (LEFT)  
CAMERA FACING N.  
PHOTOGRAPH NO. 11.

The large living room contains 2 nine-over-six windows in the east and west walls. The architraves of these windows and of the north and south doorways have bullseye squares at the top corners. A chair rail extends along each wall. A fireplace in the north wall has a brick hearth. The wooden mantel shelf and molded frieze are supported by two tapered reeded columns on each side, each set on plinths. Other Montgomery County properties with this double-columned mantel treatment include the "Old Chiswell Place" (1826, M17/9) and the "Dr. Thomas Poole House" (1830, Poolesville Historic District).

A door beside the fireplace leads to a sitting room added in 1942 with multiple windows on three walls and bookcases on the fourth wall.
