NATIONAL REGISTER OF HISTORIC PLACES INVENTORY - NOMINATION FORM

1. NAME
 COMMON: Chiswell's Inheritance
 AND/OR HISTORIC: same

The five-bay main facade faces east. It is laid up in Flemish bond with a water table of quarter-round profile about two feet above ground level. The central doorway is topped by a five light transom; two large twelve over twelve double hung sash windows are on each side of the doorway. The second story has five nine over six double hung sash windows. The walls are carried over the openings by jack arches.

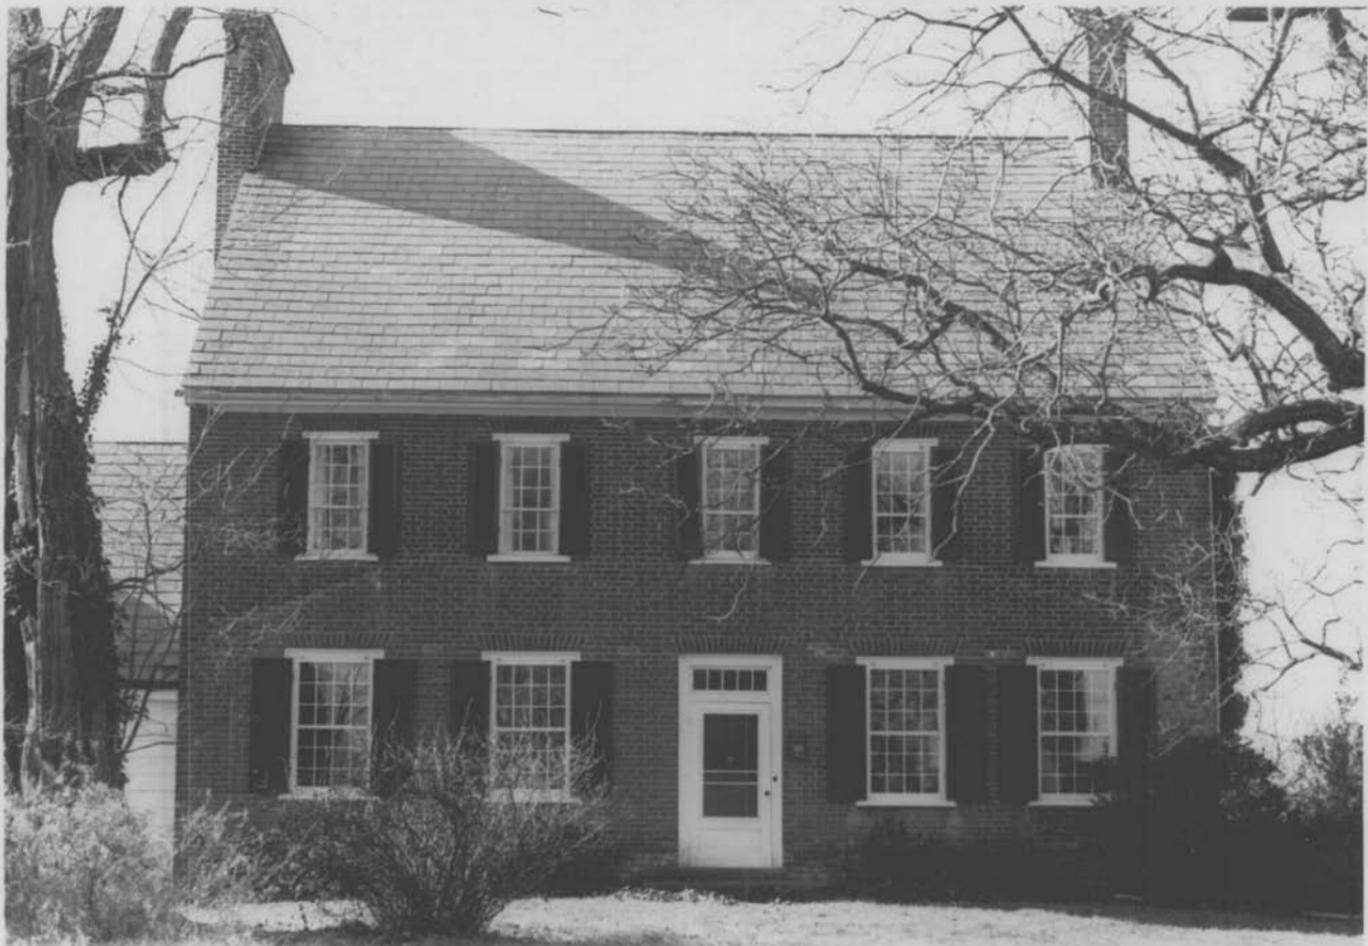
NAME M:# 17-19 CHISWELL'S INHERITANCE

FACADE E

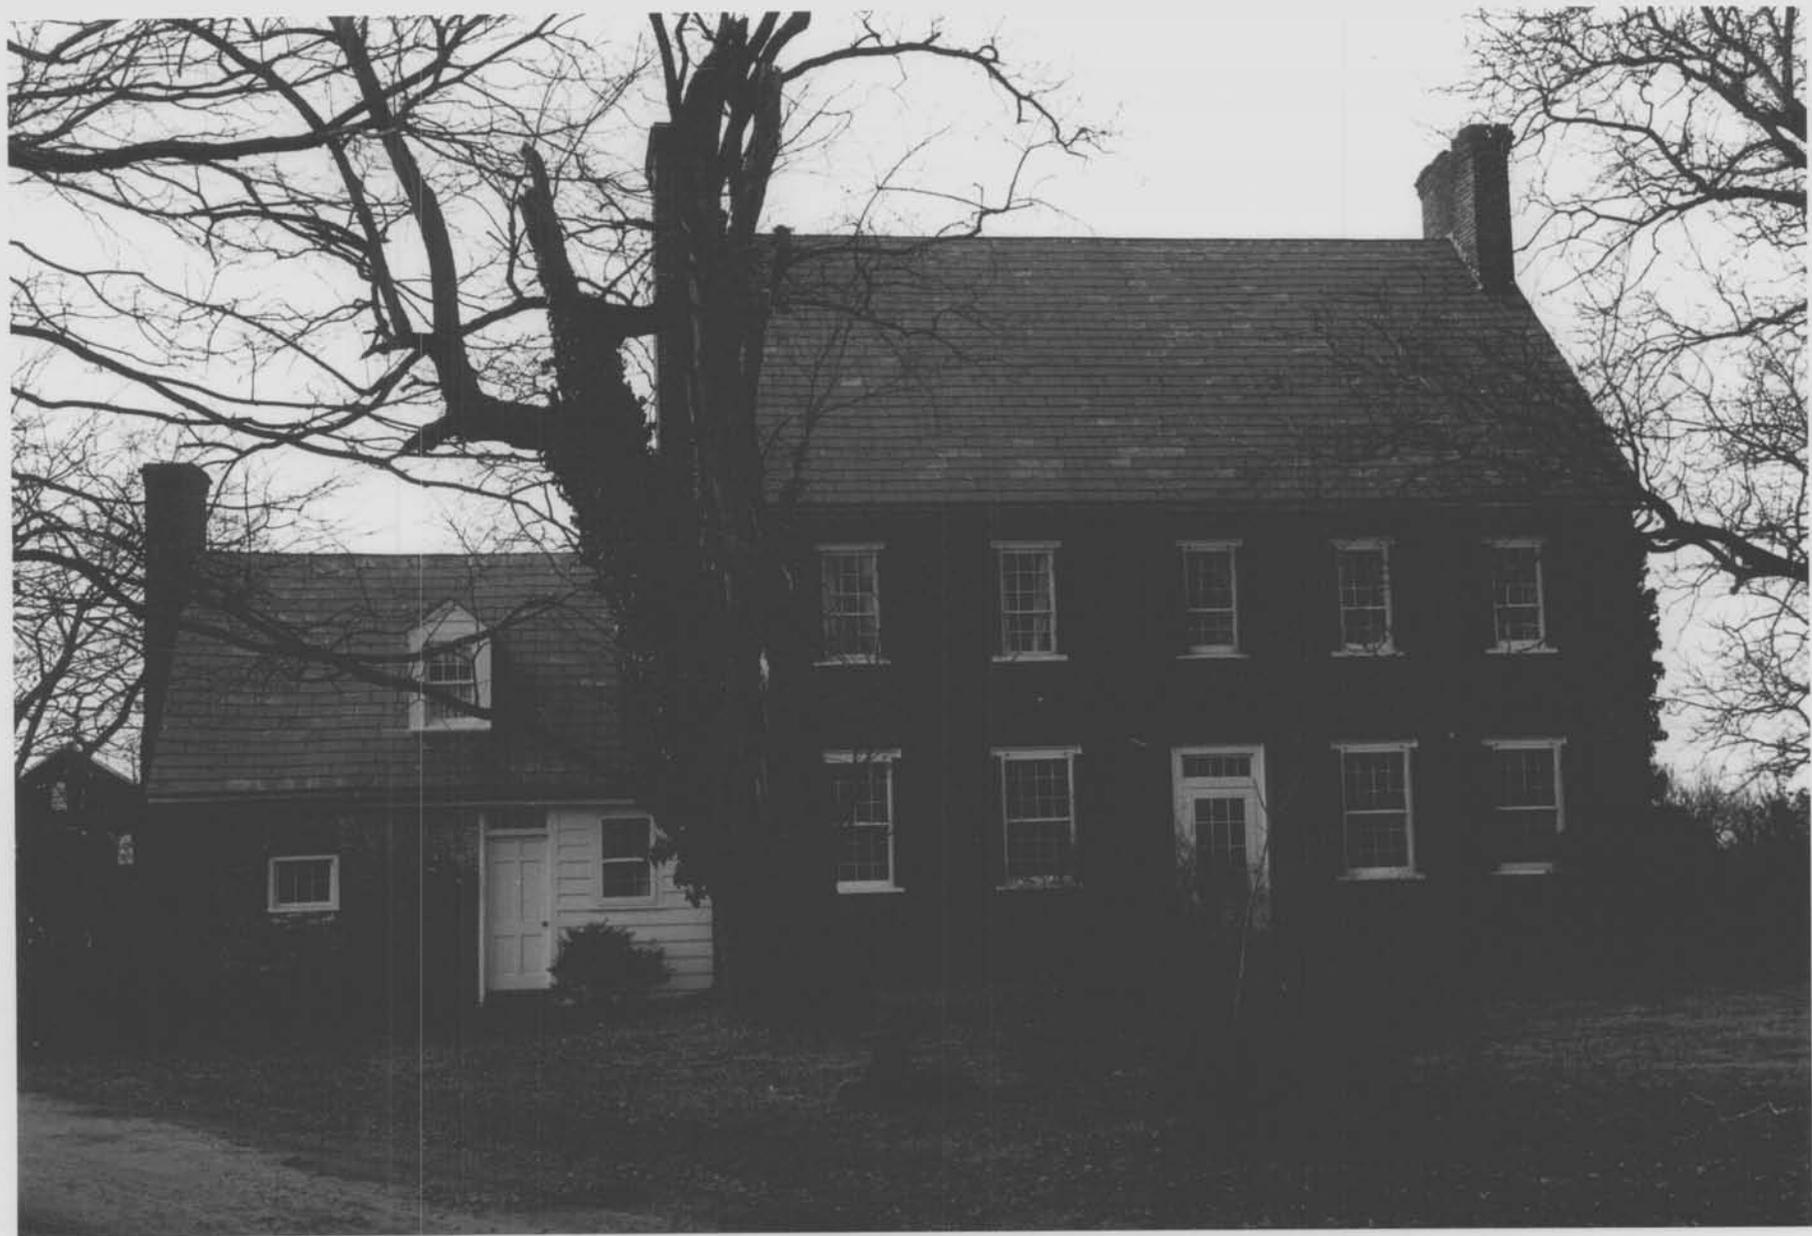
East Facade

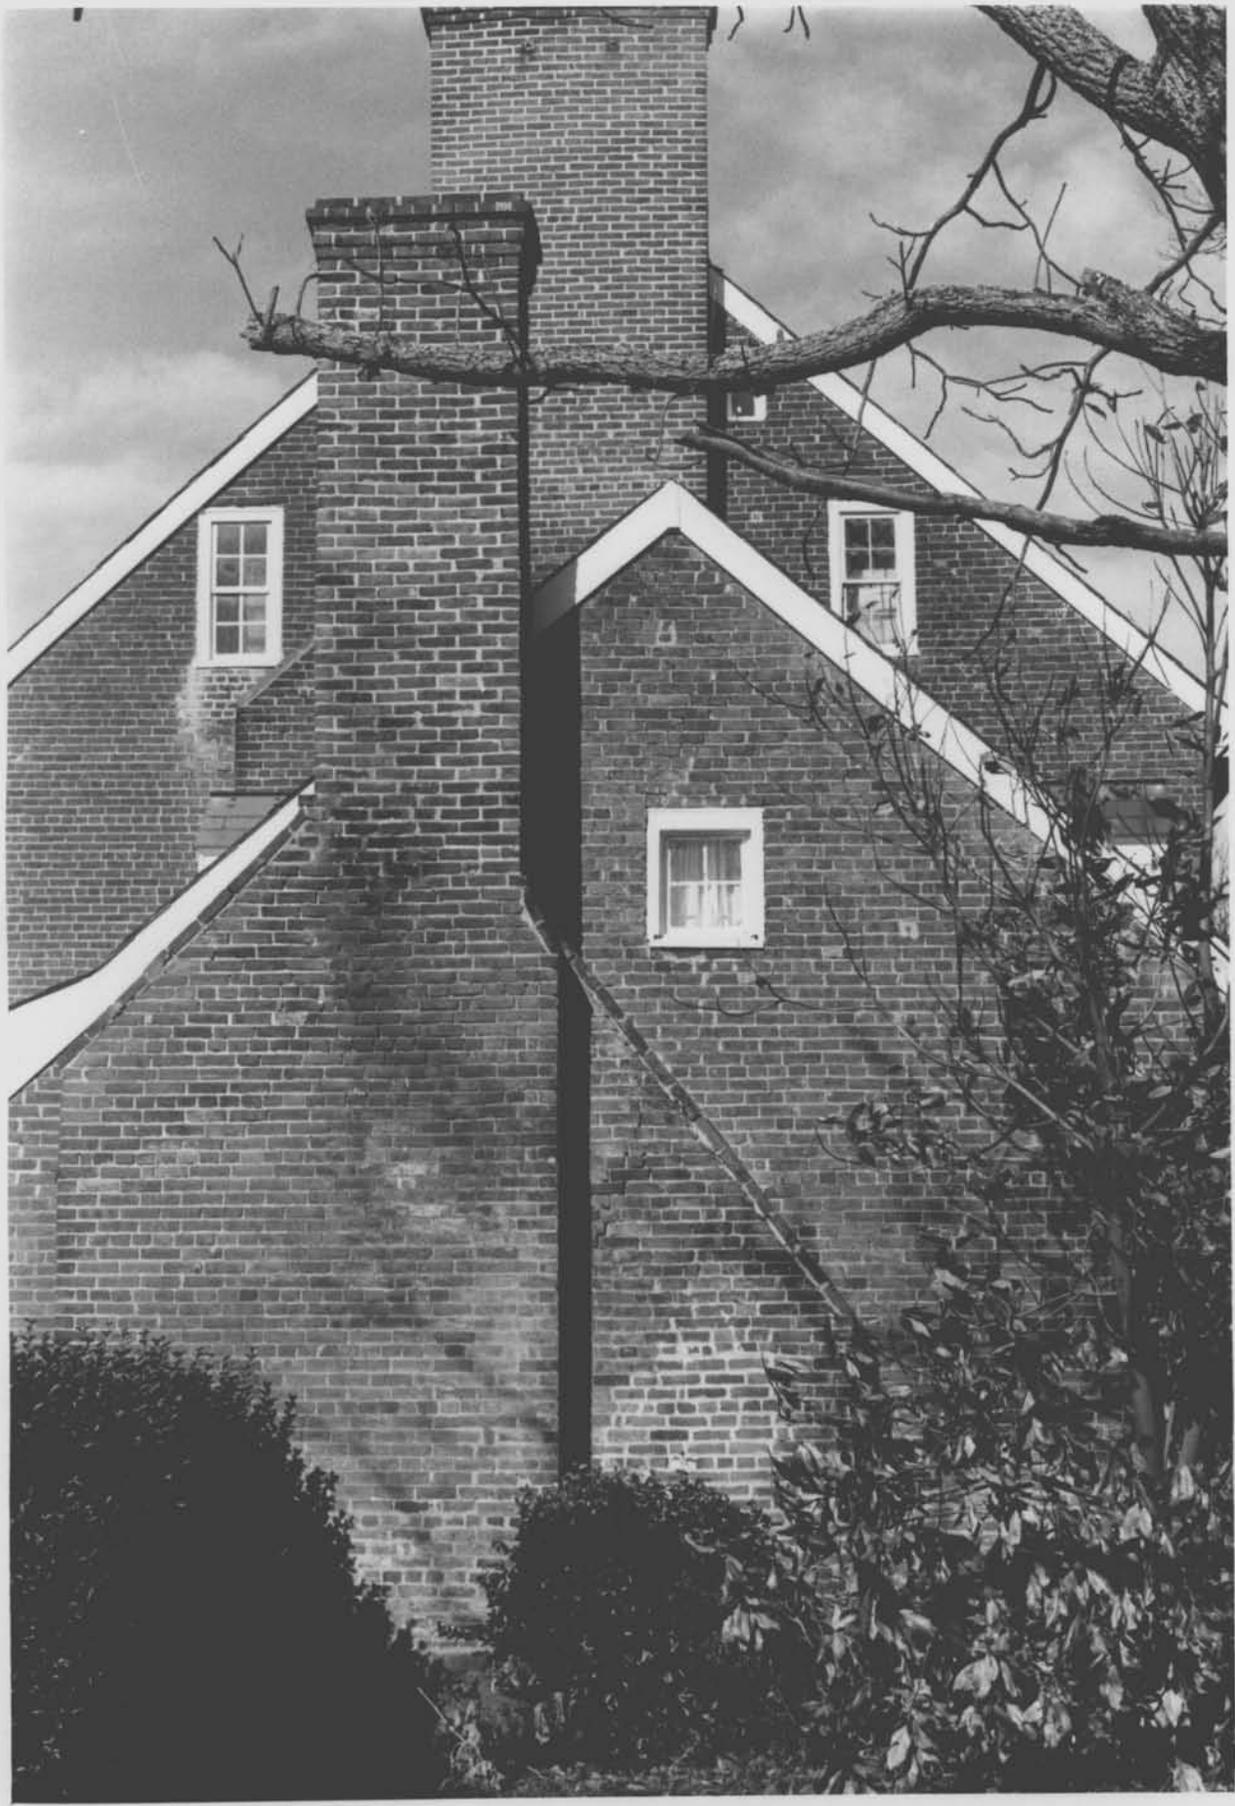
#25, Chiswells Inheritance, 1/4

South Wall of House showing
Chimney Construction

The south end has an external chimney with a two-story base tapering to a stack. Small single light windows pierce the gable on either side of the stack with two larger four over four double hung sash below. A door opening exists on the south as well as on either side of the kitchen wing. The western door opens to a recently added porch. The eastern door opens into a walkway to the kitchen wing which was formerly exposed, but was enclosed at sometime in the past.

The kitchen wing rests on a stone foundation without a basement. It has an external chimney on the south end with a free-standing stack capped by four courses of corbelled brick. The chimney base is of two depths, one for the main cooking fireplace, and one for the bake-oven. The one-and-one-half-story base has tapered weatherings, the east part of the base projecting outward about one-and-one-half feet less than the rest. Dormers on either side of the roof are later additions.

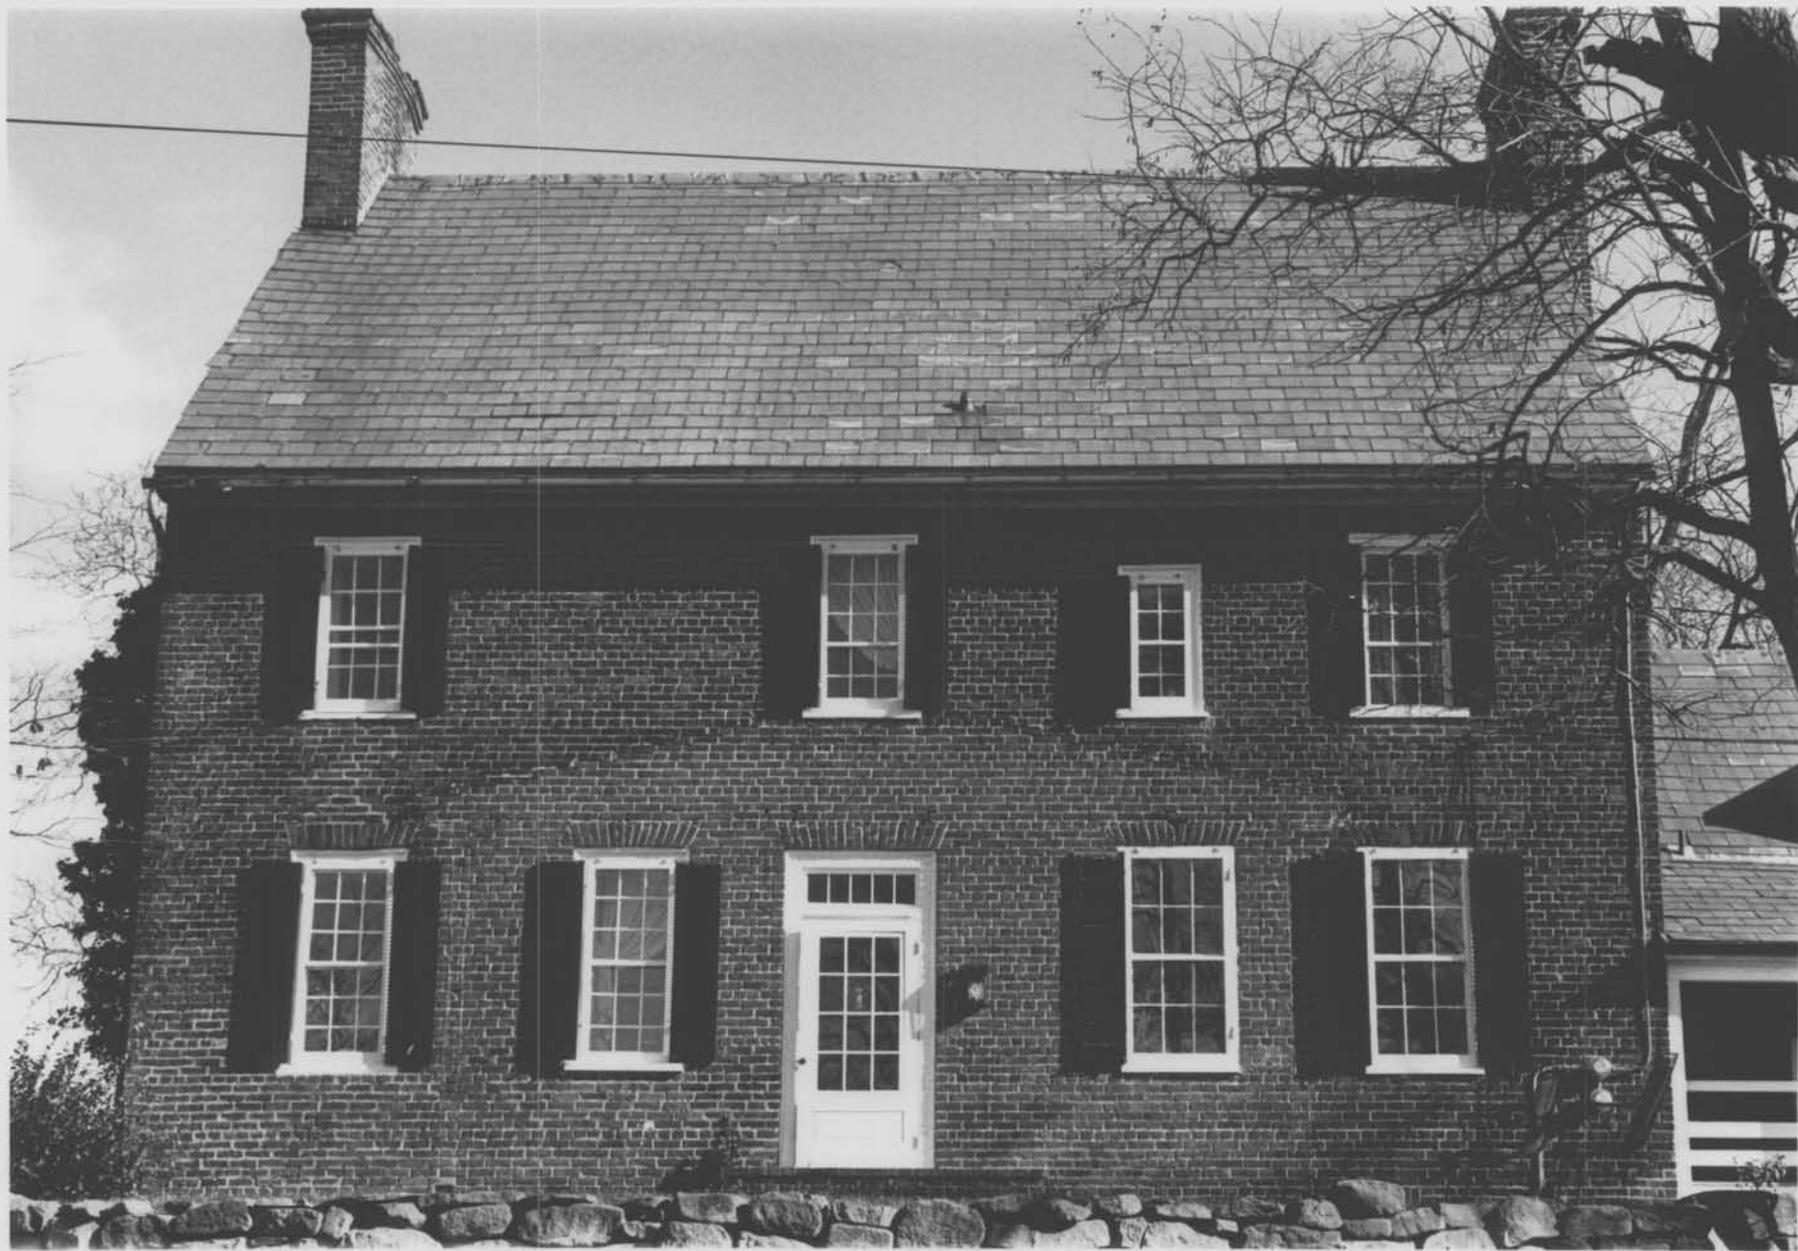
West Facade
Christopher Owens
11/22/1973

The west facade, laid up in common bond, has a central rear door with two nine over nine hung sash to the north and two six over six double hung sash to the south on the ground floor. On the second floor there are three symmetrically spaced, equal sized nine over six windows and an additional small, four over four double hung sash with a single shutter.

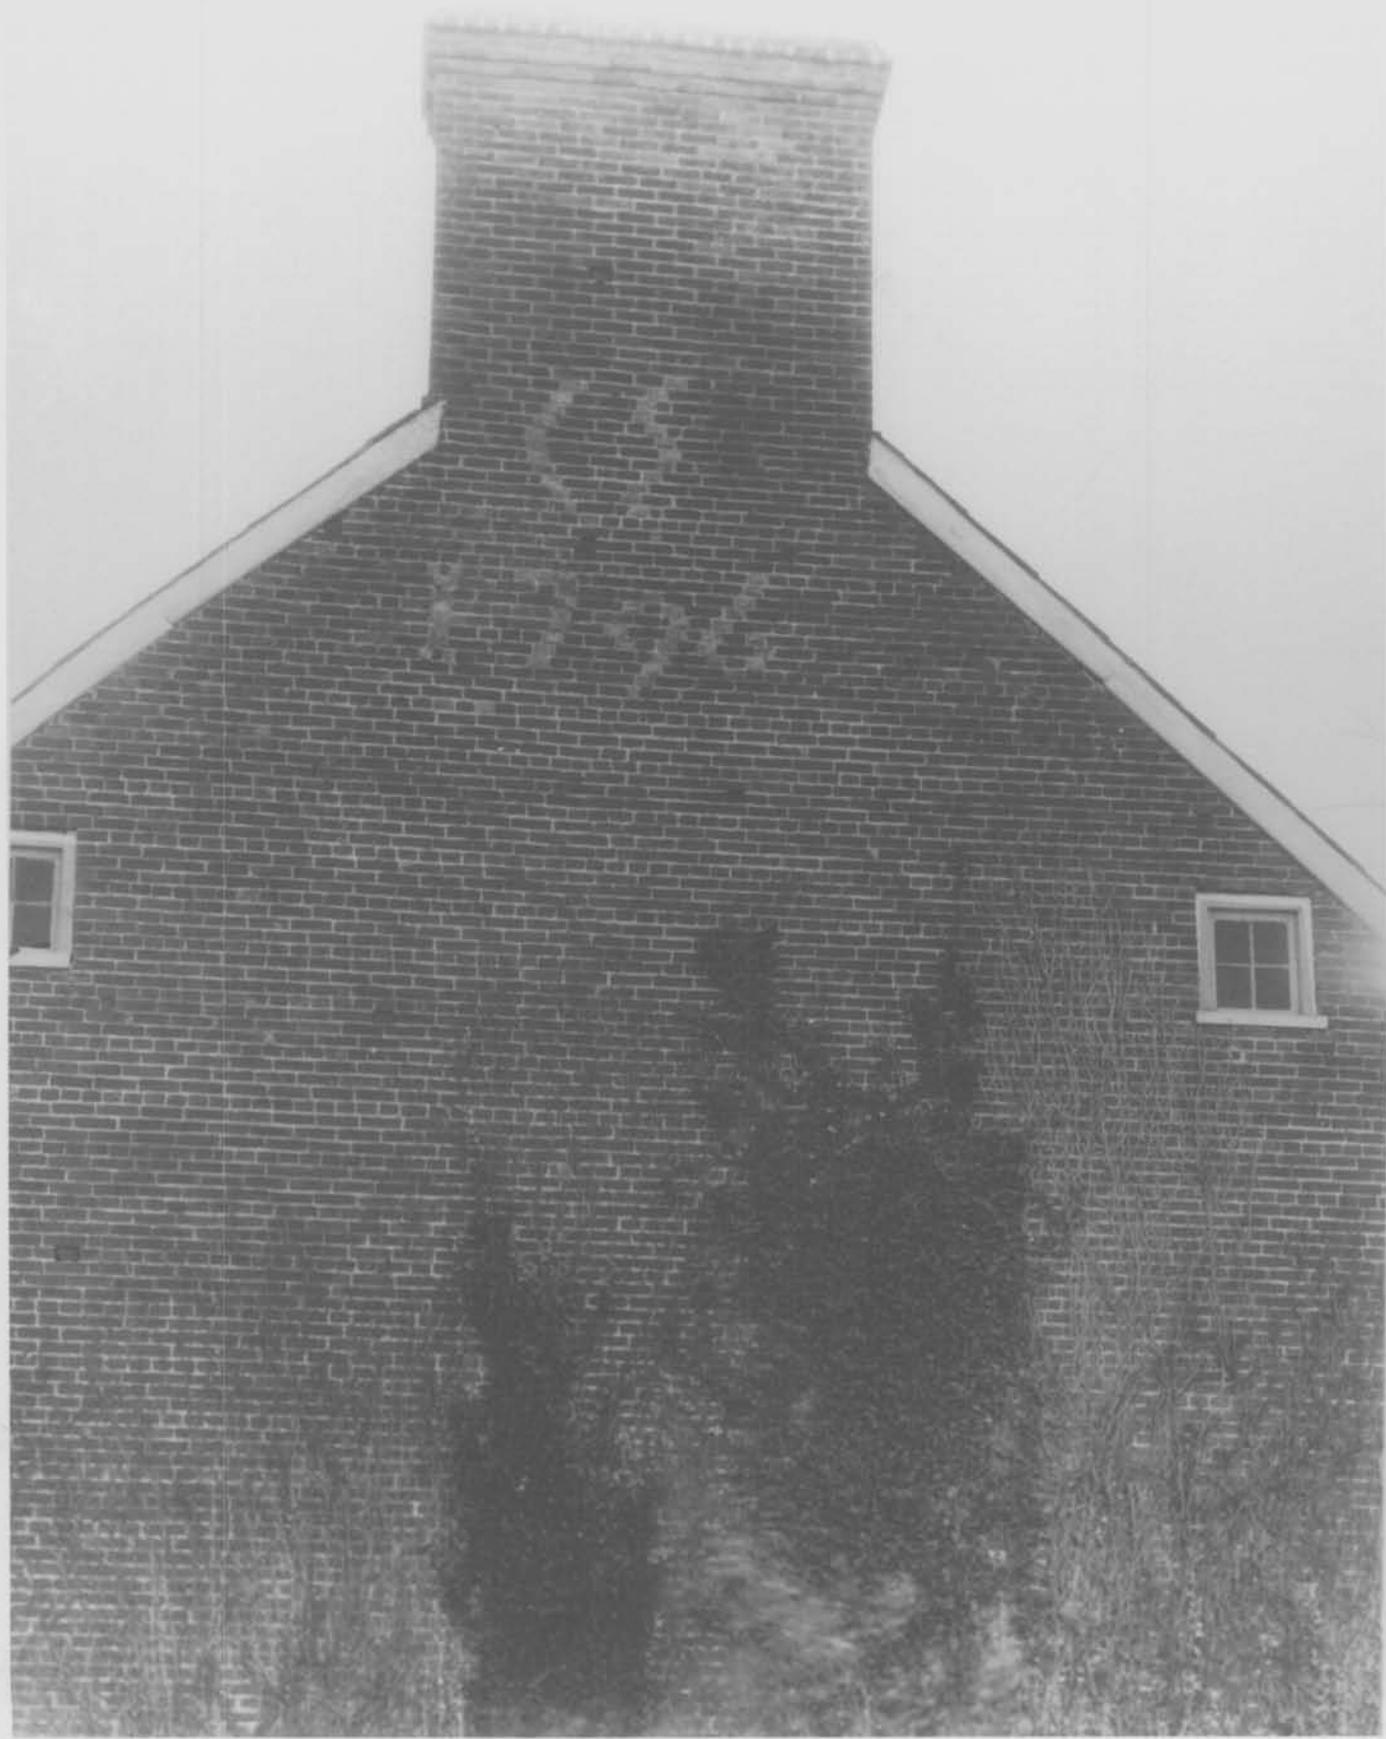
M: 17-19

North wall w/ glazed bricks

The north end, laid up in common bond, has a flush gable chimney capped with five courses of corbelled bricks. Inlaid in glazed brick near the peak of the gable is the inscription "C S" with the date "1796" below. There are small four light windows opening into the attic on the extreme of the gable. Two windows at the east and west extremes of the first floor have been bricked in.
