**NATIONAL REGISTER OF HISTORIC PLACES  
INVENTORY -- NOMINATION FORM**

MORGAN HILL FARM (preferred); Hill Farm

NAME AND LOCATION OF STRUCTURE  
**MORGAN HILL FARM**  
CALVERT COUNTY

HISTORIC AMERICAN  
BUILDINGS SURVEY  
SHEET 1 OF 4 SHEETS

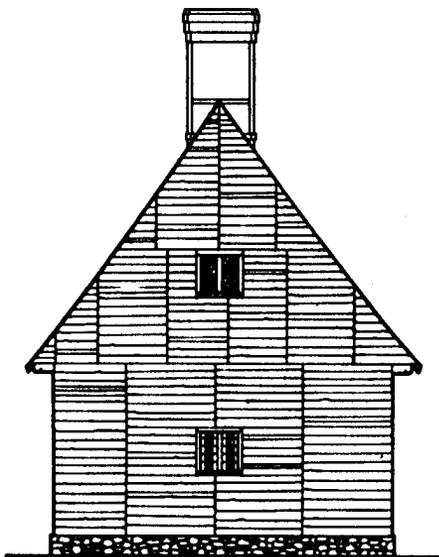
WEST ELEVATION

- Overall dimensions
- Location of central chimney.
- Position of doorway.
- Probable position and length of windows on South elevation.
- Placement and detailing of tie beams.
- Window frames after two-light casement found at Holly Hill.

**CONJECTURAL RECONSTRUCTION OF PERIOD I**

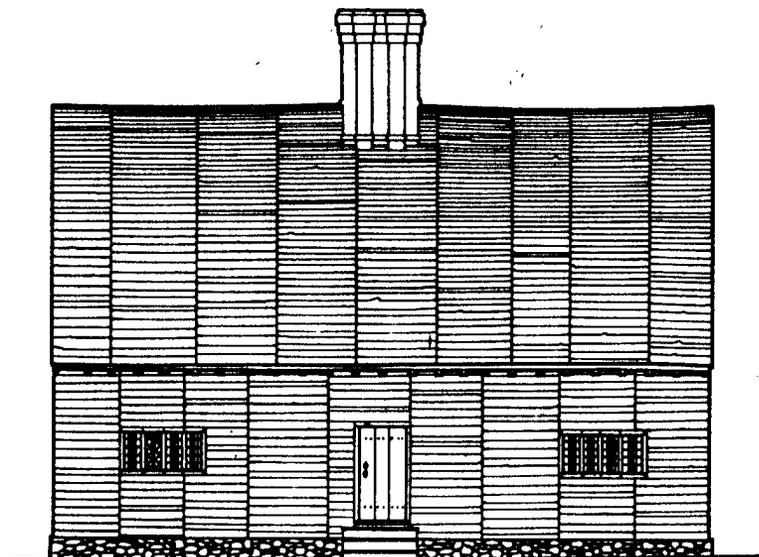
SOUTH ELEVATION

Note: no window stud mortice  
Possible location of original staircase

The present facade of Hill Farm faces southeast, although whether this elevation was the original front is not known. Its center door appears to occupy its original location, but the frames of the two windows flanking it are early nineteenth century enlargements of the originals. The earlier windows were probably similarly positioned but undoubtedly smaller. The same fenestration and door placement is repeated on the northwest elevation, but the door now provides passage between the original house and the later rear wing.

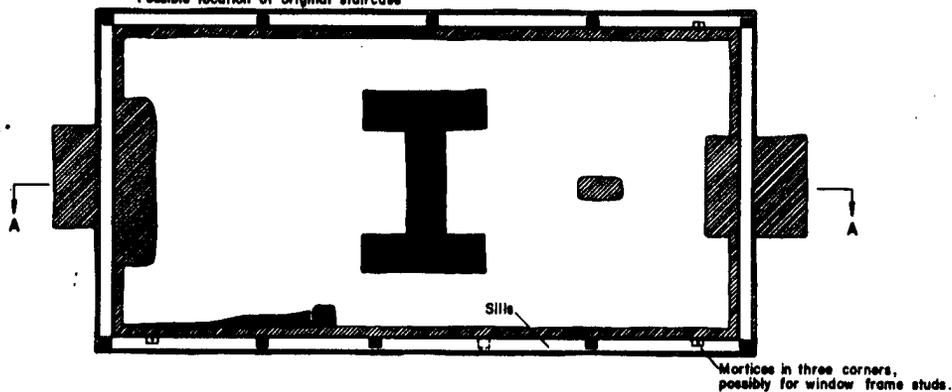
PLAN OF FOUNDATIONS

- PERIOD I = C. 1700
- ▨ PERIOD II = C. 1820-50
- PERIOD I POSTS

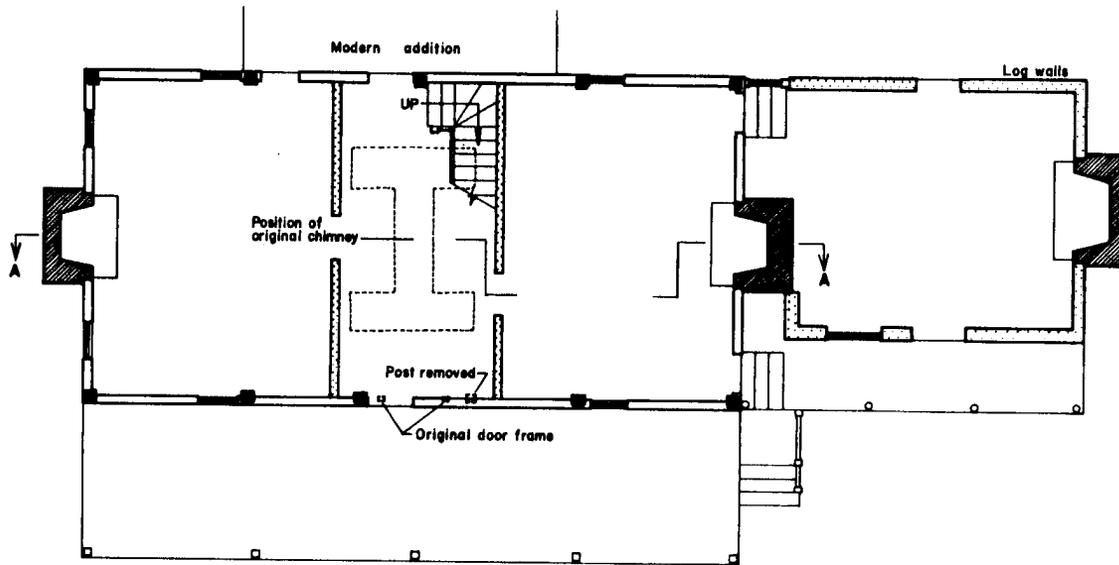
GROUND FLOOR PLAN

- PERIOD I - C. 1700
- ▨ PERIOD II - C. 1820-50
- PERIOD I POSTS

- ▤ LOCATION OF PERIOD I CHIMNEY
- ▨ PERIOD II - C. 1820-50

The first floor room configuration of Hill Farm (see plan A) consists of a center stair hall flanked by a single room on each side. Until the early nineteenth century, the center of the house was dominated by a massive chimney with expansive back to back fireplaces (see plan B). When the chimney was removed, two new (or altered) partition walls were built to provide for the existing center hall. The stair, which has an open balustrade and unusually designed newells composed of two chamfered posts joined at the top by an arched cap, stands in the northeast corner and rises in two flights to the attic. This stair, though undoubtedly

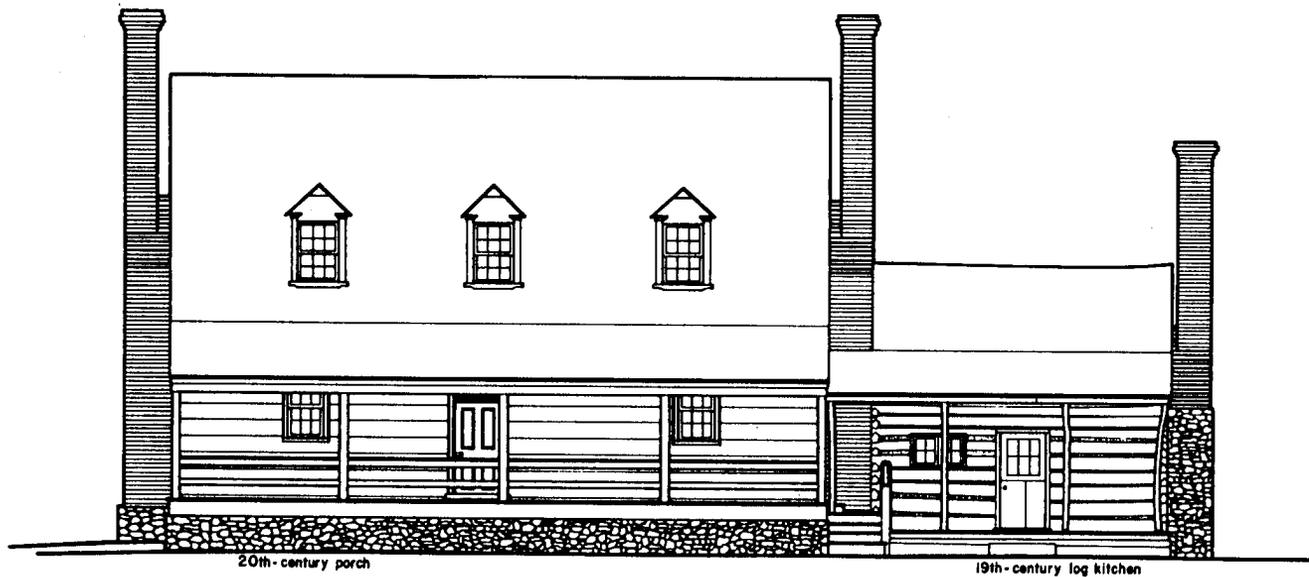
SOUTH ELEVATION

20th-century porch

19th-century log kitchen

The front (southeast) elevation is sheathed with beaded random width flush boards. Although applied using wrought nails, the boards are believed to be contemporary with the early nineteenth century renovations. The remainder of the house is covered with random width lapped boards of about the same vintage. At the end of the house stand single exterior chimneys with stepped weatherings, free-standing stacks, and fieldstone bases. These chimneys were added to the house in the early nineteenth century when a massive central chimney was removed. On the south slope of the gable roof are three peaked dormers. Two dormers (originally three) are on the north slope. These windows were apparently added during the renovation and do not appear to have replaced earlier windows. The eaves are now boxed but were originally open, revealing projecting joist ends with rounded bases and diagonal false plates with chamfered edges. The exposure of the eaves was a fairly common treatment throughout the seventeenth and eighteenth centuries; however, few examples have been found that display the same decorative treatment as those at Hill Farm.

On the northeast end of the house, positioned east of center line, is a one-story log wing moved here from a former location near the town of Lusby. Its detailing suggests that it was first built in the early nineteenth century. It now houses a modern kitchen and has a large fireplace on the northeast end.

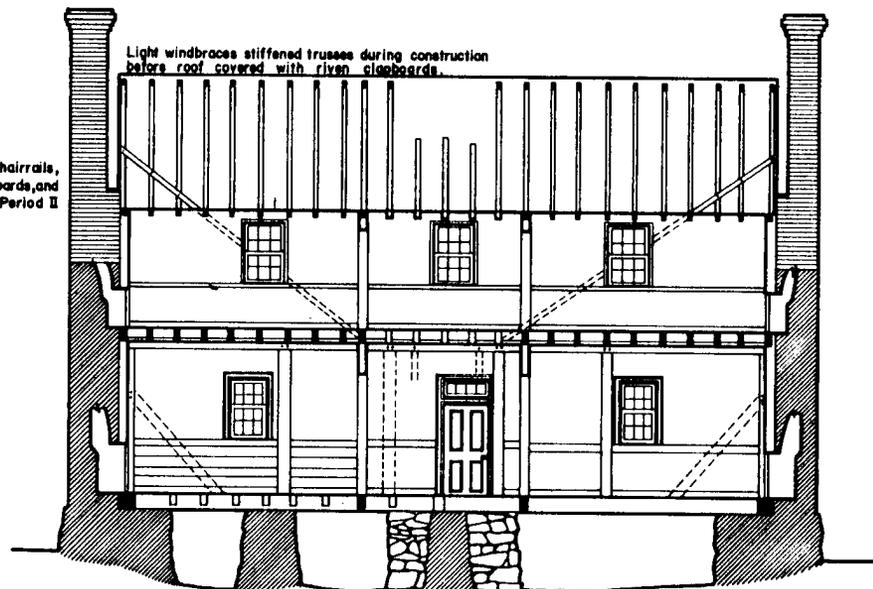
SECTION AT A-A

Light windbraces stiffened trusses during construction before roof covered with riven clapboards.

All chairrails, base boards, and dados Period II

Hill Farm is framed in five ten-foot bays. Major wall posts, five on a side including corners, are exposed in all three first-floor rooms. These, as well as the exposed wall plates, end girt and ceiling joists, have beaded edges and are painted. The remaining wall surfaces are plastered. The baseboards, rails, window and door surrounds, doors, mantels and window sash are of the early nineteenth century. In the attic are two bedrooms and a hall, all with exposed and beaded principal rafters, purlins, diagonal wind braces and collars. Like the first floor, the remaining wall surfaces are plastered.

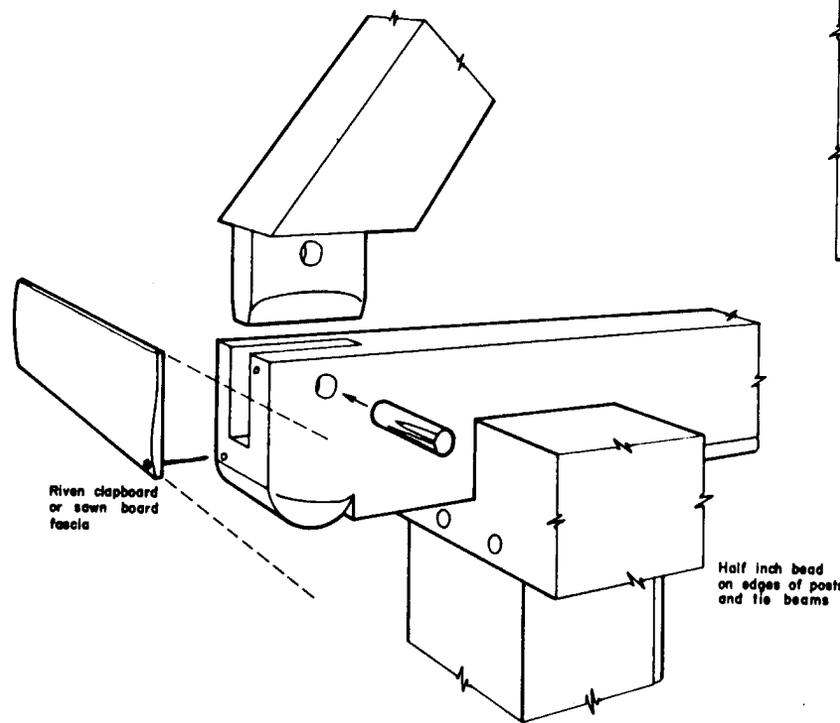
**EXPLODED VIEW**  
 EAVES CONSTRUCTION ON NORTH ELEVATION  
 (Not to scale)

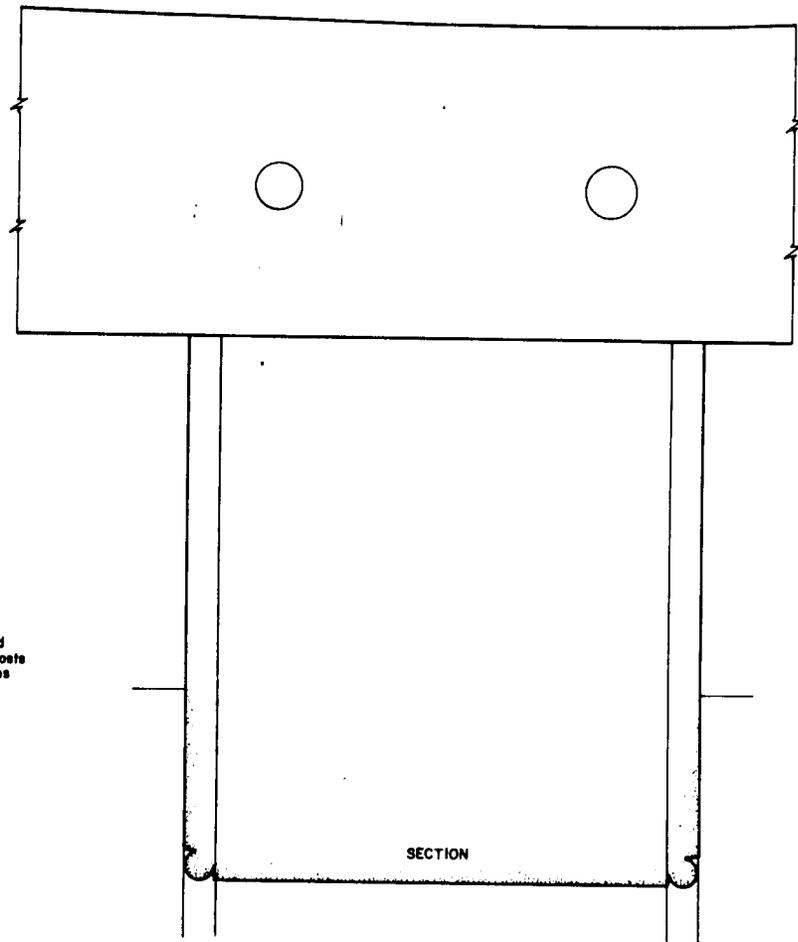
**INTERIOR POST AND PLATE DETAIL**
