**NATIONAL REGISTER OF HISTORIC PLACES  
INVENTORY -- NOMINATION FORM**

William Hilleary House

Magruder House or Old Stone House

4703 Annapolis Road

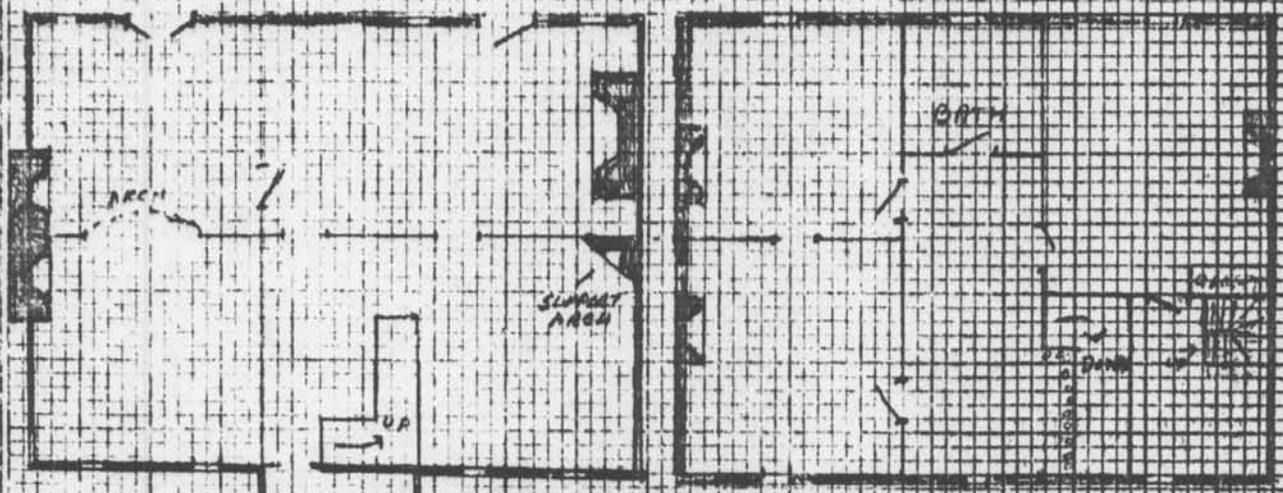
1ST FLOOR

BASEMENT

2ND FLOOR

SUPPORT ARCHES

NOT DRAWN TO SCALE

The floor plan is similar on all three floors being that of a center hallway, with a room on either side of it at the front of the house. The hall terminates in the southwest room at the rear of the house on the first floor and in the cellar. The main entrance door (north facade) is panelled both inside and outside. It is extremely wide and has HL hinges. It is set in a conventional frame on the top and west side. The east side has no trim on the frame, being set flush with the east wall of the hallway. The door and window casings are about six inches wide. Only one

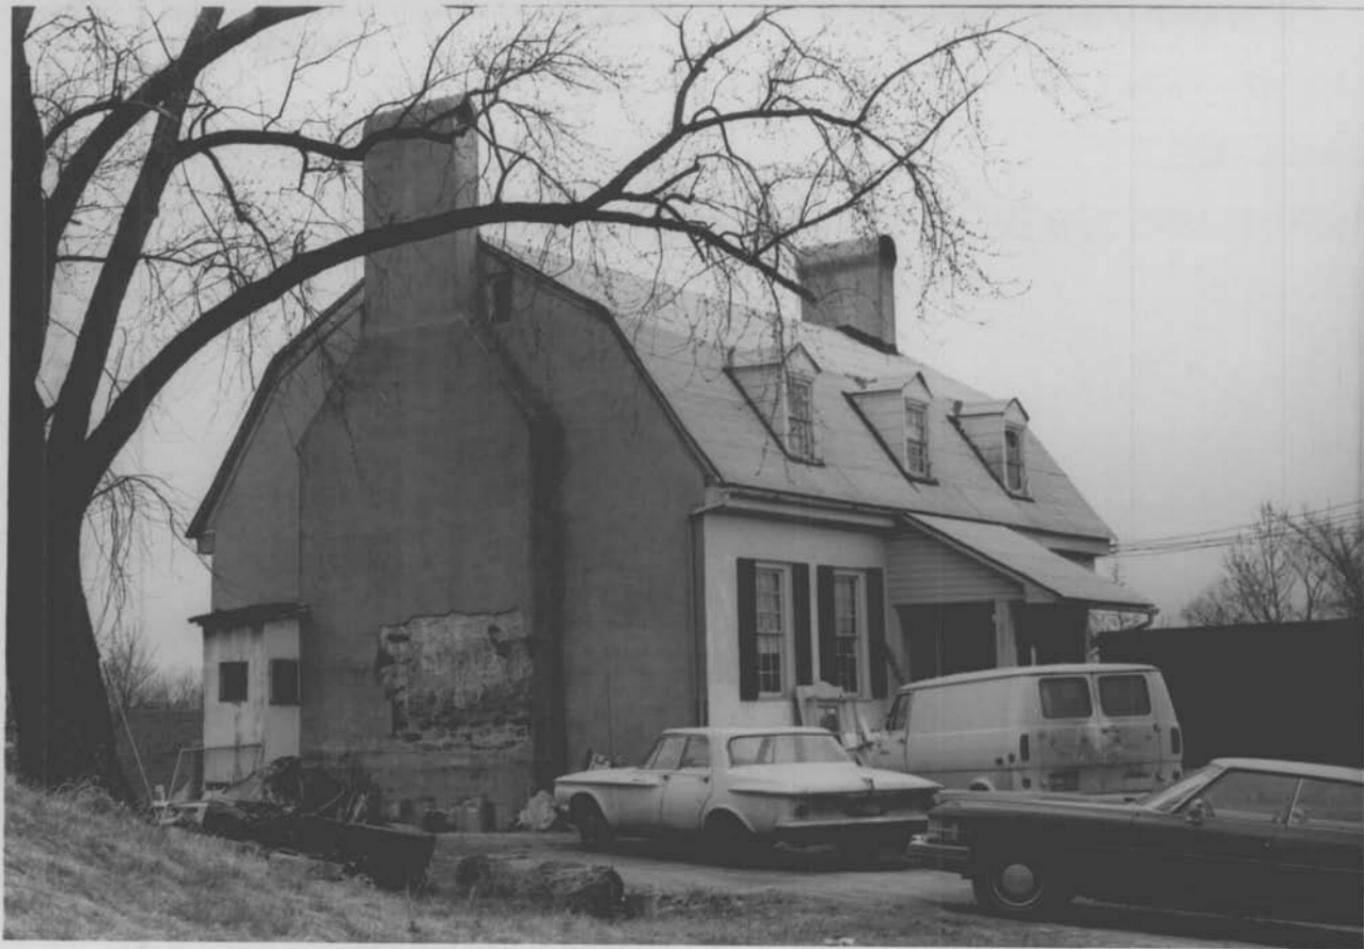
NAME MAGRUDER HOUSE

FACADE NE

The main entrance is centered on the five-bay north facade. On either side of it are two evenly spaced nine-over-nine-light sash windows. Four small basement windows are beneath these at ground level. The walls of the house, at the doorway, are curved inward, toward the doorway, decreasing their thickness. The wide door has six panels--two tall panels at the top and bottom and two square ones in the center. A modern doorway has been placed in the southeast corner of the house for outside access to the first floor kitchen. It has a small stoop and stairway leading to the rear ground level. The windows at the first floor level on the south side of the house are unevenly spaced as are the doors and windows on the ground level. All the openings at ground level have vaulted lintels of brick. Near the west end there is a door with a six-over-six window on each side of it. At the opposite end of the rear wall is a double-width door and one window of four lights.

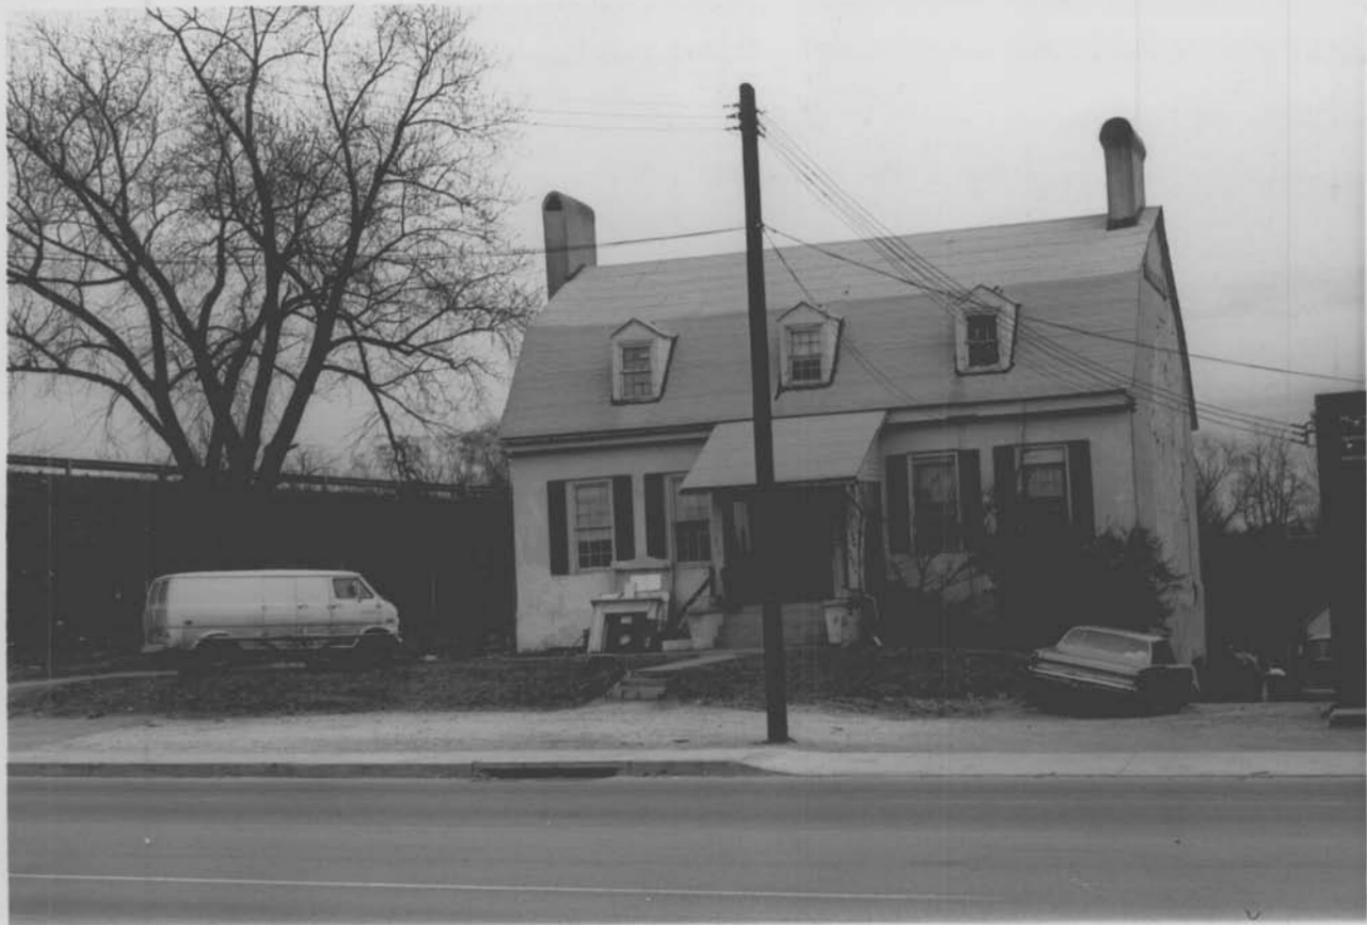
NAME MAGRUDER HOUSE (William Hilleary House PG: 69-7)

FACADE N
