# NATIONAL REGISTER OF HISTORIC PLACES INVENTORY -- NOMINATION FORM

Little Elk Farm (PREFERRED)

The Little Elk Farm is a late 18th century (1775-1800) stone structure located a mile north of Maryland Route 273 on Little Elk Creek Road. The main facade faces southwest with the primary gable running on a northwest/southeast orientation. The farmhouse has a scenic view of meandering Little Elk Creek.

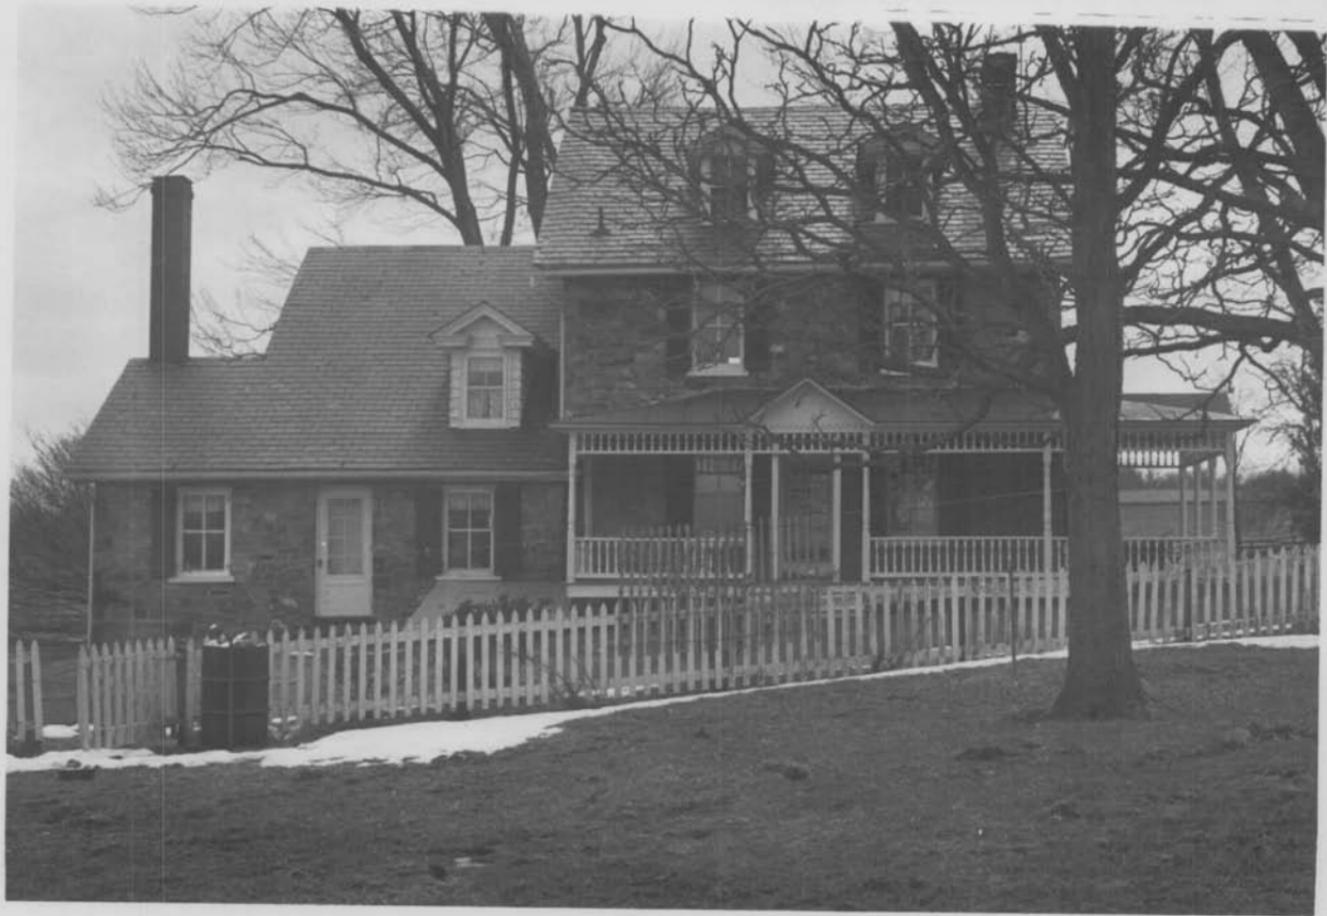
②

The north (rear) side of the main block is three bays across with the central bay as an entrance with French doors. There are only two windows on the second floor. Dormers identical to those on the front of the house are also located on the north slope of the roof. The back porch extends across the full length of the north wall.

back of house  
from north

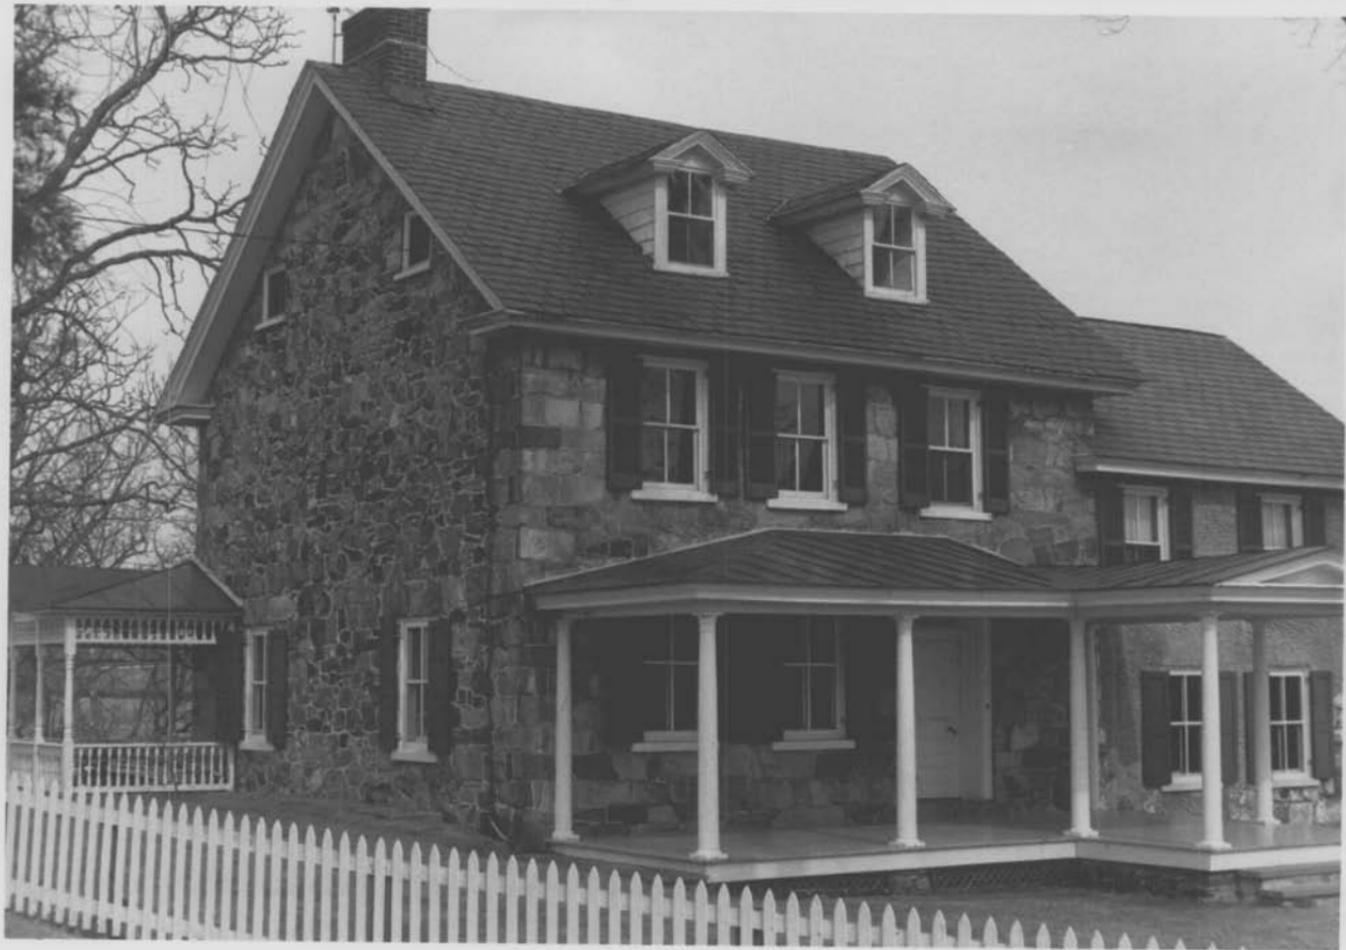
Little Elk Farm

The southwest (front) facade is laid with cut and coursed stone with larger cut quoins. The entrance is the third of five bays from the west. A late 19th century door with multi-pane transom has replaced the earlier door. The door has two horizontal panels below the lock rail and is glazed above. The window openings are symmetrically placed. A 2/2 sash with half-round molding for window surrounds has replaced the earlier sash in every instance. There are two 2/2 sash dormers on the main roof. The eaves on the dormers are extended with short returns. The sides are weatherboarded. The main cornice was replaced when the roof was recovered.

SOUTHWEST ELEV.

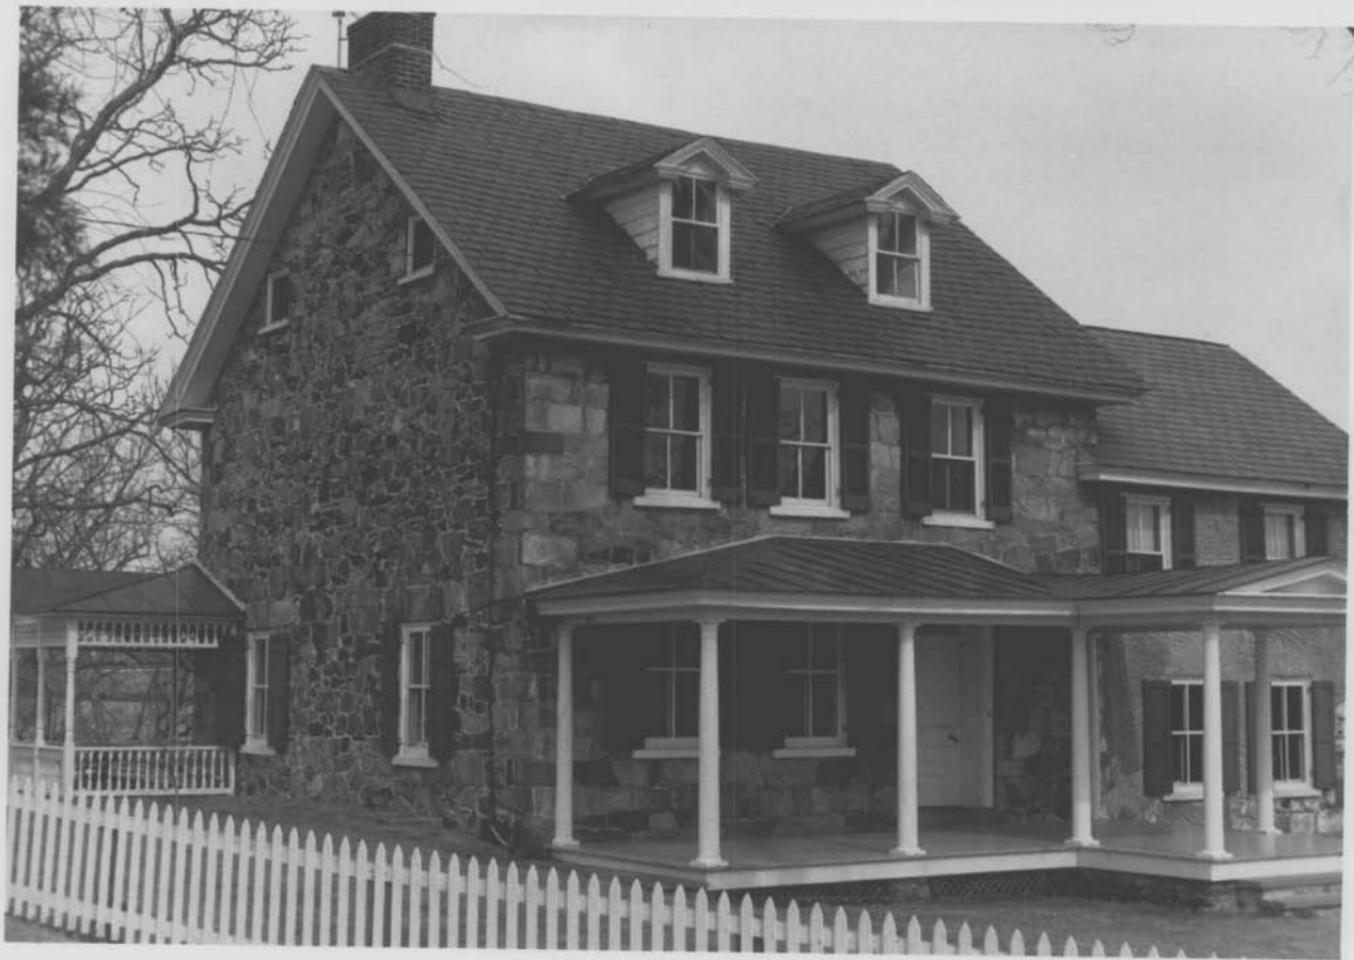
LITTLE ELK FARM

SOUTH WEST
