National Register of Historic Places  
Inventory—Nomination Form

and/or common Octorara Farm

city, town Conowingo  vicinity of congressional district First  
state Maryland code 24 county Cecil code 015

CE-41

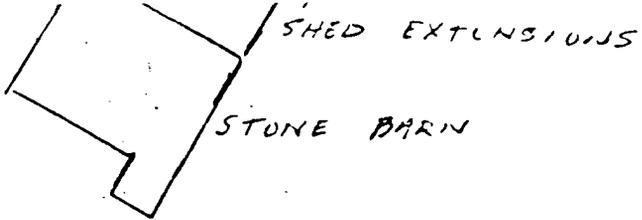
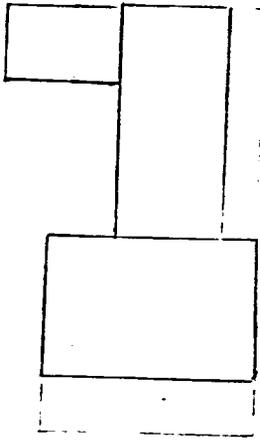
SKETCH OF FARM PLAN

MAIN HOUSE

DRAWING NOT TO SCALE

The main block, which faces west, is a 2½-story, four-bay wide brick structure composed of four rooms on both the first and second floors; it was probably added to the rear section around 1830-1840. The rear section, with a principal axis perpendicular to the main block, has undergone two periods of rebuilding and alteration. The present kitchen, which constitutes the central room of the three rooms of the rear section, is the earliest section of the house. The stuccoed stone hall/parlor structure, as originally built, was three bays across by one room deep and 1½ stories high. A 2½-story fieldstone addition, three bays across by one room deep was attached to the eastern gable in the early to mid-19th century. Positioned perpendicularly to this latter addition is a contemporaneous two-bay by one room, 2-story fieldstone section joined to the latter addition at second story level with a passageway separating the sections on the first floor. This latter addition, three bays across by two deep with a medium sloped slate roof, contains an entrance in every wall except the north one where there occur two 4-pane windows similar to the small windows which illuminate the second floor.

In the second quarter of the 19th century, when the entire character and orientation of Octorara was transformed by the construction of the adjacent main block, other changes altered the configuration of the rear section including the raising of the roof of the 1½ story kitchen section to two stories and the enlarging of the original hall of that section into a dining room by two additional bays to the west of the doorway. At this time, the rear section received two-story porches to its north and south facades.

Evidence for this building sequence occurs in the attic of the kitchen section where there are two obsolete gable-end windows which substantiate the fact that the adjacent section was previously lower. In addition, the fact that the original 1½ stories predated that raising is indicated by the trim in the second story of the kitchen section which corresponds closely with its contemporaneous trim in the main block. The raised panel dining room door with raised reveals is an earlier version of the paneled doors in the rest of the house. Differences in the first floor joists were also an indication of a later addition. The joists under the kitchen area were left in the round while those under the present dining room were sawn. On the exterior of the kitchen wing are other indications of an earlier date: ovolo backbanded window trim and dining room door architraves and narrow 9/9 window sash.

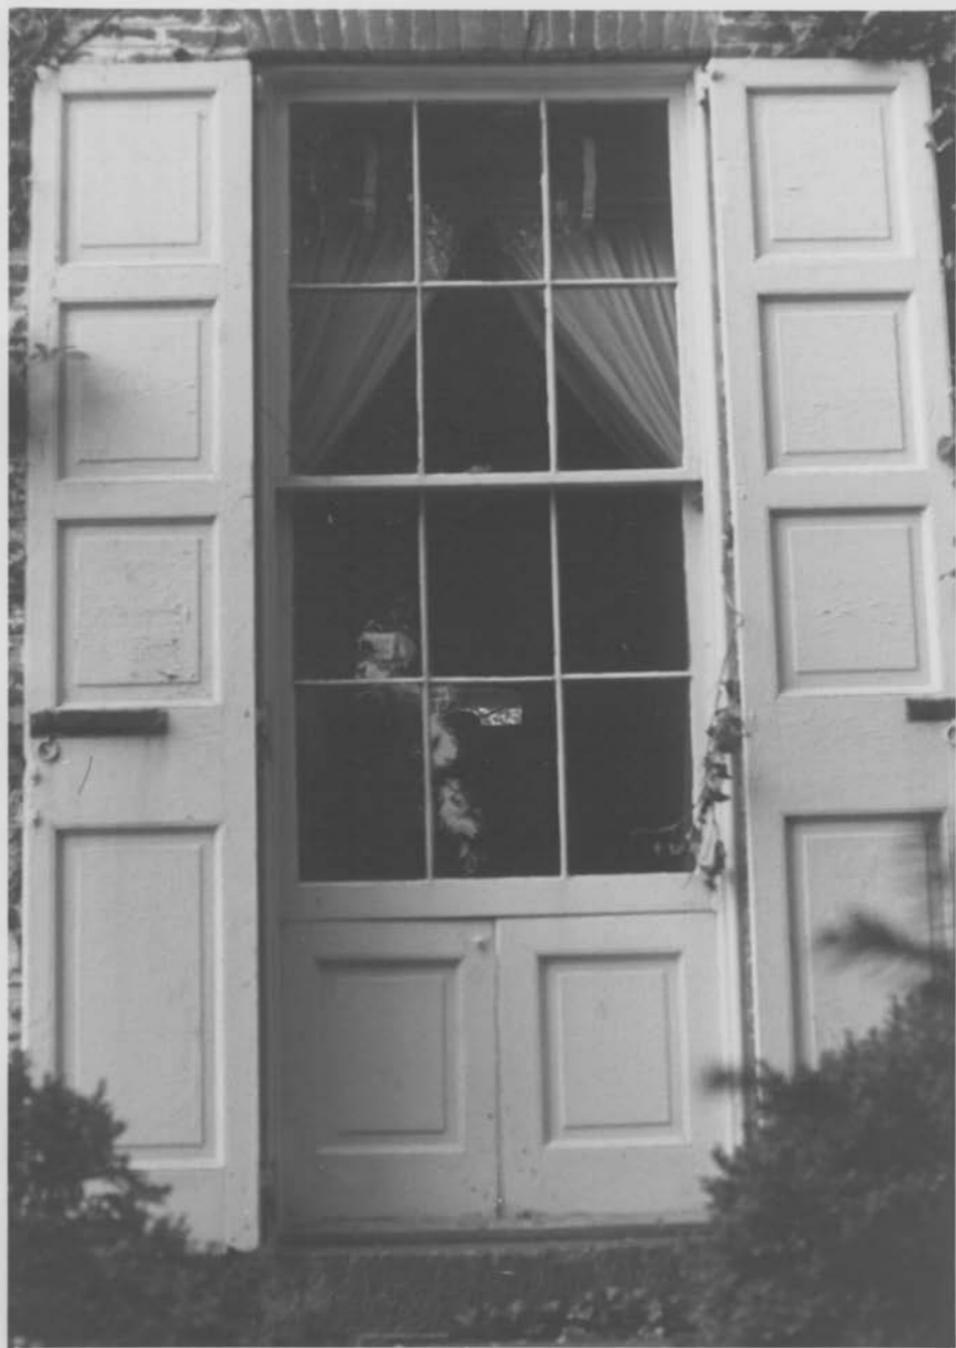
SOUTH ELEVATION -

JIB

DOOR

The south facade of the main block is detailed like the north gable end except for a jib door which opens into the library. This entrance is approached by a brick stoop.

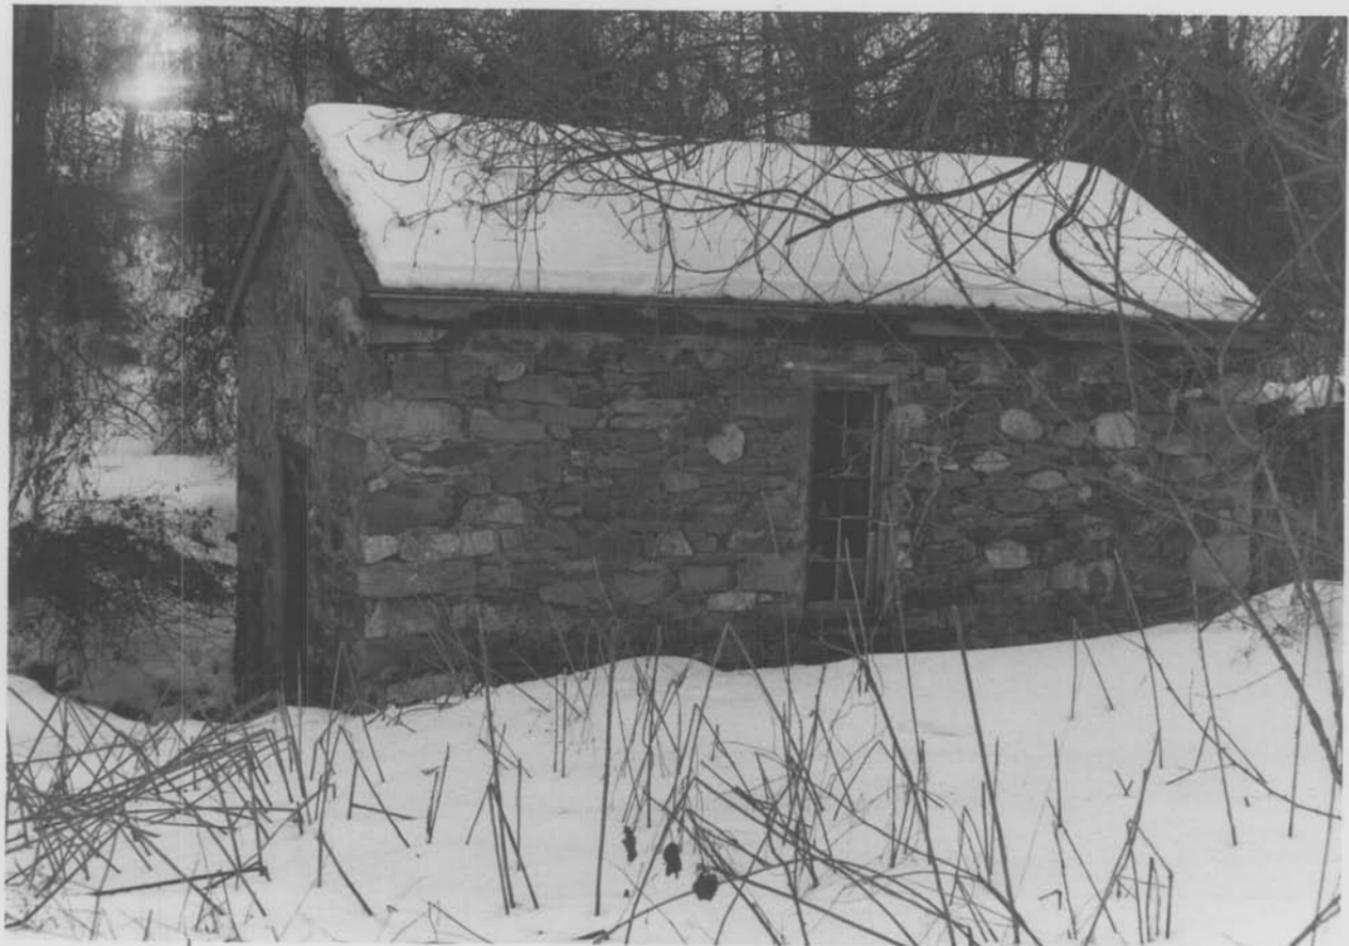
SPRING HOUSE

EASTERN ELEVATION

Two uncoursed field-stone structures stand at the southern extremity of Octorara Farm, a springhouse and a probable tenant dwelling. The springhouse is a single-story, one bay by one bay structure topped by a wood-shingled, gable roof of medium slope. Access to the interior is gained through a board door in the south gable end. A narrow, ten-pane window with a single beaded surround punctuates the east facade.
