National Register of Historic Places Inventory—Nomination Form

historic Kirk, Elisha, House (PREFERRED)

and or common Emery House

Elisha Kirk House, Cecil County
Continuation sheet Maryland Item number 7 Page 1

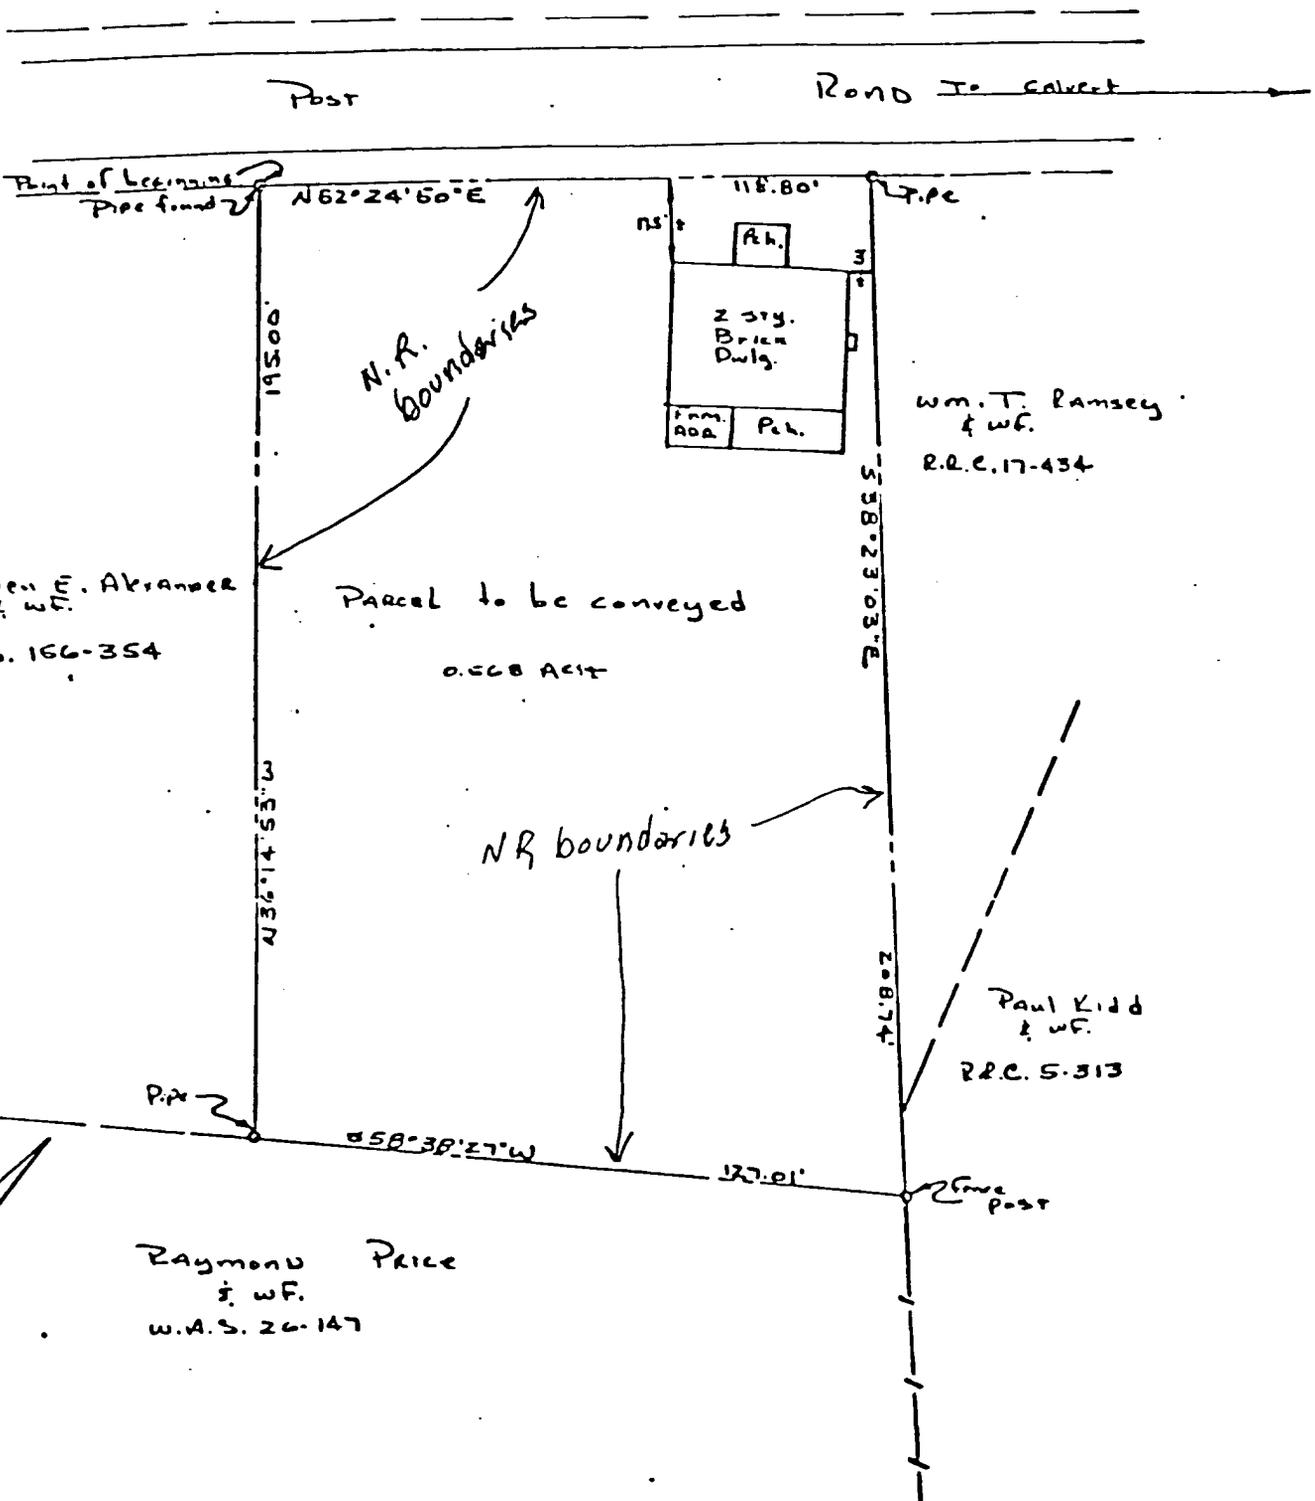
National Register boundaries

The boundaries of the property being nominated are delineated on the enclosed map labeled National Register Boundaries.
