**National Register of Historic Places  
Inventory—Nomination Form**

historic Gallagher Mansion and outbuilding

street & number 431-435 Notre Dame Lane, near York Road N/A not for publication

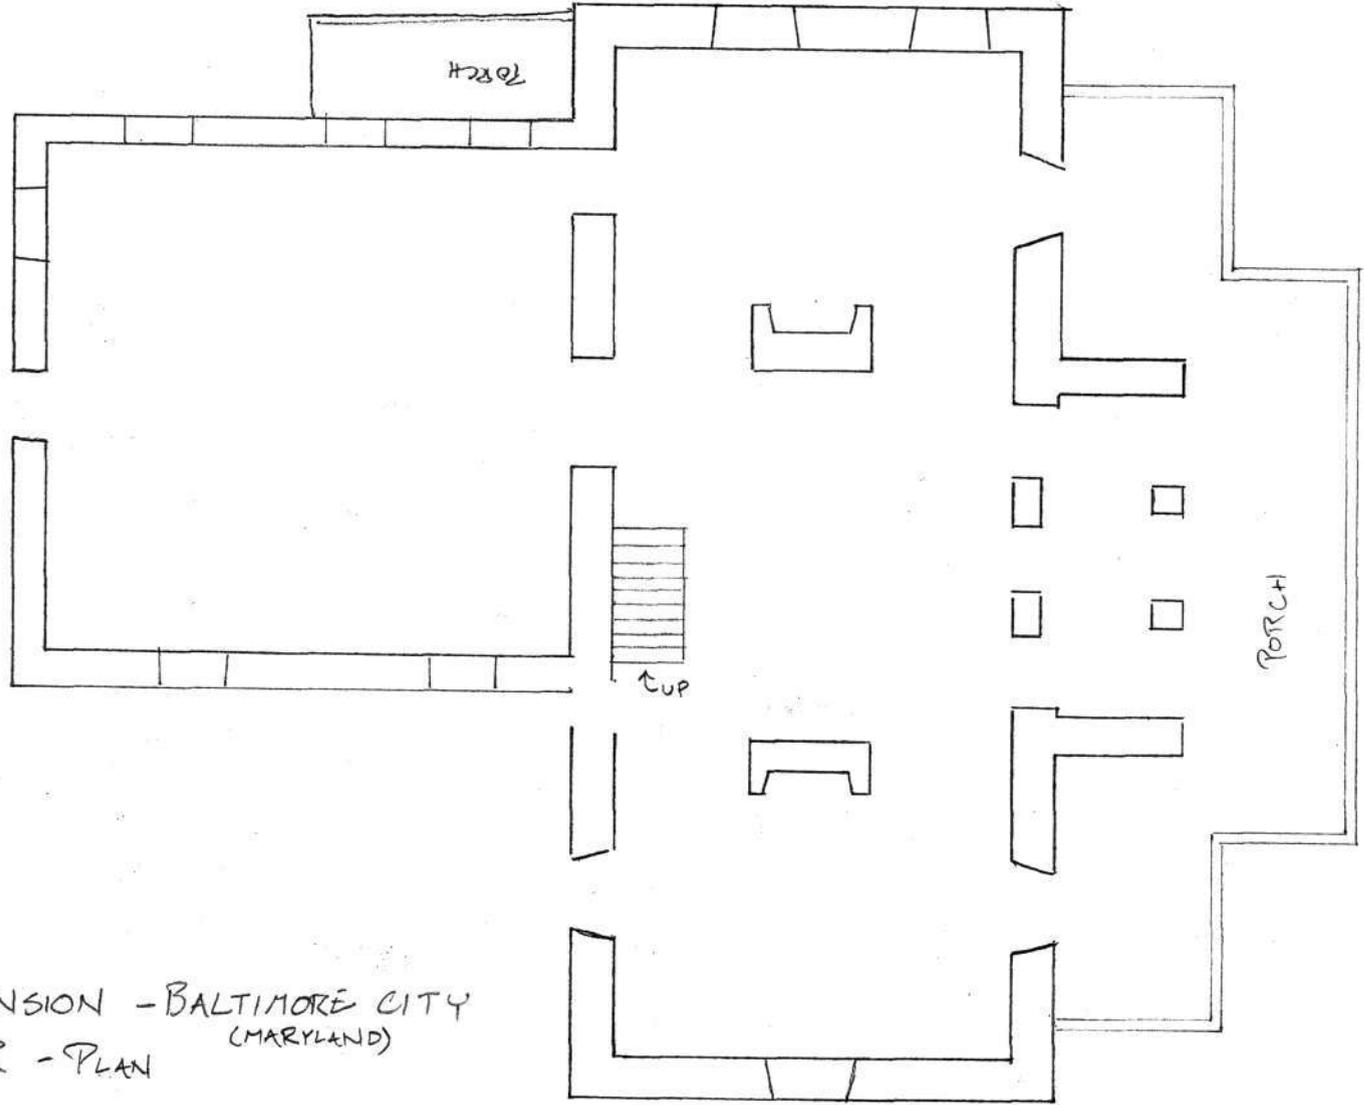
GALLAGHER MANSION - BALTIMORE CITY  
FIRST FLOOR - PLAN (MARYLAND)

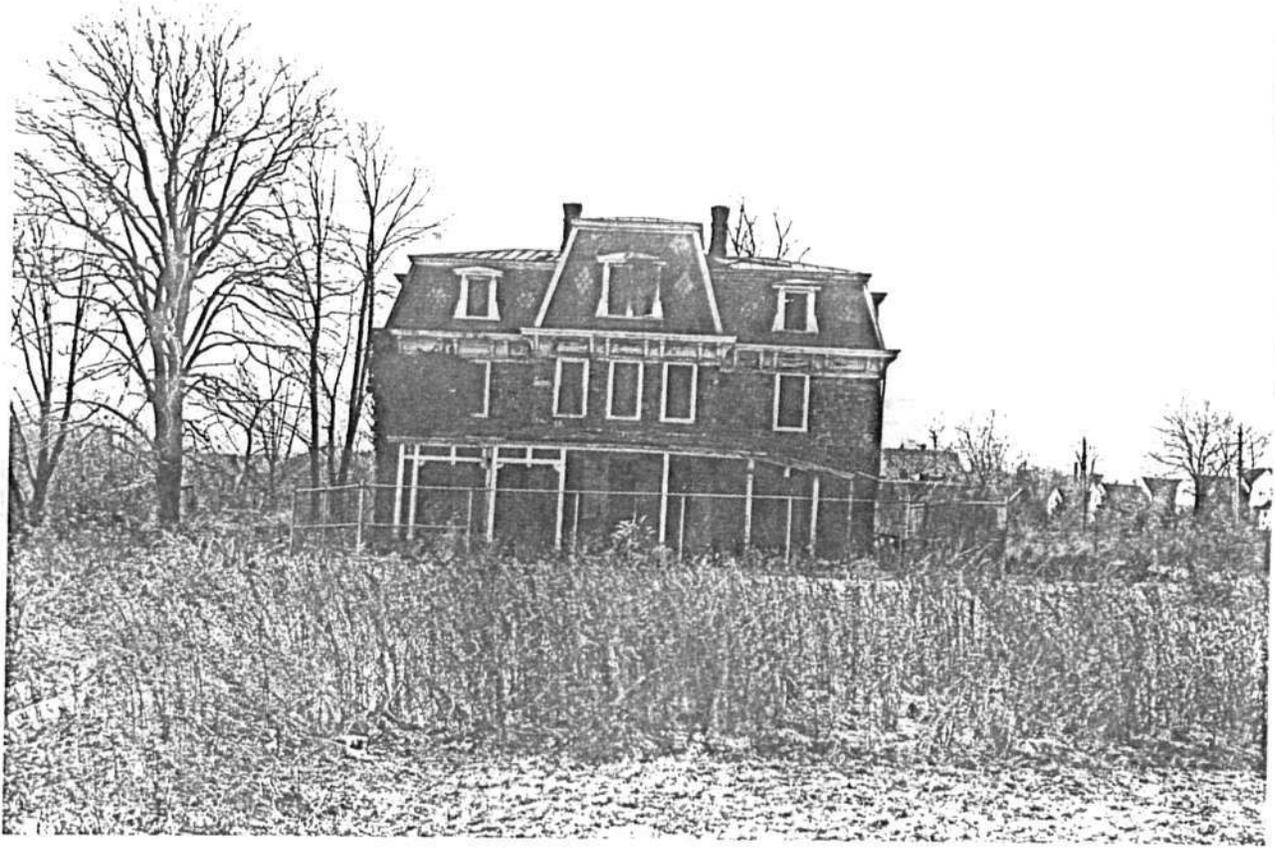
#1/21

GALLAGHER MANSION  
BALTIMORE CITY  
FEB. 1982  
PHOTO BY JEFFREY HONICK  
NEG. AT C. H. A. P.  
MAIN (EAST) ELEVATION

On the main (eastern) elevation, a central section three bays wide projects forward from the rest of the house, and the mansard on this section is higher than the roof on the rest of the house. At the first story of this projection there are three arches leading into an entrance loggia, where there is a doorway in the center and French windows on either side with full-height louvered shutters. On the second story on this front projection there are three 4/4 windows. At the third story, on the front of the mansard, there is a pair of 4/4 windows in a single pedimented dormer.

On either side of the front projection there is a large side wing. The east (front) elevation of each side wing is one bay wide, but it is a very wide bay. On the first story of the east elevation of each side wing there is a French window; on the second story of each wing there is a 4/4 window; and on the third story of each wing there is a 2/2 window in a pedimented dormer.

Across the entire first story of the east facade there is a roofed wooden porch with square wooden posts and quarter-round decorative brackets.

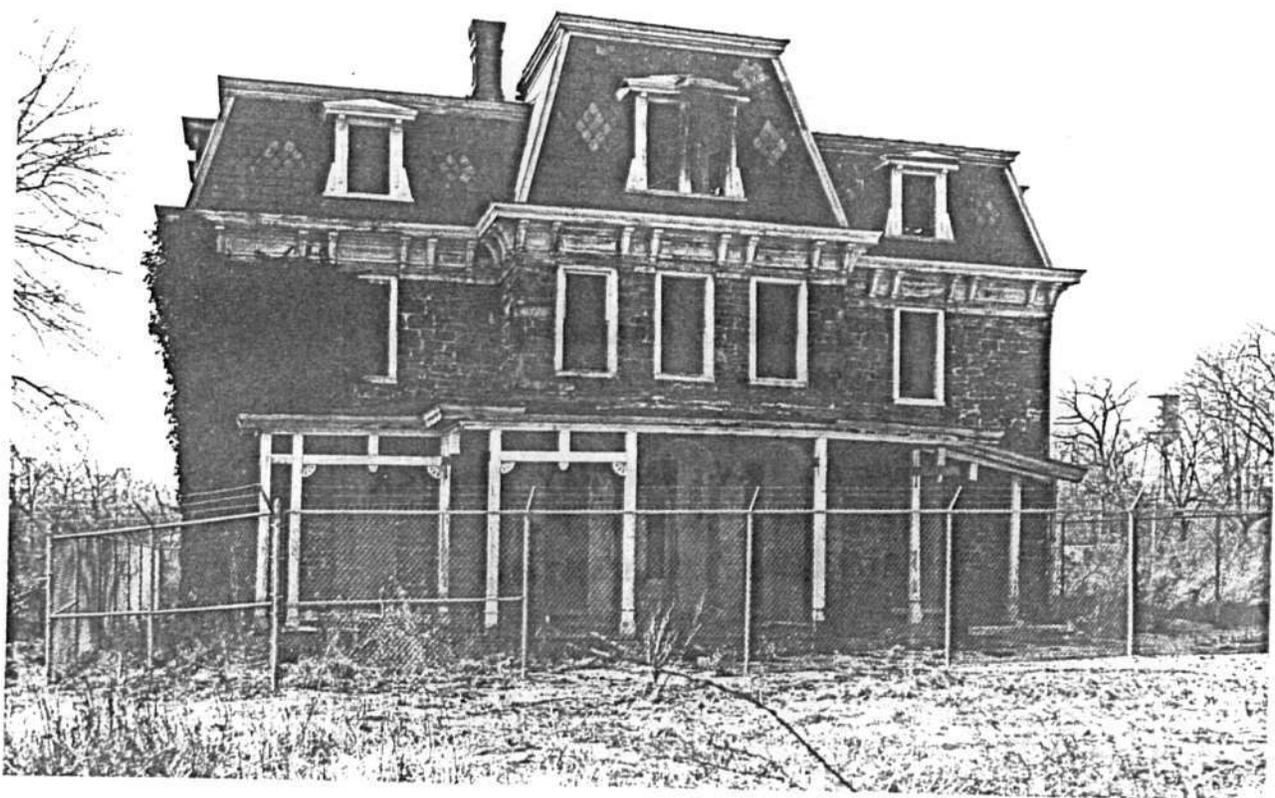
#2/21

GALLAGHER MANSION  
BALTIMORE CITY  
FEB. 1982  
PHOTO BY JEFFREY HONICK  
NEG. AT C. H. A. P.  
MAIN (EAST) ELEVATION

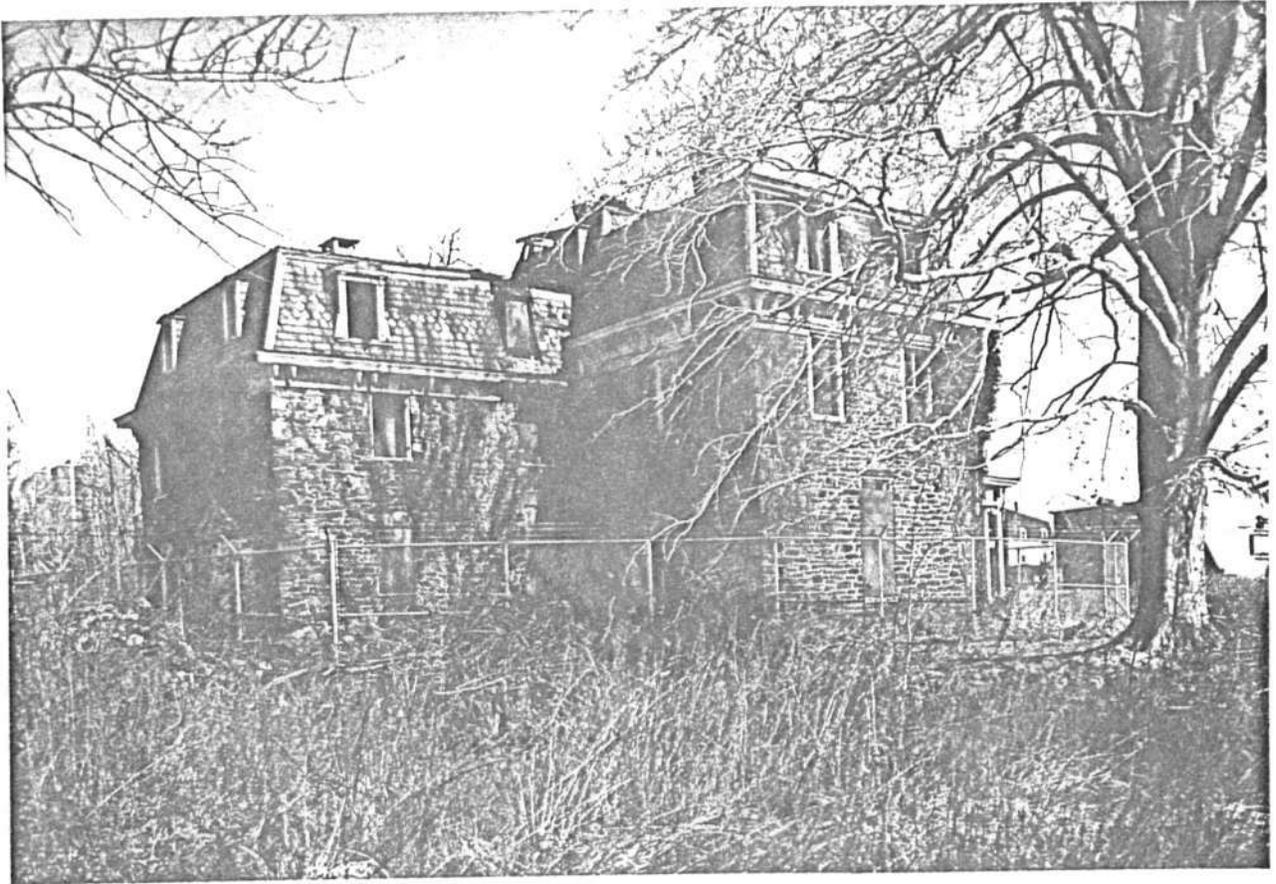
#3/21

GALLAGHER MANSION  
BALTIMORE CITY  
FEB. 1982  
PHOTO BY JEFFREY HONICK  
NEG. AT CHAP  
VIEW FROM S. W.

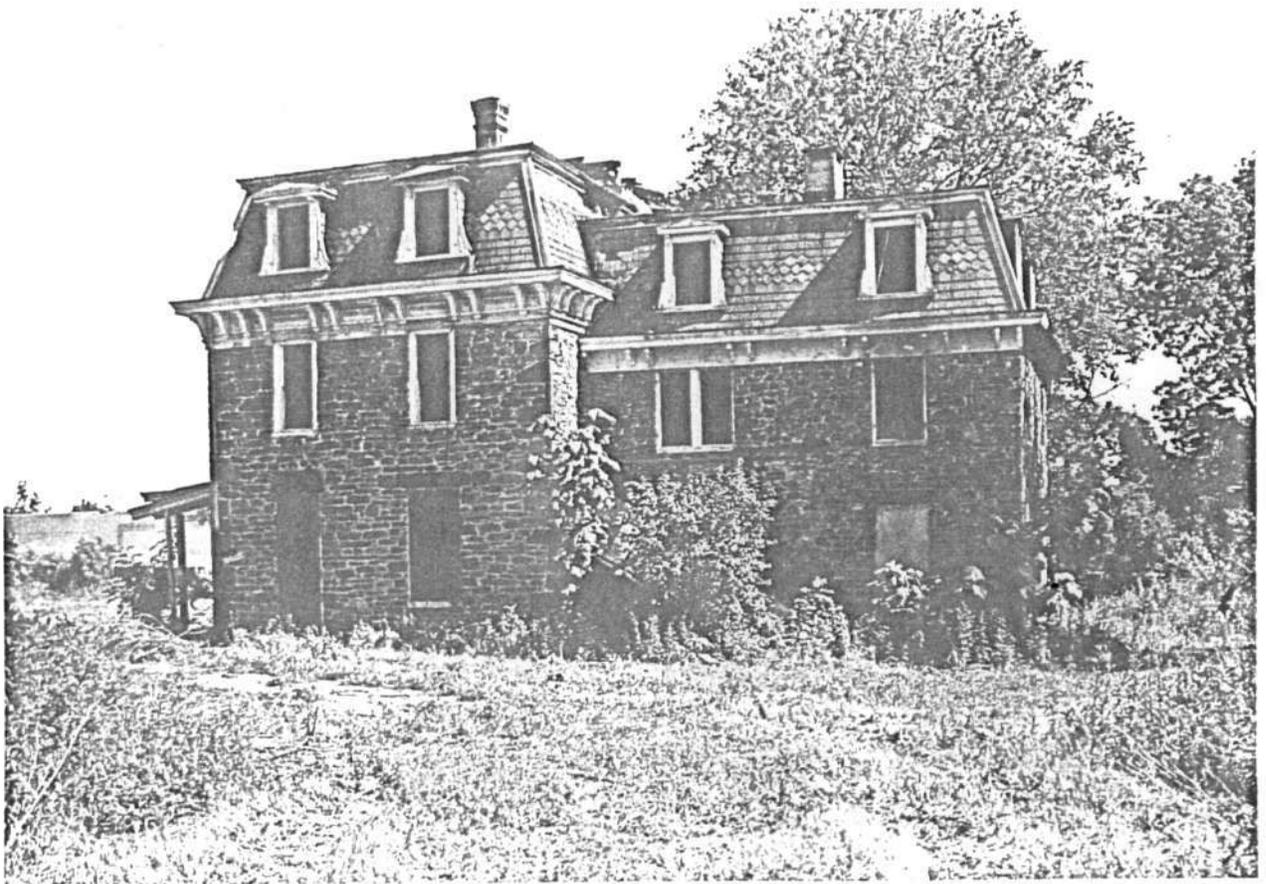
GALLAGHER MANSION - BALTIMORE CITY  
PHOTO BY JEFFREY HONICK  
JUNE 1980  
NEG. AT CHAP  
VIEW FROM NORTH

The north elevation of the northern side wing is two bays wide. On the first story there is a French window and a 6/6 double-hung window. On the second story there are two 4/4 windows, and on the mansard there are two 2/2 windows, each inside a pedimented dormer. The south elevation of the southern side wing is similar, except that it has only a French window in the center of the first story.

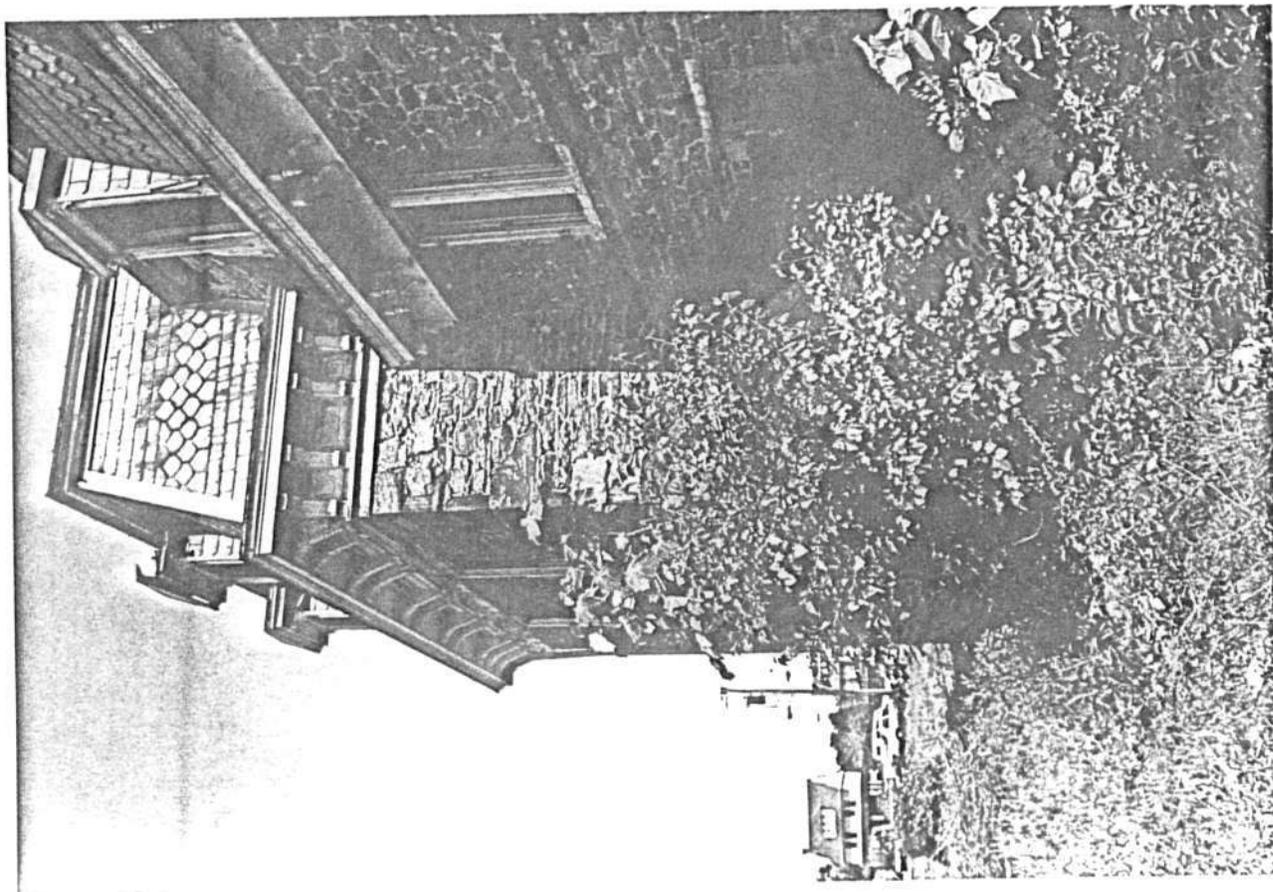
#5/21

DETAIL OF NORTH SIDE

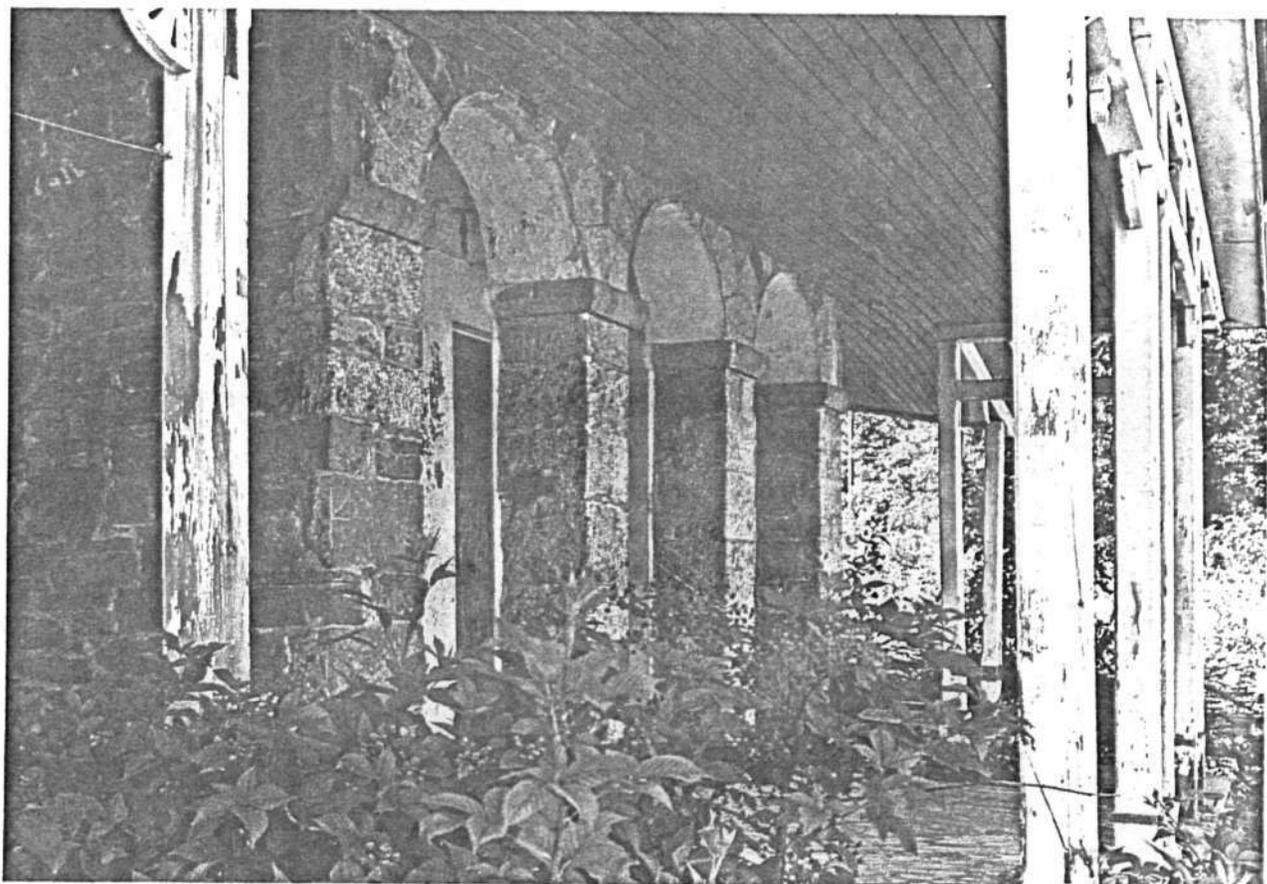
#10/21

THREE ENTRANCE ARCHES LEADING  
TO ENTRANCE PORTICO

The most identifiably Italianate feature on the house is the entrance loggia with its three round arches. The main part of the house was originally only two stories high; the roof was probably a low-pitch hip roof. There is no evidence of there having been a tower, but there may have been a cupola. Unlike many Italianate villas which are massed asymmetrically, this house was built symmetrically.

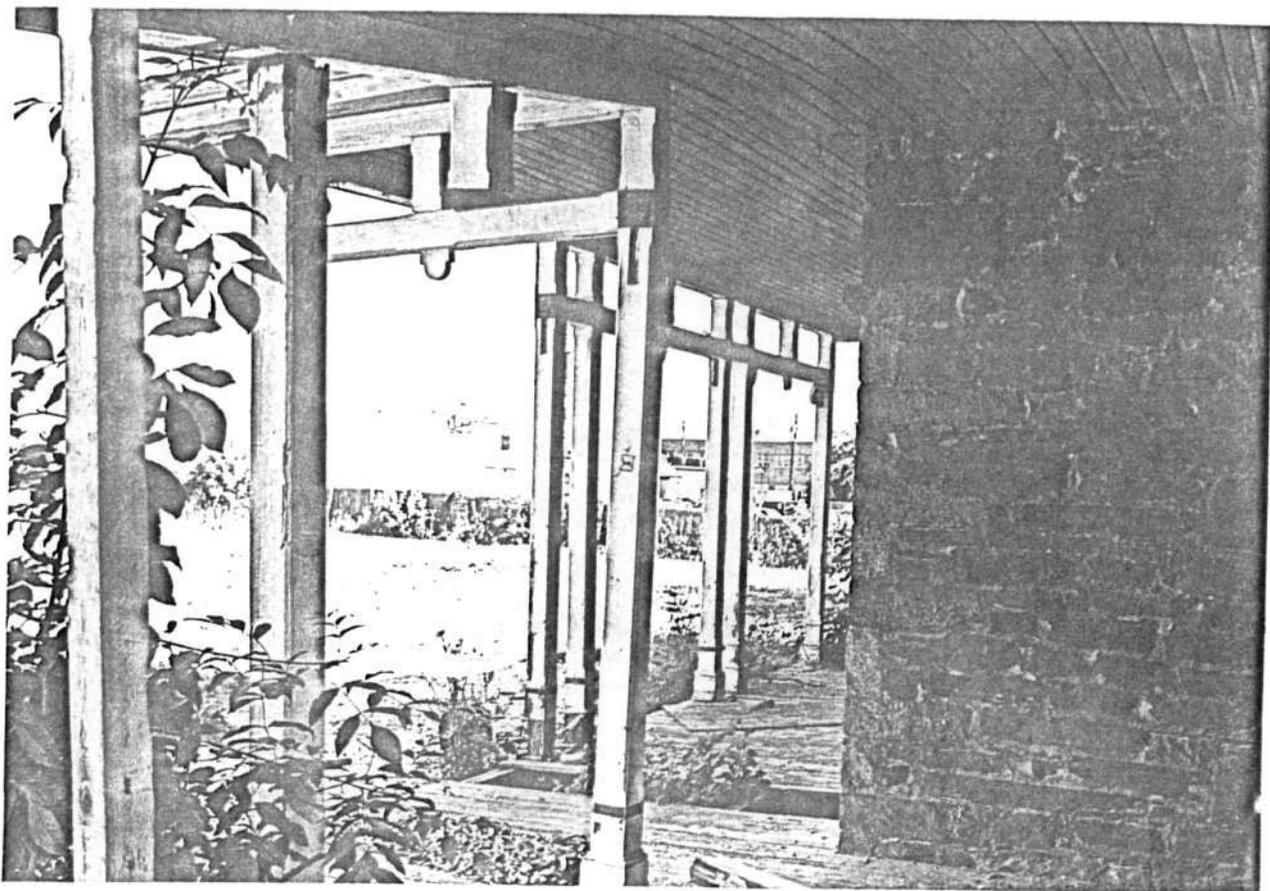
# 7/21

GALLAGHER MANSION - BALTIMORE CITY  
PHOTO BY JEFFREY HONICK  
JUNE 1980  
NEG. AT CHAP  
FRONT PORCH FROM NORTH

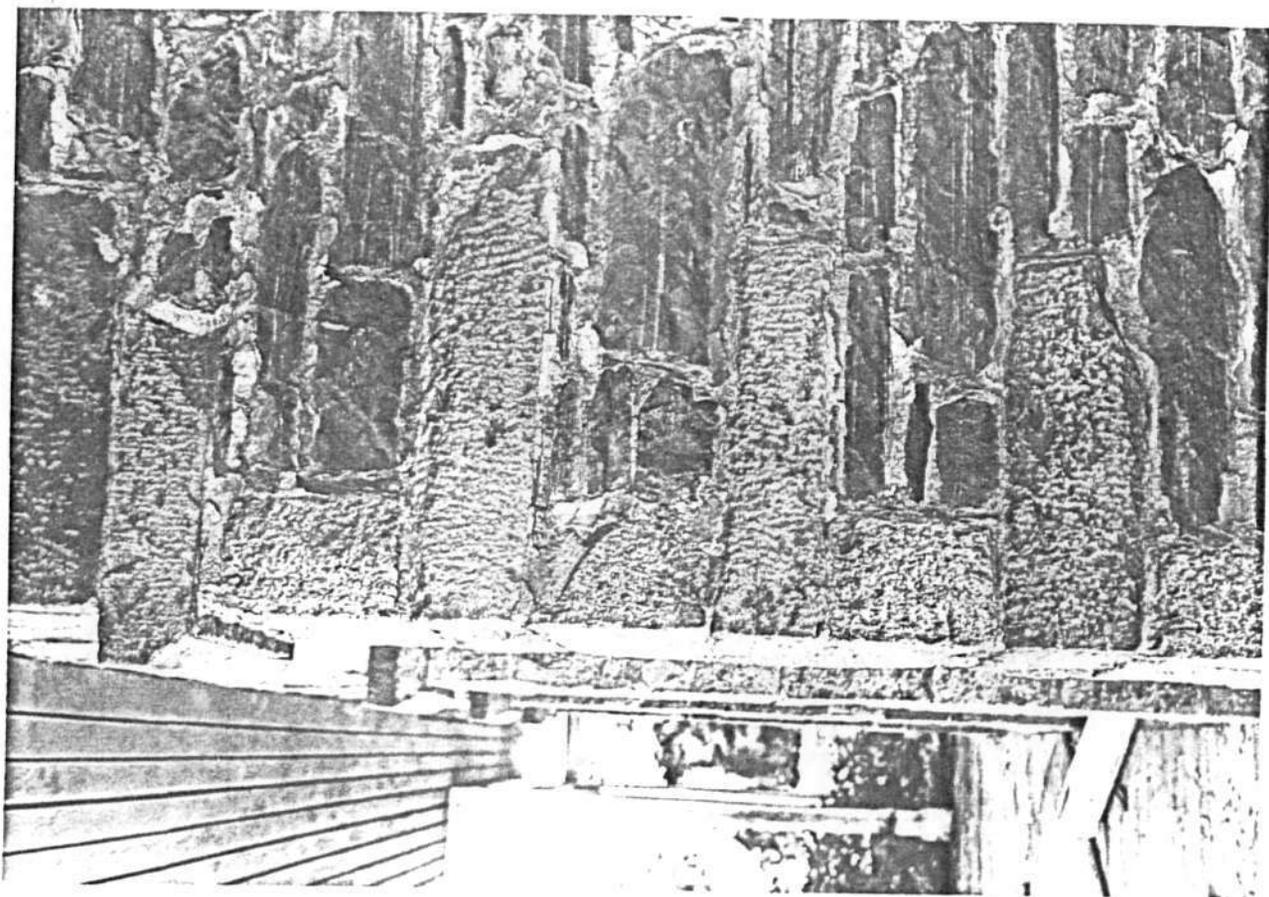
GALLAGHER MANSION - BALTIMORE CITY  
PHOTO BY JEFFREY HONICK  
JUNE 1980  
NEG. AT CHAP  
DETAIL OF EXTERIOR MASONRY, SHOWING  
QUOINED TRANSITION FROM GRANITE FRONT TO  
SIDE OF OTHER MATERIAL

The stonework on the house varies from section to section. On the rear wing it is rubble of random sizes and shapes laid in hardly discernible courses. The stonework on the main body of the house is also rubble, but it is more clearly coursed, and it is quoined with large squared-off blocks. The piers of the entrance arches are of granite ashlar, more finely finished than the rest of the stone.

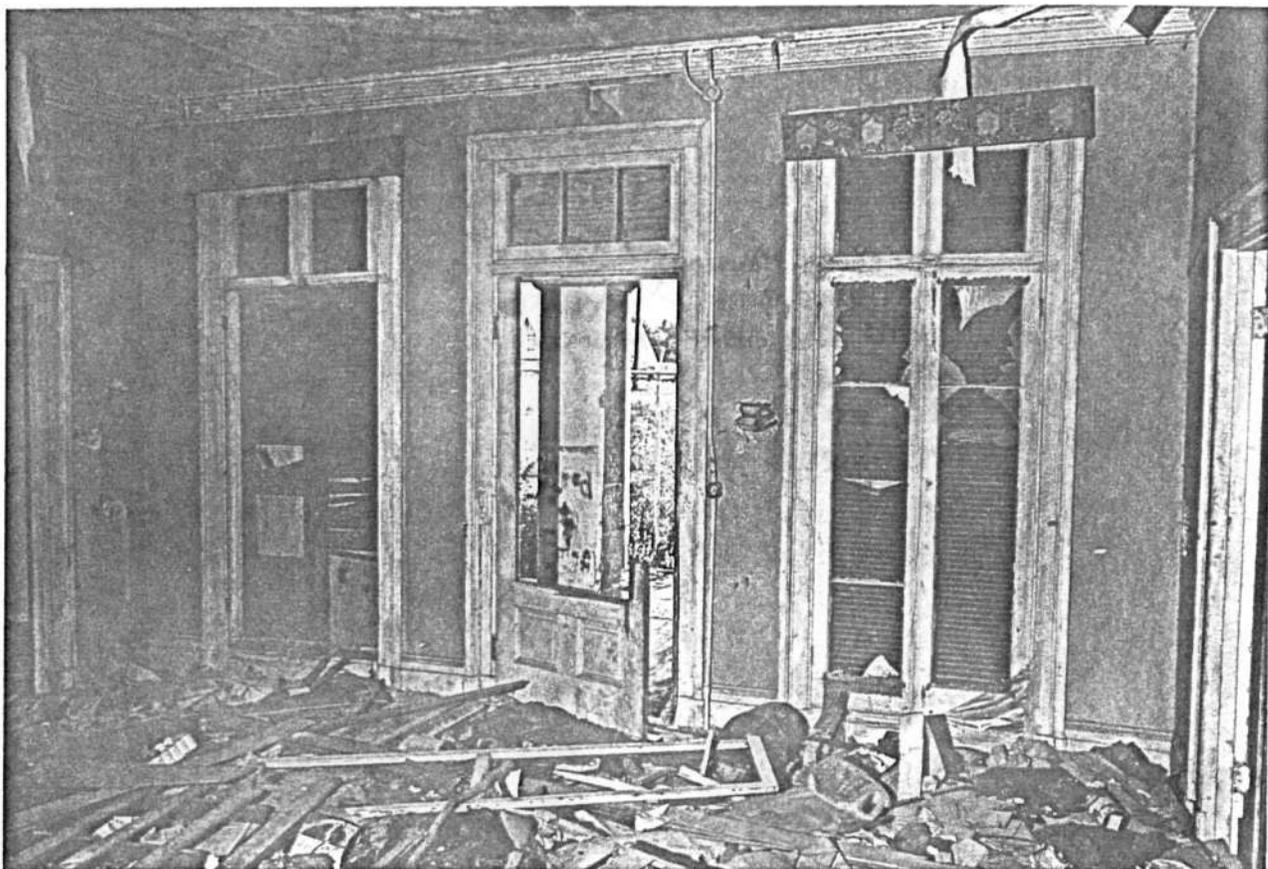
#9/21

GALLAGHER MANSION  
BALTIMORE CITY, MARYLAND  
PHOTO BY JEFF JEROME  
SEPT. 1982  
NEG. AT C.H.A.P.  
INTERIOR-ENTRANCE HALL

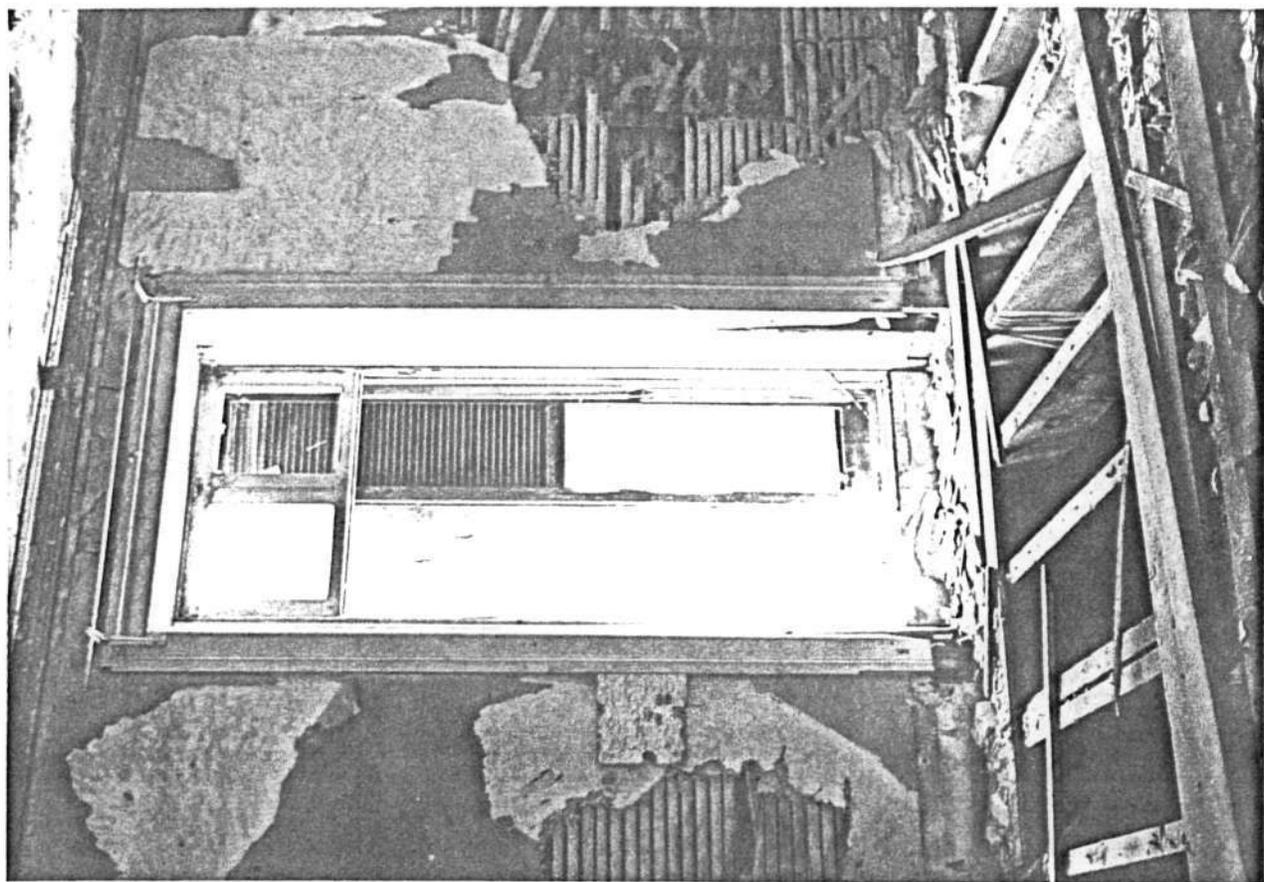
#10/21

GALLAGHER MANSION - BALTIMORE CITY  
PHOTO BY JEFFREY HENNER  
JUNE 1980  
NEG. AT CHAD  
FIRST STORY - ROOM TO SOUTH OF ENTRANCE  
HALL

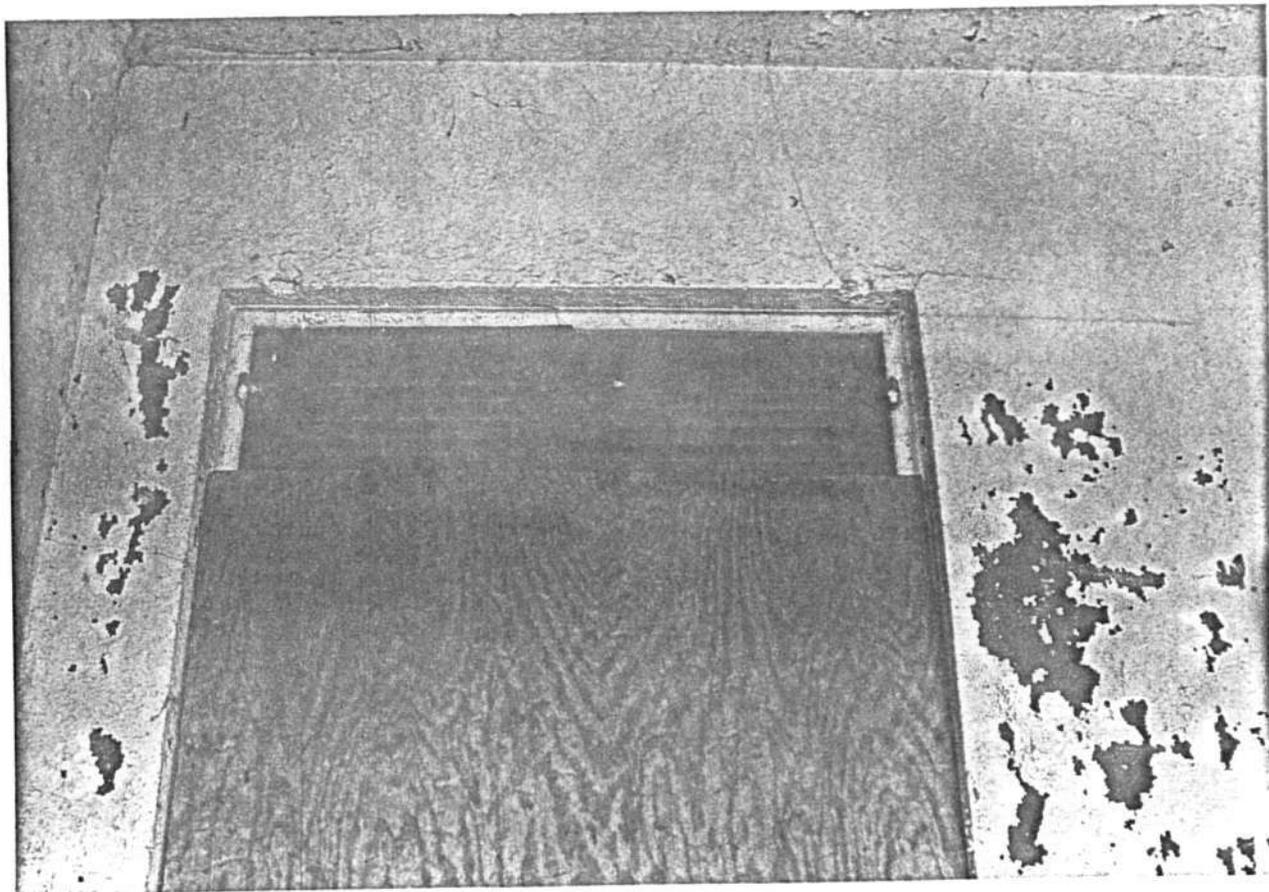
# 11/21

GALLAGHER MANSION - BALTIMORE CITY  
PHOTO BY JEFFREY HOUICK  
JUNE 1980  
NEG. AT CHAP  
ONE OF <sup>THE TWO FRENCH WINDOWS</sup> ~~THE TWO FRENCH WINDOWS~~ IN MAIN ENTRANCE  
ORIGINAL SHUTTERS VISIBLE ABOVE BOARD

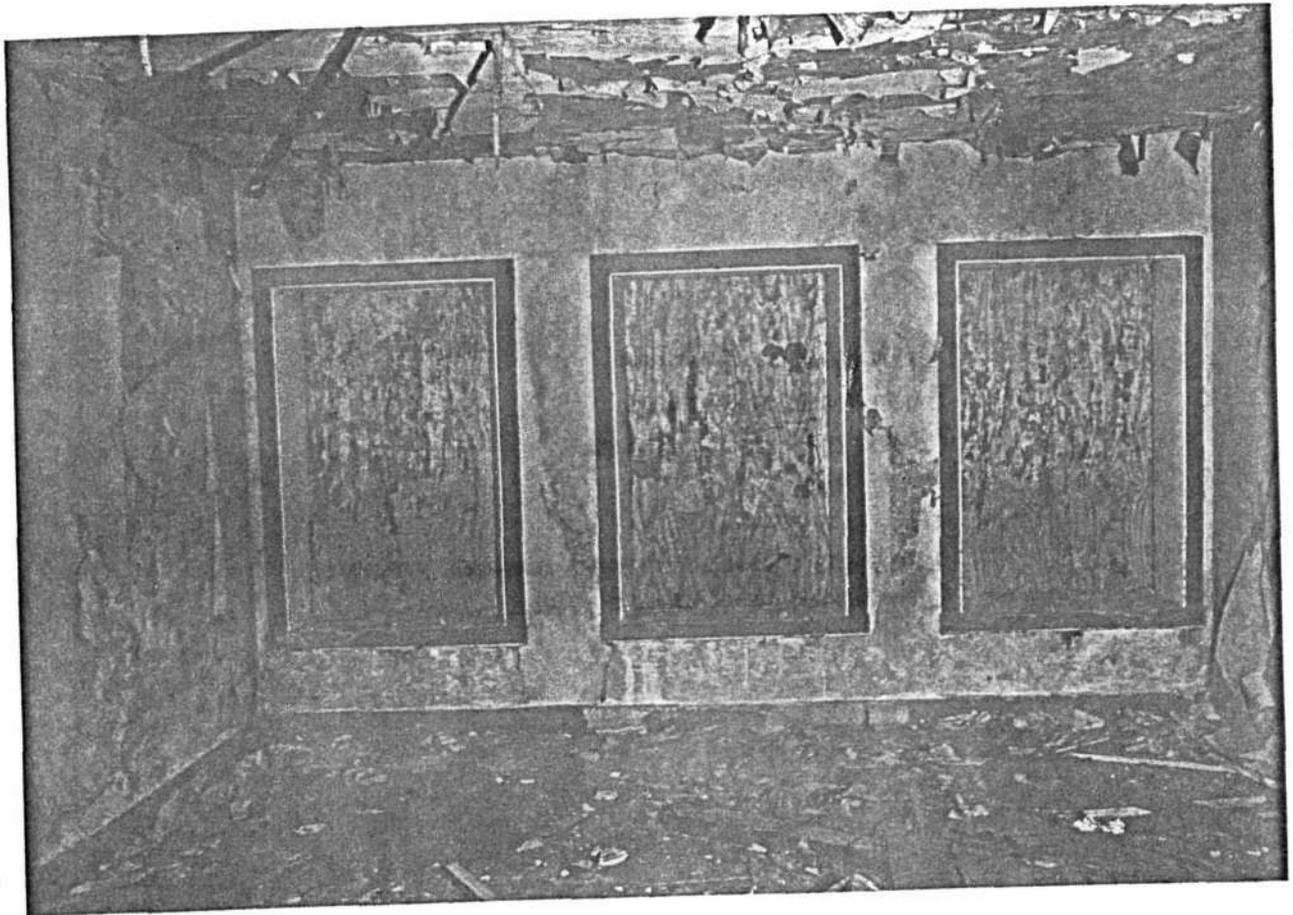
#13/21

GALLAGHER MANSION  
BALTIMORE, MARYLAND  
PHOTO BY JEFF JEROME  
SEPT. 1982  
NEG. AT C.H.A.P.  
INTERIOR - SECOND STORY - LARGE CENTRAL  
ROOM OVER ENTRANCE HALL

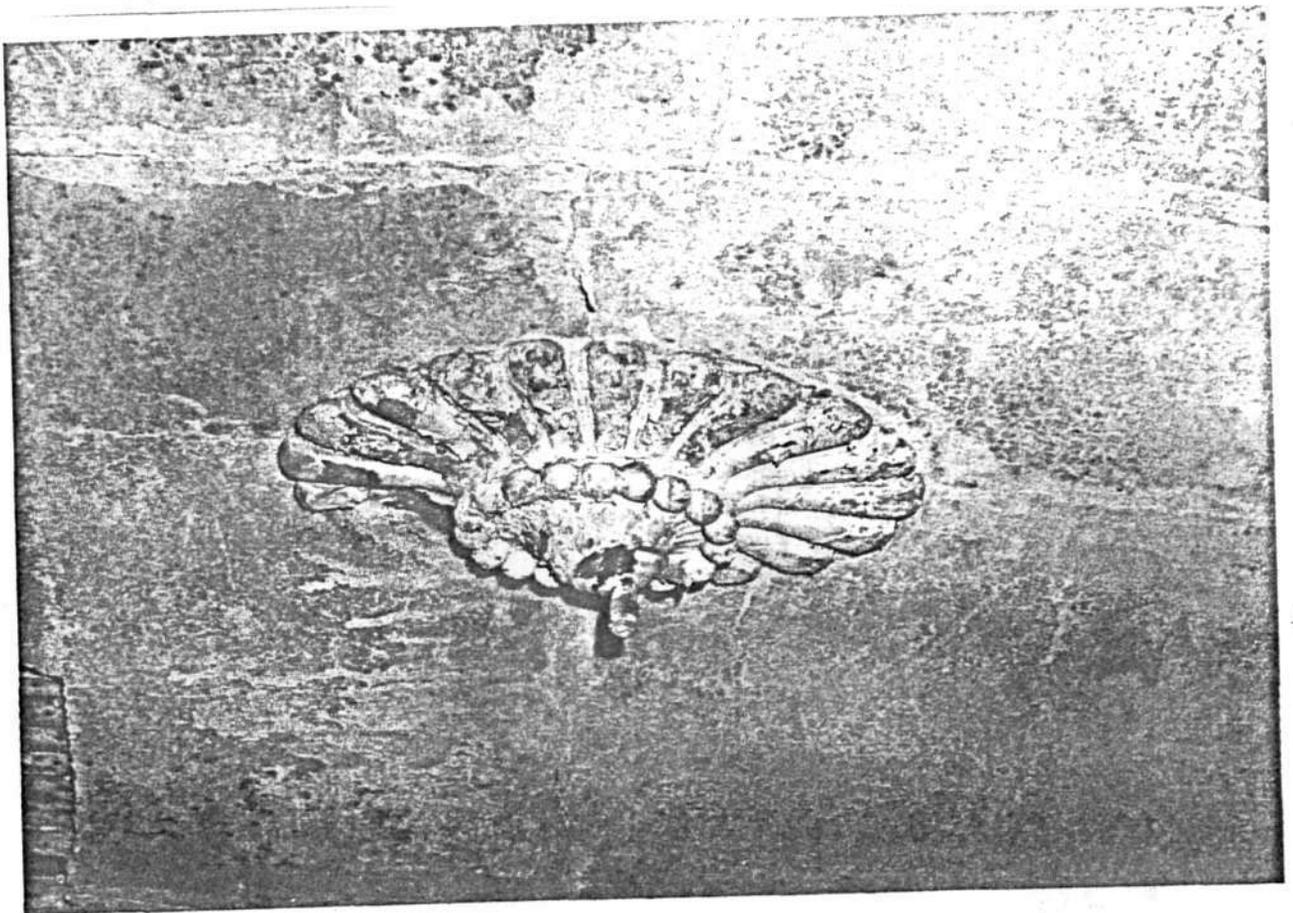
#14/21

GALLAGHER MANSION  
BALTIMORE CITY, MARYLAND  
PHOTO BY JEFF JEROME  
SEPTEMBER, 1982  
NEG. AT C.H.A.P.  
LIGHT FIXTURE ROSETTE IN CEILING OF  
ENTRANCE HALL

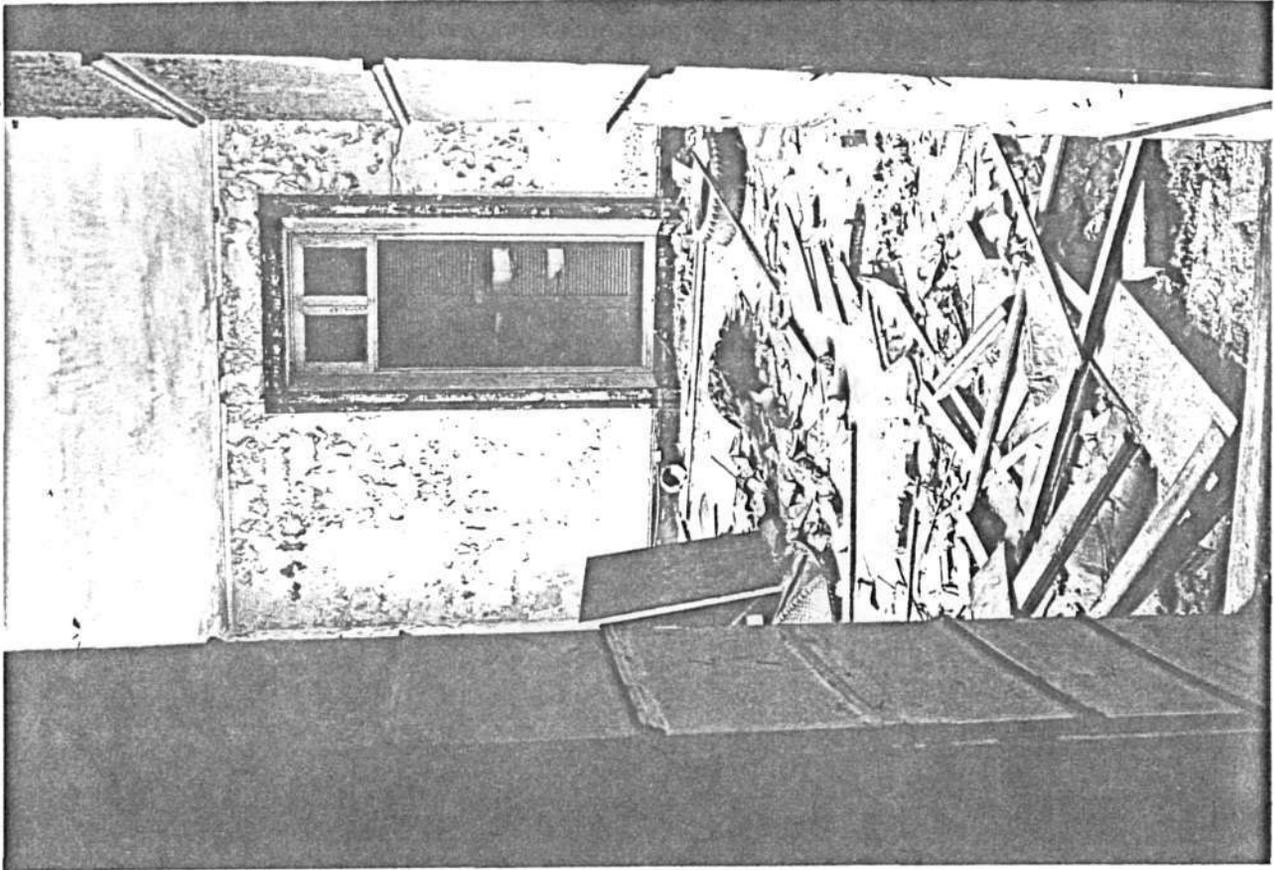
#15/21

GALLAGHER MANSION  
BALTIMORE, MARYLAND  
PHOTO BY JEFF JEROME  
SEPT. 1982  
NEG. AT C.H.A.P.  
INTERIOR - FIRST STORY - LARGE ROOM ON  
NORTH SIDE

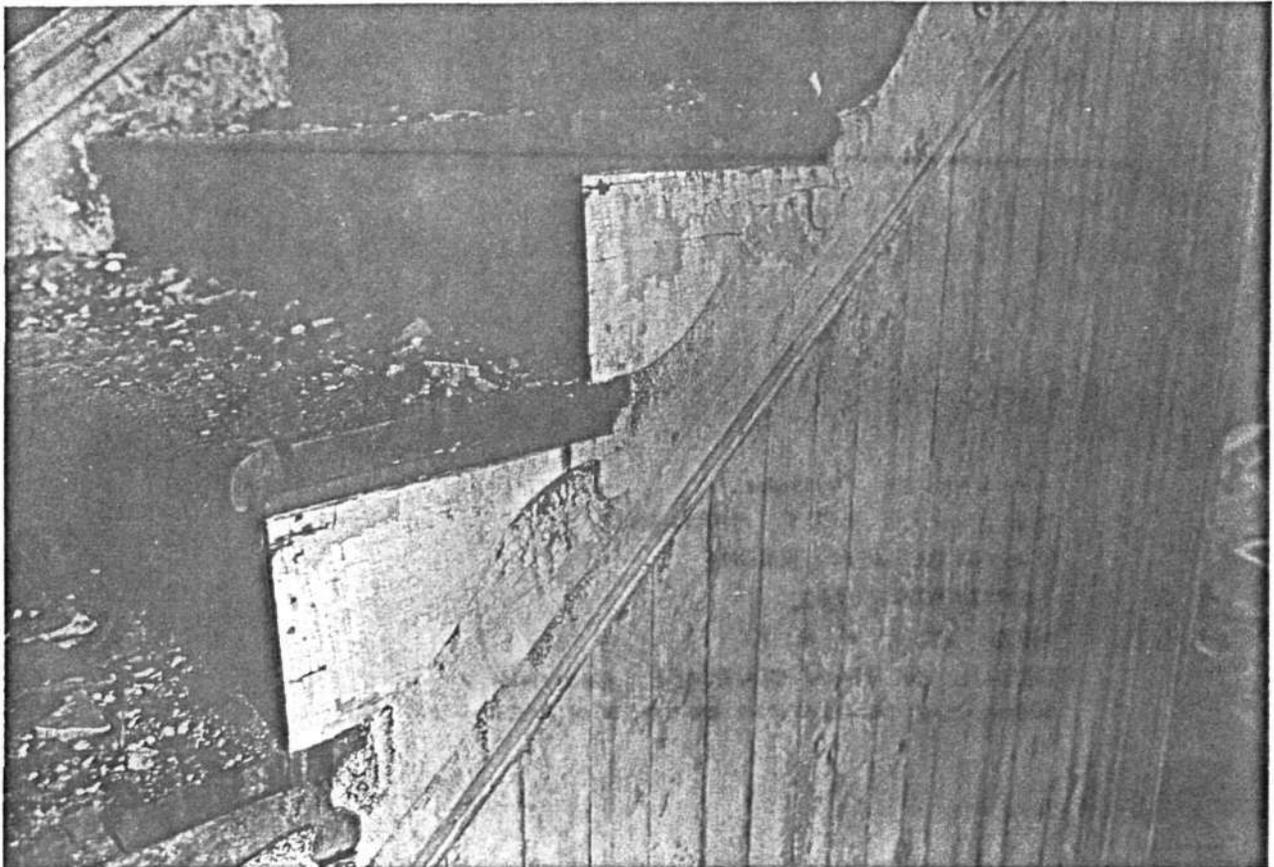
GALLAGHER MANSION  
BALTIMORE CITY, MARYLAND  
PHOTO BY JEFF JEROME  
SEPTEMBER, 1982  
NEG. AT C.H.A.P.  
DETAIL OF MAIN STAIRCASE SHOWING  
SCROLL-CUT DECORATIONS ON SIDES OF EACH STEP

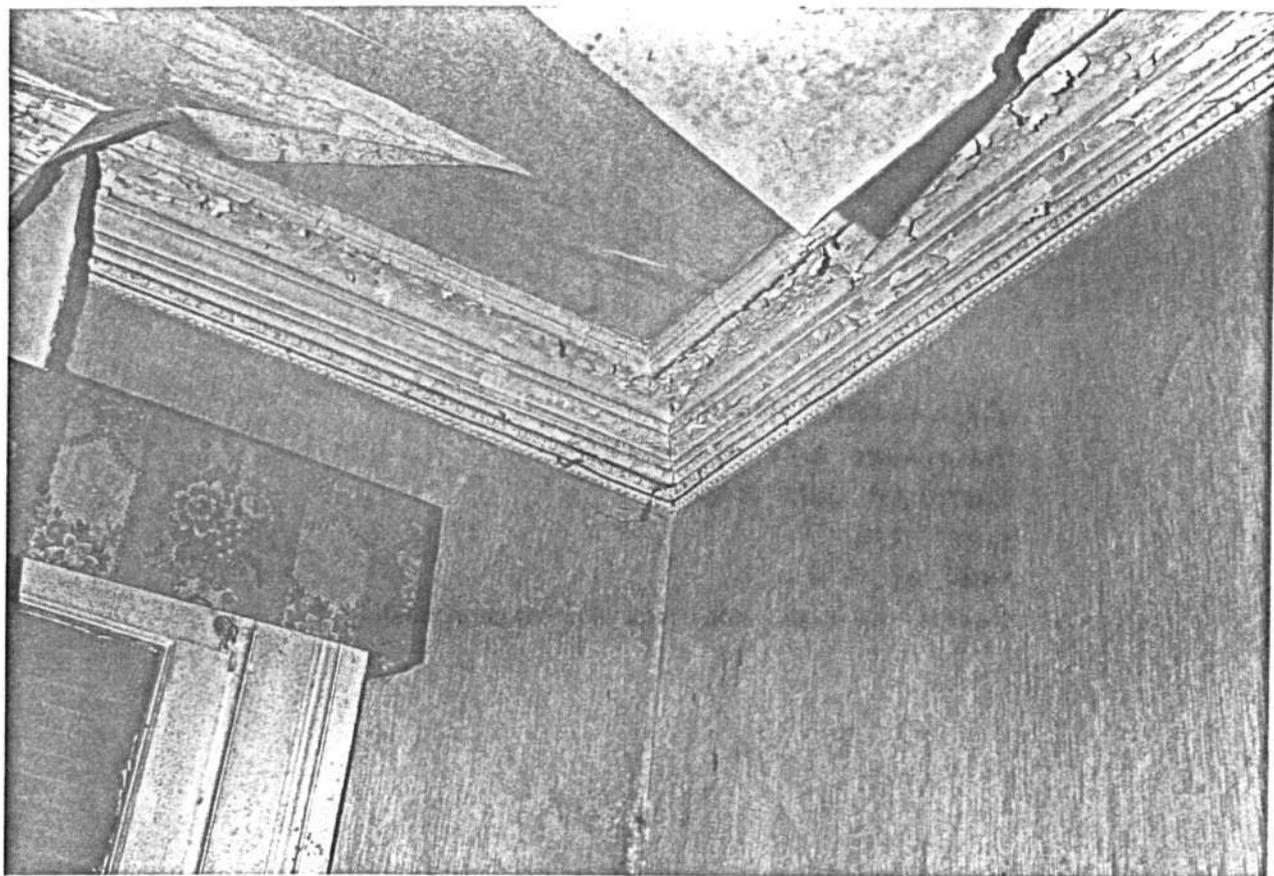
#17/21

GALLAGHER MANSION  
BALTIMORE CITY, MARYLAND  
PHOTO BY JEFF JEROME  
SEPT. 1982  
NEG. AT C. H. A. P.  
DETAIL - CEILING MOLDING - ENTRANCE HALL

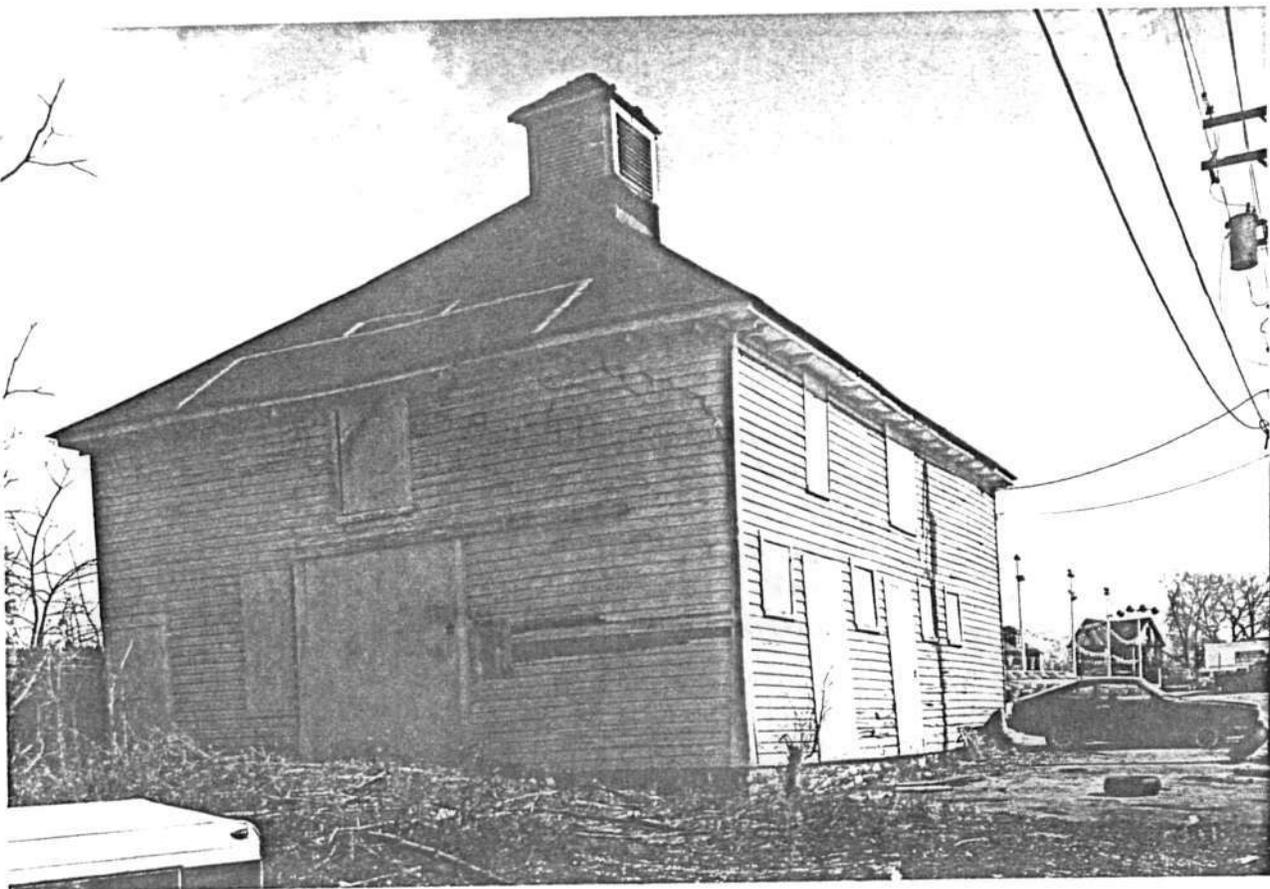
#18/21

GALLAGHER MANSION - OUTBUILDING  
BALTIMORE CITY  
FEB. 1982  
PHOTO BY JEFFREY HONICK  
NEG. AT CHAP  
VIEW OF OUTBUILDING FROM ~~S.E.~~  
S.W.

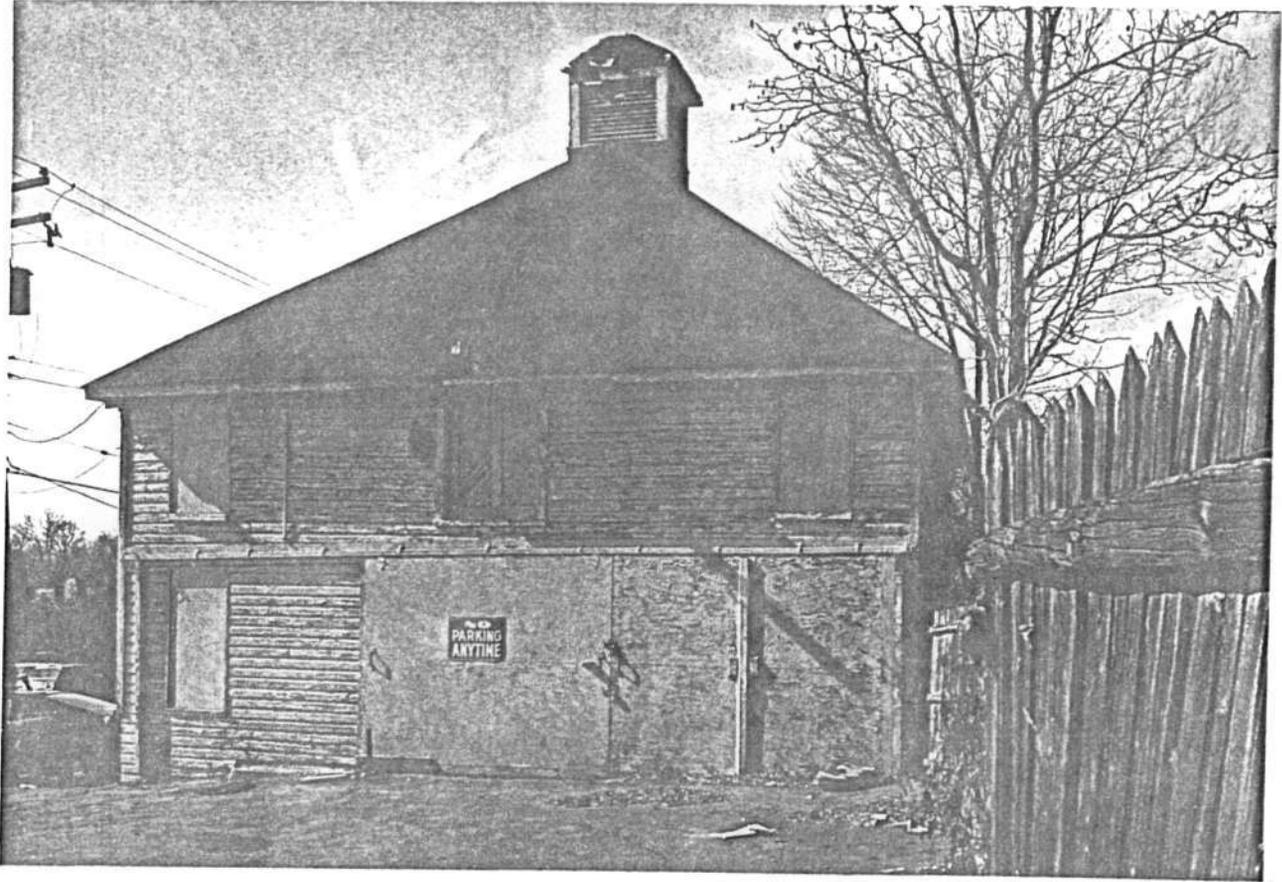
#19/21

GALLAGHER MANSION - OUTBUILDING  
BALTIMORE CITY  
FEB. 1982  
PHOTO BY JEFFREY HONICK  
NEG. AT CHAP  
EAST ELEVATION

The east side has a large sliding garage door and a large window on the first story. On the second story there is a window at either end, and in the center there is a pair of diagonal board doors in a wide loading bay; above that is a protruding beam with block and tackle.
