**National Register of Historic Places  
Inventory—Nomination Form**

historic Gallagher Mansion and outbuilding

street & number 431-435 Notre Dame Lane, near York Road N/A not for publication

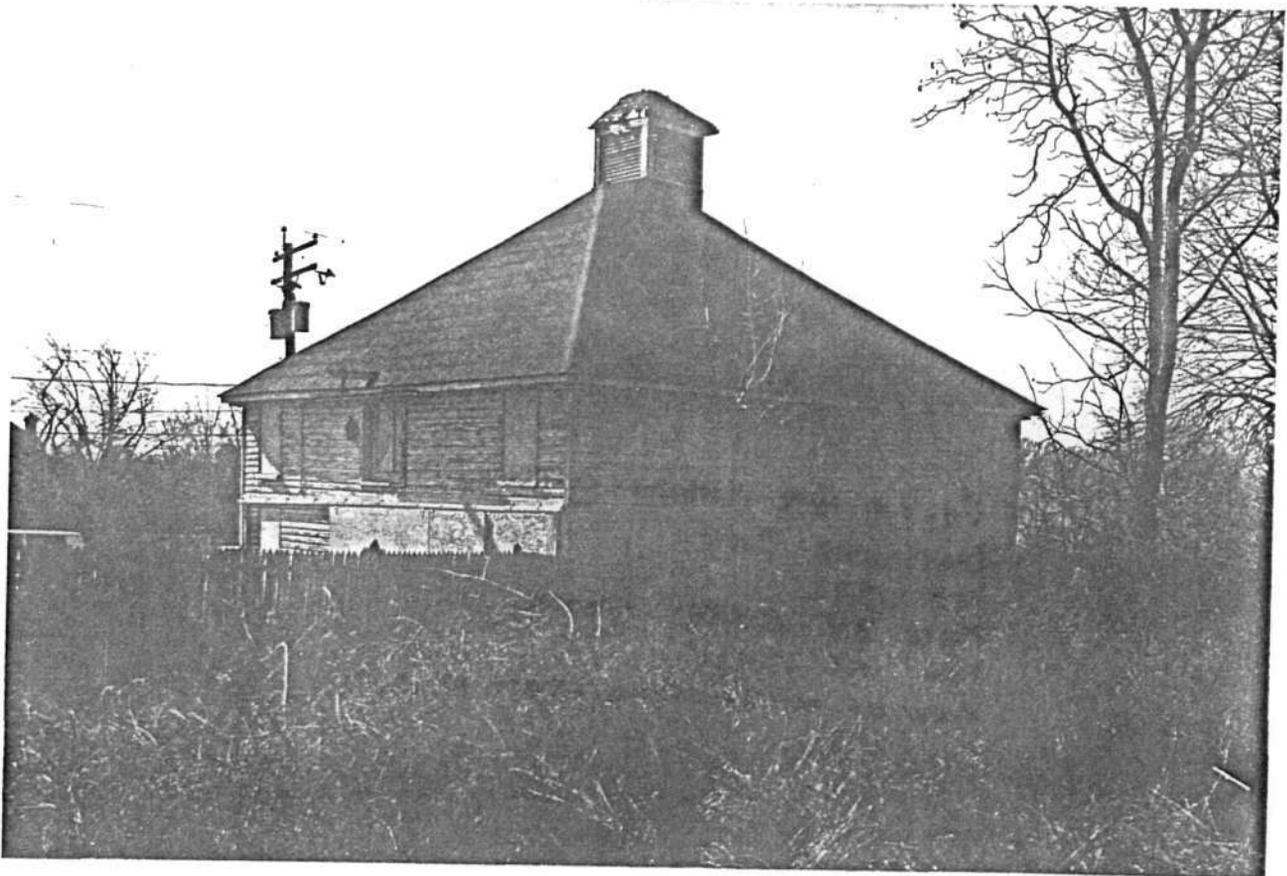
#20/21

GALLAGHER MANSION - OUTBUILDING  
BALTIMORE CITY  
- FEB. 1982  
PHOTO BY JEFFREY HONICK  
NEG. AT CHAP  
VIEW OF OUTBUILDING FROM N.E.

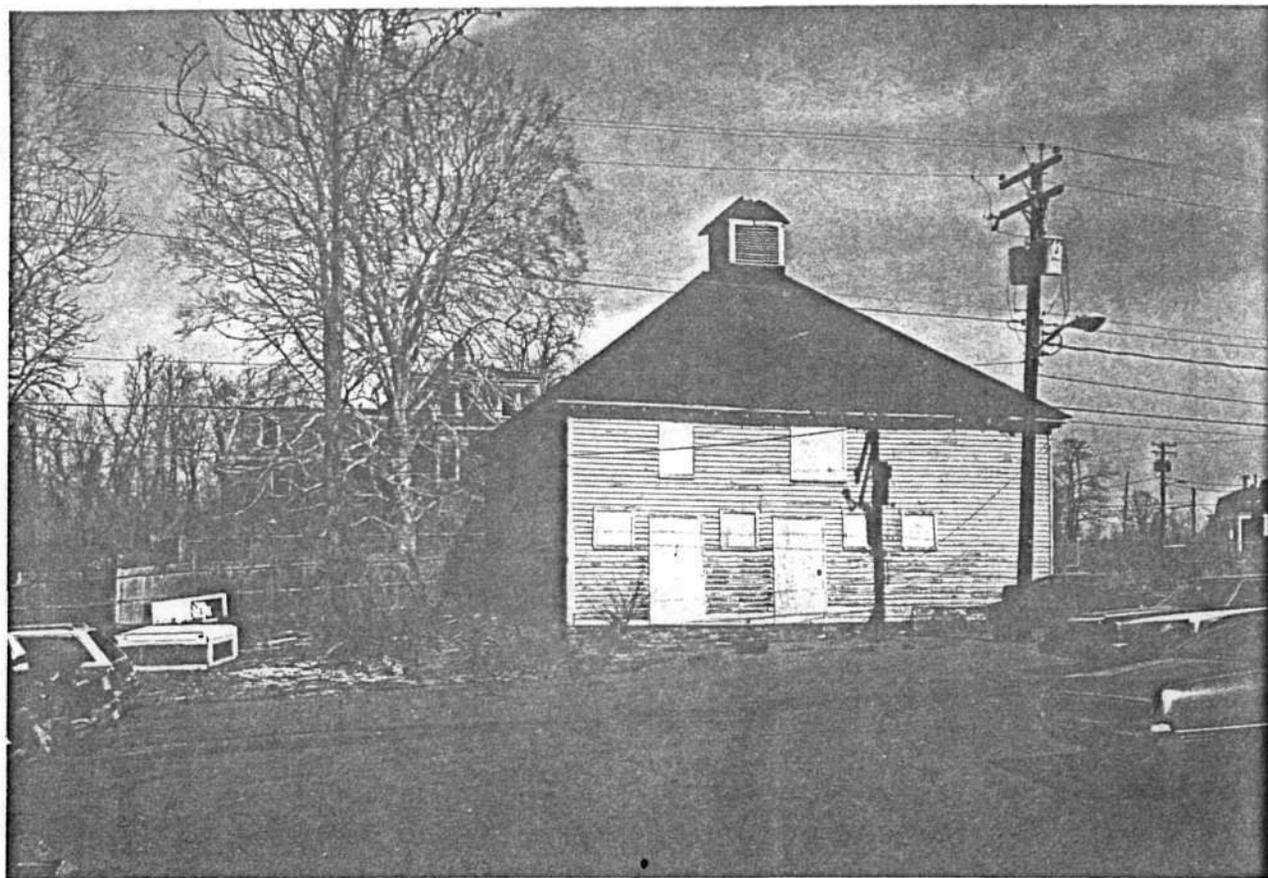
GALLAGHER MANSION - OUTBUILDING  
BALTIMORE CITY  
FEB. 1982  
PHOTO BY JEFFREY HONICK  
NEG. AT CHAP  
SOUTH ELEVATION OF OUTBUILDING

The south side has two doors and four small square windows in a row that suggests stable stalls. On the second story there are two windows.

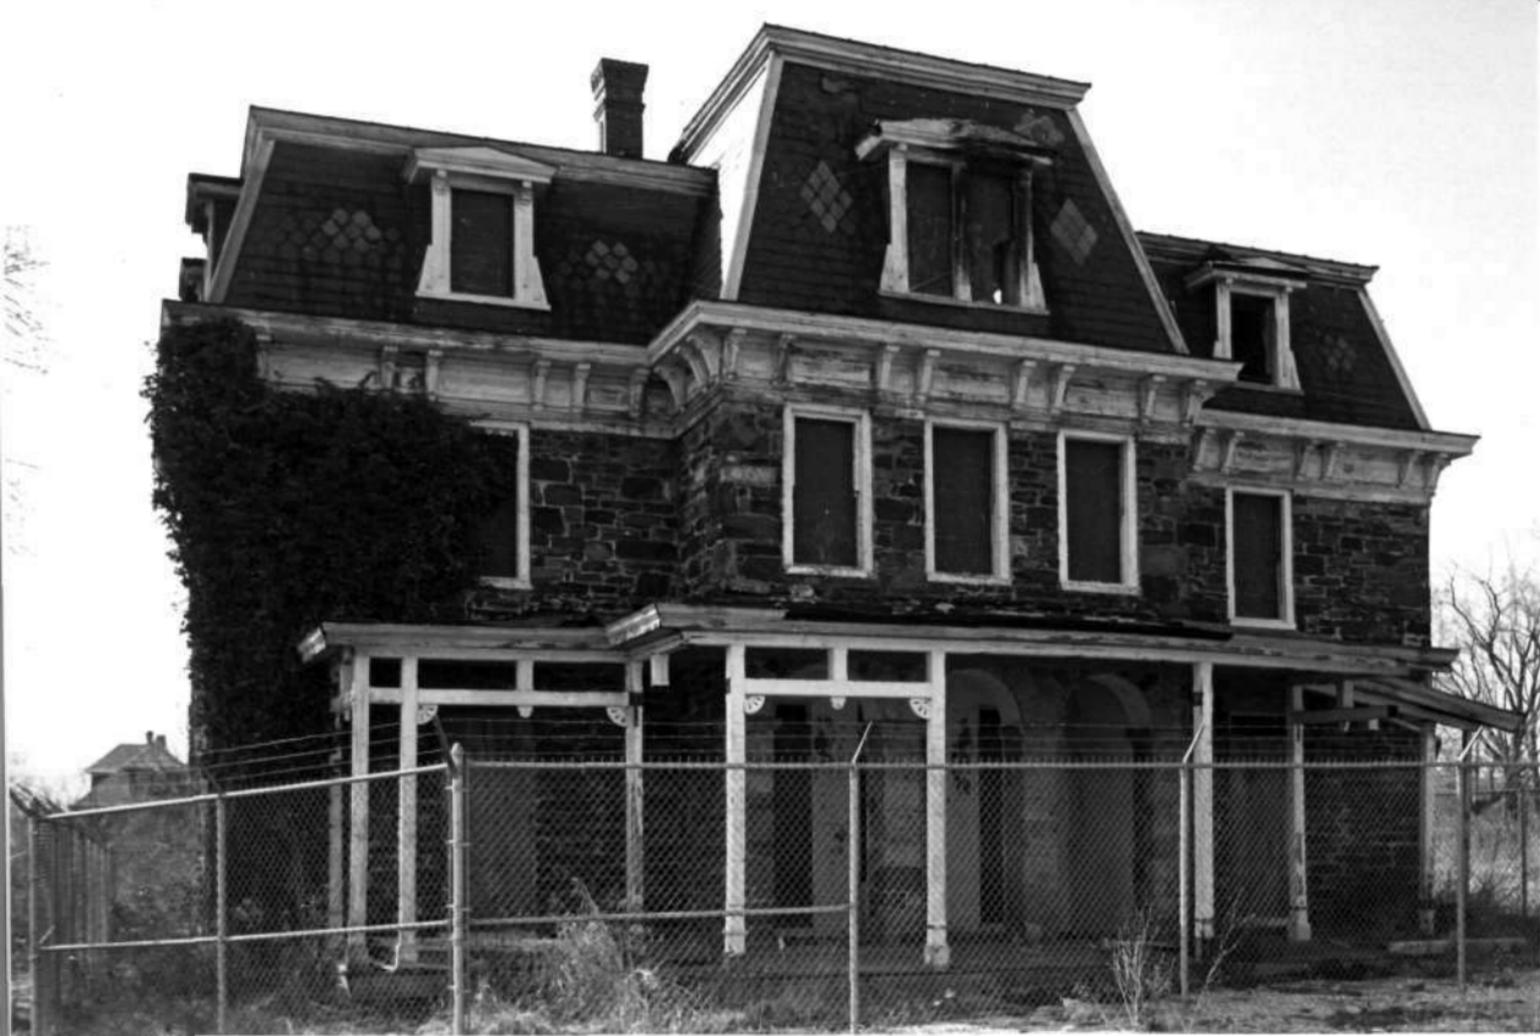
GALLAGHER MANSION      B-3738  
BALTIMORE CITY  
FEB. 1982  
PHOTO BY JEFFREY HONICK  
NEG. AT C.H.A.P.  
MAIN (EAST) ELEVATION

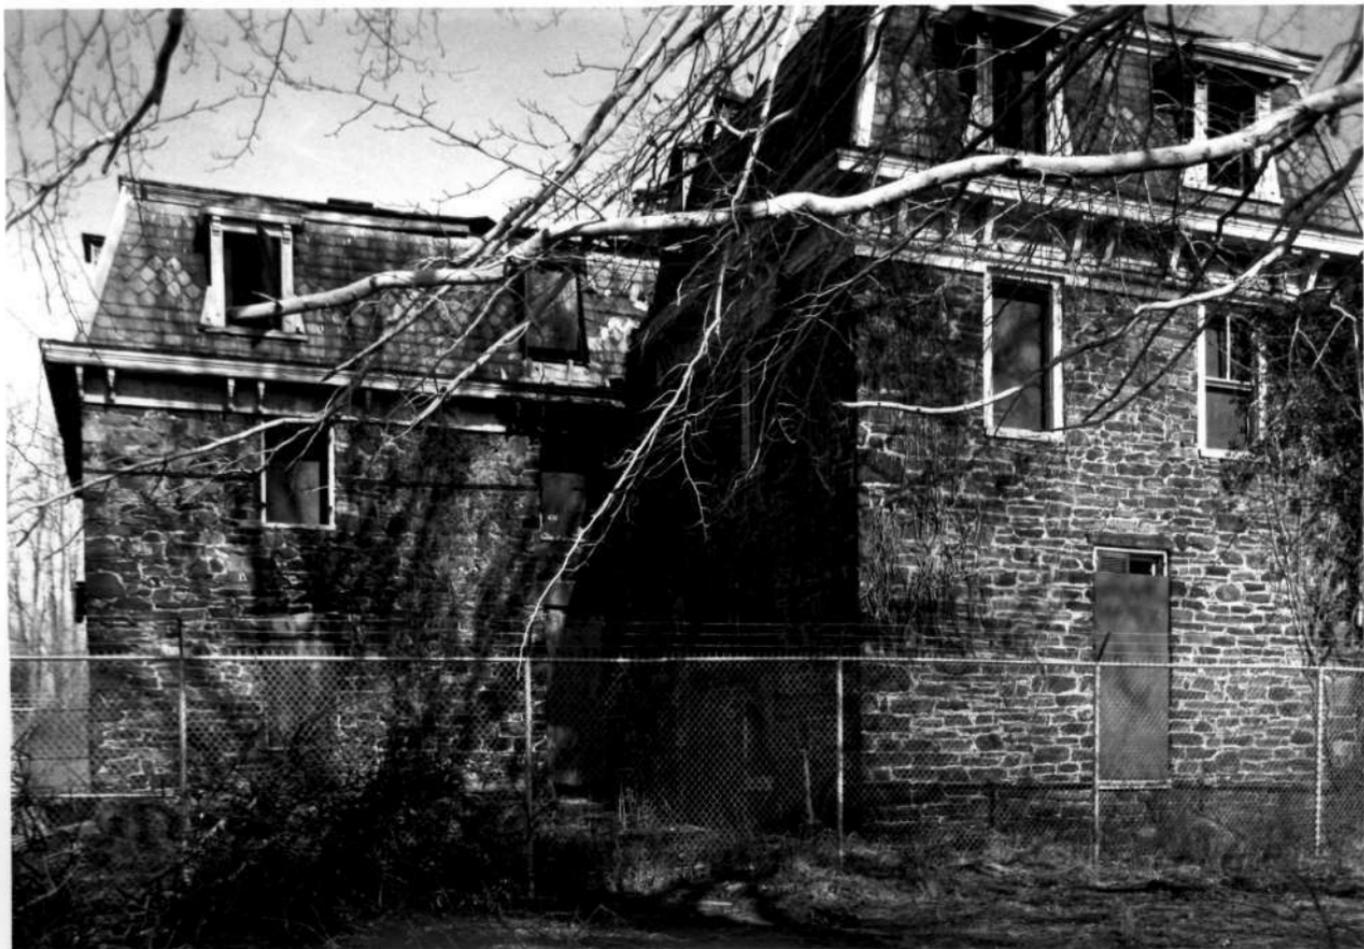
GALLAGHER MANSION B-3738  
BALTIMORE CITY  
FEB. 1982  
PHOTO BY JEFFREY HONICK  
NEG. AT C.H.A.P.  
SOUTH ELEVATION

RED LINE INDICATES OLD  
HEIGHT OF WALL OF REAR  
WING

It is possible to see the old height, width, and roof angle on the southern and western walls of the rear wing. On the south wall, there is a barely visible horizontal line in the stone at the level about the middle of the second story windows. On the west wall there are barely visible diagonal lines near the top of the wall where the gable used to be; the point of the gable was above the present cornice line.

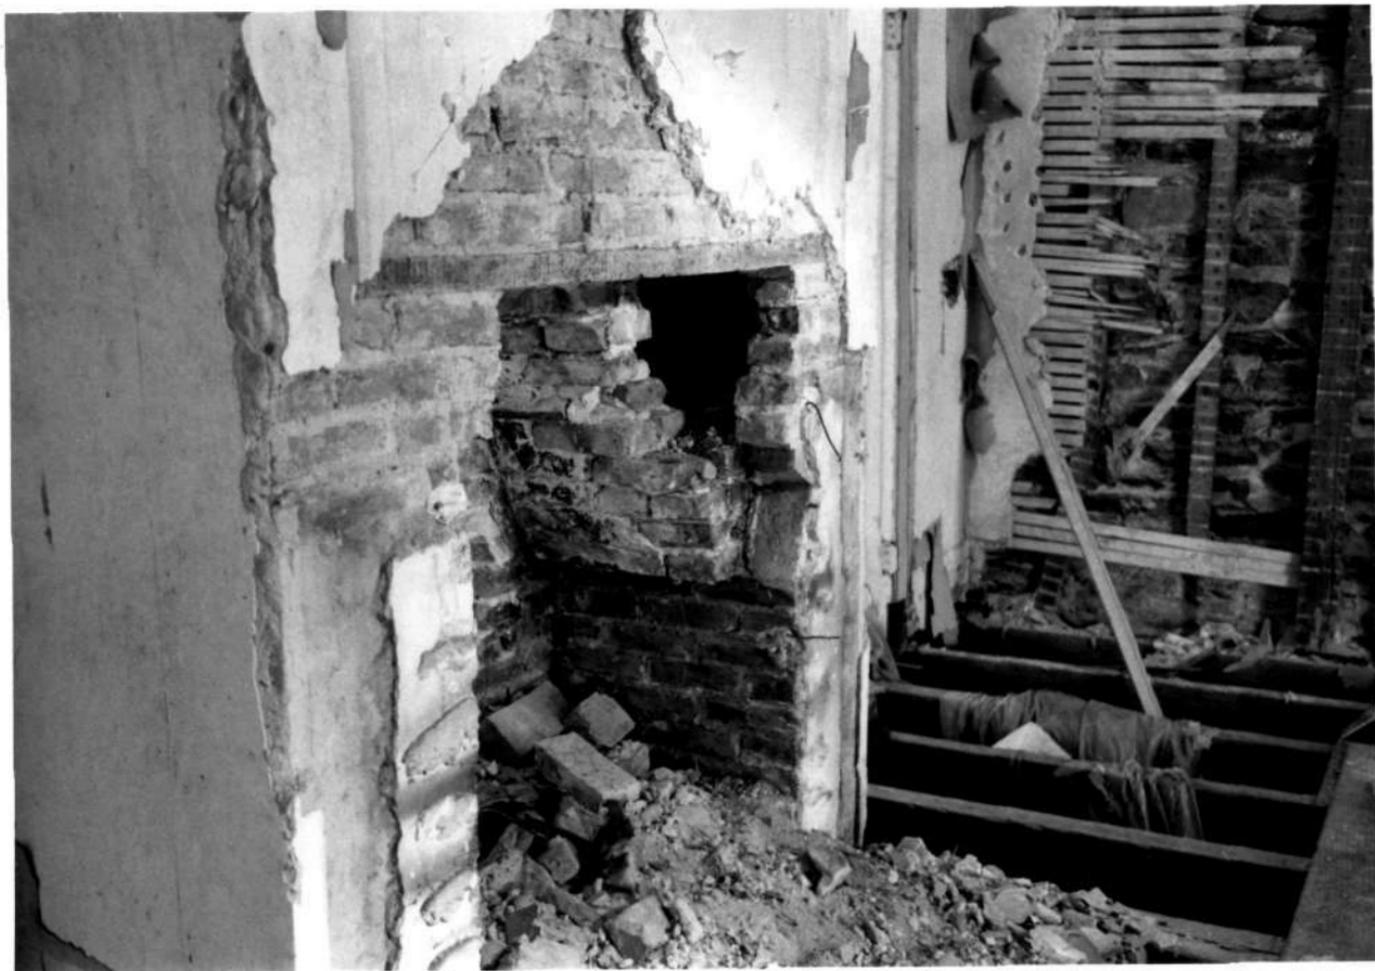
FIRST STORY - FIREPLACE IN ROOM TO  
~~NORTH~~ OF ENTRANCE HALL  
SOUTH

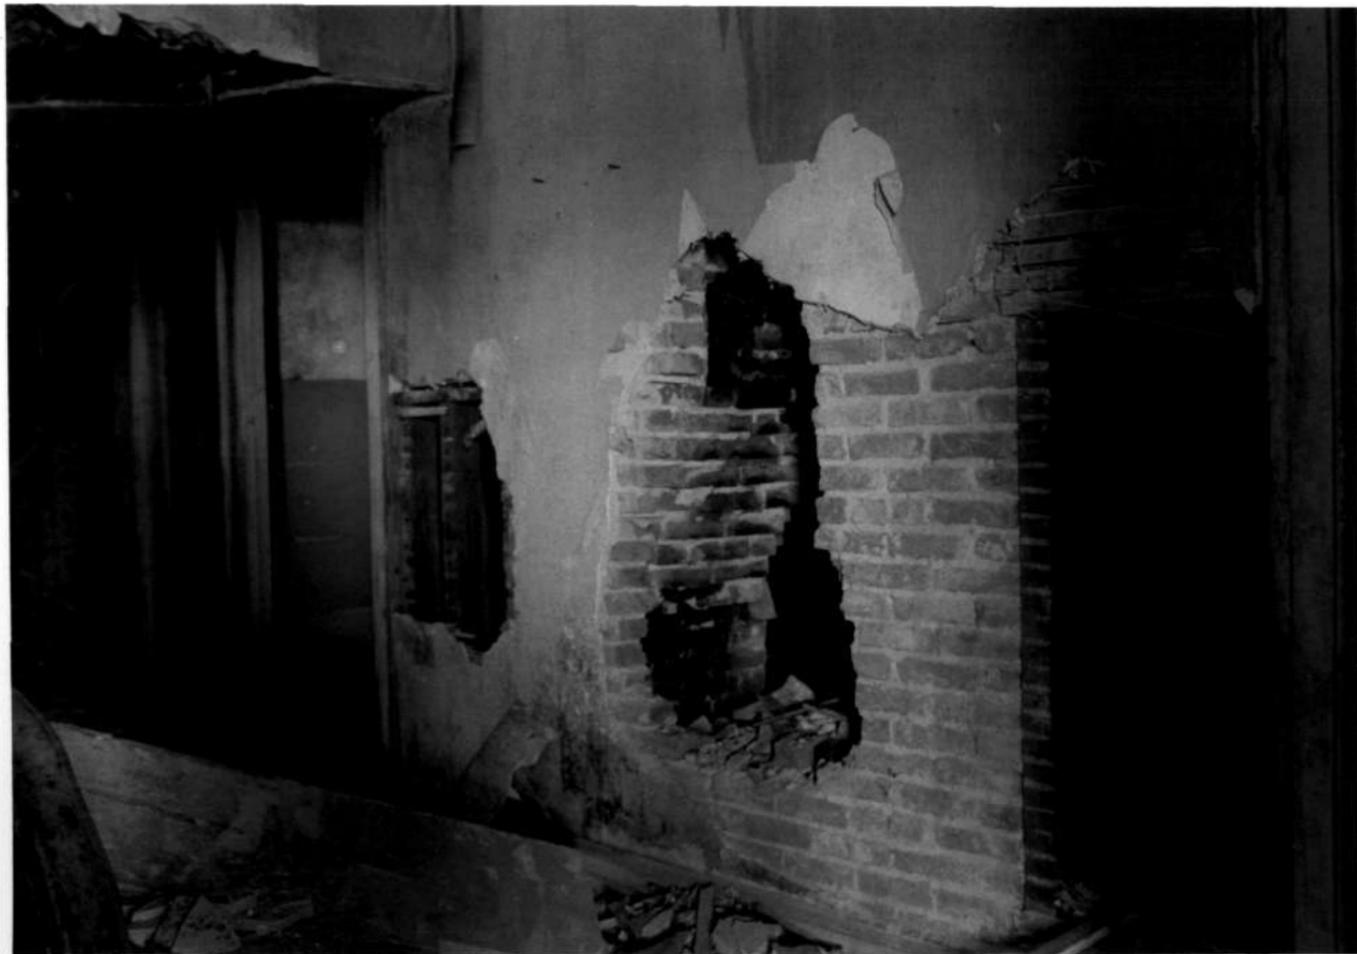
GALLAGHER MANSION - BALTIMORE CITY  
PHOTO BY JEFFREY HONICK  
JUNE 1980  
NEG. AT CHAP  
ENTRANCE HALL - NORTH WALL

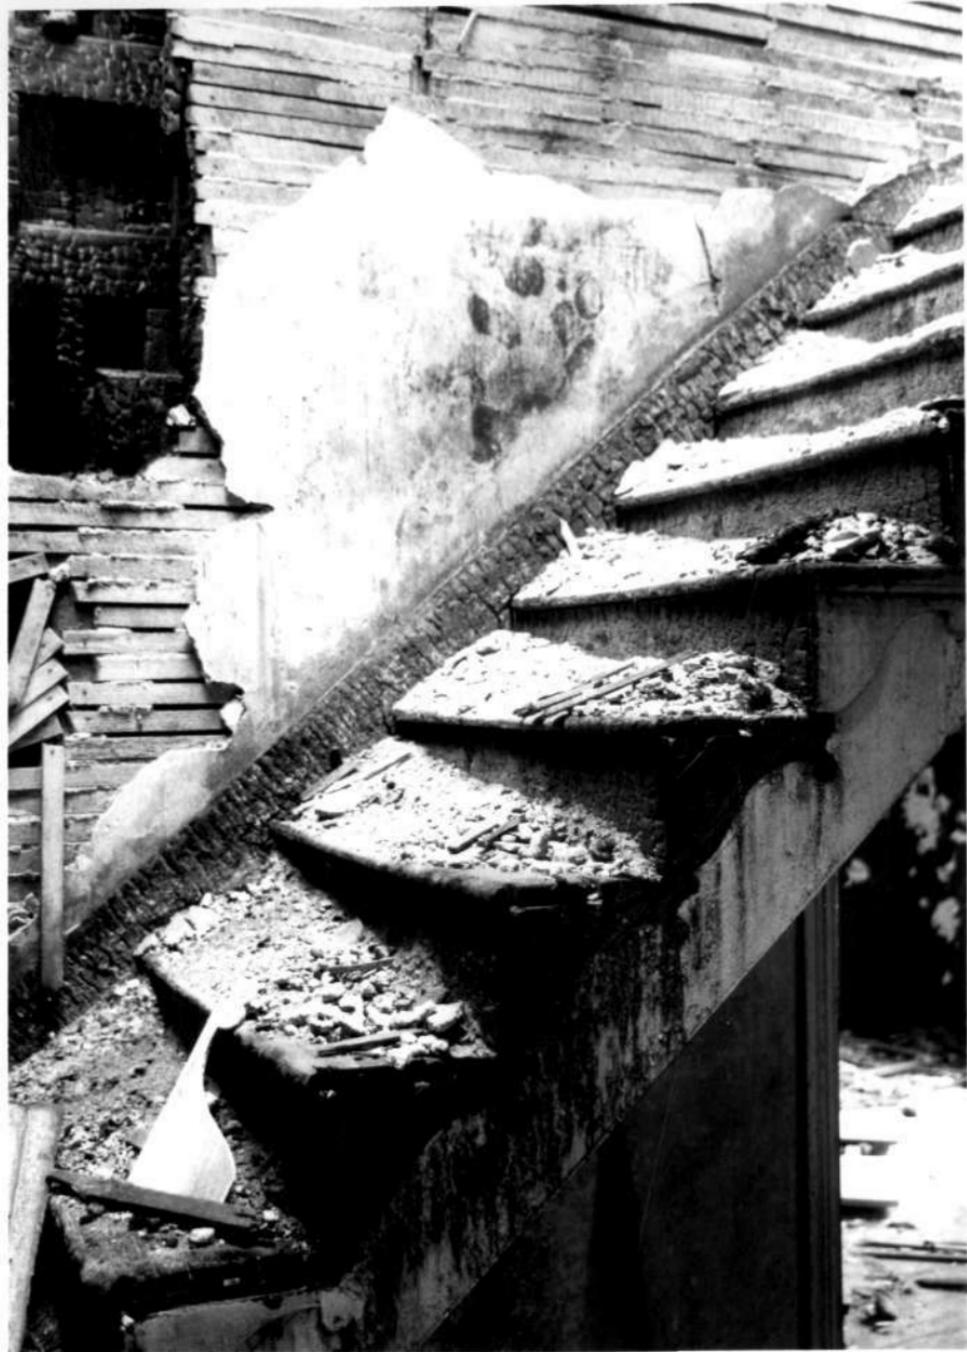
GALLAGHER MANSION - BALTIMORE CITY  
PHOTO BY JEFFREY HONER  
JUNE 1980  
NEG. AT CHAP **B-3738**  
INTERIOR - STAIRWAY

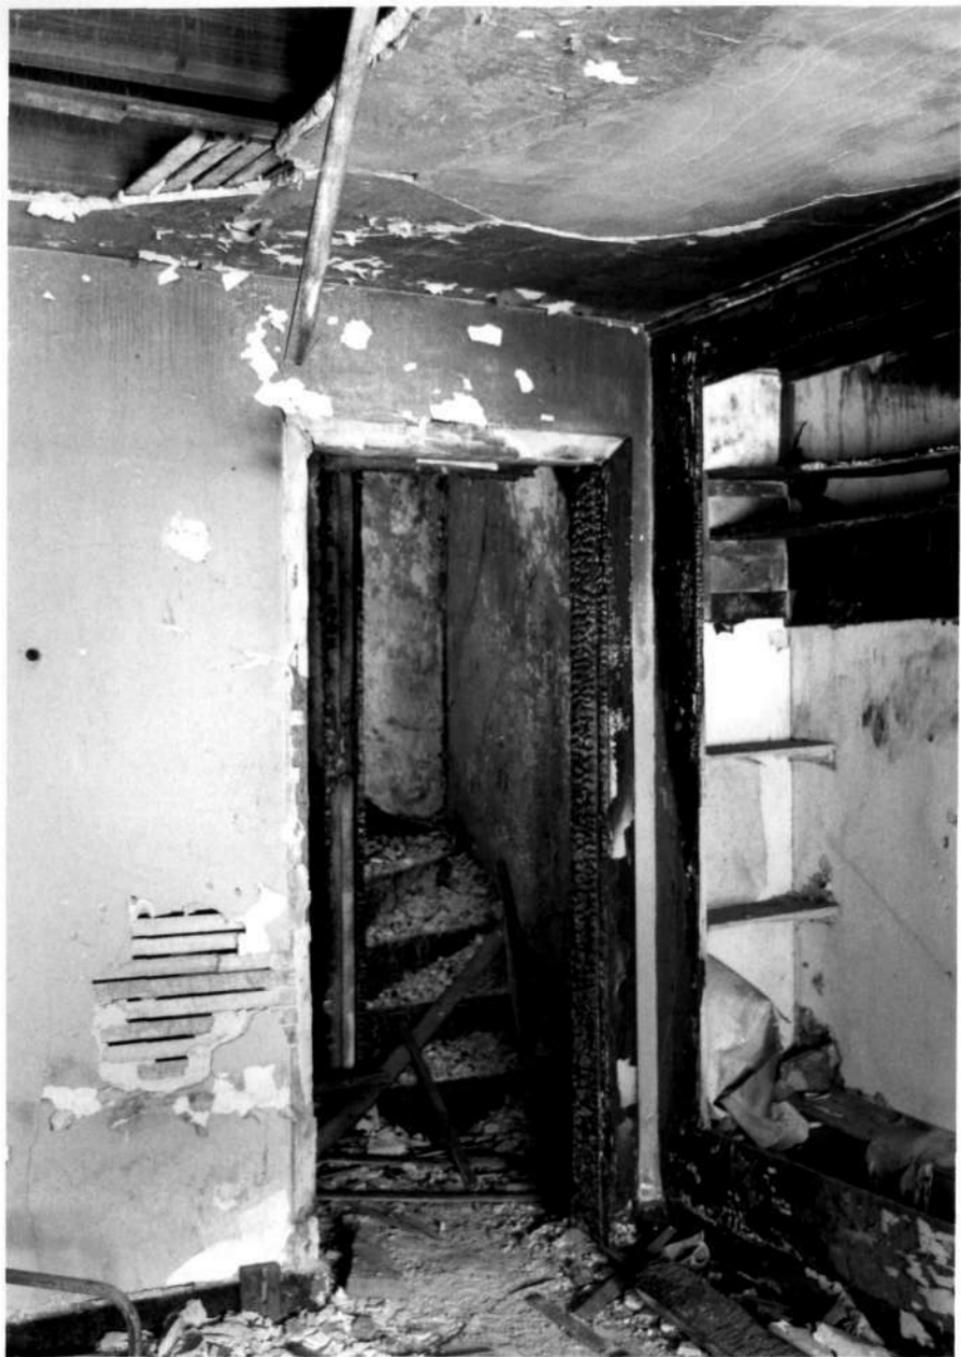
INTERIOR VIEW TOWARD BACK STAIRWAY

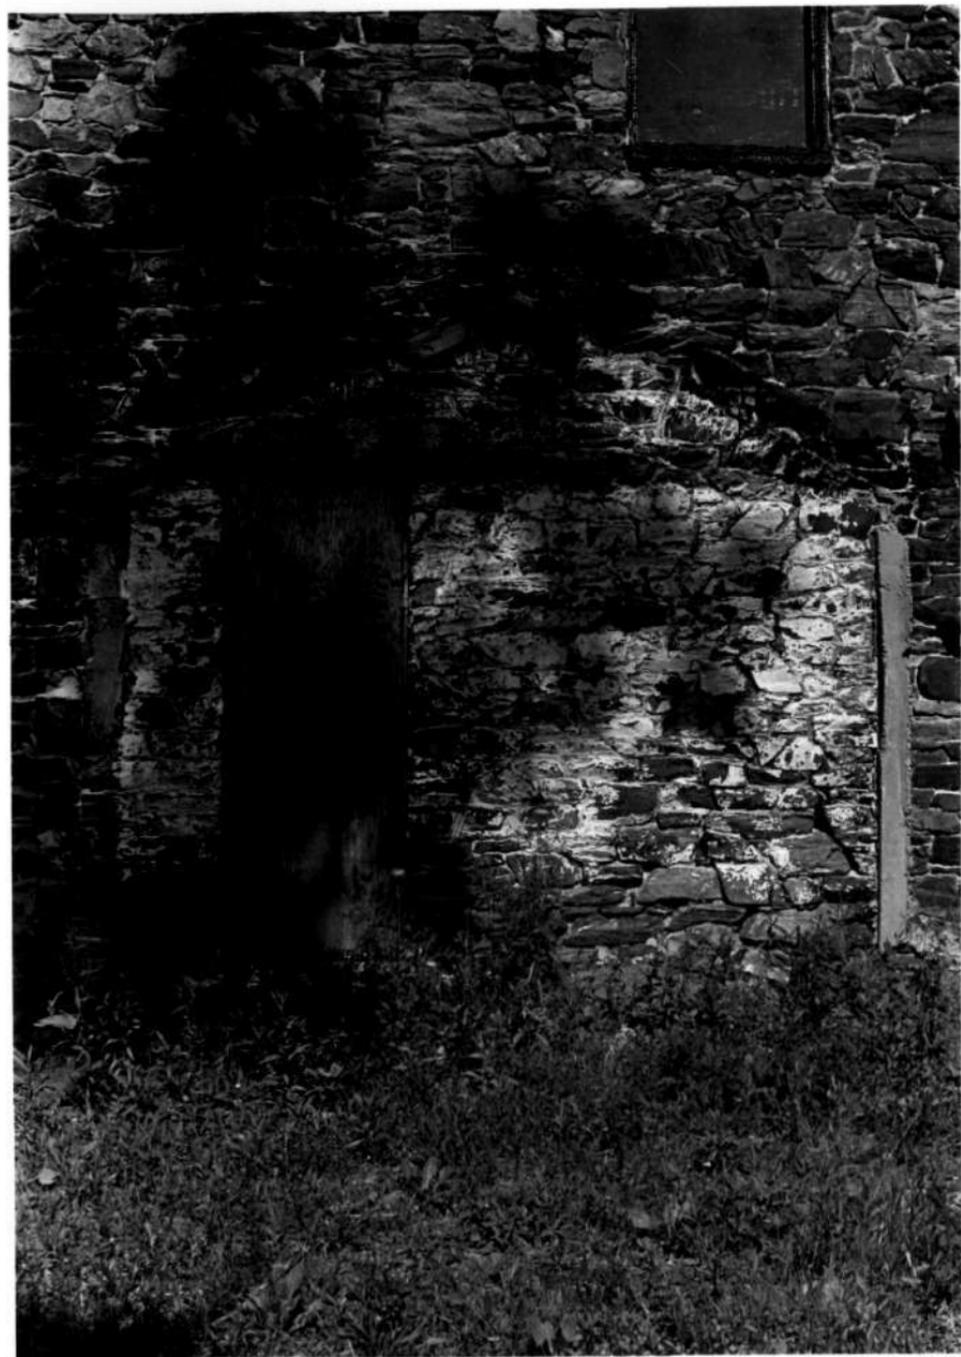
DETAIL, WEST (REAR) FACADE; NOTE SILHOUETTE  
OF A SINCE-DEMOLISHED ADDITION

The west (rear) elevation of the rear wing has a small wooden door and a large 6/6 window on the first story. The doorway is surrounded by the silhouette of a one story wooden rear addition that is no longer standing. On the second story of the west elevation there are two windows, and on the mansard there are two dormers that are smaller and simpler than those on the sides and front of the house.
