National Register of Historic Places  
Inventory—Nomination Form

historic Frizzell, Andrew P., House and Farm Complex

SUMMARY: The Andrew P. Frizzell House and Farm Complex is a well-preserved example of the Victorian style in rural Carroll County, Maryland. Built in 1896, the farmhouse retains many characteristics of the regional farmhouse tradition, such as the basic massing and proportions, two story height, gable roof, and five-bay symmetrical facade. However, it also presents an up-to-date and fashionable Victorian appearance through its T-shaped plan and exterior ornamentation including the bracket cornice, centrally-located gable dormer, three-bay porch with decorative motifs, and two-story bay window on the south gable end. It also retains numerous interior characteristics that display the Victorian period in Carroll County farmhouses including Queen-Anne style mantelpieces, gessoed cornice and picture frame moldings, grained doors and doorframes, and late nineteenth century boxlocks and hardware. The farm complex retains domestic and agricultural outbuildings, including a washhouse/smokehouse, privy, chicken house, corn crib and bank barn, in a layout representative of t

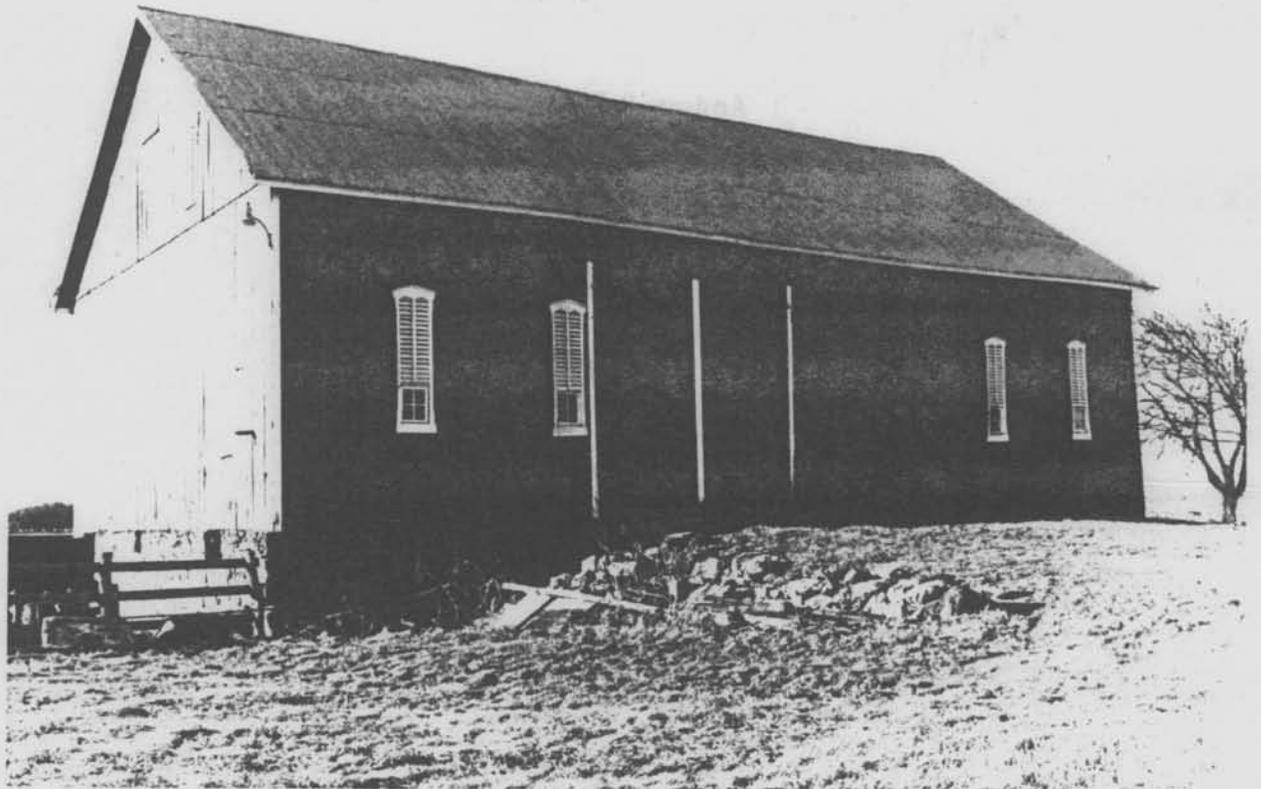
1. Andrew P. Frizzell House
2. Carroll County, Maryland
3. Joe Getty
4. January 1986
5. Md. Hist. Trust, Annapolis, Md.
6. Bank barn--s & n elev.
7. 28/29

The original bank barn was destroyed by a fire in 1905. Its appearance is shown in the early photograph. It had four cupolas along the roof and three tiers of white ventilator openings along the facades. The barn on the site today was built in 1906 on the original fieldstone foundation. It has a sheet-metal roof without the cupolas. The east and west elevations have just one row of tall ventilator openings

framed with ornamental pointed-arch cornices. On the east elevation, the lower portion of each ventilator contains a four-paned window. The west elevation has a cantilevered forebay with the doors and windows to the stalls at the foundation level. The barnyard is enclosed by a shed-roofed loafing shed which was only partially destroyed by the fire. The early photograph shows that the original northern portion of the loafing shed was larger which was used for housing pigs. The rebuilt loafing shed provided protection to the animals from the westerly winds on the site.

The orientation of the barn poses an interesting question about the layout of the farmstead. Practically all of the 19th century bank barns in Carroll County have a southern exposure on the side of the forebay. The Frizzell bank barn, however, is oriented to the west. While there is no documentation to support this theory, the possibility exists that the Frizzell barn was built as a reaction against barnyard diseases that were found prevalent in barns with a southern exposure which were too protected from the wind to allow natural ventilation to dry out the barnyard and stalls thus providing conditions conducive to disease. The turn-of-the-century period was one of reappraisal of barn designs for sanitary and healthy conditions. The Frizzell barn appears to be constructed to take full advantage of the prevailing westerly winds at its location to maintain dry and healthy conditions in the barnyard.

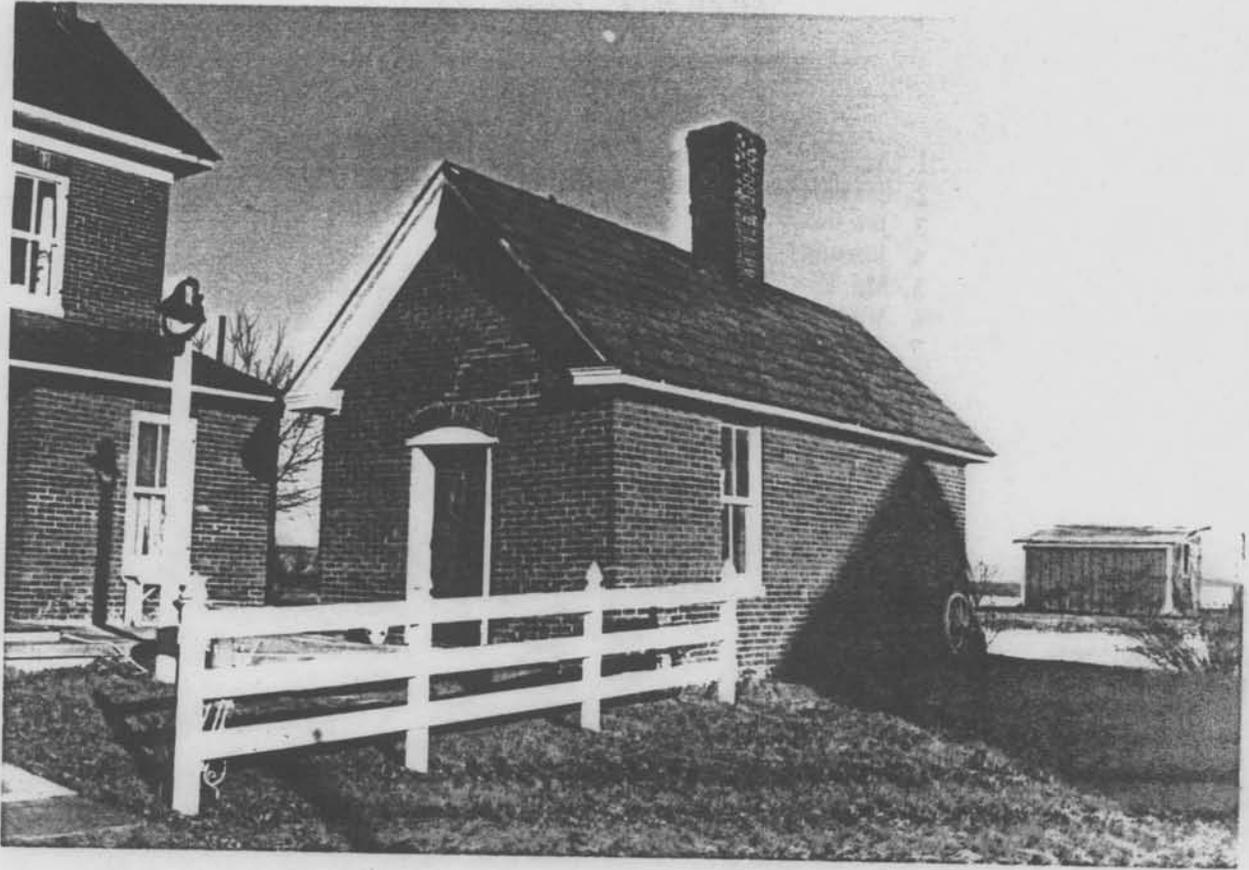
1. Andrew P. Frizzell House
2. Carroll County, Maryland
3. Joe Getty
4. January 1986
5. Md. Hist. Trust, Annapolis, Md.
6. Washhouse--s & w elev.
7. 21/29

The brick washhouse is a one story structure with a gable roof. It has a gable front main (west) facade with a central entrance and molded cornice that returns at the corners. The structure is actually a combination washhouse and smokehouse with the western room serving as a washhouse and summer kitchen. It is lit by two over-two windows on the north and south elevations. On its east wall is a small cooking fireplace. The northern room has no windows and a single entrance on the north facade. The beams are exposed for hanging meats and on the west side is a stone hearth for the fire.

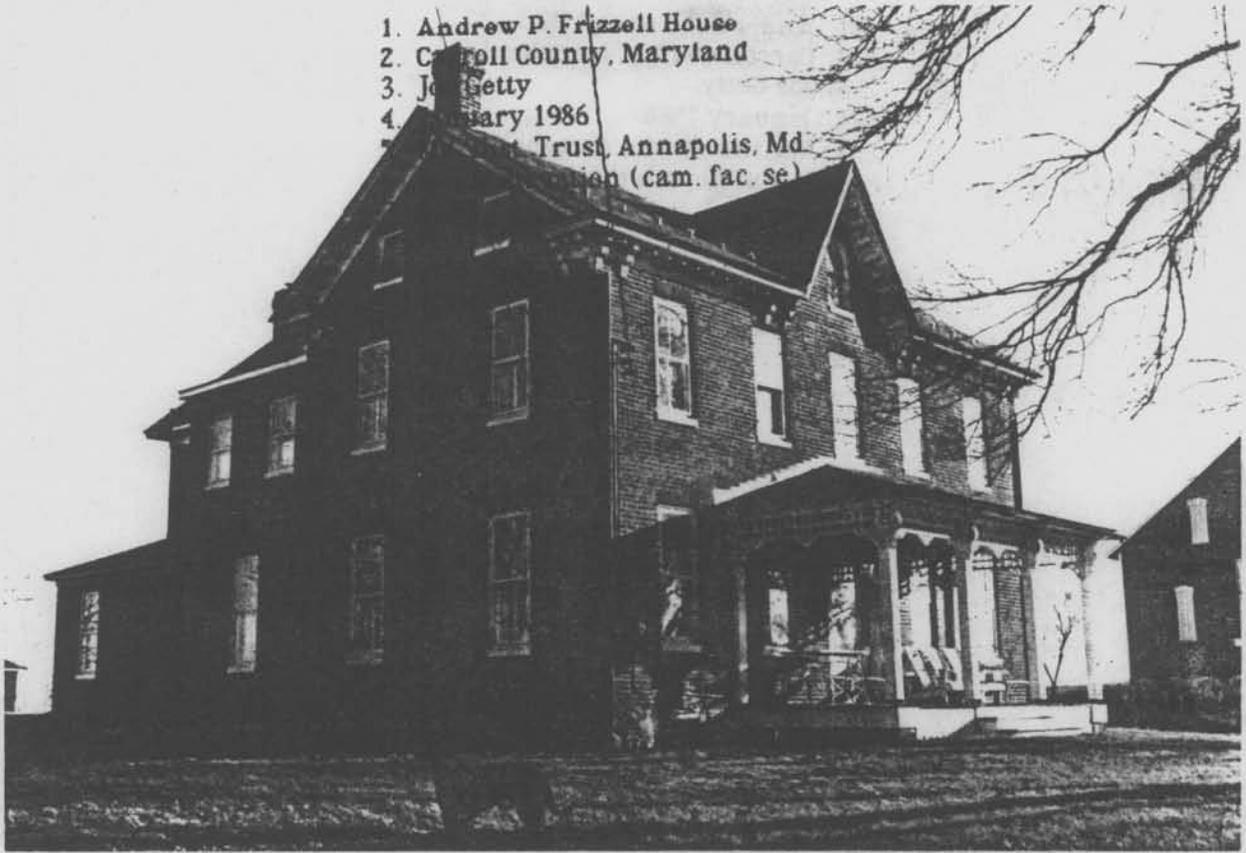
1. Andrew P. Frizzell House
2. Carroll County, Maryland
3. Joe Getty
4. January 1986
5. Md. Hist. Trust, Annapolis, Md.
6. n & w elevation (cam. fac. se)
7. 1/29

The main house is a two and one-half story, five bay by two bay, brick structure with an T-shaped plan. Its basic massing and proportions are traditional of the farmhouse design in this region throughout the 19th century. However, its T-shaped plan and the retention of the ornamental characteristics make it an exemplary Victorian period structure in Carroll County. These characteristics include the bracket cornice, centrally-located gable dormer, three-bay porch with decorative motifs, and two-story bay window on the south gable end. The house has a gable roof covered in slate shingles and has interior end brick chimneys with corbelled caps. The structure is built on a fieldstone foundation.

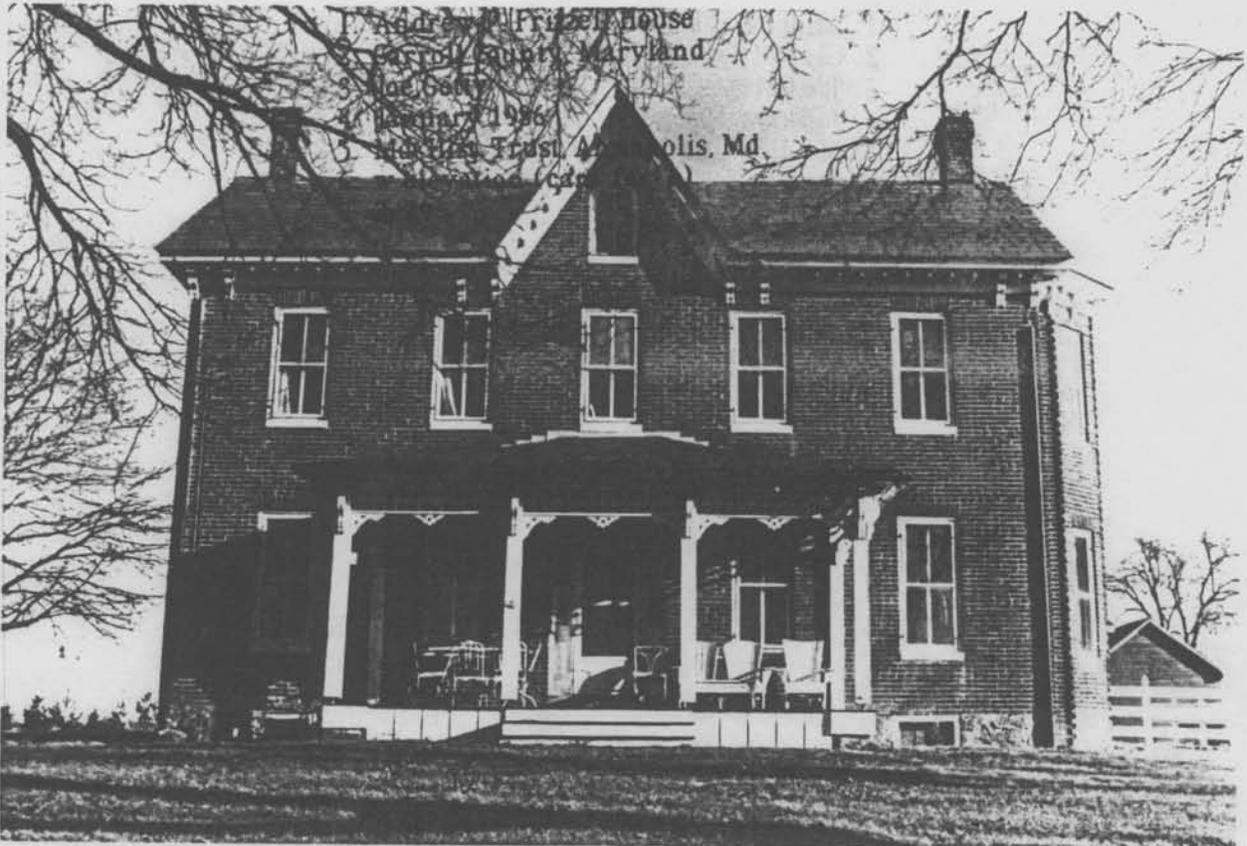
1. Andrew P. Frizzell House
2. Carroll County, Maryland
3. Joe Getty
4. January 1986
5. Md. Hist. Trust, Annapolis, Md.
6. w elevation (cam. fac. e)
7. 2/29

The main facade (facing west) is five bays wide with a central entrance on the first story and two-over-two sash windows on the other bays of the first and second stories. The windows have flat jack-arches and wooden sills. The central entrance has a granite sill, a three-pane transom, three-pane sidelights with paneling, and a four paneled door. This facade is highlighted by Victorian style trim including a gabled dormer with round-arched window, a bracket cornice, and a one-story, three-bay porch with

hipped roof. The porch is supported by square posts that have elaborate serpentine brackets. Running between the posts is an ornamental stick pattern with brackets and drops containing floral motifs. The main cornice of the house contain a pattern of scroll brackets interspersed with a row of plain serpentine brackets.
