MARYLAND INVENTORY OF
HISTORIC PROPERTIES

Maryland Historic Trust
State Historic Sites Inventory Form

and/or common Wells House

Street & number 4506 Beechwood Road not for publication

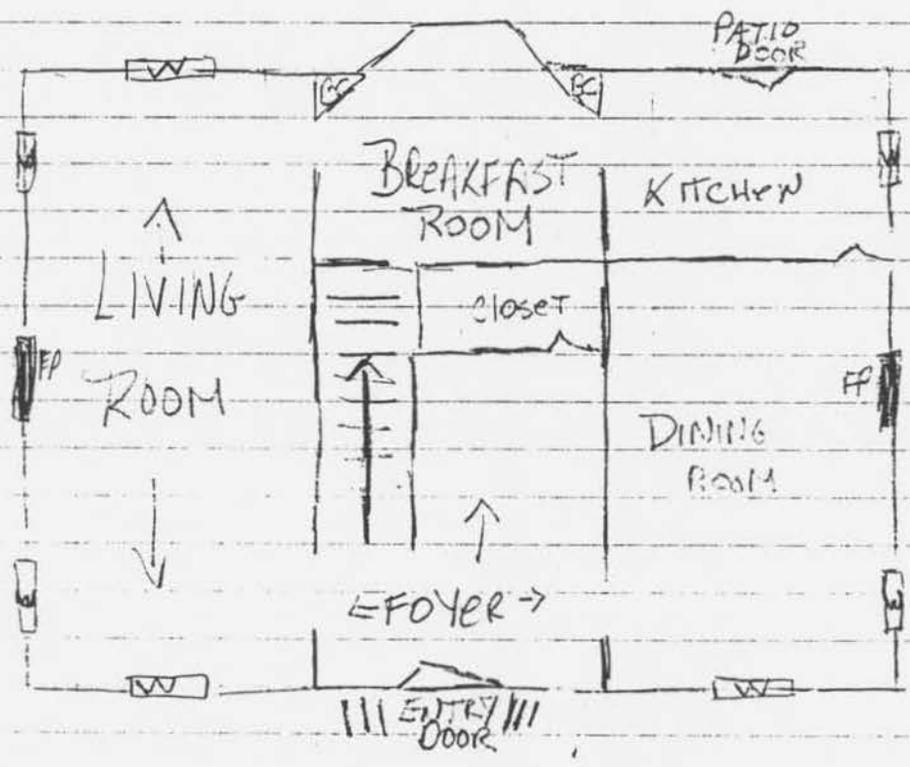
FIRST FLOOR

The interior of the house is in good condition. On the first floor are a living room, dining room, and kitchen, and breakfast room. (See accompanying floor plan.) The dining room and living room each have one fireplace, and both rooms have oak hardwood flooring. The moulding and the cornice in the living room were taken from one of the 16th Street mansions in the District of Columbia. The dining room has a chair rail. There are built-in bookshelves on each side of the bay window in the breakfast room. I did not see the upper floor. The house is a total of 1,482 square feet.
