PRINCE GEORGE'S COUNTY
HISTORIC SITE SUMMARY SHEET

Building Name: Elwood J. Taylor House

Location: 8516 58th Avenue, Berwyn Heights, Maryland

Maryland Historical Trust State Historic Sites Inventory Form

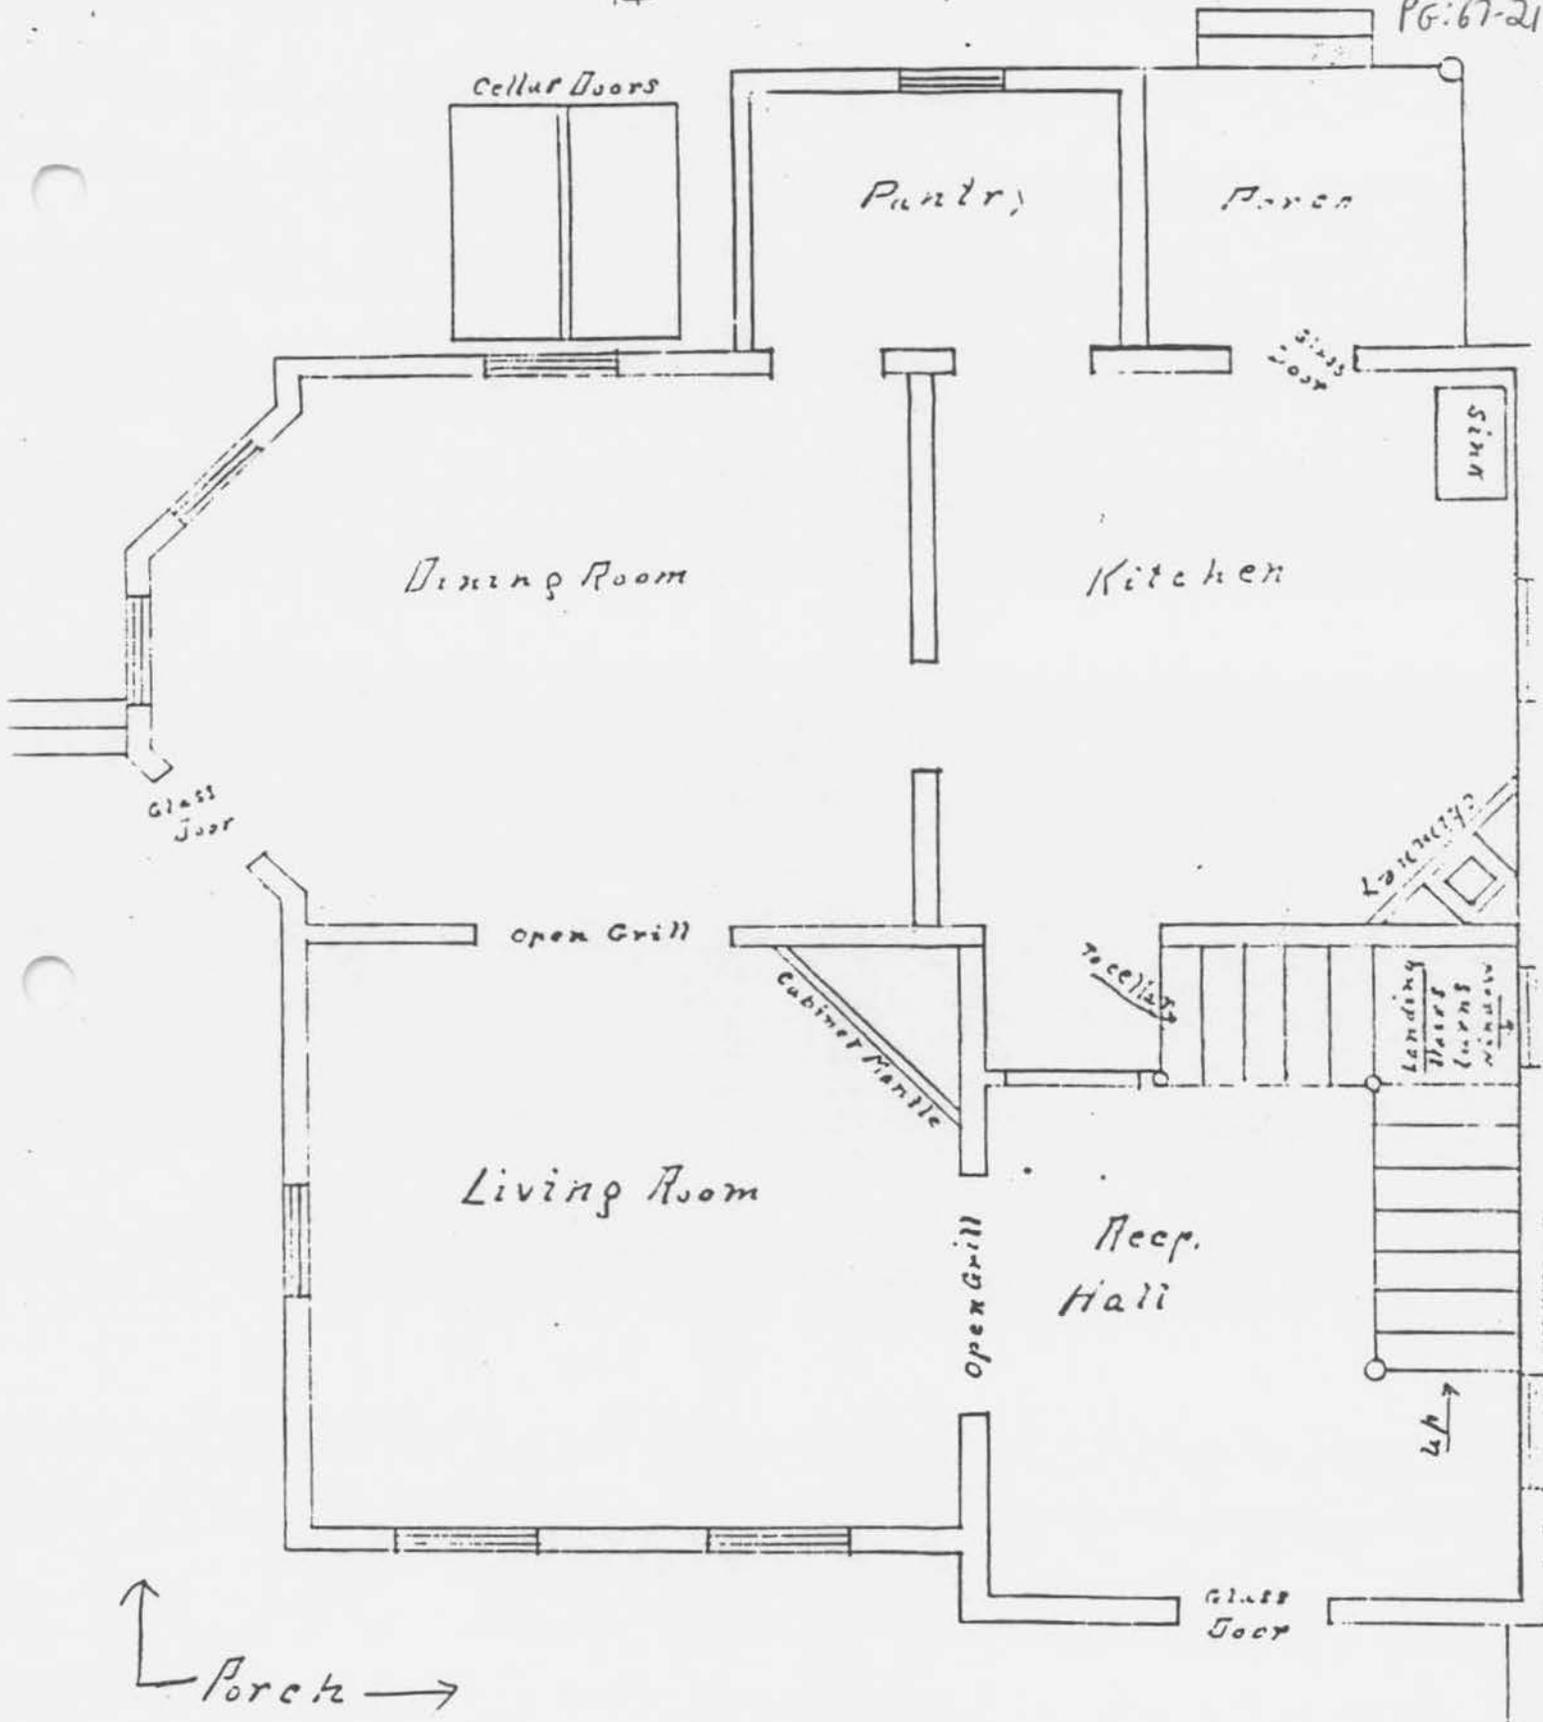
FIRST LEVEL PLAN

Interior plan of the house includes four nearly equal spaces, with entrance into the stairhall in the northeasterly space. The two-room open-string stair rises along the north (exterior) wall of the stair hall, turns 90° at a landing, and rises along the west wall to the second story. The staircase has a square paneled newel, and turned balusters.

Interior moldings are typical of the period, with multi-band surrounds and bulls-eye corner blocks. The wide doorways between stair hall and living room, and between the living room and dining room, once had decorative grille work (according to the original floor plans), but nothing remains of these embellishments.

A "cabinet mantel" is shown on the floor plan in the northwest corner of the living room; this was probably removed at the time of the expansion of the dining room. Circa 1950, the south wall of the living room was

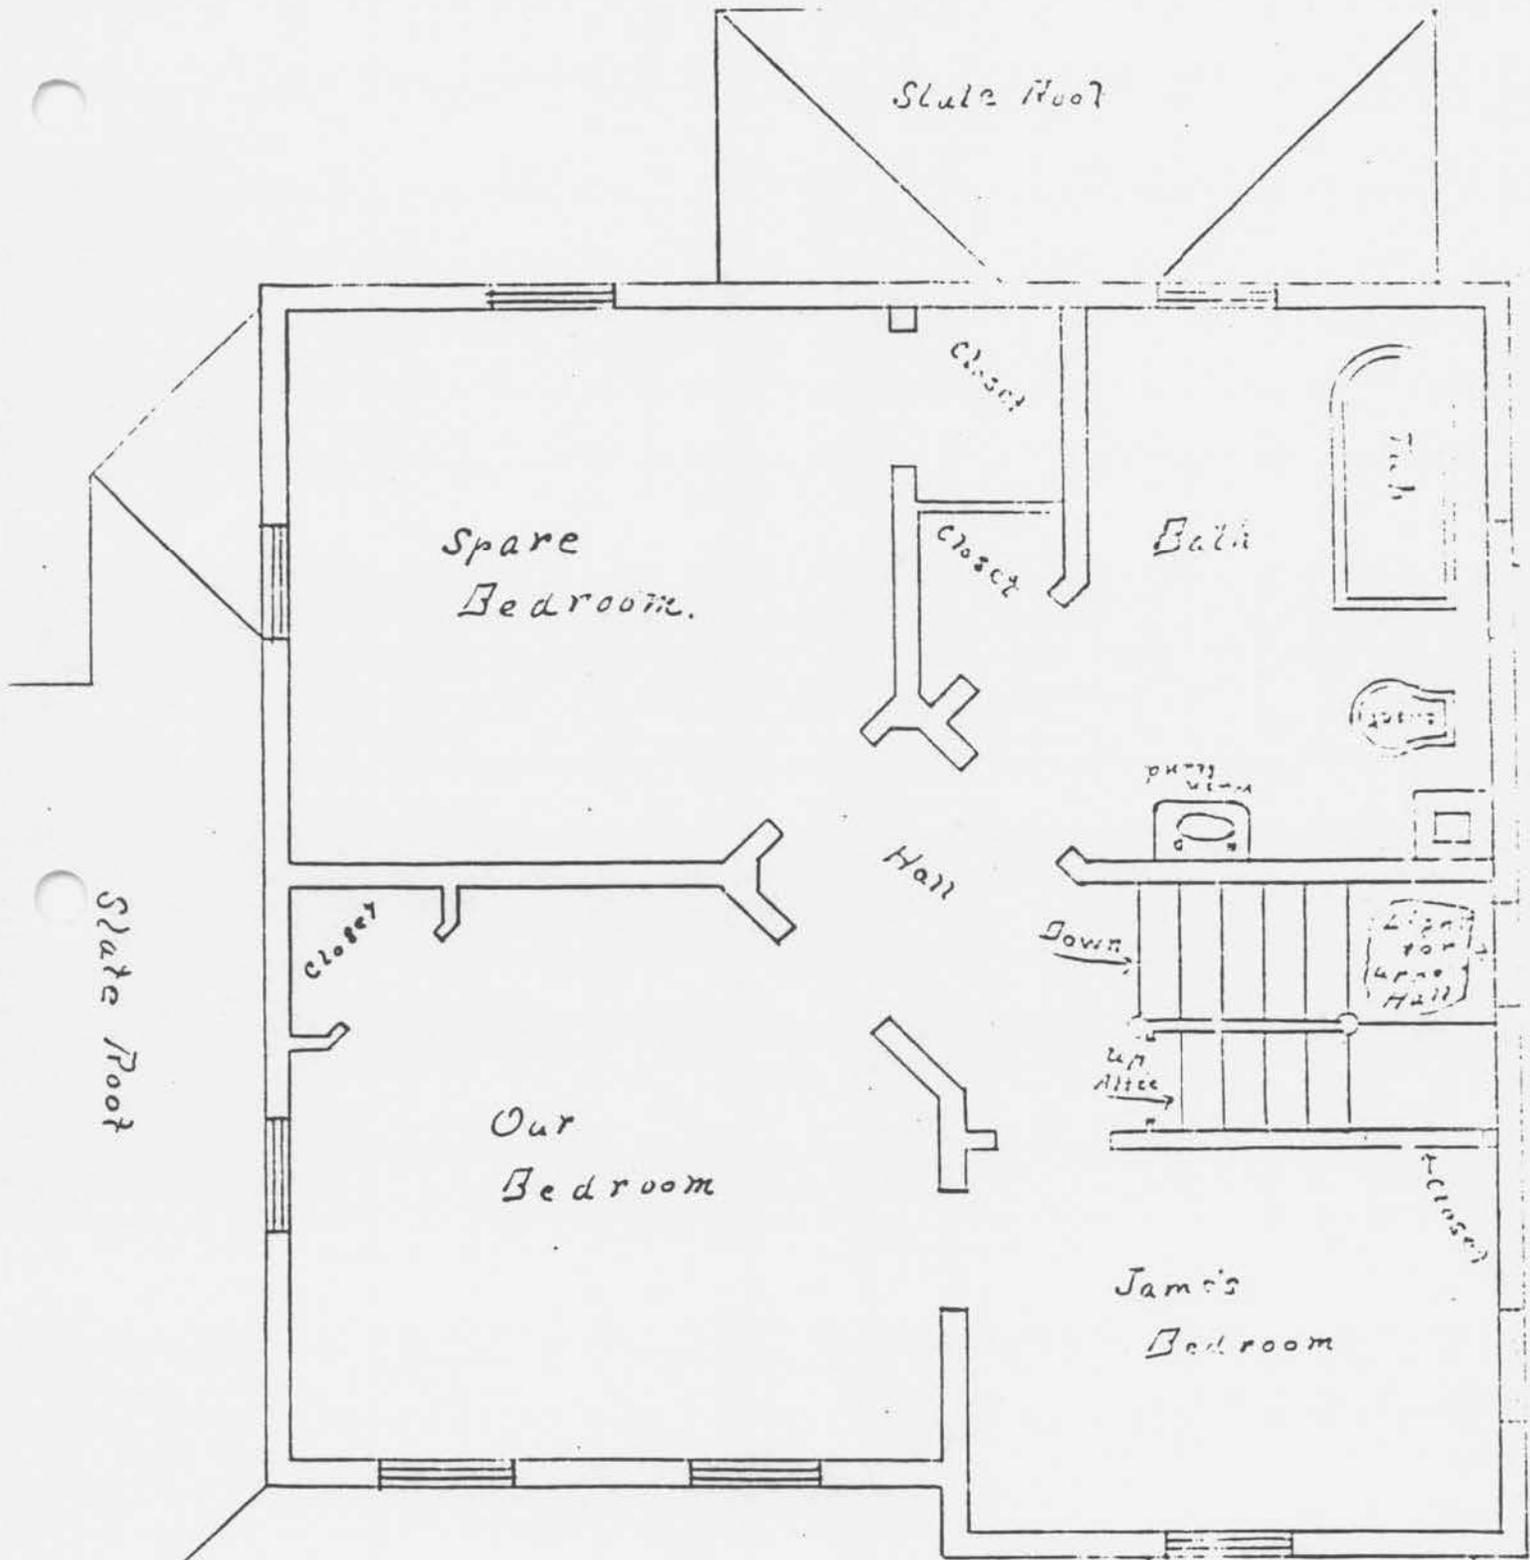
— SECOND LEVEL PLAN —

Slate Roof

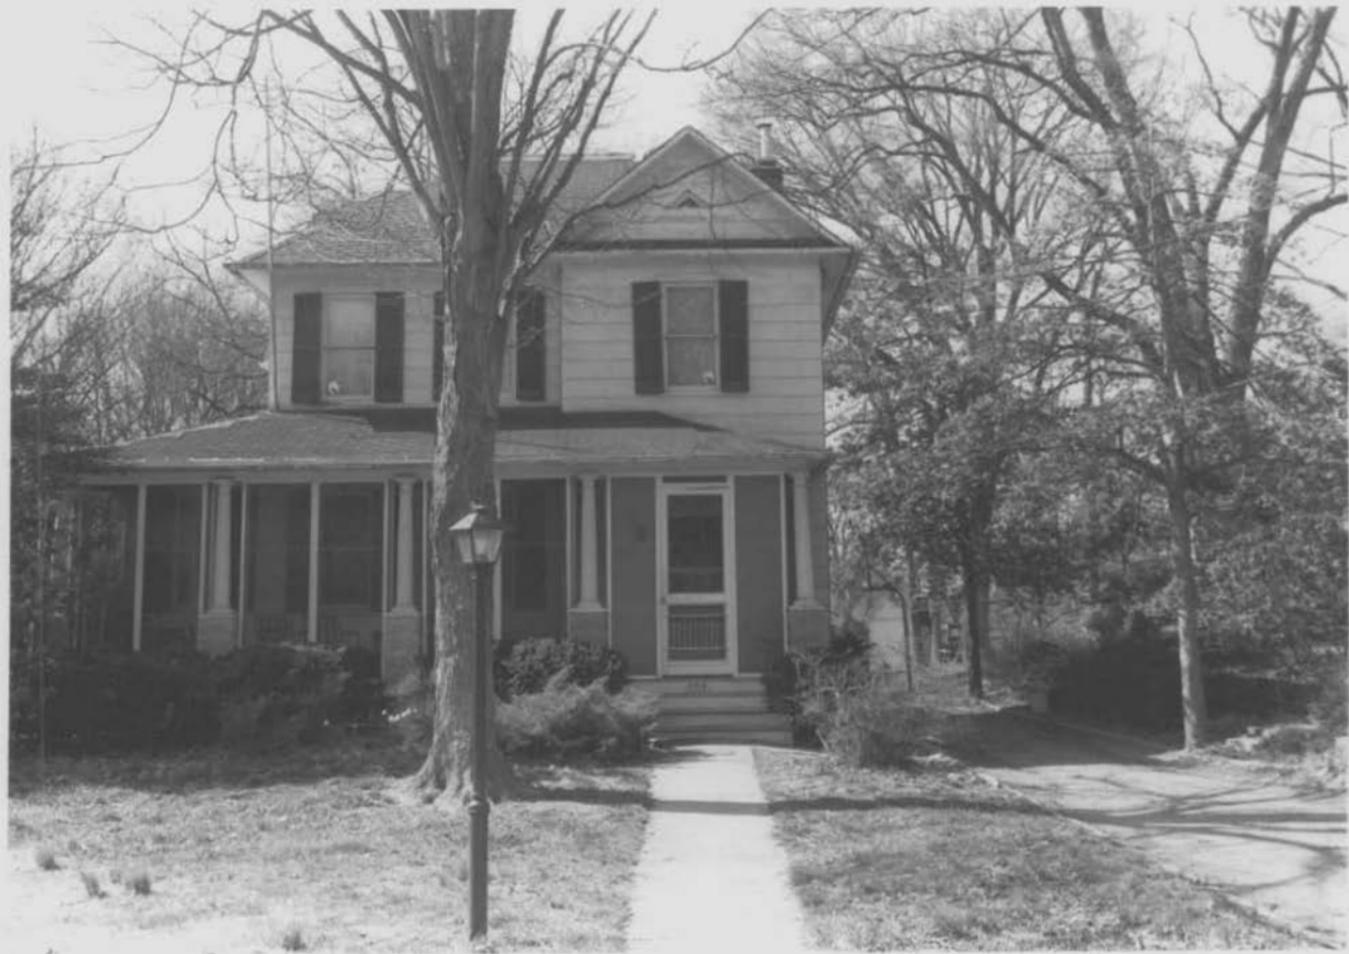
Elwood J. Taylor House
Prince George's County, MD.
Susan G. Pearl
April 1986
East elevation
Neg: Md. Hist. Trust, Annapolis, MD.

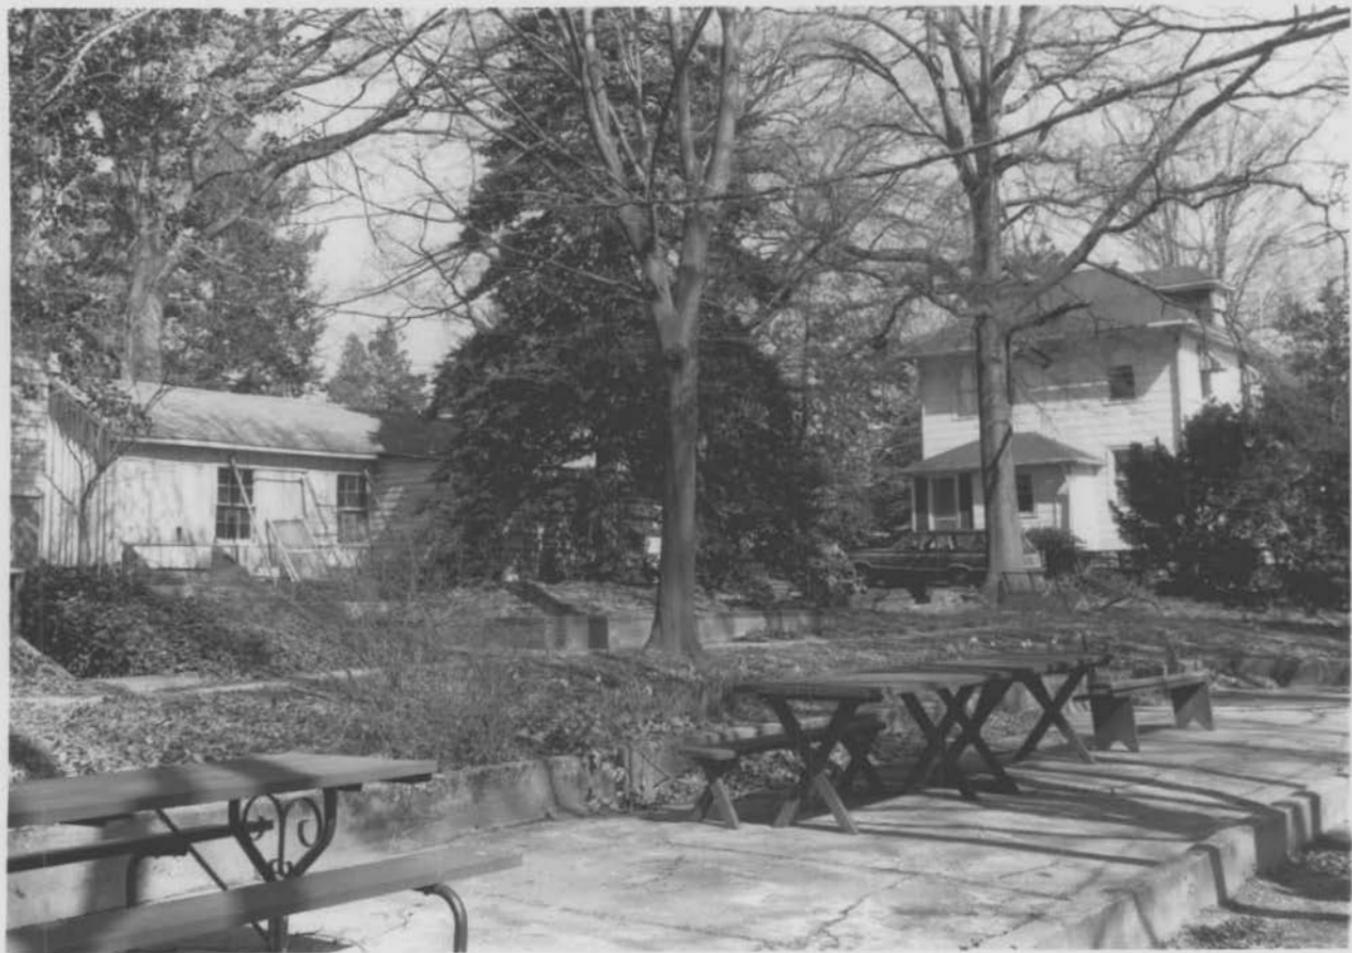
Elwood J. Taylor House
Prince George's County, MD.
Susan G. Pearl
April 1986
View from southwest
Neg: Md. Hist. Trust, Annapolis, MD.

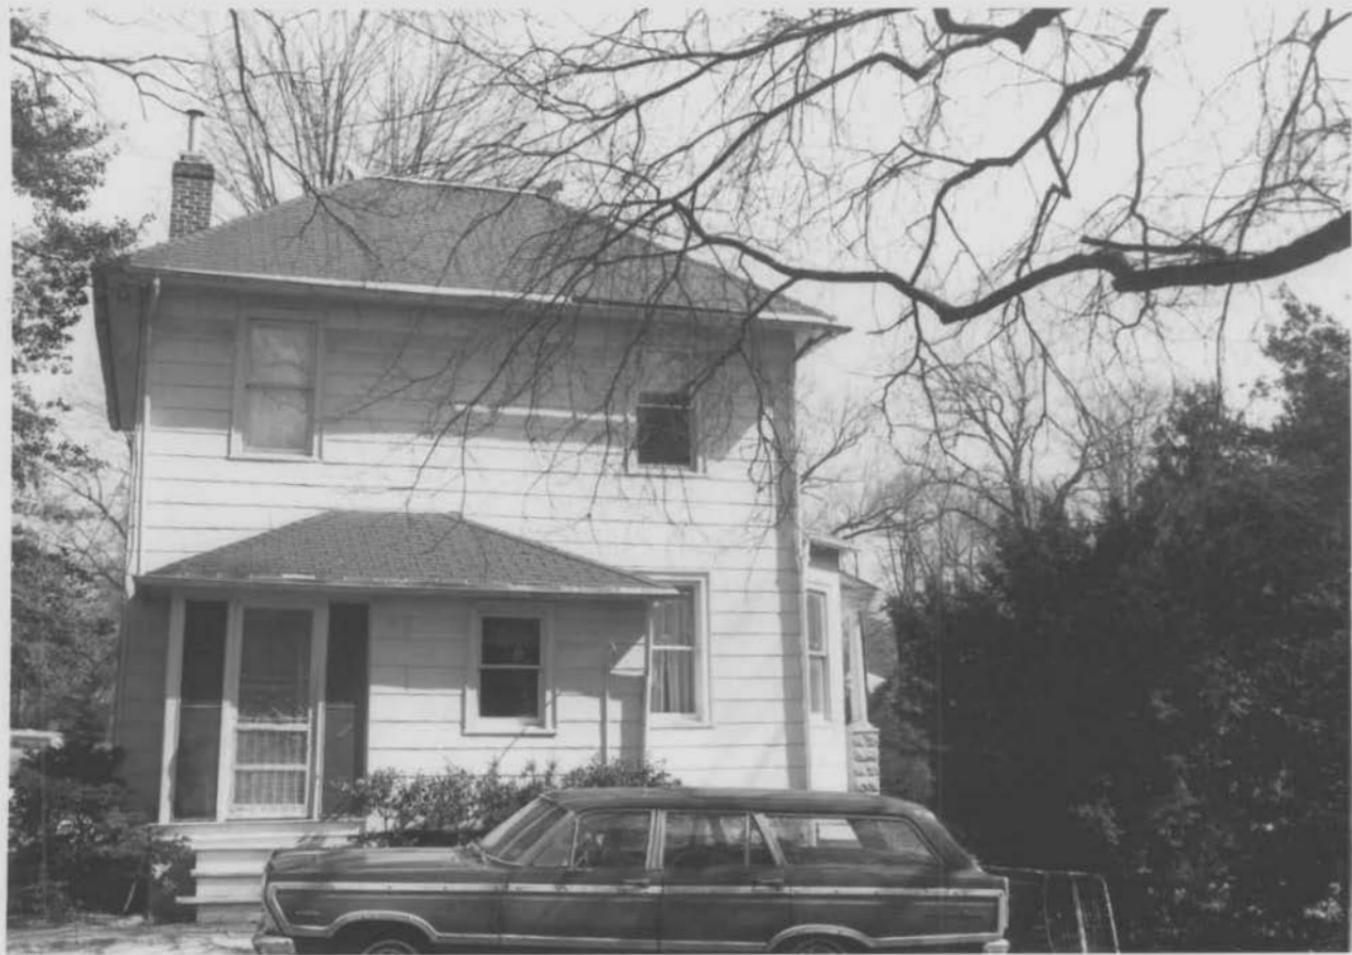
Elwood J. Taylor House
Prince George's County, MD.
Susan G. Pearl
April 1986
West elevation
Neg: Md. Hist. Trust, Annapolis, MD.
