PRINCE GEORGE'S COUNTY  
HISTORIC SITE SUMMARY SHEET

Survey #:     P.G. #68-12-14     Building Date:     circa 1900

Building Name:                     Martha Miller House

Location:           4320 41st Street, Brentwood, Maryland

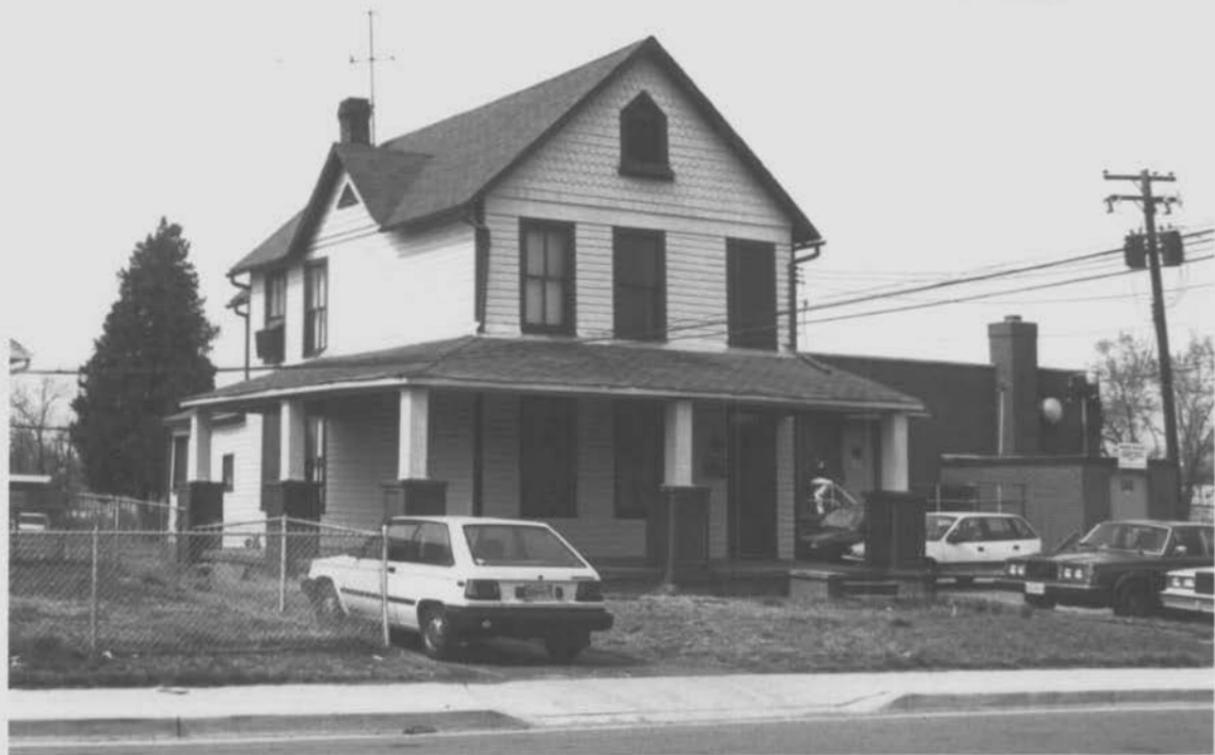
Pg # 68-12-14

Martha Miller House  
4320 41<sup>st</sup> Street  
Brentwood, P.G. Co.  
Susan H. Pearl  
March 1992  
Antitrust records
