P. G. #72~~X~~-17
Samuel Hargrove house
5907 K Street, Fairmount Heights, Md.
Priv/Occ/Res/Good

Maryland Historical Trust State Historic Sites Inventory Form

historic Samuel Hargrove House

street & number 5907 K Street ___ not for publication

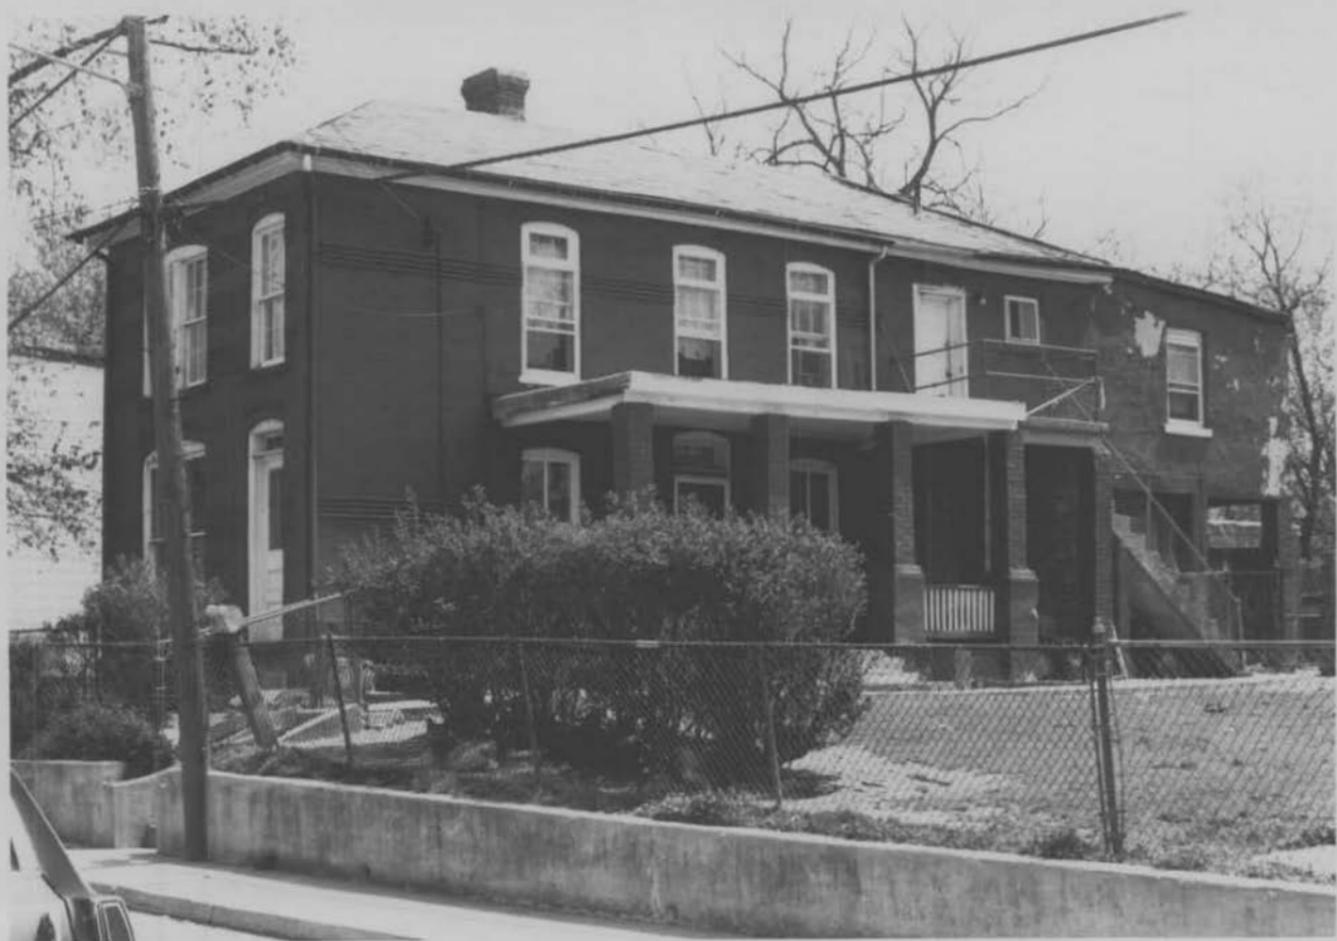
P6:72-17

Samuel Hargrove House
Prince George's County, Md.
Susan G. Pearl
April 1983
West Elevation
Neg: Md. Hist. Trust, Annapolis, Md.

The Samuel Hargrove house is a very handsome two-story brick hip-roofed town-house, with its narrow (two-bay) facade facing the street to the north. The longer four-bay west facade has a one-story flat-roofed porch sheltering the three original bays, of which the central is a door; this porch is supported by brick-pier columns. This porch has been extended one further bay to the south, and a staircase built, in order to provide access to a later second-story door to a private apartment. Beyond this, there is a two-story shed roof addition extending the house to the south. The west long facade is highlighted by two four-band string courses of torus molded brick, one at ground level, the other at second story level.

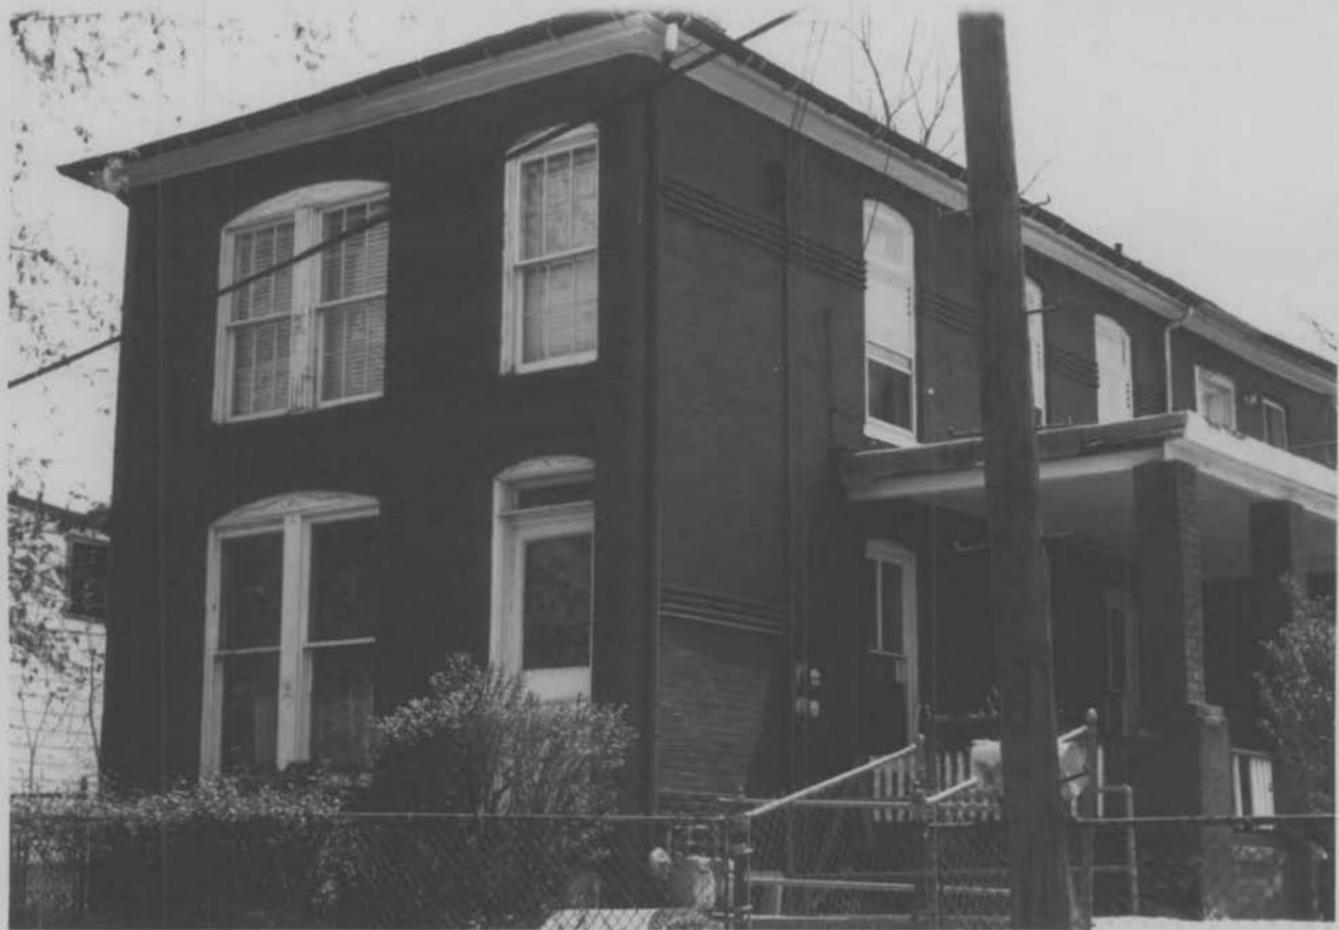
P6:72-17

Samuel Hargrove House
Prince George's County, Md.
Susan G. Pearl
April 1983
Northwest 3/4 Elevation
Neg: Md. Hist. Trust, Annapolis, Md.

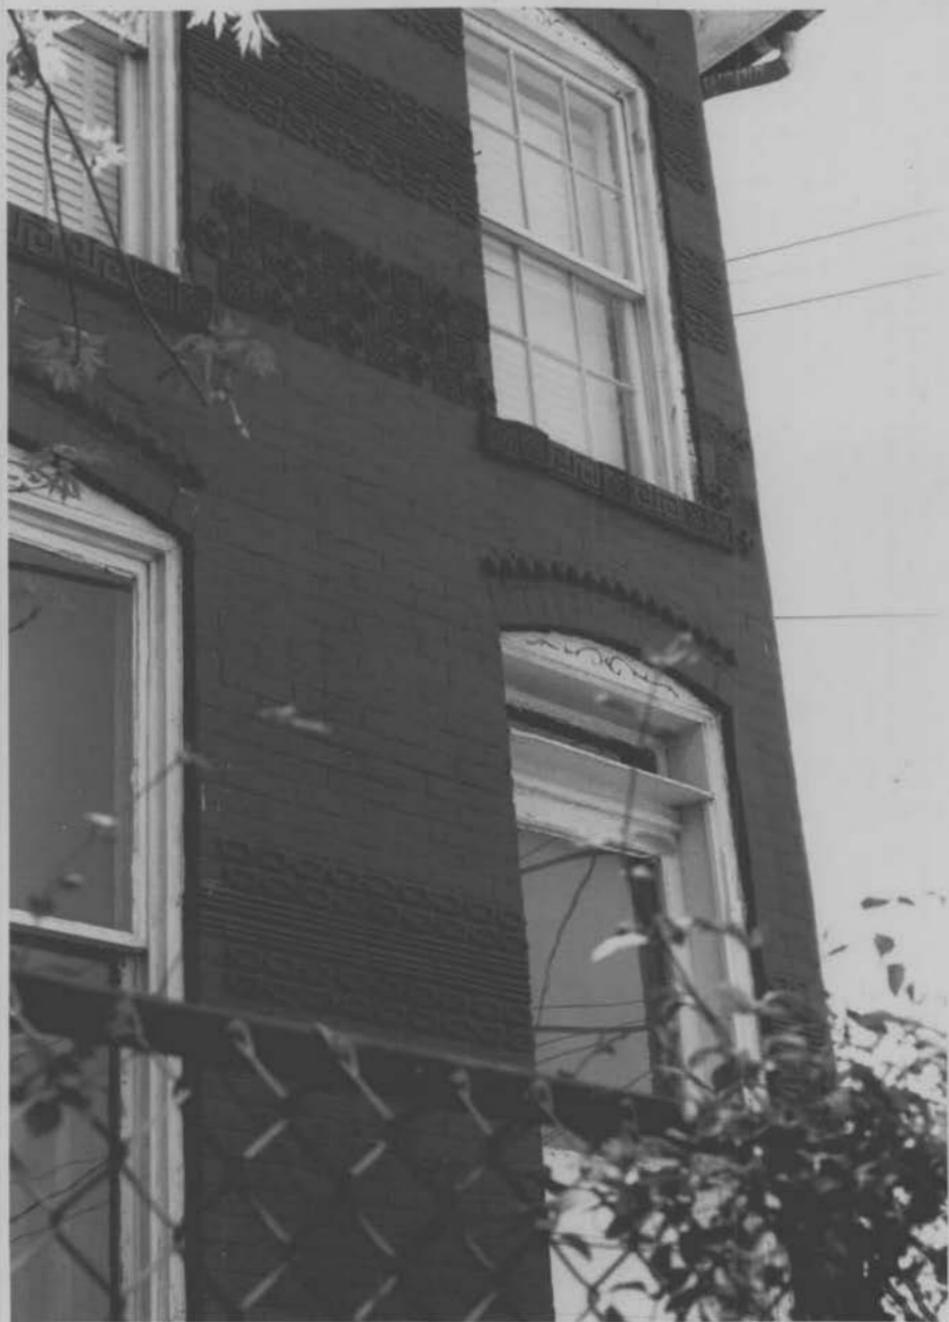
P. G. 72~~A~~-17

Samuel Hargrove House
Prince George's County, Md.
Susan G. Pearl
April 1983
North Elevation, Detail
Neg: Md. Hist. Trust, Annapolis, Md.

The two-bay north facade, with double window in the first bay, and single window/door in the second, is distinguished by very elaborate molded brick decoration. Above each window and door is a segmental brick arch, and above the arch a row of pearl molding, following and highlighting the line of the arch. Running horizontally across the ground level of the north facade (approximately at the center of the openings and interrupted by the double window and then by the door) is a wide band of molding consisting of two rows of oval-link chain, above which are two courses of three-torus moldings, above which are repeated the two rows of oval-link chain.

At second level, the complete band described above is repeated twice, at the top and at the center of the two second-story windows. The band of molding which runs across this facade at the lower part of the second-story windows consists of three courses of alternating rosettes and patterned plaques. The same plaques alternate with a modified Greek meander to form the sills of these second-story windows.
