PRINCE GEORGE'S COUNTY  
HISTORIC SITE SUMMARY SHEET

Survey #: P.G. #74A-7 Building Date: early 1840's

Building Name: Bermondsey

Location: 2202 Bermondsey Drive, Mitchellville, Maryland

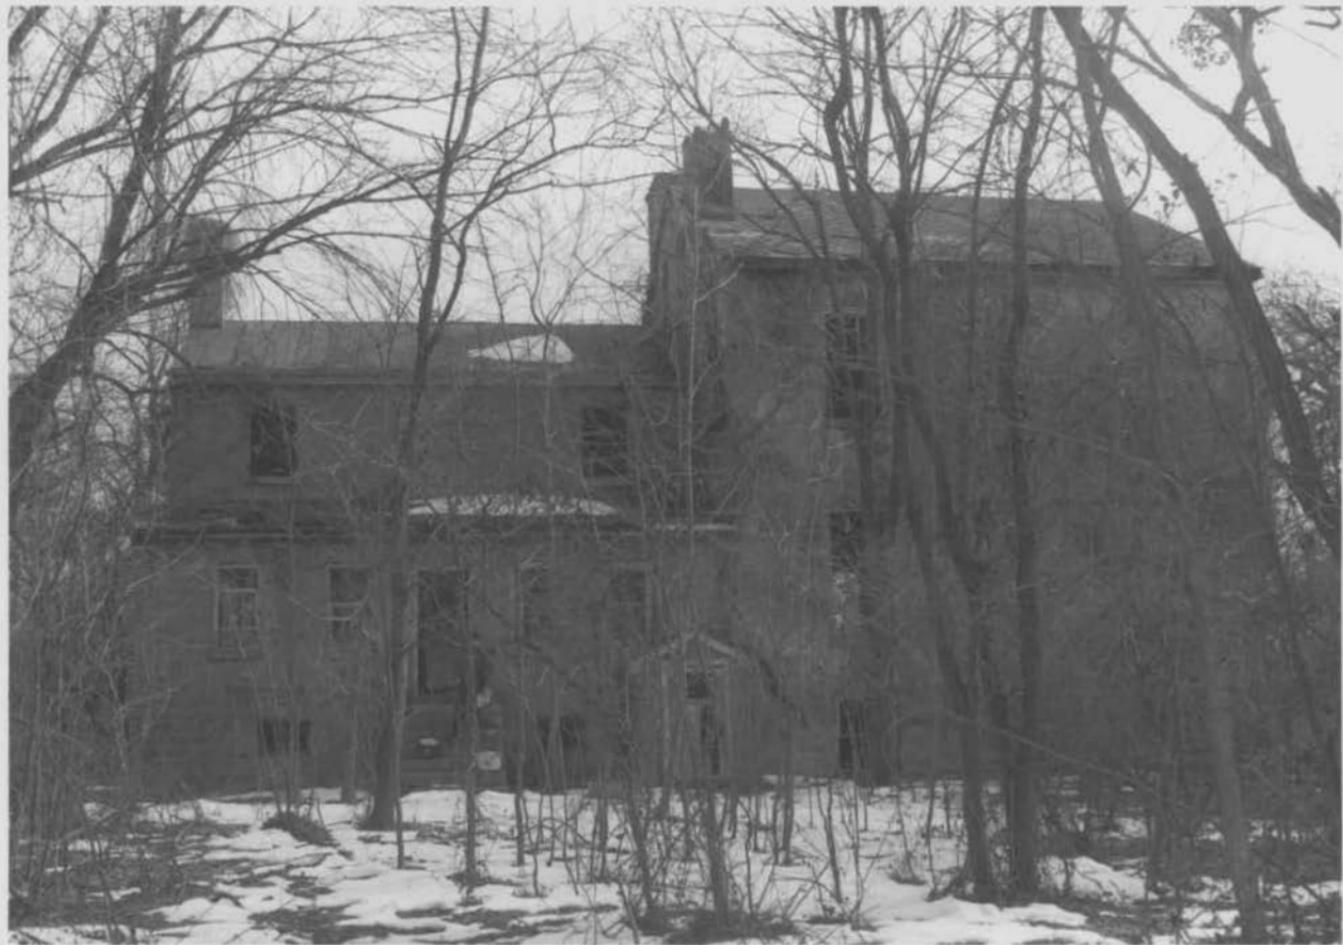
P.G. #74A-7

Bermondsey  
Prince George's County, Maryland  
Susan G. Pearl  
February 1987  
West elevation  
Neg: Maryland Historical Trust  
Annapolis, MD

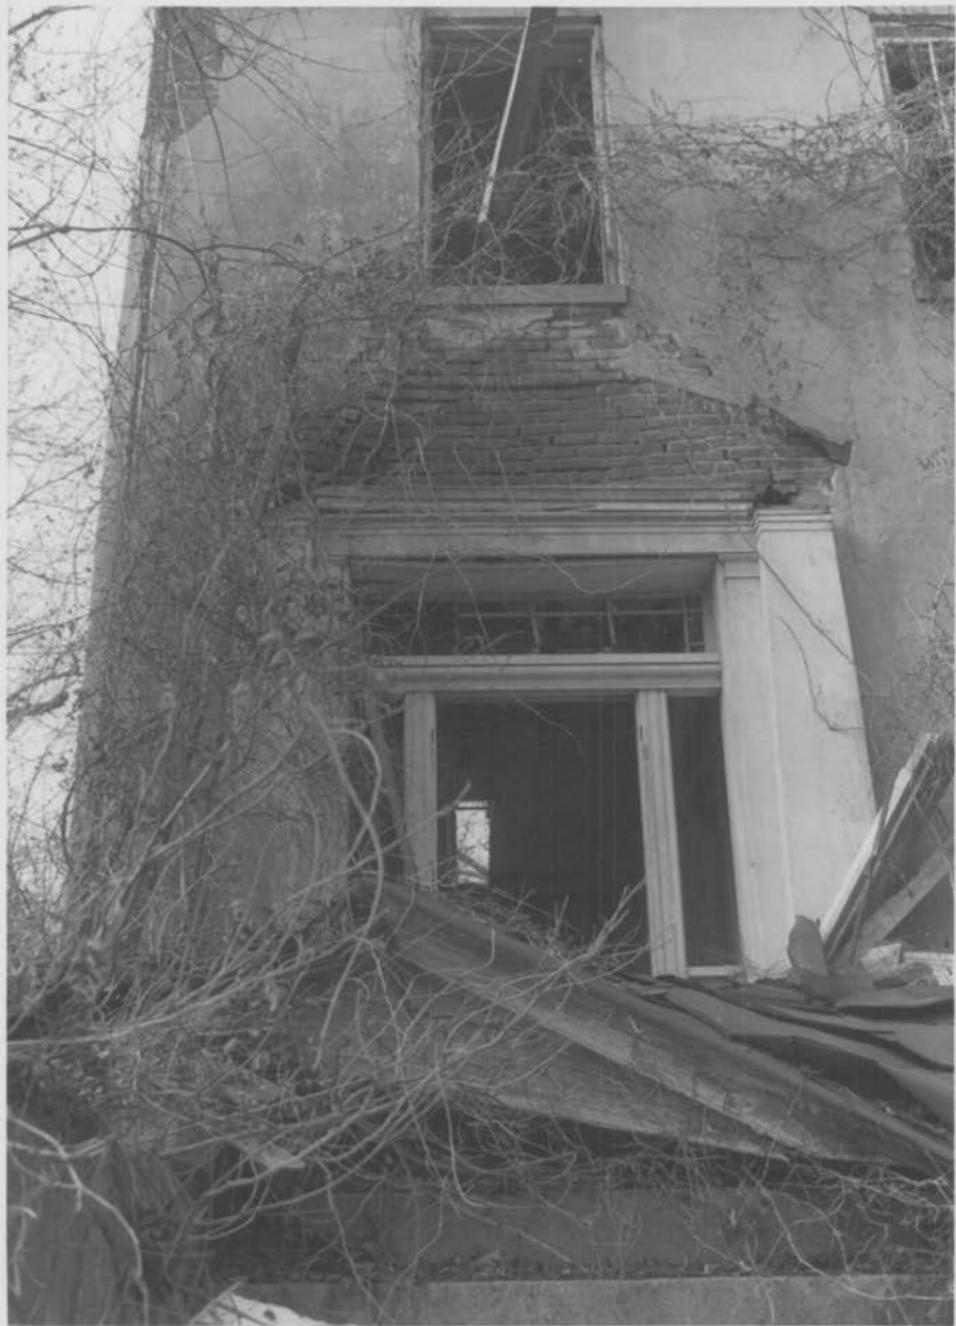
P.G. #74A-7

The main block is two-and-one-half stories, with gable roof, three bays by two bays, 33 by 37-1/2 feet. Entrance is in the first bay of the principal east facade, through a door with a wide transom, and sidelights over wainscot panels. Most of the glass is missing from transom and sidelights, and the six-panel wood door has been removed. The entry porch which once sheltered this door is now missing, the 1936 Historic American Buildings Survey photograph shows this high porch with fully pedimented gable roof supported by two wood Tuscan-style columns, and geometric patterned railings bordering the sides. The wide supporting wood pilasters remain, as do the wide stone steps.

Bermondsey  
Prince George's County, Maryland  
Susan G. Pearl  
February 1987  
East entrance, exterior  
Neg: Maryland Historical Trust  
Annapolis, MD

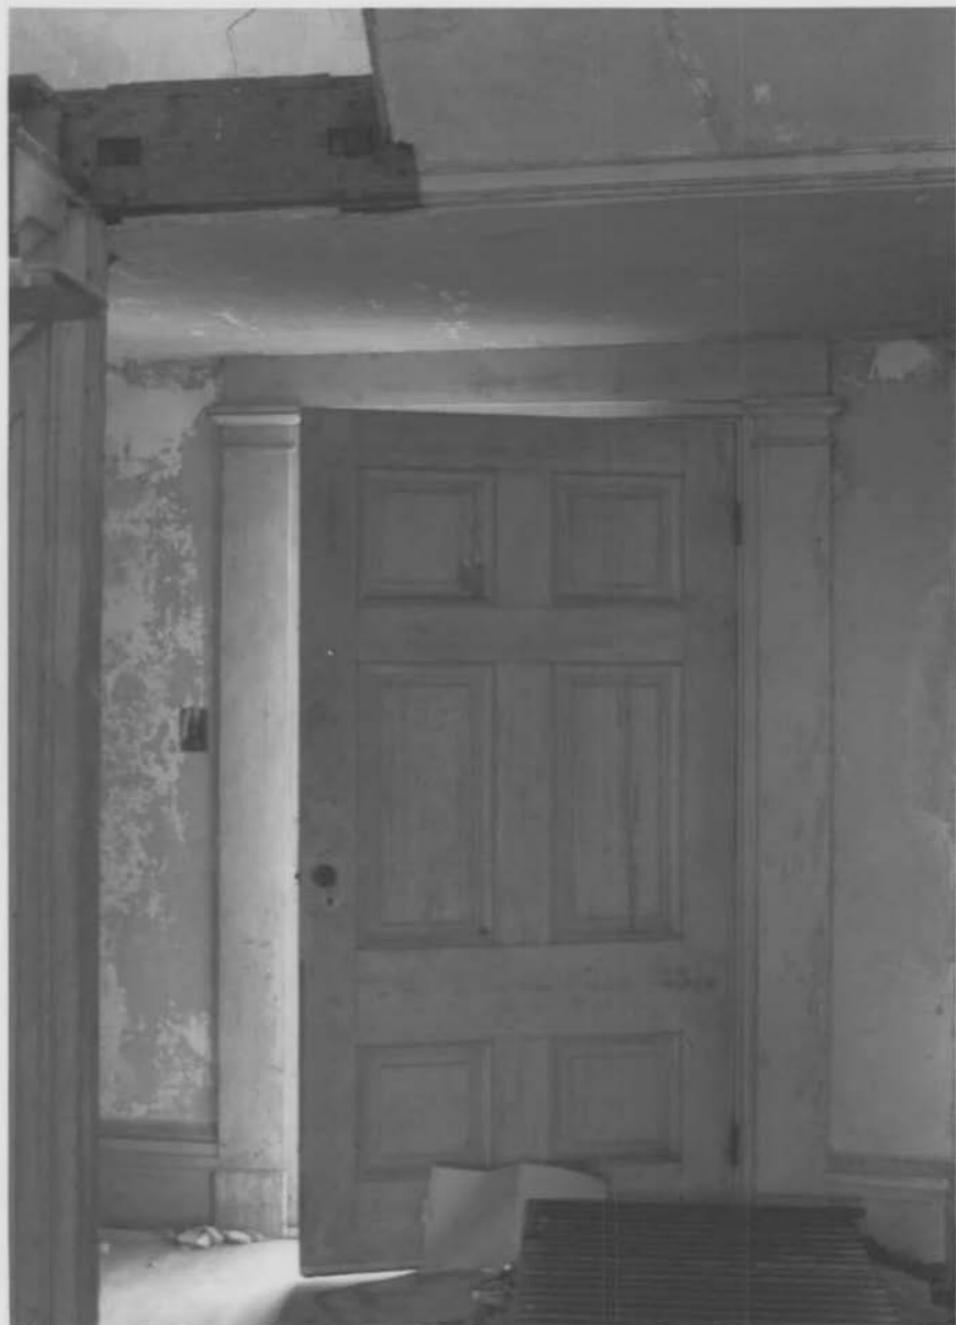
P.G. #74A-7

West entrance interior

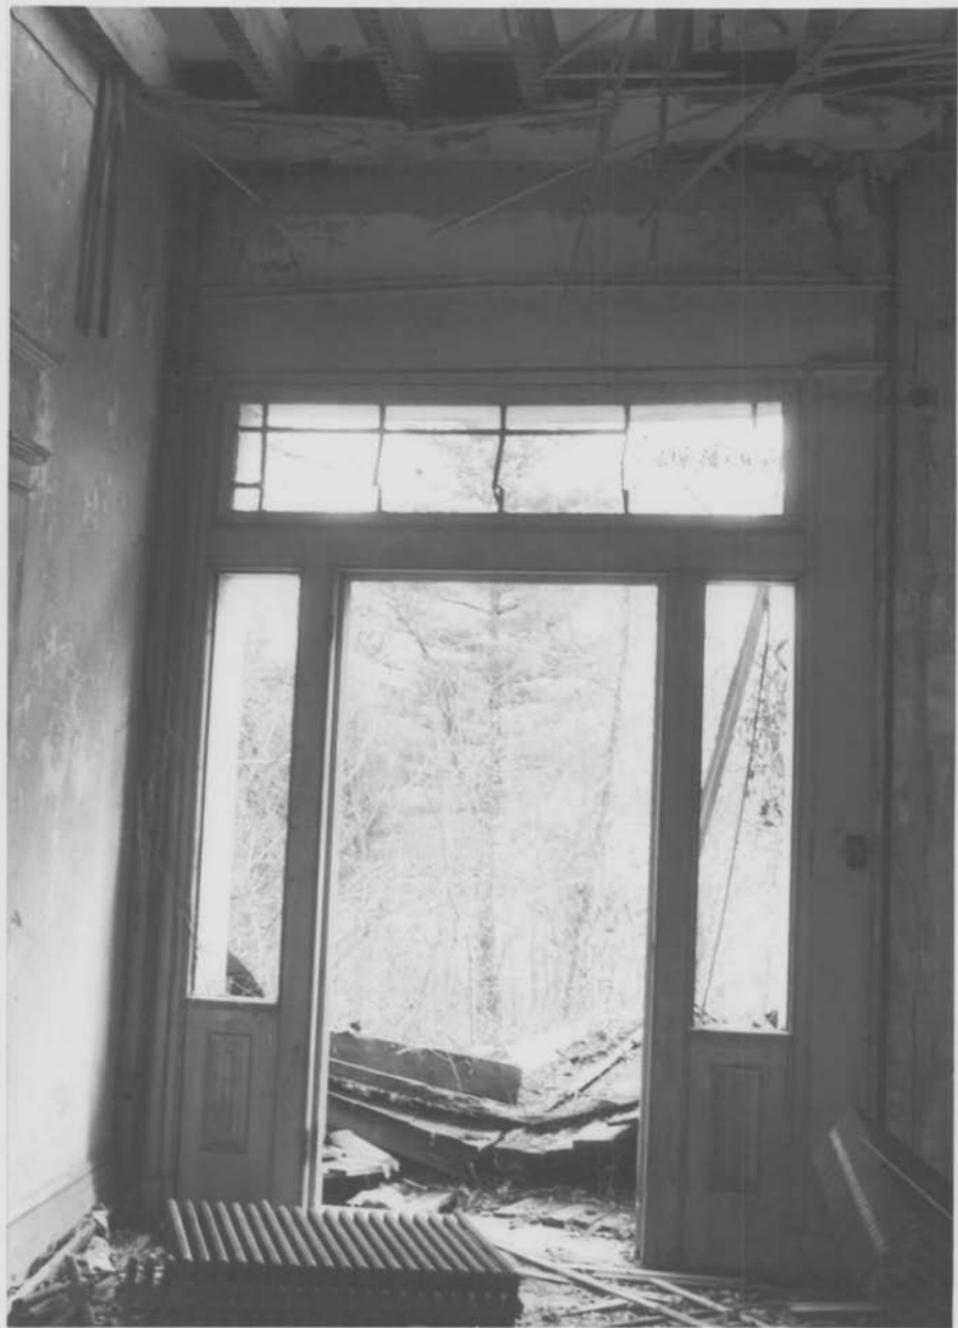
P.G. #74A-7

Bermondsey  
Prince George's County, Maryland  
Susan G. Pearl  
February 1987  
East entrance from interior  
Neg: Maryland Historical Trust  
Annapolis, MD

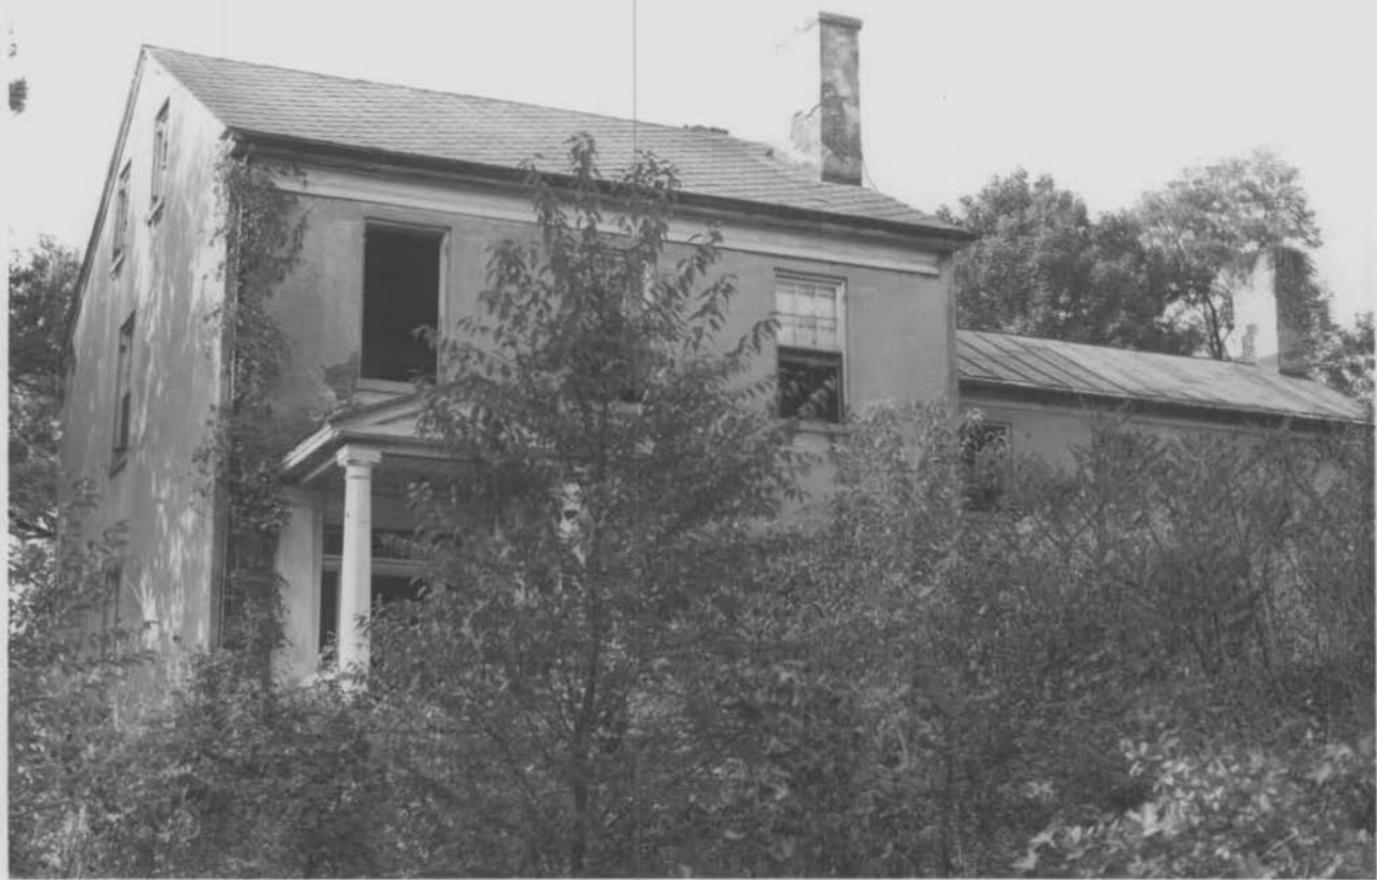
NAME BERMONDSEY

FACADE SE

PHOTO TAKEN 10/7/74 M DWYER PG: 74A-7

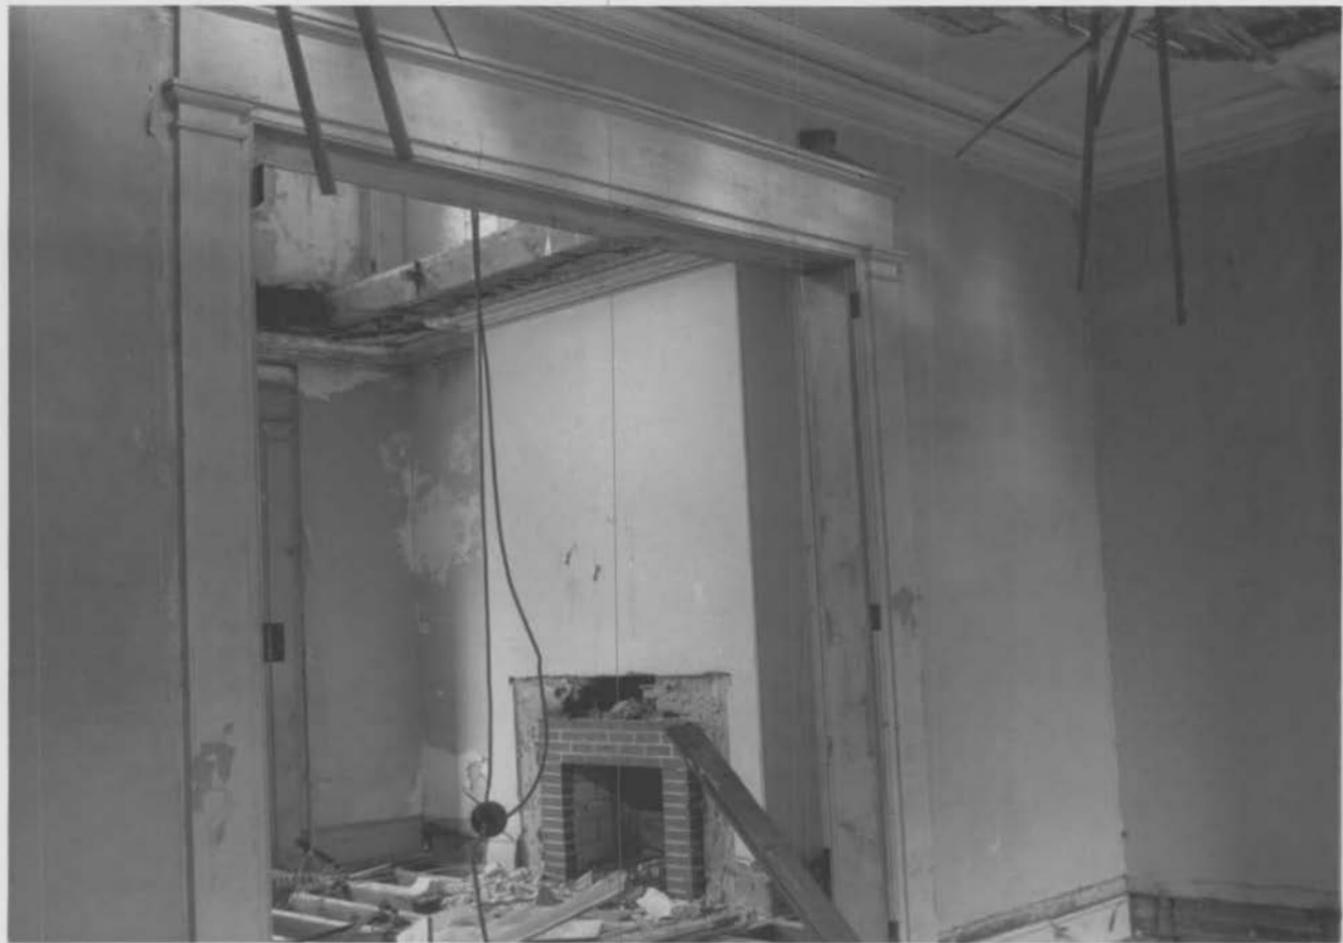
P.G. #74A-7

Bermondsey  
Prince George's County, Maryland  
Susan G. Pearl  
February 1987  
Doorway, double parlor  
Neg: Maryland Historical Trust  
Annapolis, MD

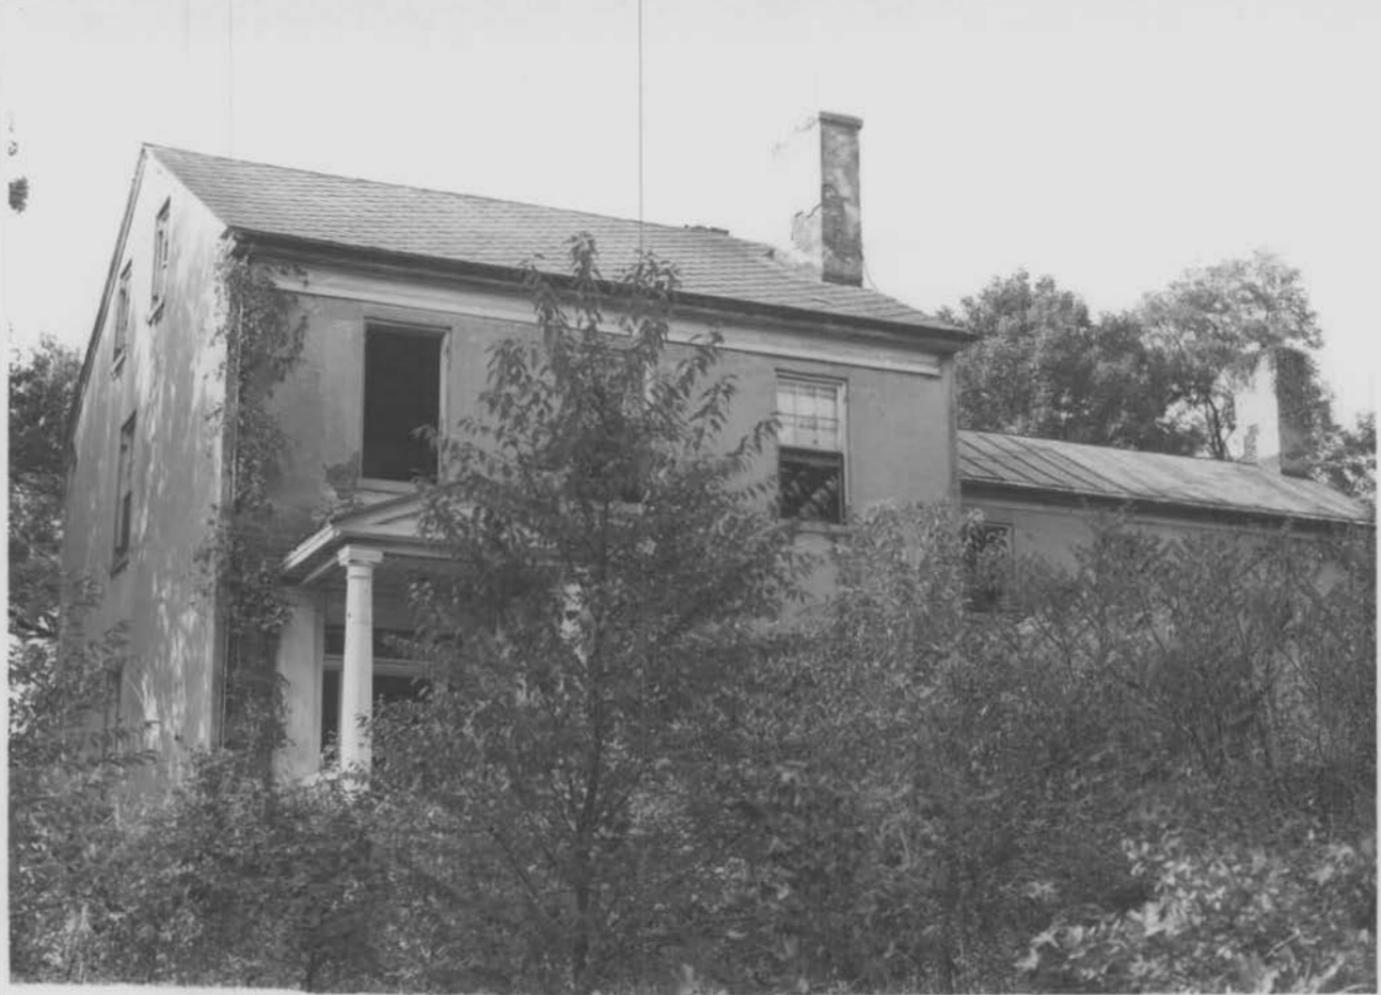
NAME BERMONDSEY

FACADE SE

PHOTO TAKEN 10/7/74 MOWYER
