MARYLAND HISTORICAL TRUST NR-ELIGIBILITY REVIEW FORM

Property Name: Summit Investment Property

Address: 7913-7917 Marlboro Pike, Forestville, Prince George's County, Maryland, 20747

Project: I-495/I-95 Capital Beltway Corridor Transportation Study Agency: State Highway Administration

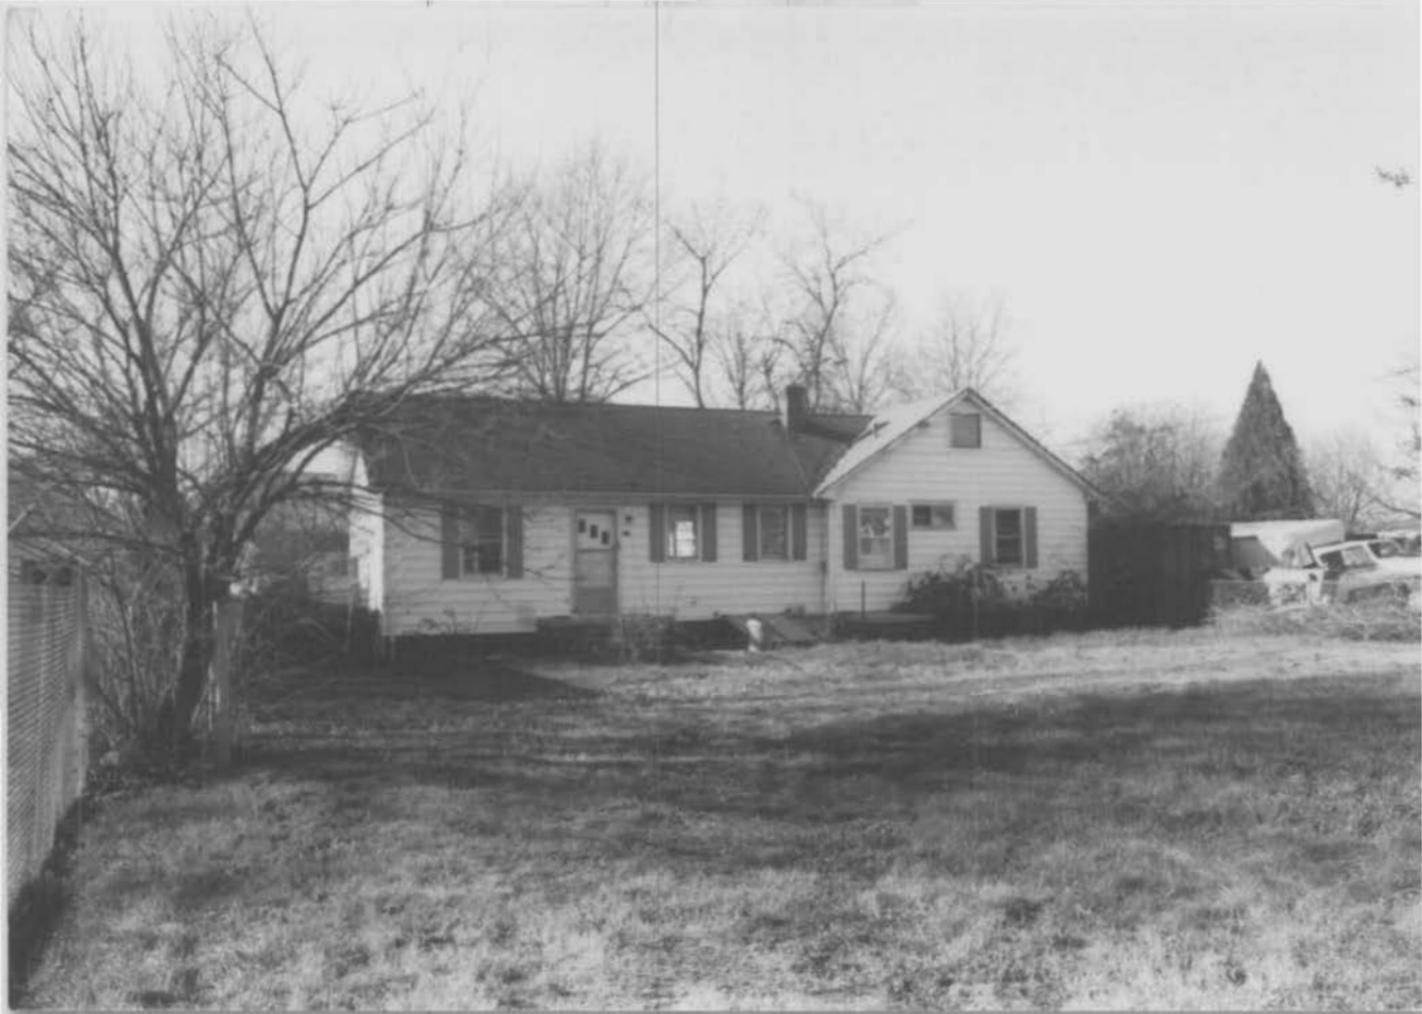
8. 1 of 7

7 7913 Marlboro Pike house, View New

The house at 7913 Marlboro Pike (See Photos 1-3) is a 1-story, 6-bay residence with a 2-bay front-gable wing. The house has a concrete-block foundation, aluminum siding and an asphalt-shingle roof. A brick chimney is located in the center of the roof. The main entry is located in the second bay from the east on the front (north) elevation. It consists of a wood door with three glass panes and a plain surround. The 2/2 horizontally-divided windows found throughout the

house appear to be original. The house has undergone several alterations, including the addition of a modern deck on the south elevation and a sliding window between two bays on the north elevation. Southeast of the house is a small shed with aluminum siding and an asphalt-shingle, side-gable roof.

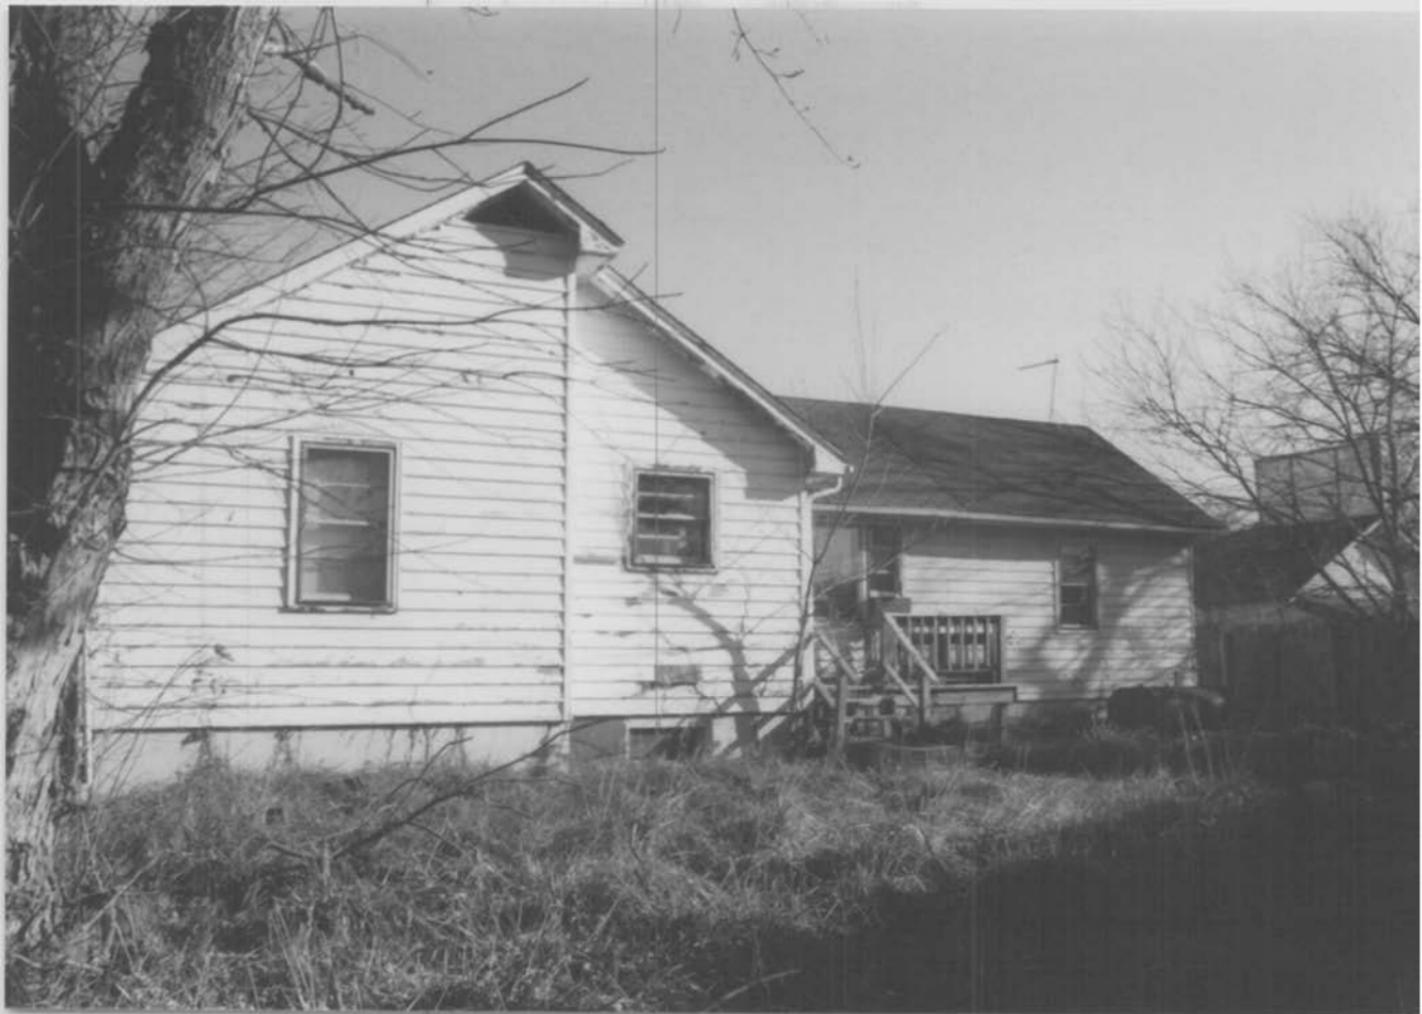
1. PG: 75A-50
2. Summit Investment Property
3. Prince George's County, MD
4. Julie Darsie
5. 12/99
6. MD SHPO
7. 7913 Marlboro Pike, house, view SE
8. 2 of 7

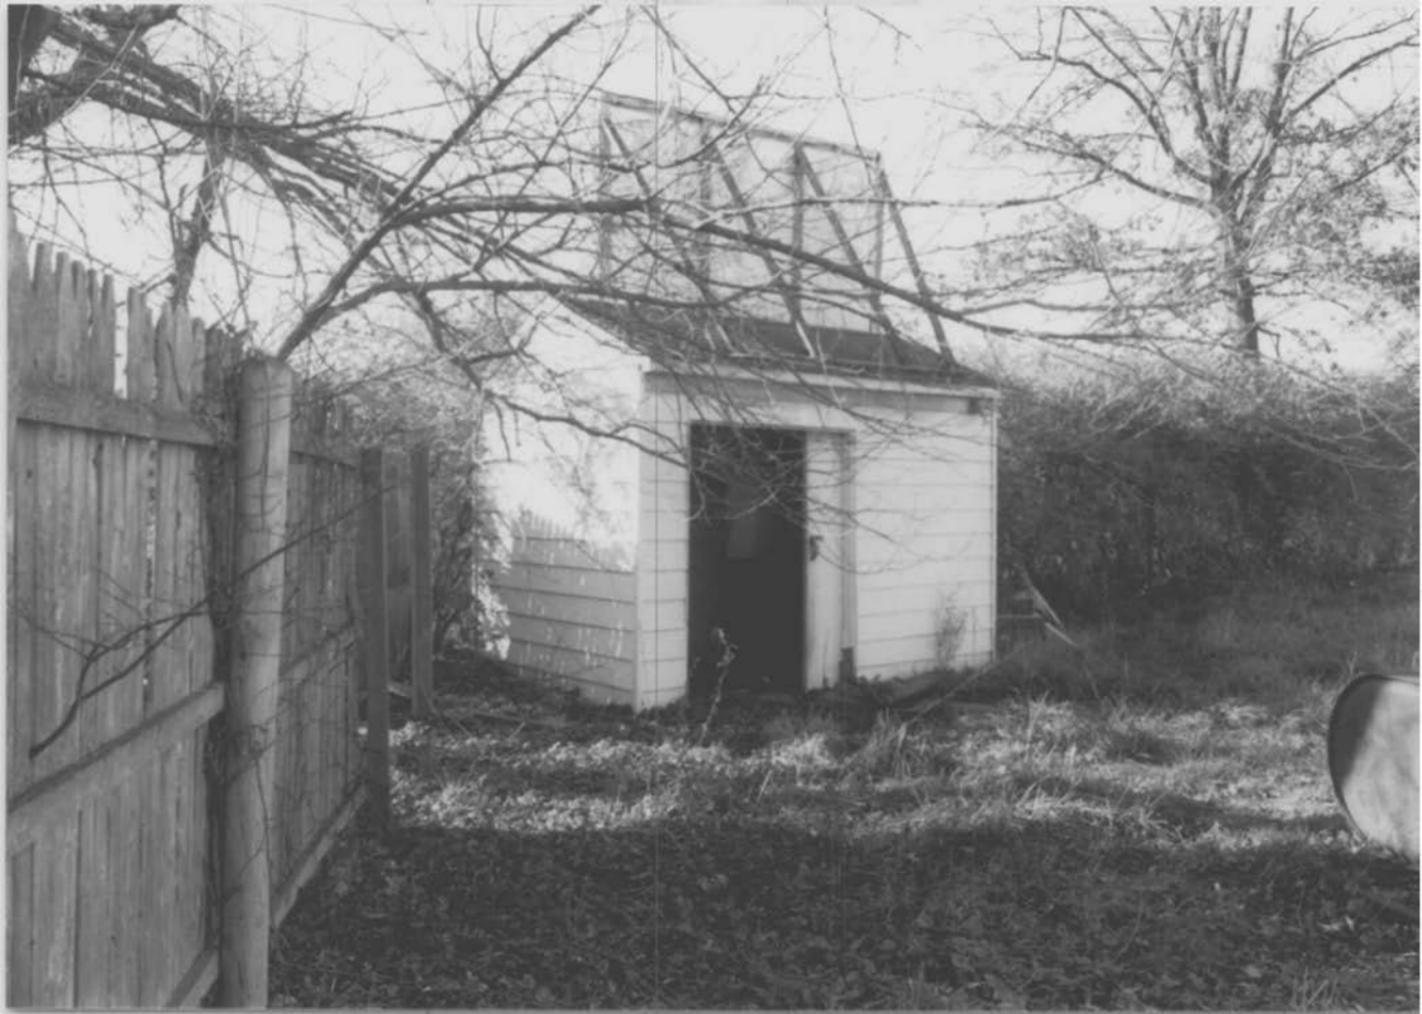
1. PG:75A-50
2. Summit Investment Property
3. Prince George's County, MD
4. Julie Darsie
5. 12/99
6. MD SHPO
7. 7913 Marlboro Pike, Shred, View SW
8. 3 of 7

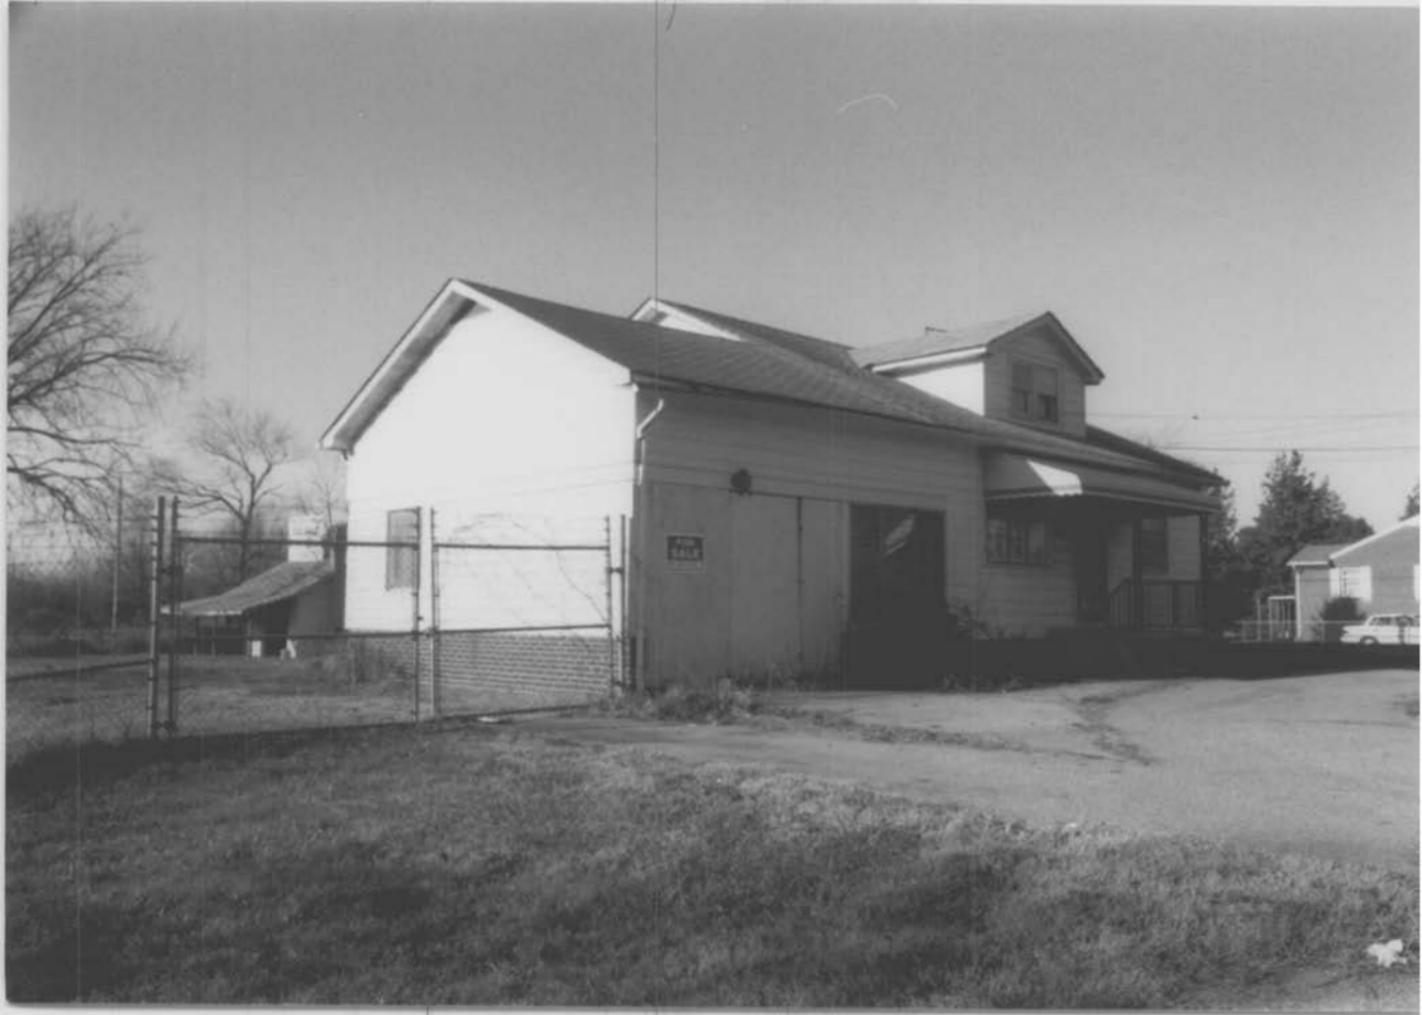
- 1 PG: 75A-50
- 2 Summit Investment Property
- 3 Prince George's County, MD
- 4 Julie Darnie
- 5 12/99
- 6 MD SHPO
- 7 7917 Marlboro Pike, house, View Mt.
- 8 4/17

The house at 7917 Marlboro Pike (Photos 4-7) is 1 ½-stories tall and 3-bays wide. It has a brick foundation, aluminum siding, and an asphalt-shingle, side-gable roof with deep eaves and a gable dormer on the front (north) elevation. A brick chimney rises from the south slope of the roof. The main entry to the house is located in the center bay of the front elevation. The wood door has four glass panes and a plain surround. An aluminum awning and a concrete stoop with a metal rail complete the entry. The original windows were 8/1 double-hung, however few of those remain. Most were replaced by 6/6 aluminum windows. A large side-gable addition, also covered in aluminum siding, extends from the east elevation of the house. The circa 1960 addition has large openings on its north elevation which are now boarded. Within the fenced back yard south of the house is a 1-story, concrete-block workshop/garage. This building has a gable roof covered in asphalt-shingle, exposed rafter ends and a concrete-block chimney.

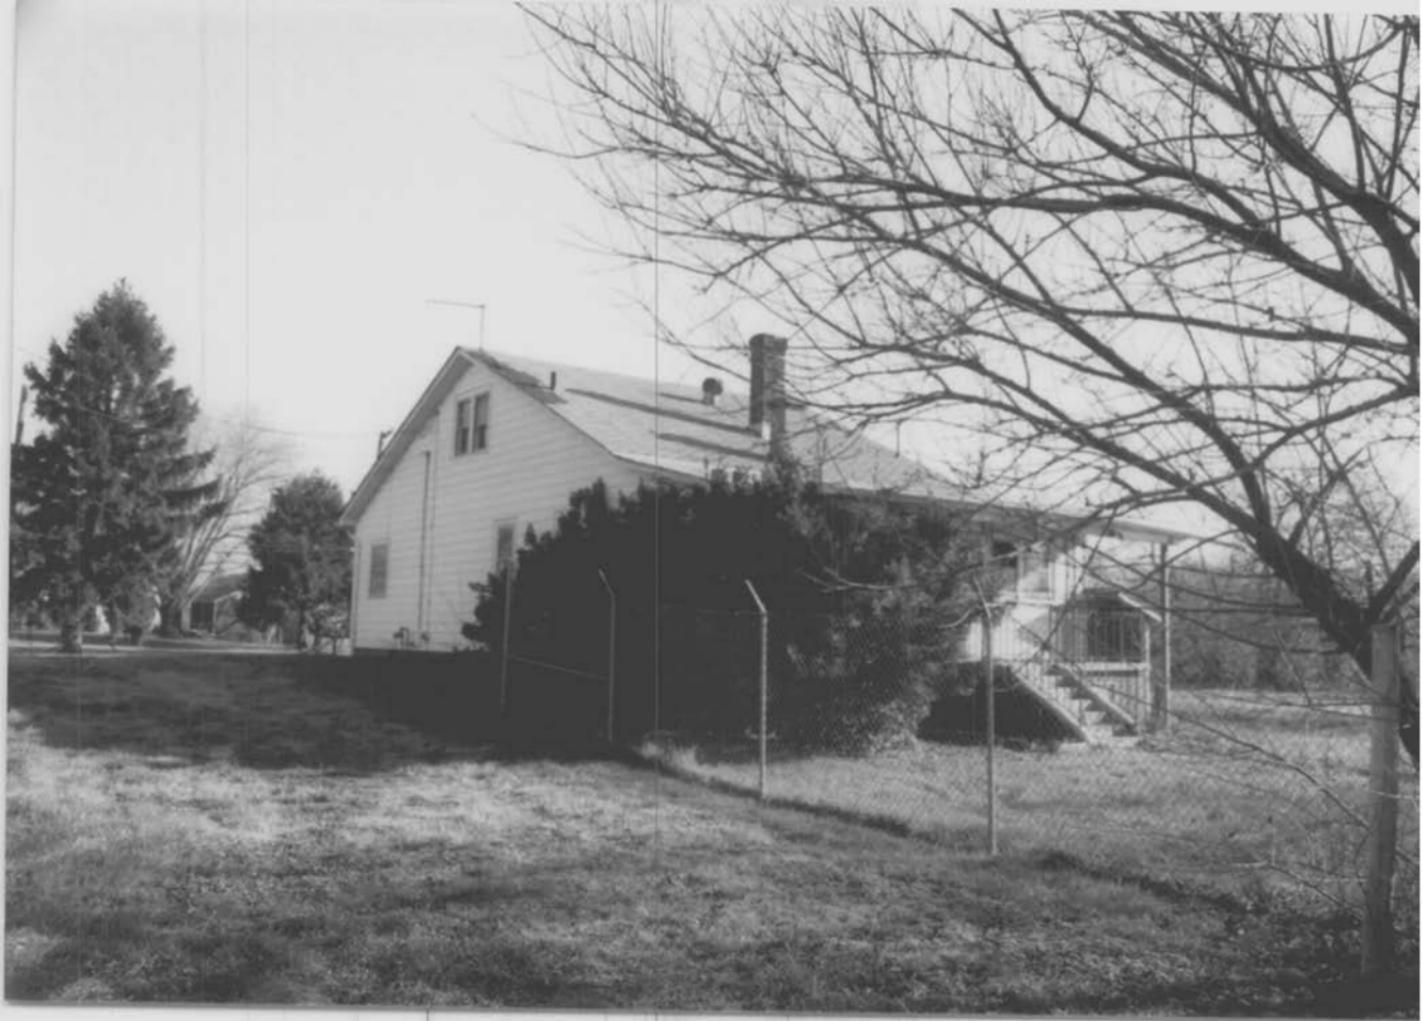
1. PG: 75A-50
2. Summit Investment Property
3. Prince George's County MD
4. Julie Darsie
5. 12/99
6. MD SHPO
7. 7917 Marlboro Pike house view NE
8. S of 7

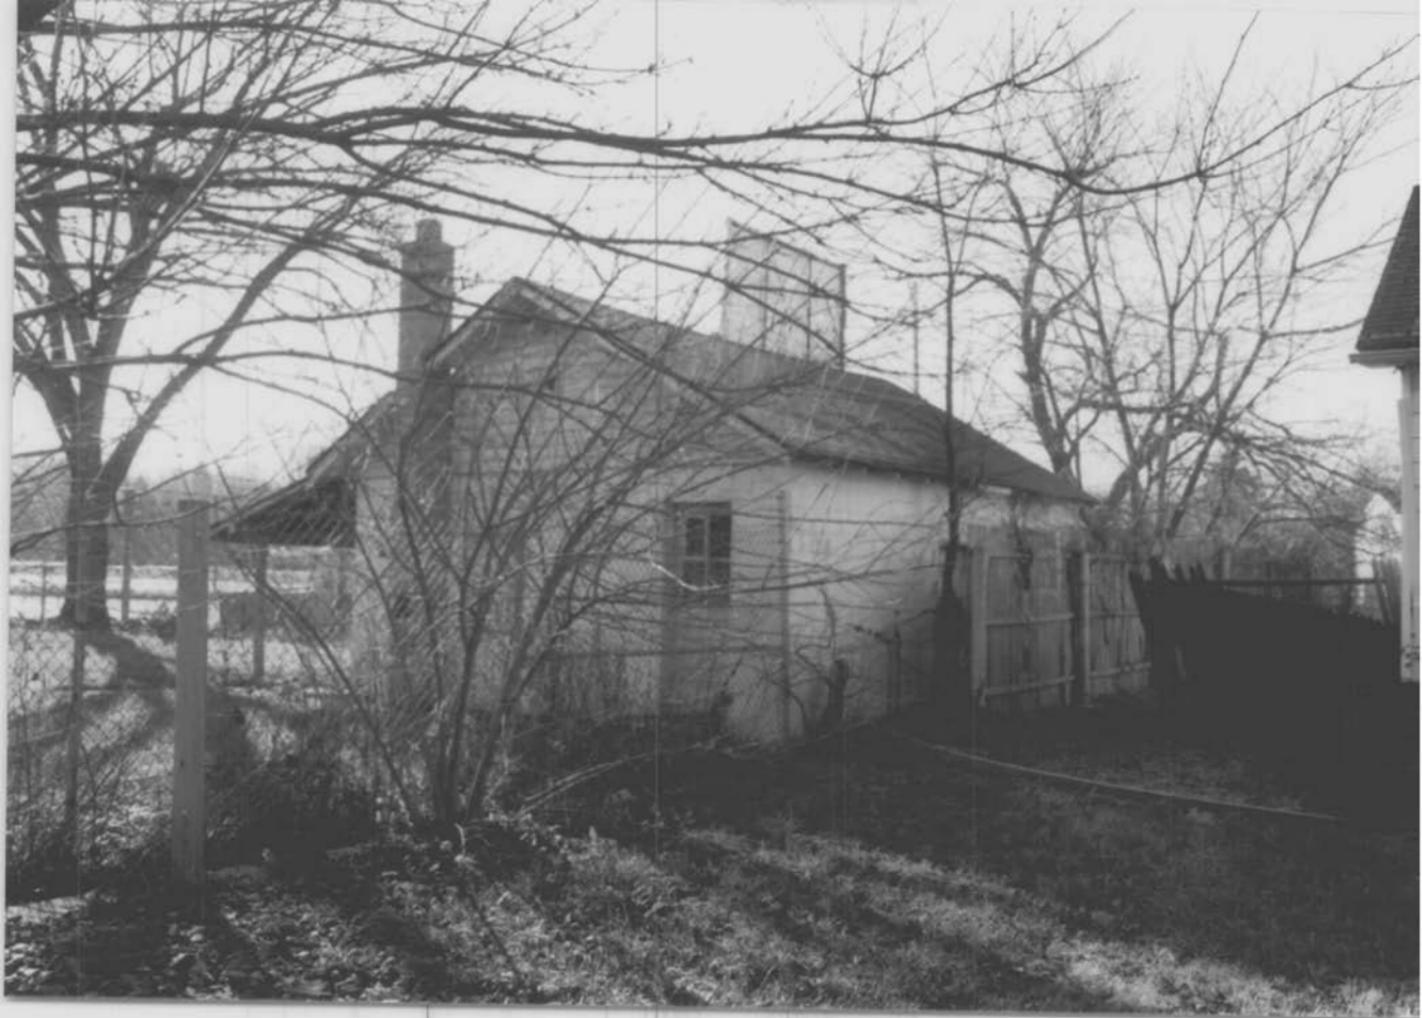
8. 6 of 7

7 7917 Marlboro Pk., garage/workshop, view St

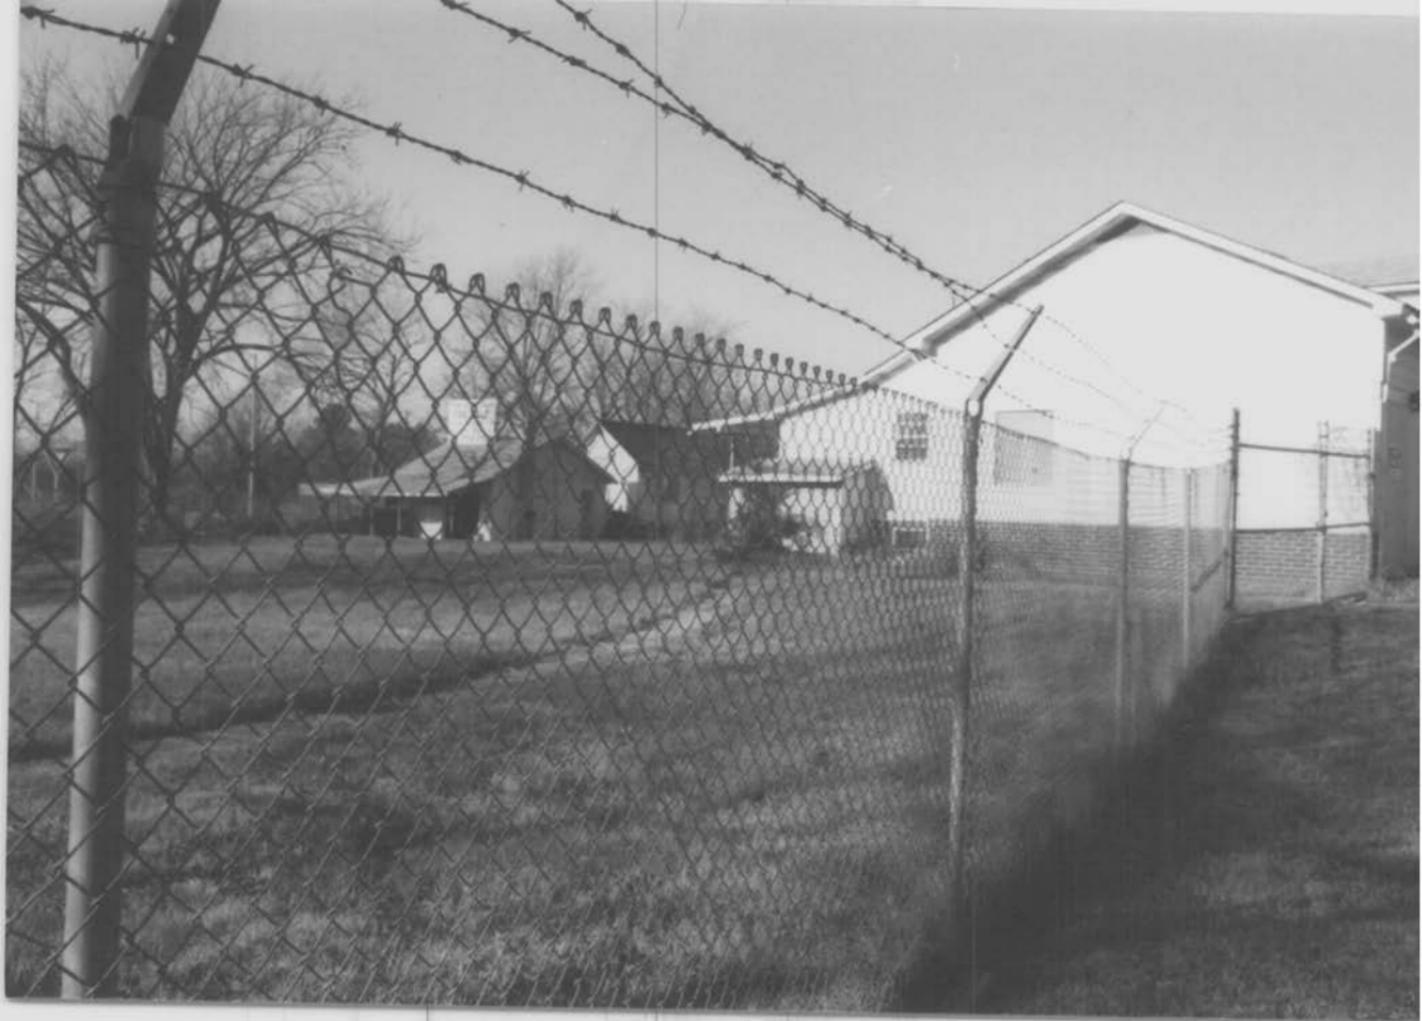
1. PG: 75A-50
2. Summit Investment Property
3. Prince George's County, MD
4. Julie Daisie
5. 12/99
6. MD 57110
7. 7917 Ma. Ibero Pike, garage/workshop, Viera, FL
8. 7.17
