MARYLAND HISTORICAL TRUST
DETERMINATION OF ELIGIBILITY FORM

Property Name: Saint Barnabas Episcopal Church Inventory Number: PG:76A-4
Address: 5203 St. Barnabas Road City: Temple Hills Zip Code: _____
County: Prince Georges USGS Topographic Map: _____
Owner: _____ Is the property being evaluated a district? ___ yes
Tax Parcel Number: _____ Tax Map Number: _____ Tax Account ID Number: _____
Project: _____ Agency: _____
Site visit by MHT staff: no ___ yes Name: _____ Date: _____
Is the property is located within a historic district? ___ yes ___ no

Maryland Historical Trust State Historic Sites Inventory Form

historic St. Barnabas Church of Oxon Hill

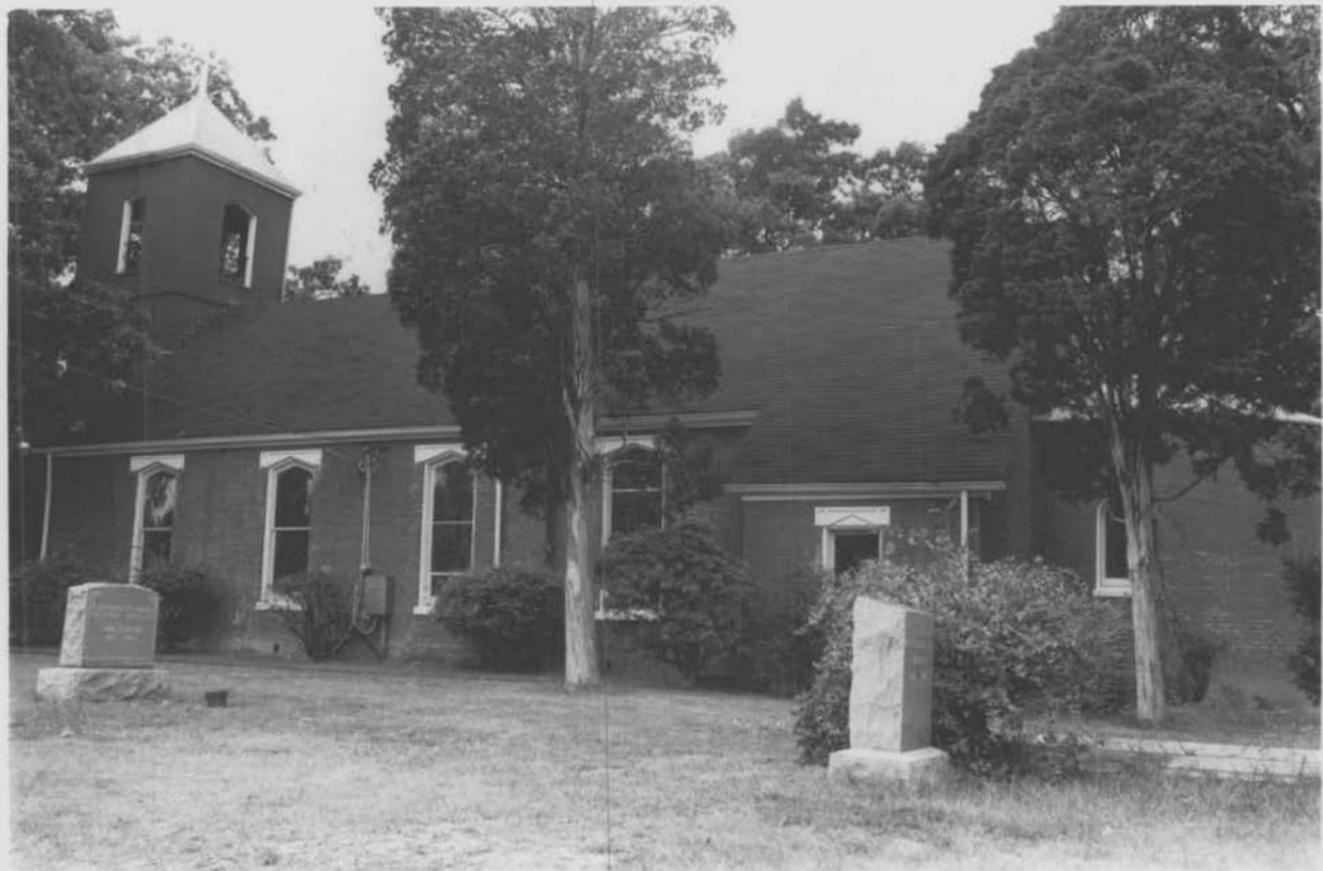
P.G. #76A-4

St. Barnabas Church, Oxon Hill
Prince George's County, MD
Marina King
July 1987
East elevation
Neg: MD Historical Trust, Annapolis, MD

The east gable end is unfenestrated, with a circular brick apse centered on the facade. The apse appears to be an addition, as the brick bond differs from that of the main block. The apse has a corbelled brick cornice composed of a course of headers with every other brick projecting an inch or so from the wall surface. The apse has a conical cap covered with standing-seam metal, the seams radiating out from the center point. The roof is surmounted by a cross. A round arch figural stained glass window is in the north and south face.

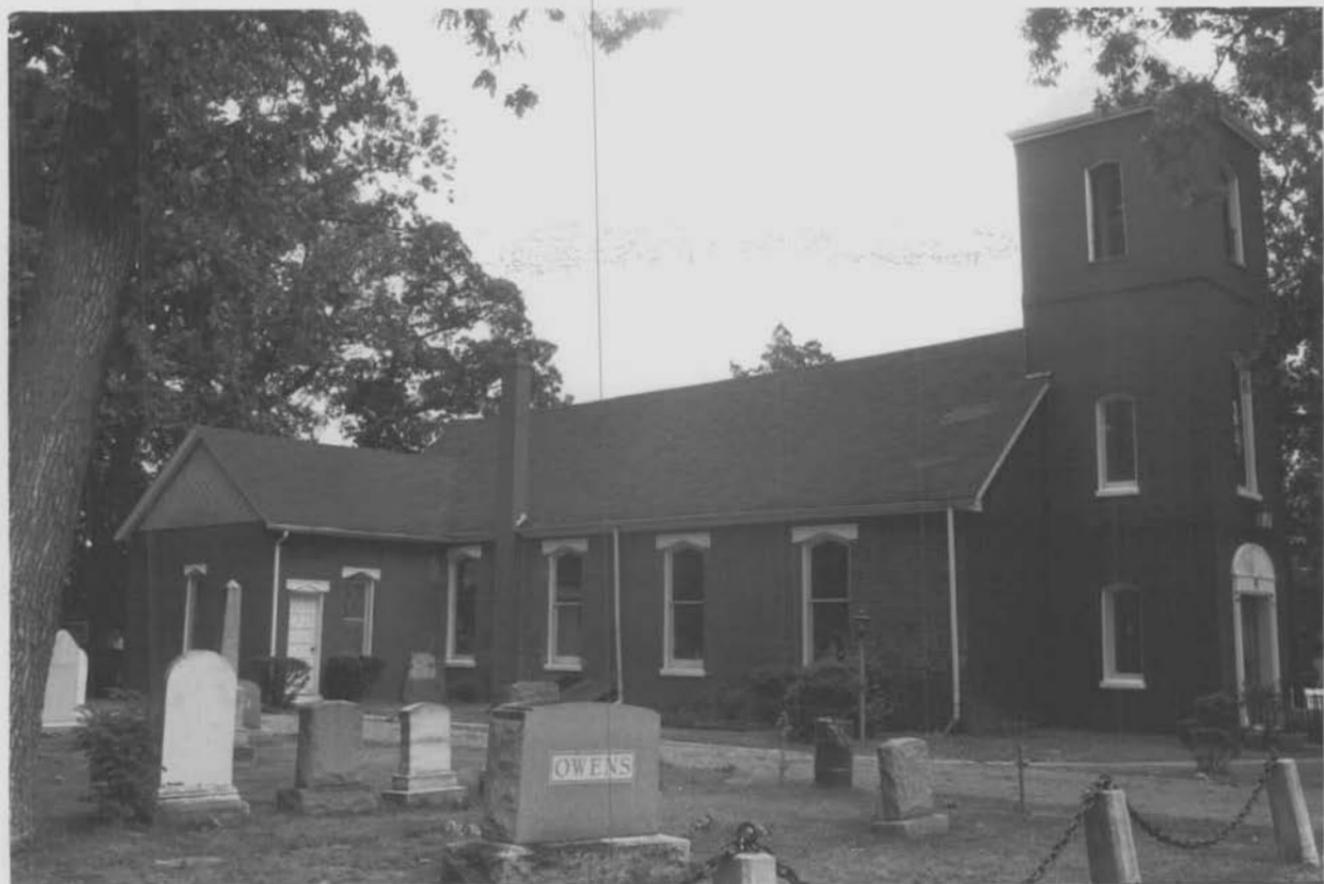
P.G. #76A-4

St. Barnabas Church, Oxon Hill
Prince George's County, MD
Marina King
July 1987
Southwest elevation
Neg: MD Historical Trust, Annapolis, MD

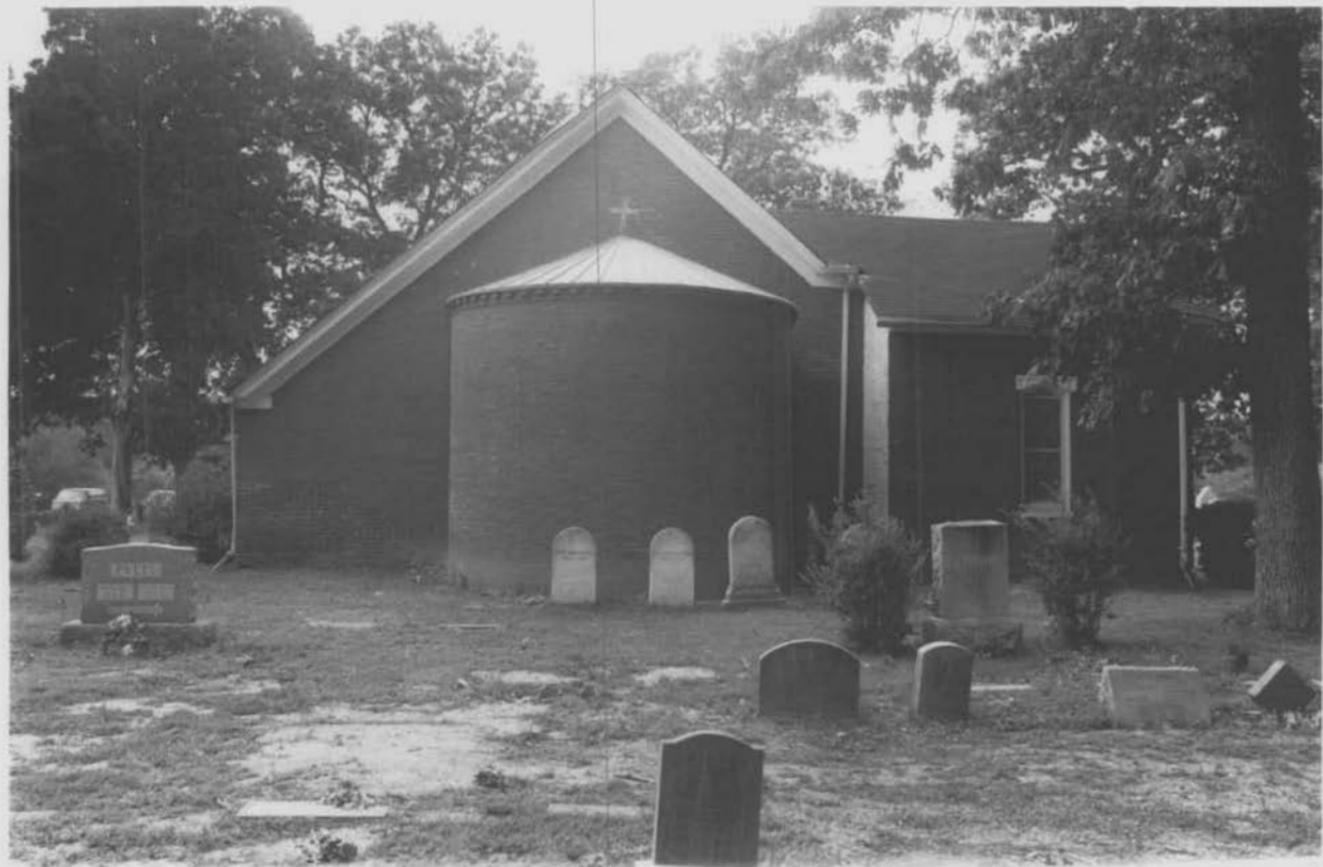
W
P.G. #76A-4

St. Barnabas Church, Oxon Hill
Prince George's County, MD
Marina King
July 1987
North elevation
Neg: MD Historical Trust, Annapolis, MD

The four bay north facade is marked by four 1/1 double-hung-sash windows with wood sills. The narrow wood surrounds have an inner bead and damaged areas where shutter hinges once were. All are glazed with stained glass panes like those on the bell tower, except the east window, which is a figural, commemorative window. The windows are surmounted by rectangular wood lintels with three inset panels. The lower edge of the lintel is cut to form a cap over the arched window heads. A narrow brick chimney rises between the east two windows. A bulkhead cellar entrance beneath the second bay leads to a small cellar lined with cement and brick, which contains the heating and air conditioning. The south facade of the main block is very similar to the north facade, including a chimney between two east windows.

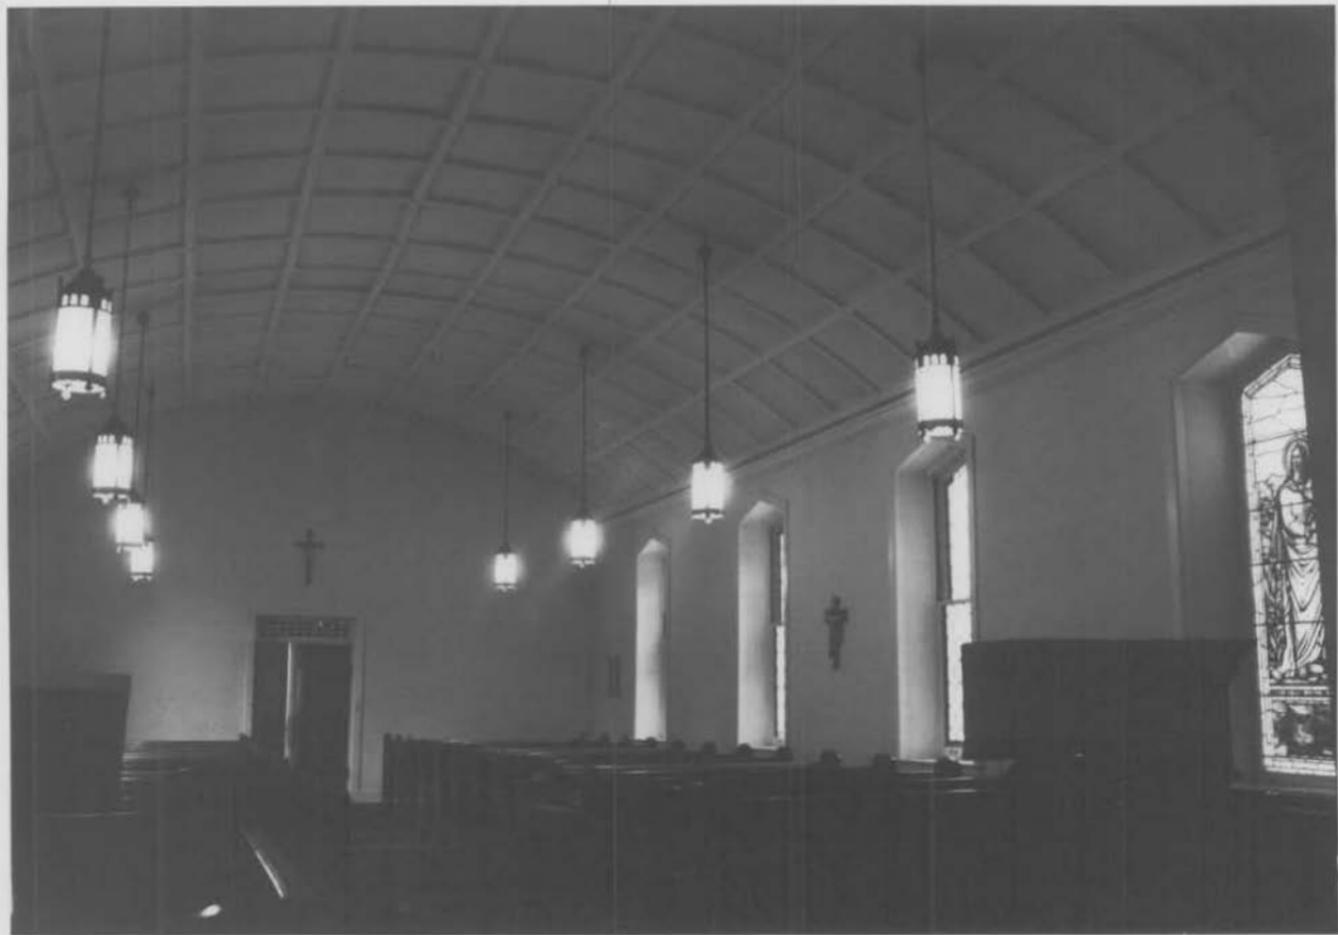
P.G. #76A-4

Sanctuary, looking south

The church interior is a rectangular open space lighted by the stained glass windows. Door and window surrounds are of wide, plain board. The flooring and pews lining both sides of the central aisle appear to be new material. The ceiling is a barrel vault with wood ribbing forming square coves over its surface. An elaborately molded cornice runs down the north and south sides of the room. A wide segmental arch provides entry to the sanctuary at the east end of the room. A matching arch provides entry into the circular apse beyond the sanctuary. The arches are supported by banded pilasters with dentiled capitals. The arches have banded wood molding and a central keystone. Round arch double doors flank the entry to the sanctuary. These lead to the small north and south wing additions. Lower segmental arched entries north and south of the central altar platform also lead to the side wings, the north wing being a choir and organ alcove. These lower arches are supported by flat pilasters with dentiled capitals and are surmounted by a keystone.

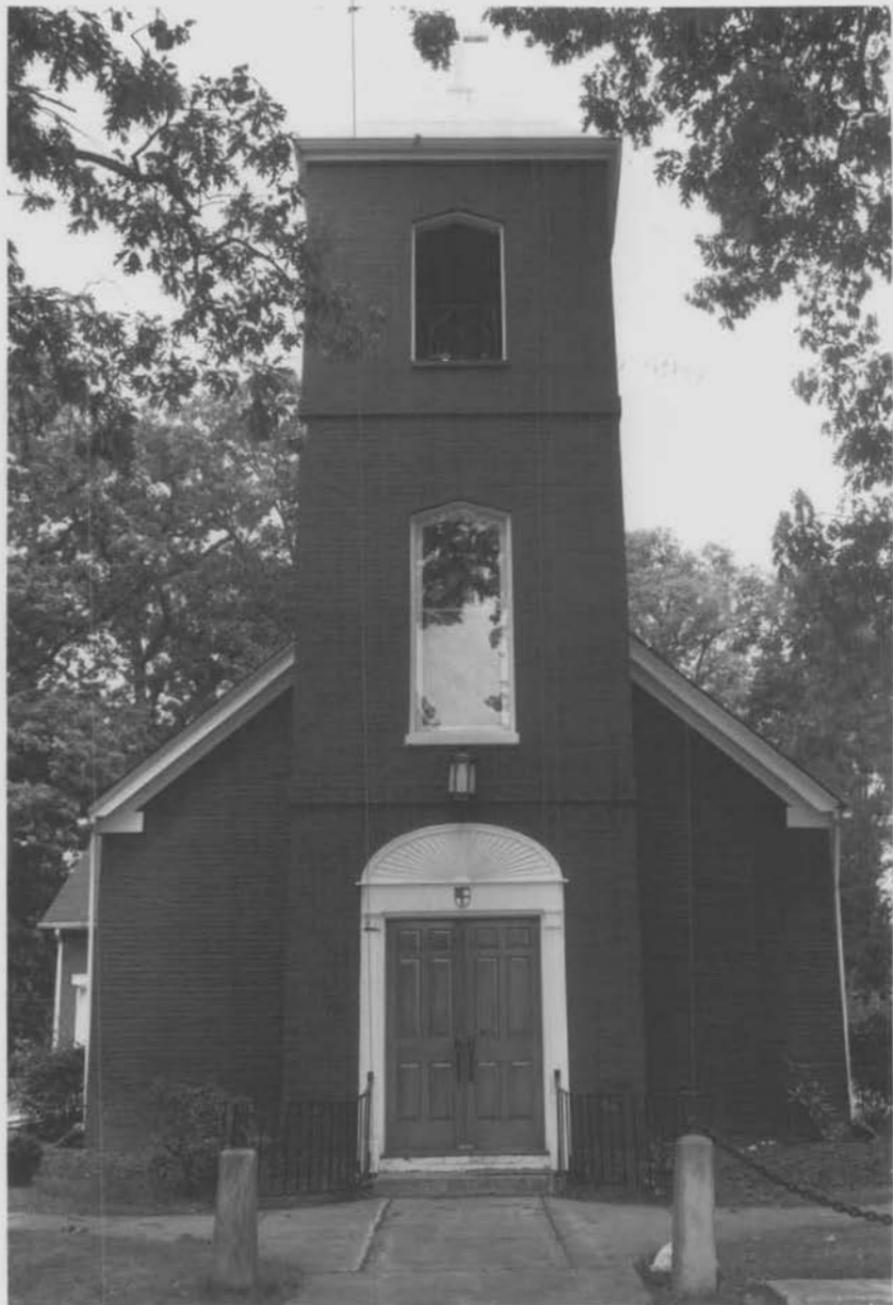
P.G. #76A-4

St. Barnabas Church, Oxon Hill
Prince George's County, MD
Marina King
July, 1987
South elevation
Neg: MD Historical Trust, Annapolis, MD

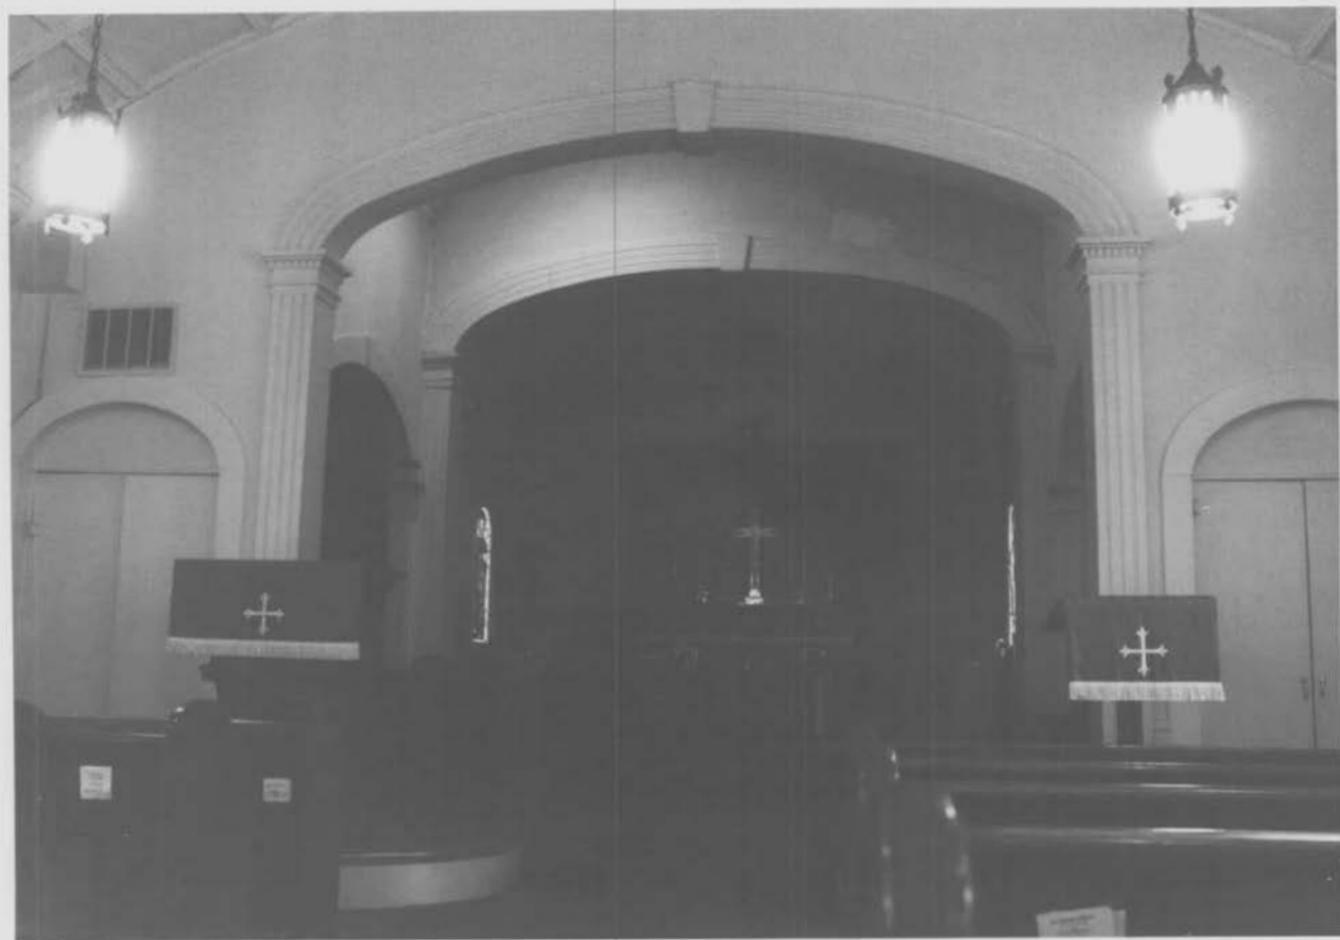
P.G. #76A-4

Sanctuary, looking north

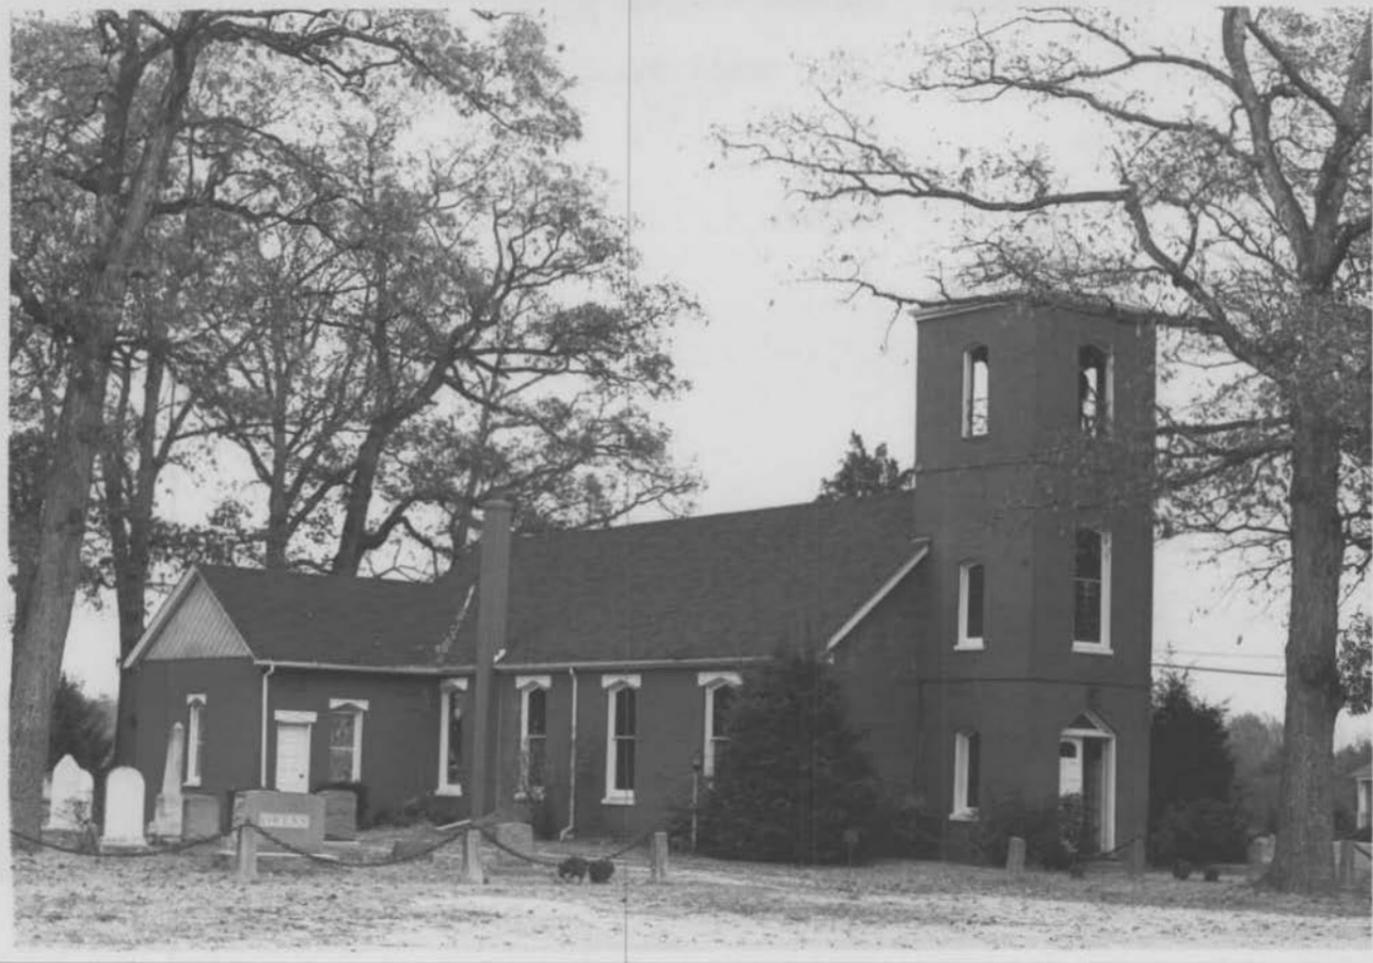
NAME ST. BARNABAS CHURCH PG-# 76A-4

FACADE SW
