# MARYLAND HISTORICAL TRUST NR-ELIGIBILITY REVIEW FORM

Property Name: Conti Mortgage Corporation Property Inventory Number: PG: 78-26

Address: 1605 Bauman Road, Westphalia vicinity, Prince George's County, Maryland, 20743

I-495/I-95 Capital Beltway Corridor Transportation

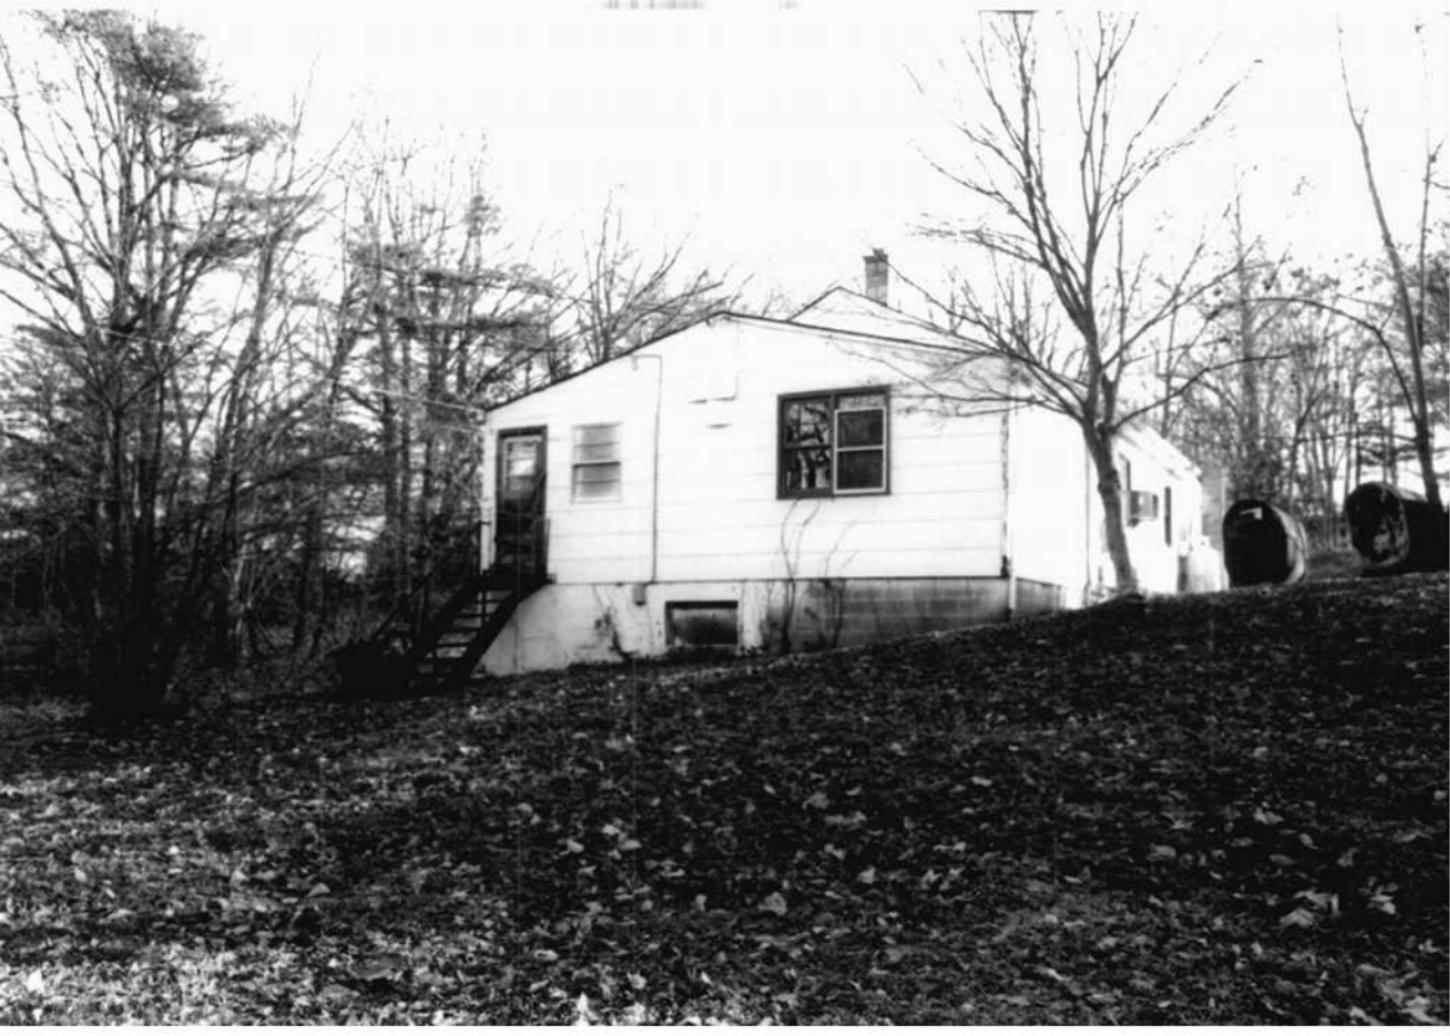
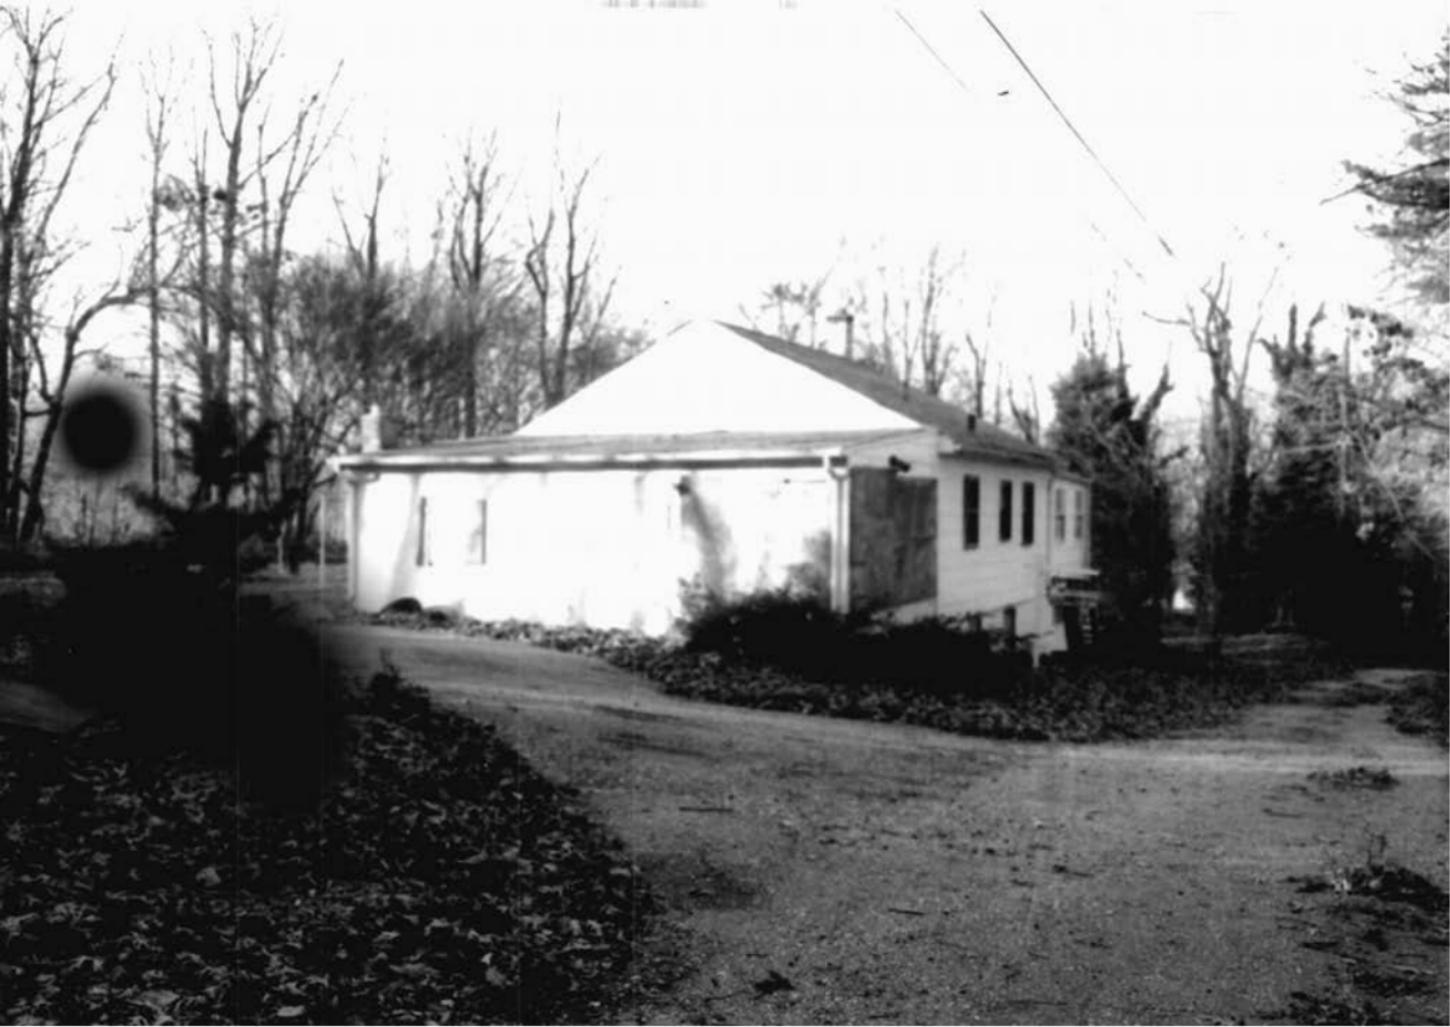
House 1 is 1-story tall and 3-bays wide with a front-gable roof. It has a concrete-block foundation, asbestos siding and an asphalt-shingle roof. A concrete-block chimney is located in the center of the roof. The house has an enclosed, front-gable porch on its north elevation. An enclosed shed porch is located on the south elevation. There are a mix of 6/6 double-hung windows and 2/2 horizontally-divided windows. (See Photos 1 and 2 of 4)

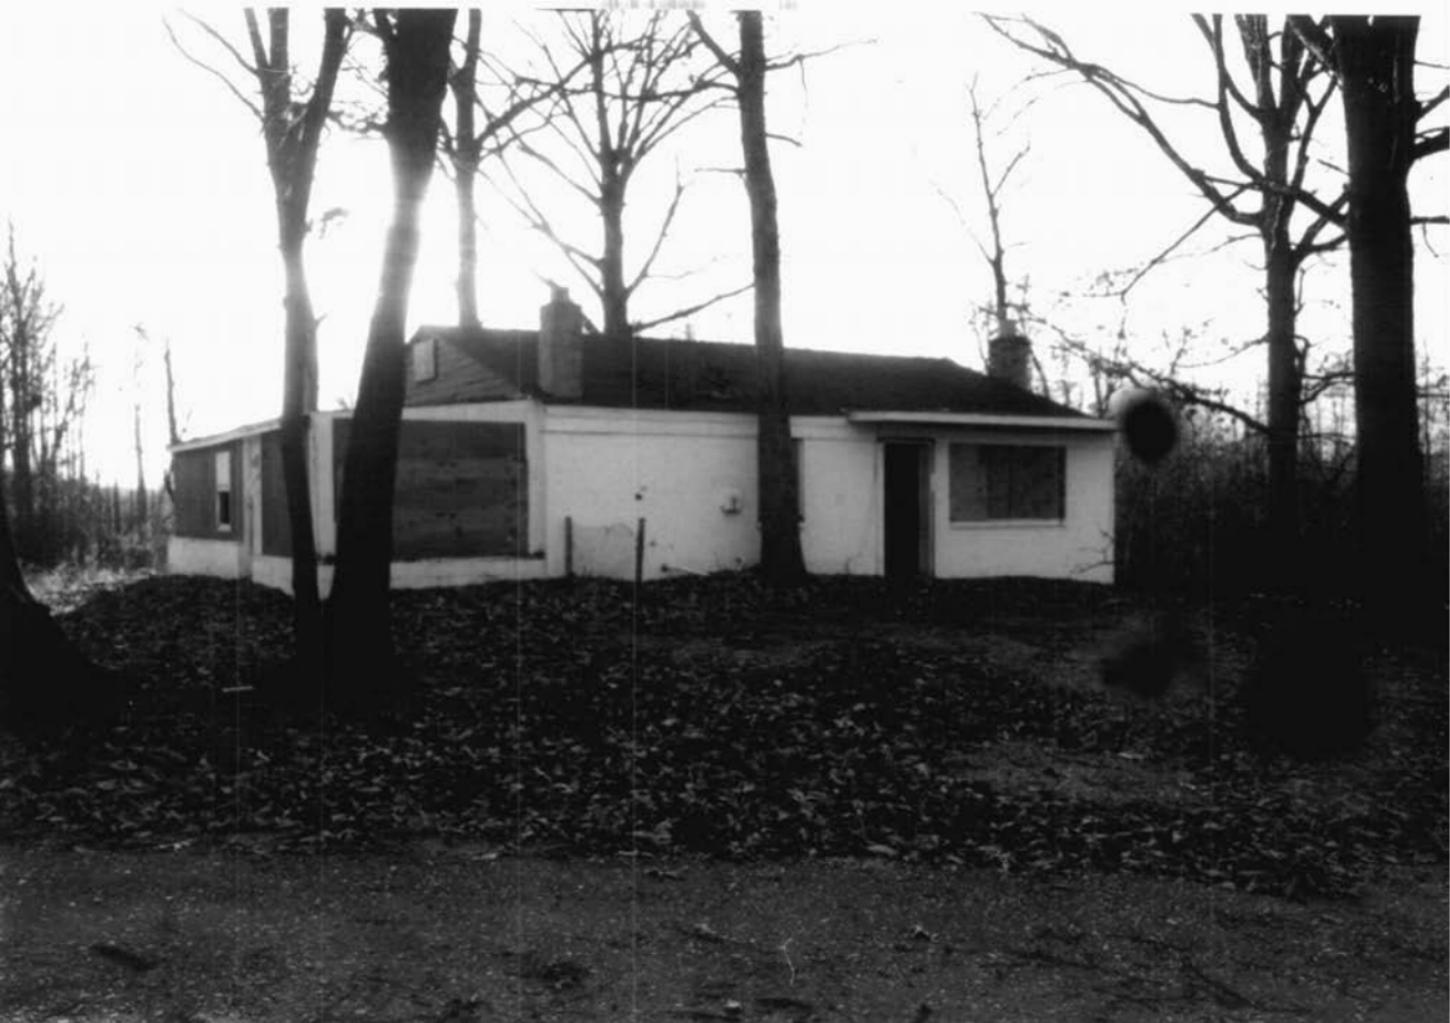
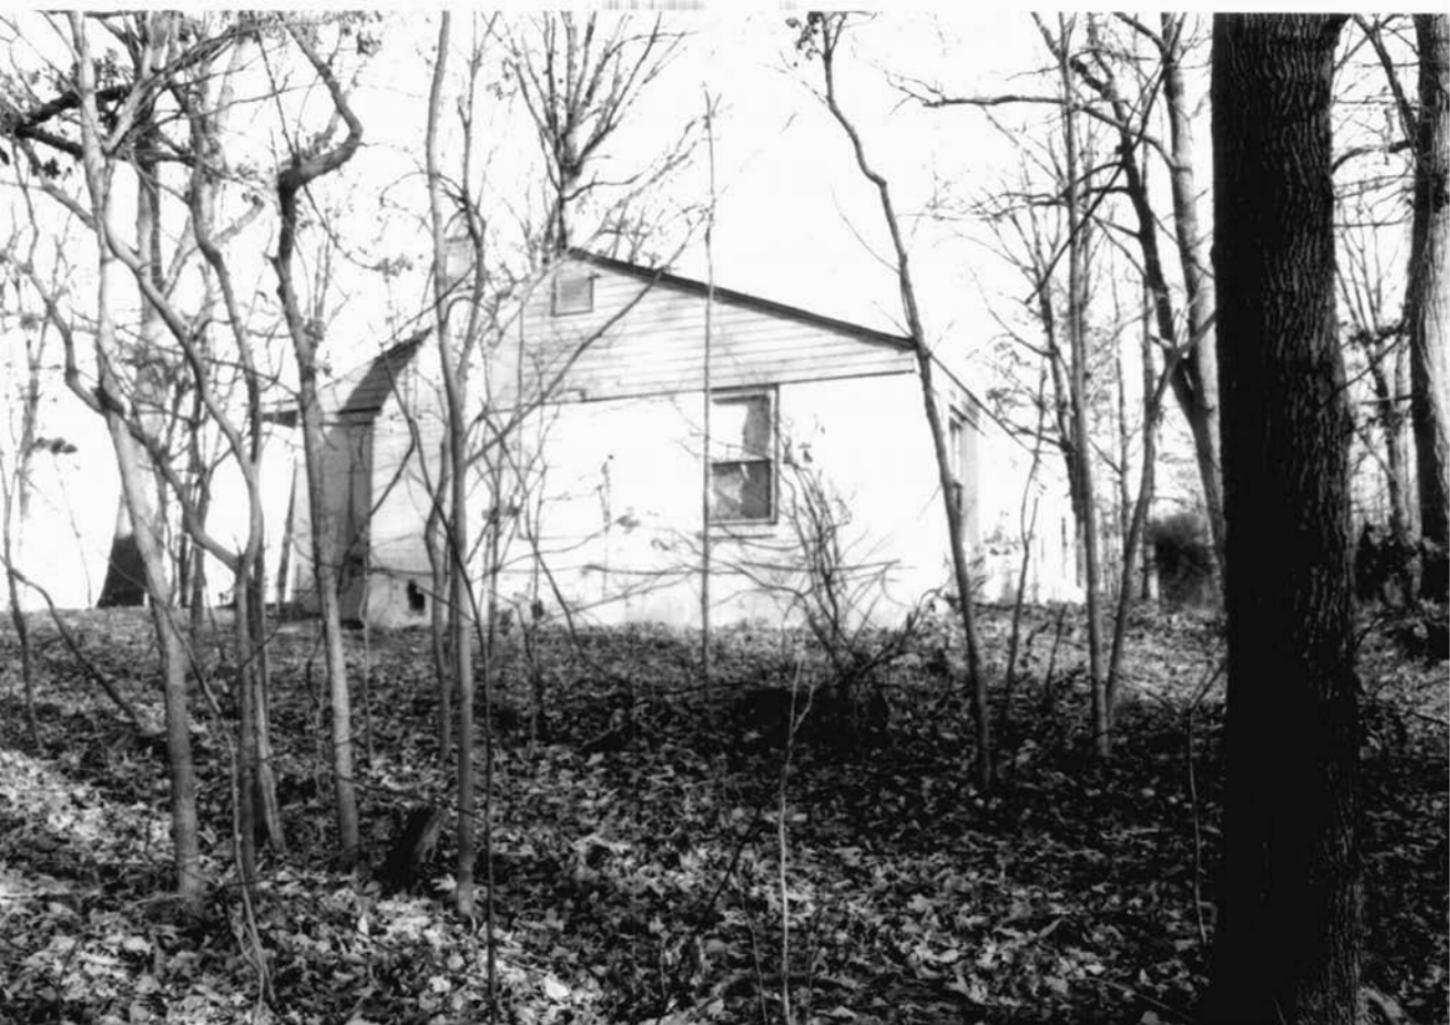
House 2 is 1-story tall and 3-bays wide. It is constructed of concrete-block with an asphalt-shingle, side-gable roof. There are chimneys in the north gable end and the southeast corner. A slight overhang shelters the entry and a former picture window on the east elevation. The door has been removed. The original windows were 1/1 double-hung with brick sills. Most of them have been boarded over. The house has a large shed addition, also boarded over, on the south elevation. (See Photos 3 and 4 of 4)
