Property Address <u>14110 Brandywine Road, Brandywine, Prince George's County</u>
Owner Name/Address <u>Carl Lewis, 13615 Cherry Tree Crossing Road, Brandywine, Maryland 20613</u>
Year Built <u>1913</u>

U.S. 301 South Corridor
Transportation Study

Maryland Historical Trust State Historic Sites Inventory Form

historic Old Bank of Brandywine

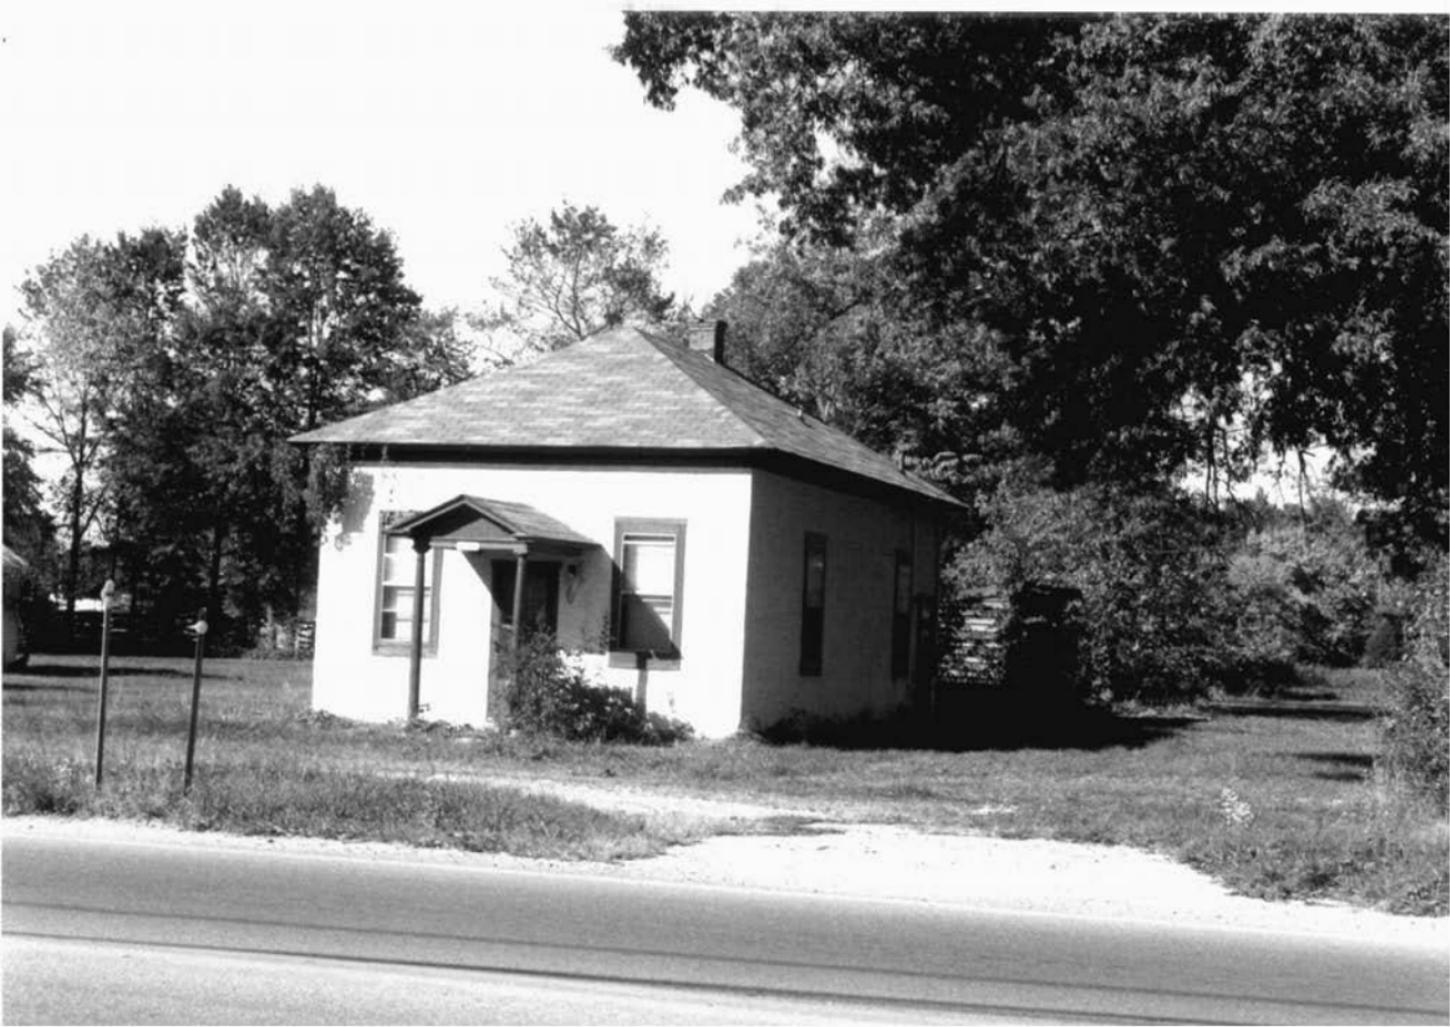
PG: 85A-30

BANK AND SHED, VIEW NORTHEAST

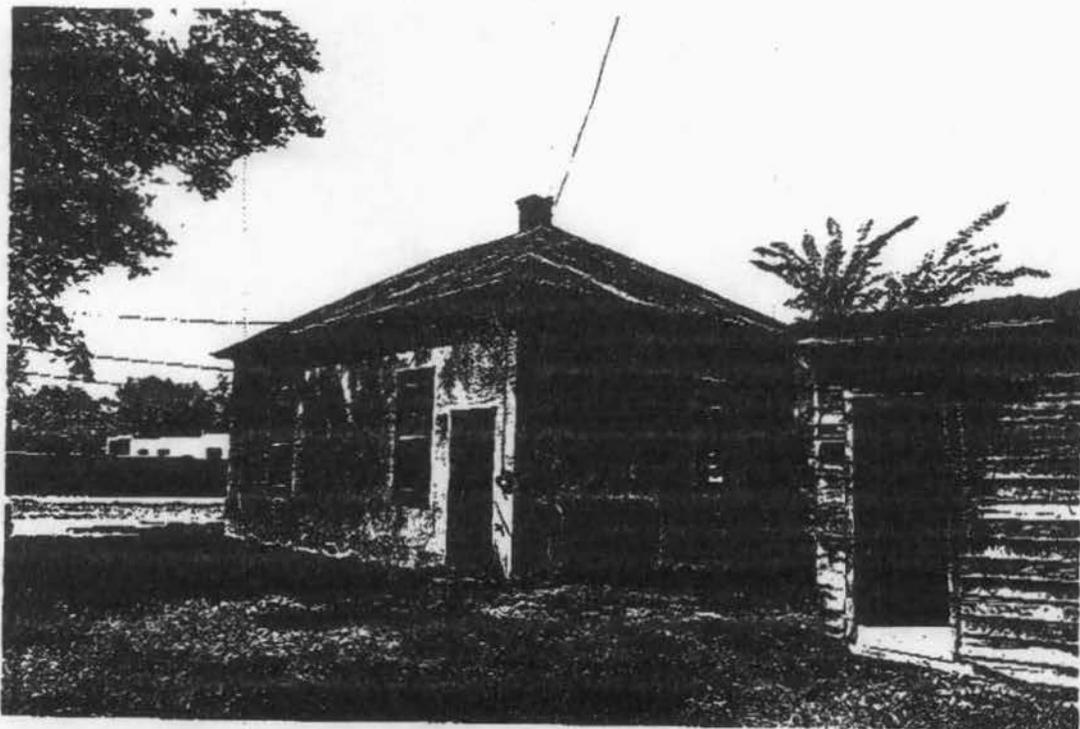
Viewed from northeast, storage shed to right

Directly north of the bank building is a shed-roof storage shed, currently containing bales of straw. There is a door in the east elevation, as well as a larger entrance in the north shed end. The roof, covered with standing-seam metal, slopes down toward the west. This storage shed is sided with lapped horizontal boards over flush horizontal board, both circular sawn, and unpainted. New replacement board is being installed in the north shed end. The building has a shallow boxed cornice. Farther to the northwest, in an overgrown thicket, are the ruins of another storage outbuilding, constructed of channelled terra cotta blocks. North of this ruinous building is a deteriorating tractor, with plow attached.

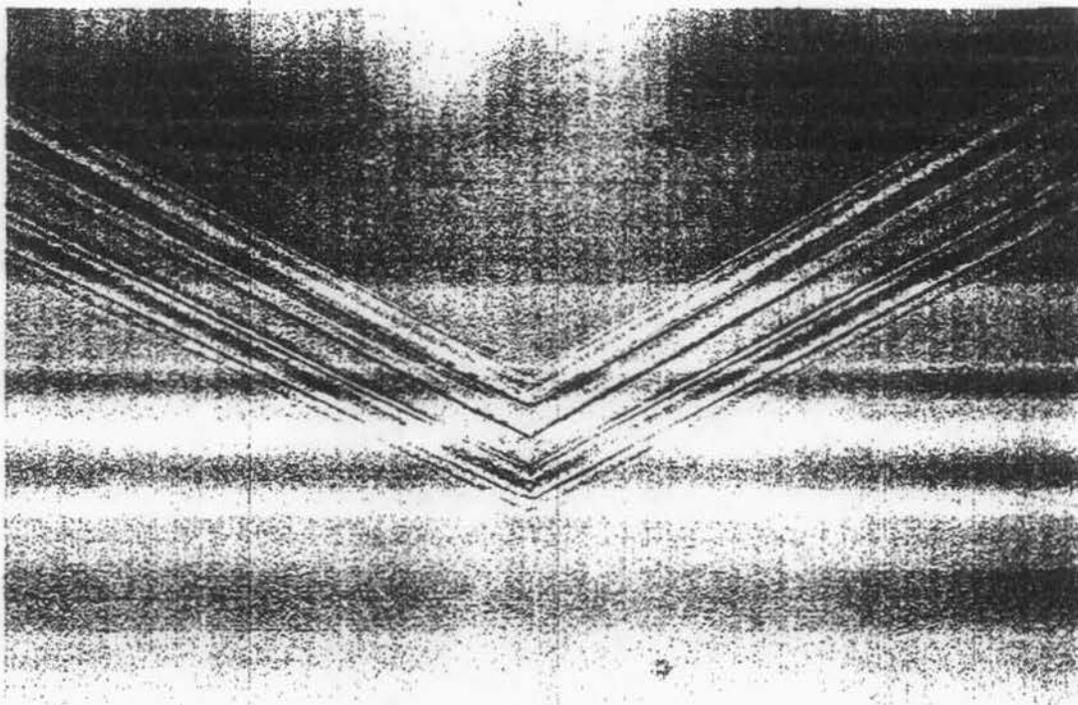
Interior, cornice of rear (office) space

front room, a modern dropped ceiling has been installed. The original high ceiling, complete with molded cornice, is intact in the rear office space. In the wall which divides the front lobby from the rear office, can be observed the flue which originally served the two stoves for heating the two spaces.

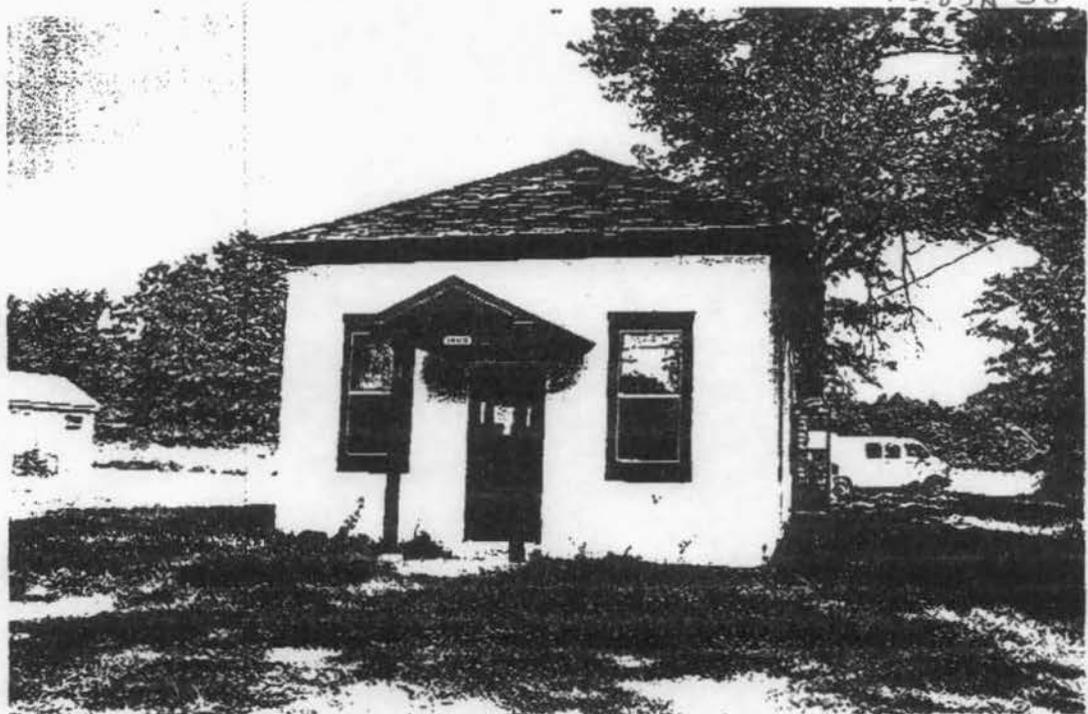
South facade

The building has a small rectangular footprint, and measures 32'6" by 20'3". It is an irregular three bays by three bays, and faces south toward Brandywine Road. Entrance is in the central bay of the south facade through a modern glazed door with plain board surround. Sheltering this door is a gable-roof entry porch which has a returned cornice with crown molding; it is supported by slim Tuscan columns.

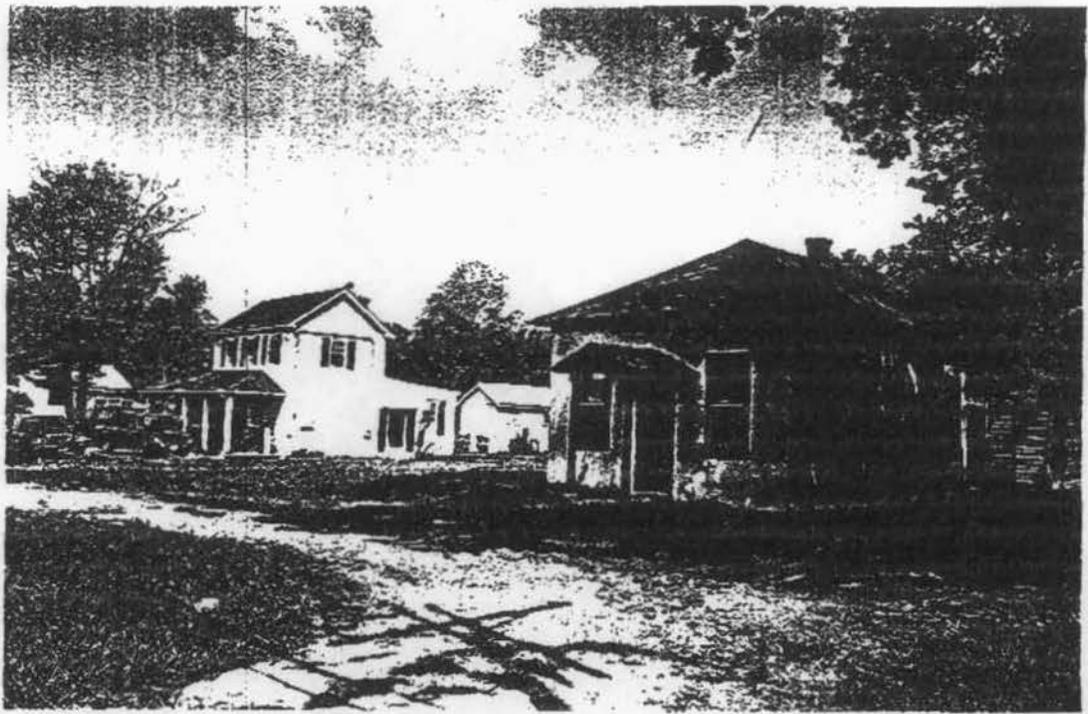
Viewed from southeast, Canter House (#85A-32-8) on left

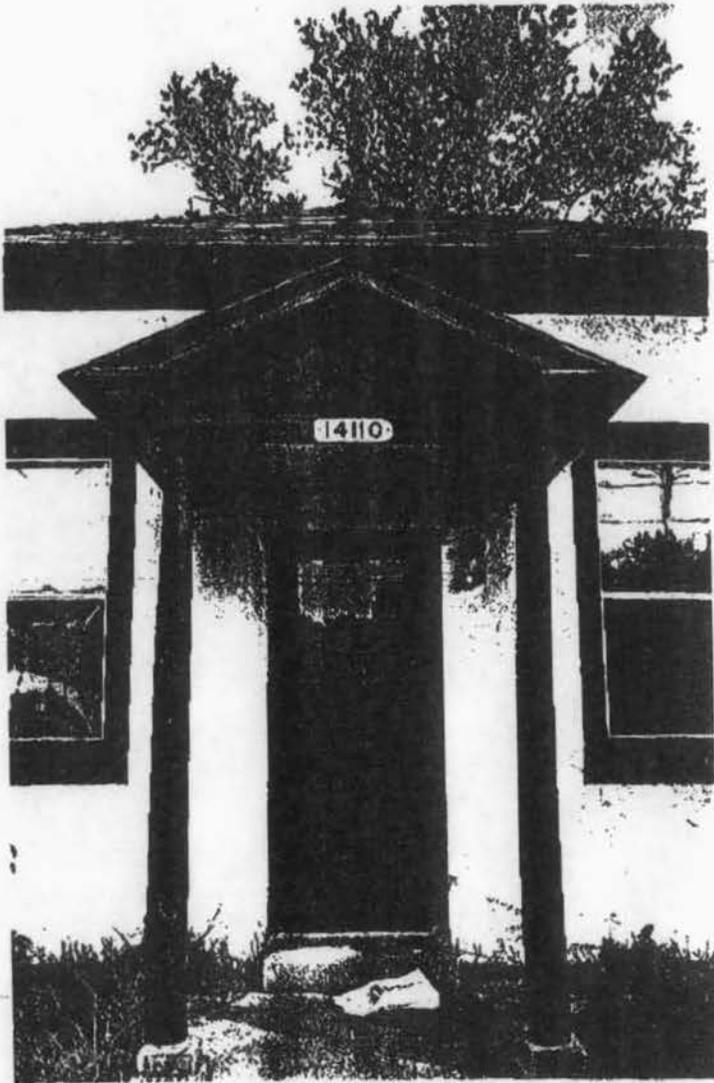
South entrance

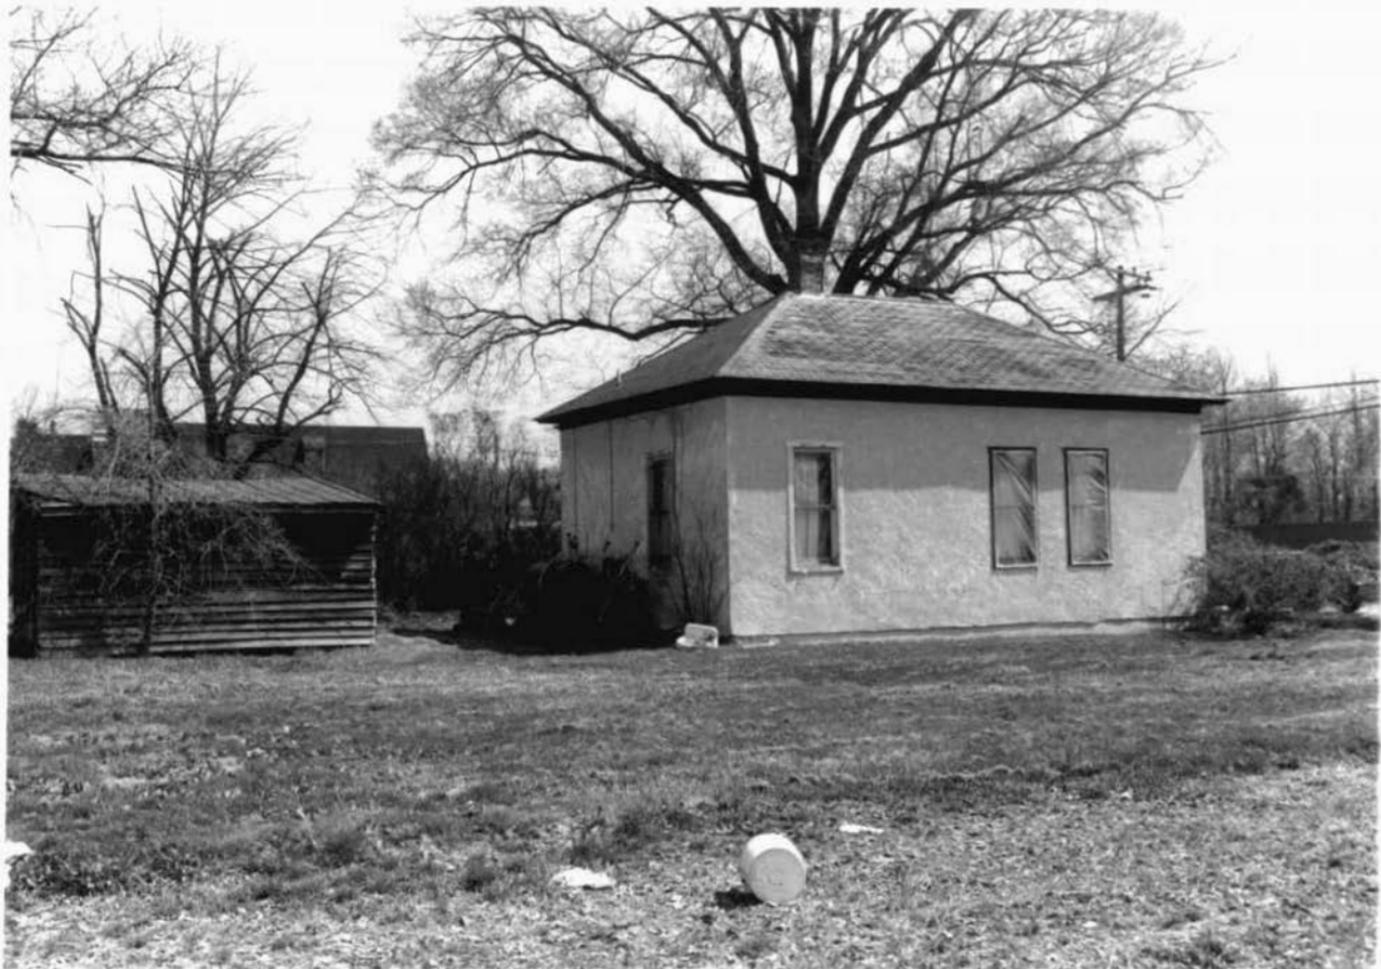
PG#85A-30

Bank of Brandywine
Prince George's County, MD
Susan G. Pearl
April 1986
West elevation with shed
Neg: MD Hist. Trust, Annapolis, MD

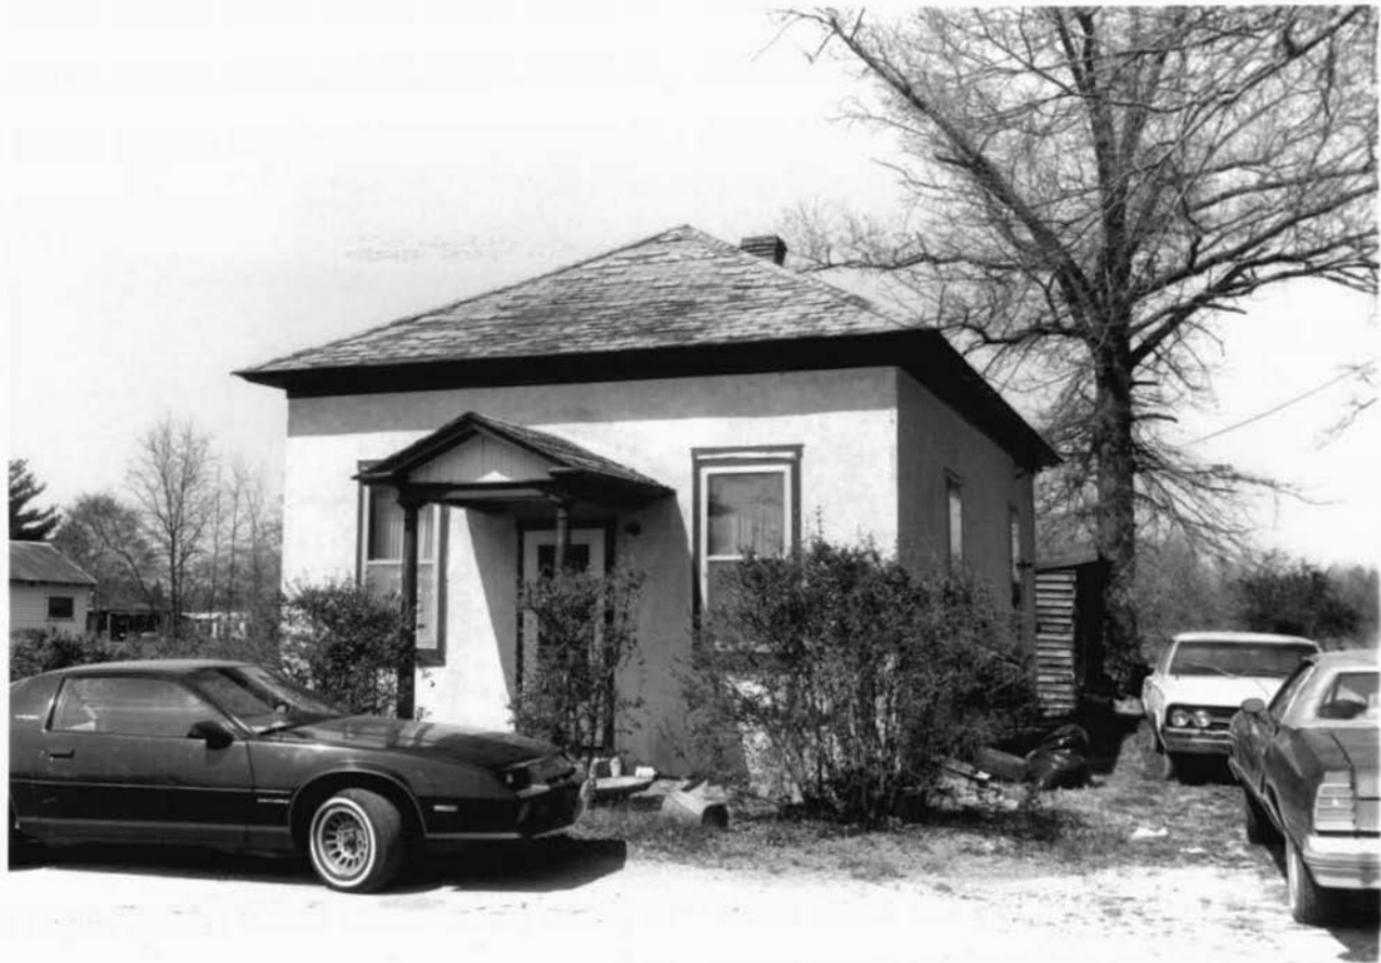
PG#85A-30

Bank of Brandywine
Prince George's County, MD
Susan G. Pearl
April 1986
South elevation
Neg: MD Hist. Trust, Annapolis, MD

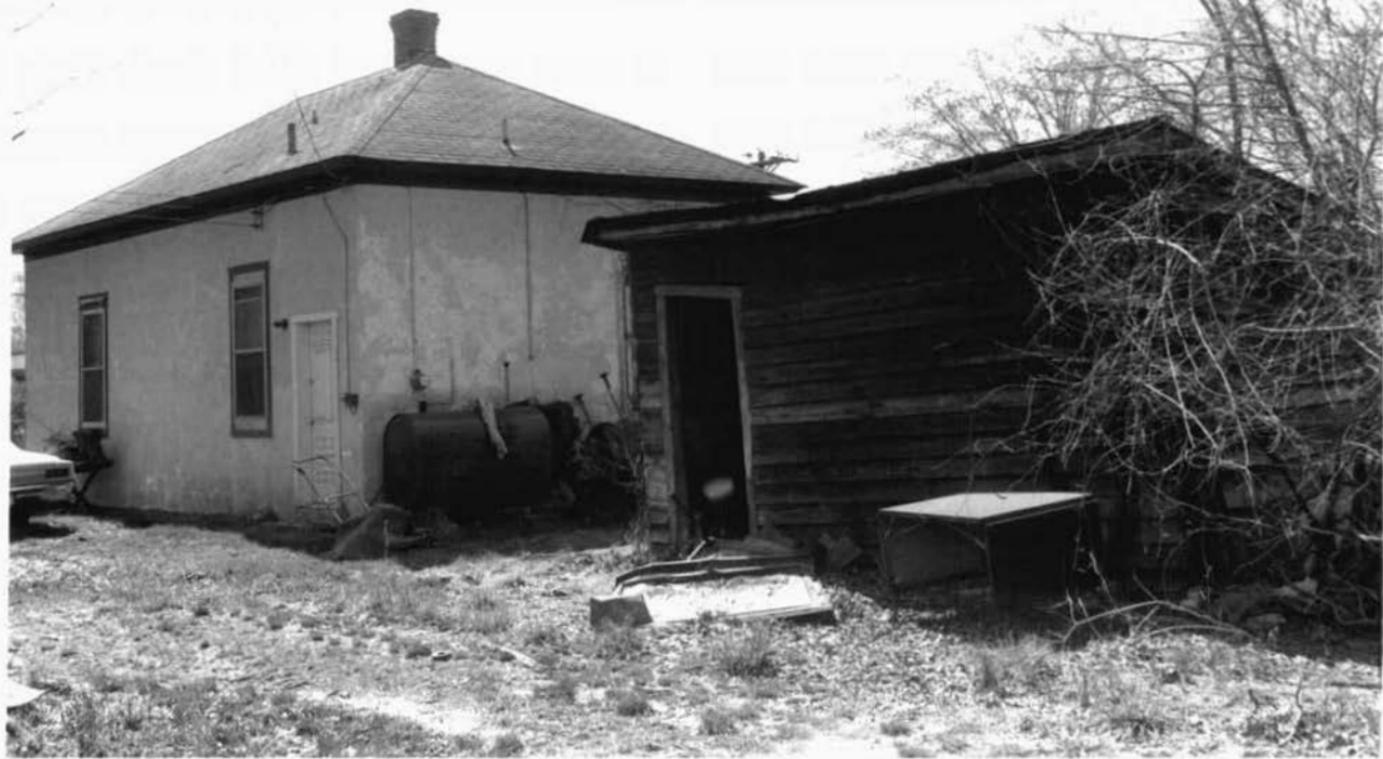
PG#85A-30

Bank of Brandywine
Prince George's County, MD
Susan G. Pearl
April 1986
Northeast 3/4 elevation and shed
Neg: MD Hist. Trust, Annapolis, MD
