MARYLAND HISTORICAL TRUST  
NR-ELIGIBILITY REVIEW FORM

Property Name: Dobson Property Inventory Number: PG:85A-40 (PACS 1.7)  
Address: 13605 Brandywine Road, Brandywine MD 20613

Project: MD 5 Brandywine Interchange Agency: State Highway Administration

Documentation on the property/district is presented in: MD 5 Brandywine Interchange Project, Prince George's County Maryland, Historic Resource Survey and Determination of Eligibility Report

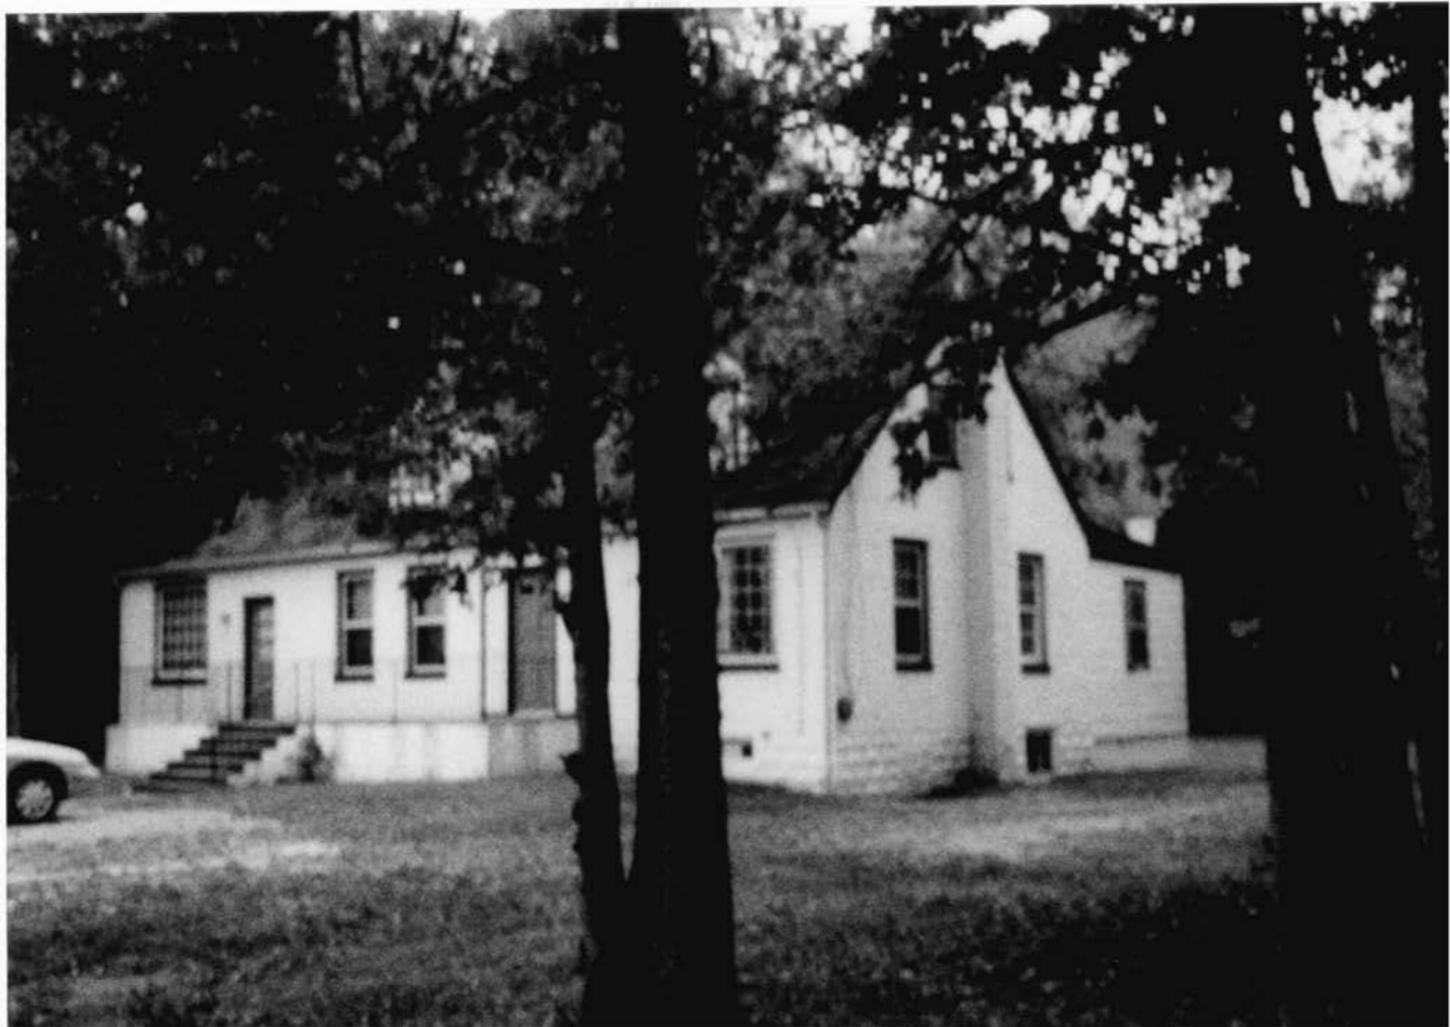
The Dobson Property is located on the west side of Brandywine Road in the T.B. vicinity of Prince George's County. A 1½-story, 5-bay residence, constructed circa 1940, is located on the property. The residence has a raised, rock-faced concrete-block foundation, stucco walls and an asphalt shingle roof. A large addition is located on the south side, and a small addition is located on the west side. The side-gable roof has two gable dormers on the east slope and a shallow, boxed cornice. Exterior brick chimneys are located in the gable ends. Large, multi-pane, fixed sash windows as well as 6/6 and 6/1 double-hung windows are found throughout the house.

On the front, or east elevation, the main entry is located in the center bay. The modern door has sidelights that are now covered in particle board. Two 6/6 double-hung windows are located south of the entry. North of the entry, the original two windows have been replaced with a single large, multi-pane, fixed-sash window. Two gable dormers containing 6/6 double-hung windows are symmetrically arranged on the second story. South of the main block is a stucco, 1-story, 2-bay addition with a hipped roof. The ridge line of the addition is lower than the ridge line of the main block. The addition has an entry with a half-glass door in the north bay and a large, multi-pane, fixed-sash window in the south bay. A modern entry porch begins in front of the entry and stretches south across the addition. The porch, constructed of concrete block, is uncovered and is surrounded by a wrought-iron railing.
