PRINCE GEORGE'S COUNTY
HISTORIC SITE SUMMARY SHEET

Survey #: P.G. #85B-4 Building Date: 1879

Building Name: Cedarville Assembly of God (Cedarville Methodist Church)

Maryland Historical Trust State Historic Sites Inventory Form

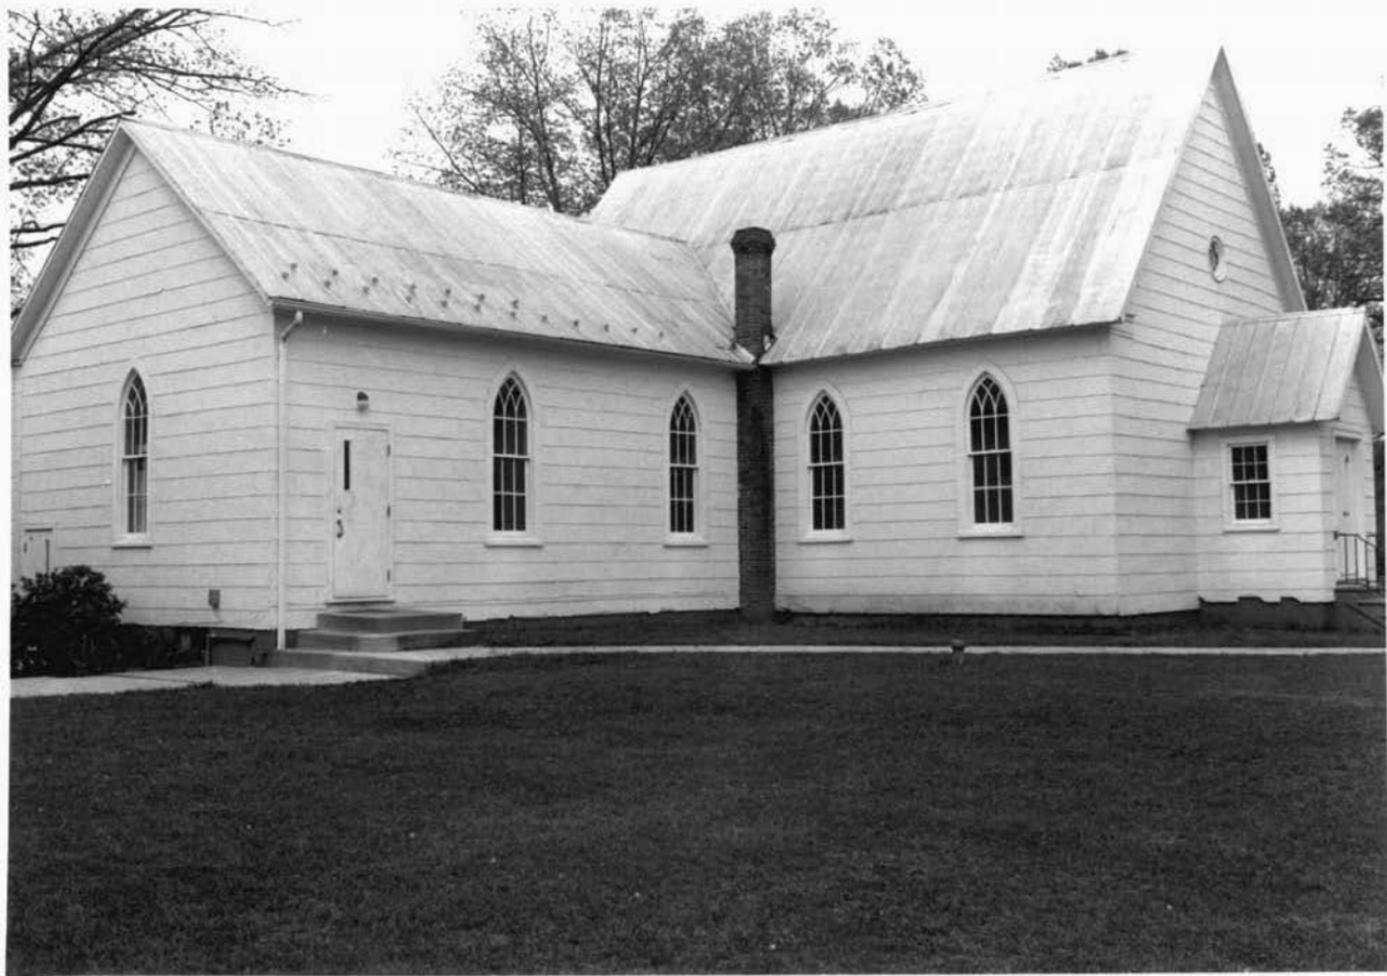
P.G. #85 B-4

Cedarville Methodist Church
Prince George's County, MD.
Marina King
April 1985
Southwest elevation
Neg: Md. Hist. Trust, Annapolis, MD.

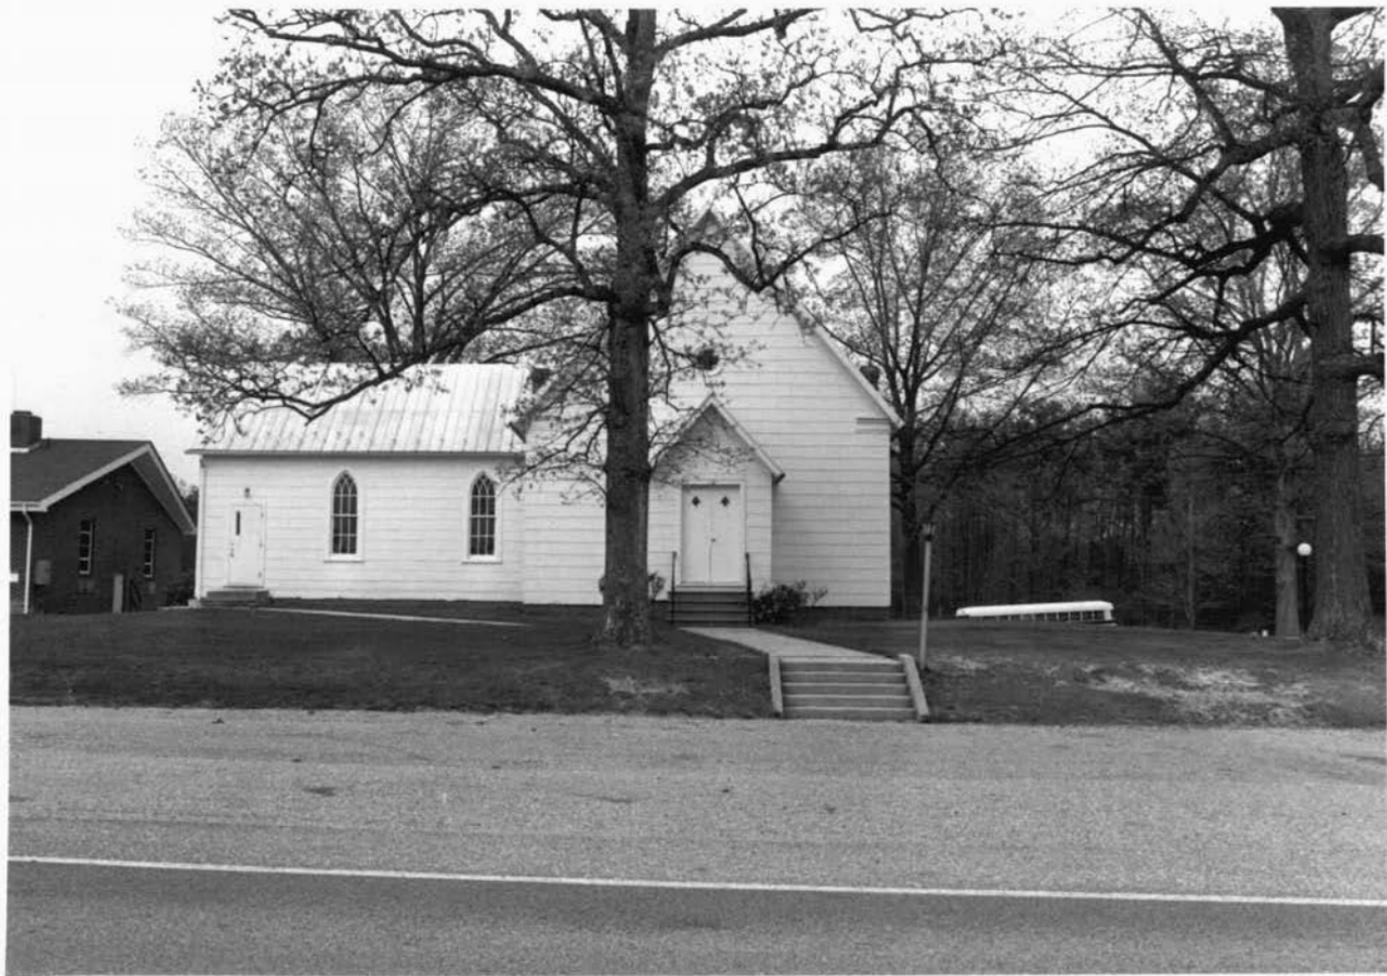
P.G. #85 B-4

The south (front) gable end has a one-story, centered, gable roof projecting bay which contains the entrance. Entrance is through modern double doors and is reached by a flight of four stairs. The entrance bay is set on a cement block foundation and has a standing seam metal roof, as does the main structure. There are 6/6 windows on its east and west sides. Above the entrance bay, centered in the gable of the main structure is a circular window with trefoil tracery.

South elevation

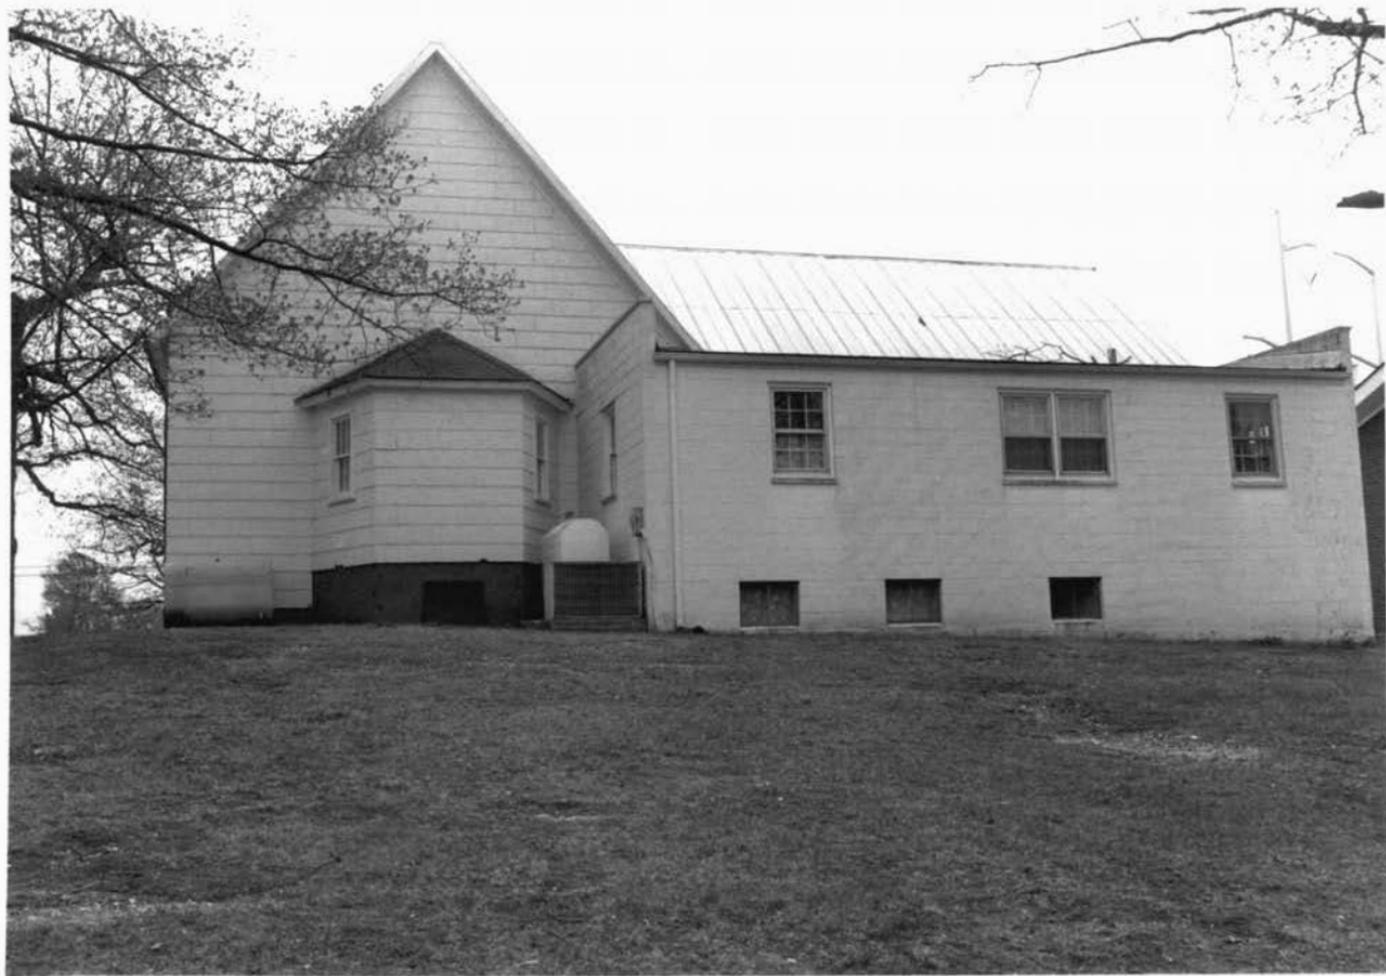
P.G. #85 B-4

The north (rear) facade has a centered, one-story, projecting semi-octagonal bay set on a cement block foundation. It has a hipped, asphalt shingle roof and two 6/6 windows, one facing east, and one west. On the northwest corner of the facade is a one-story, 3 bay cement block flat roof addition which wraps around the west side of the building and connects with the older gable roof addition.

North elevation

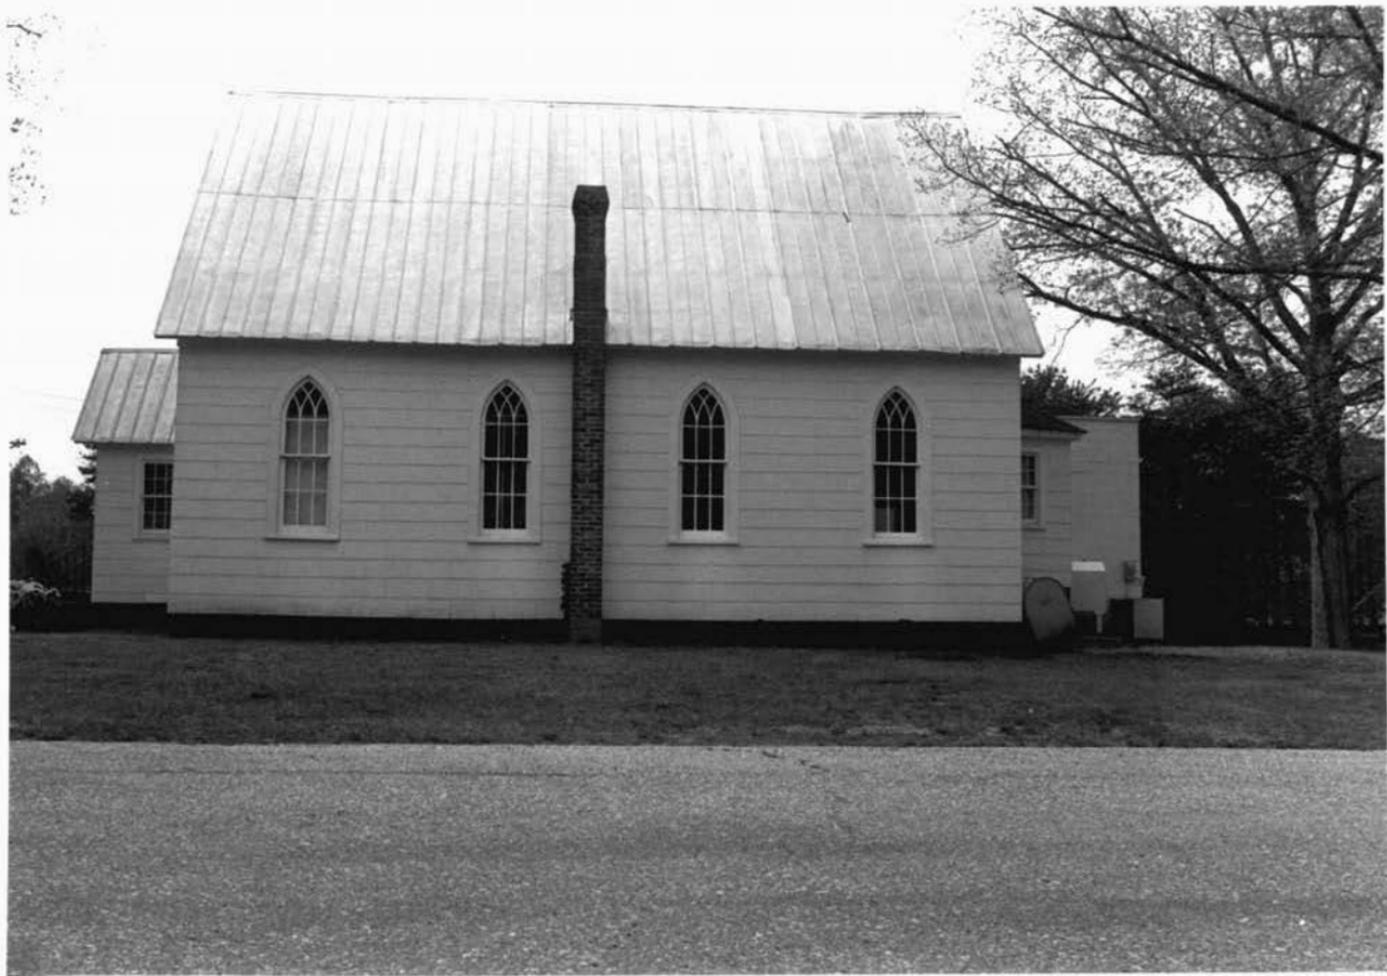
P.G. #85 B-4

The four-bay east facade has four evenly spaced large pointed arch 9/6 double hung sash windows with plain wood surrounds. There is an exterior brick chimney at the facade center line.

East elevation

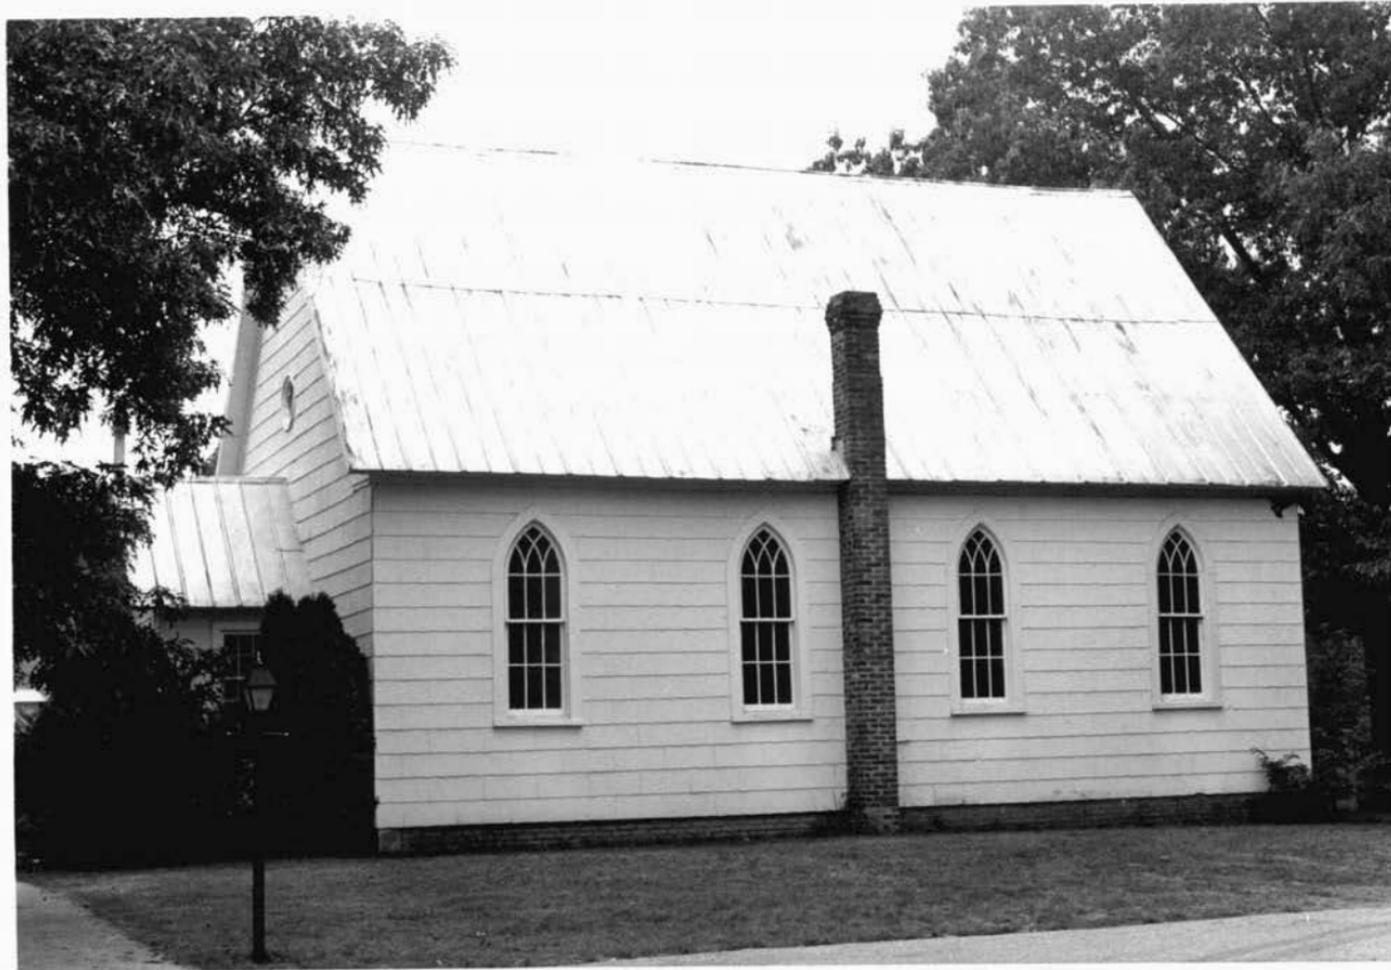
P6.85B-4

NAME CEDARVILLE METH CHURCH
LOCATION " Rd. CEDARVILLE, Md
FACADE E
PHOTO TAKEN 7/24/74 MDWYER
