PRINCE GEORGE'S COUNTY
HISTORIC SITE SUMMARY SHEET

Building Name: St. Thomas Church Rectory

Location: 10108 Croom Road, Upper Marlboro MD 20772

Maryland Historical Trust State Historic Sites Inventory Form

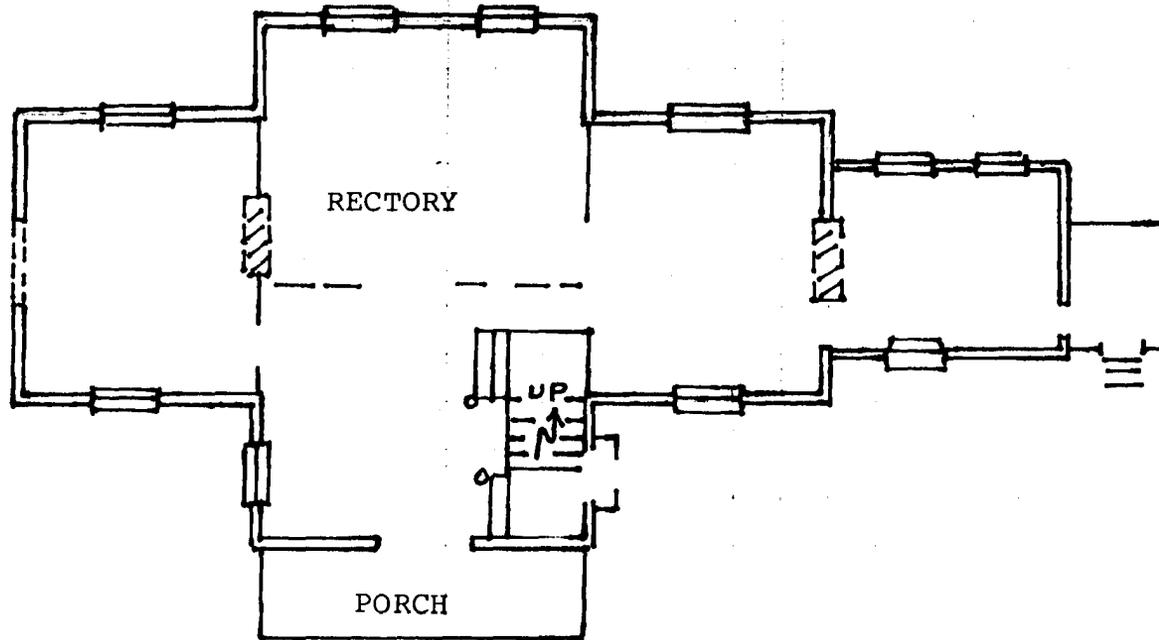
ST THOMAS' RECTORY

(not exactly to scale

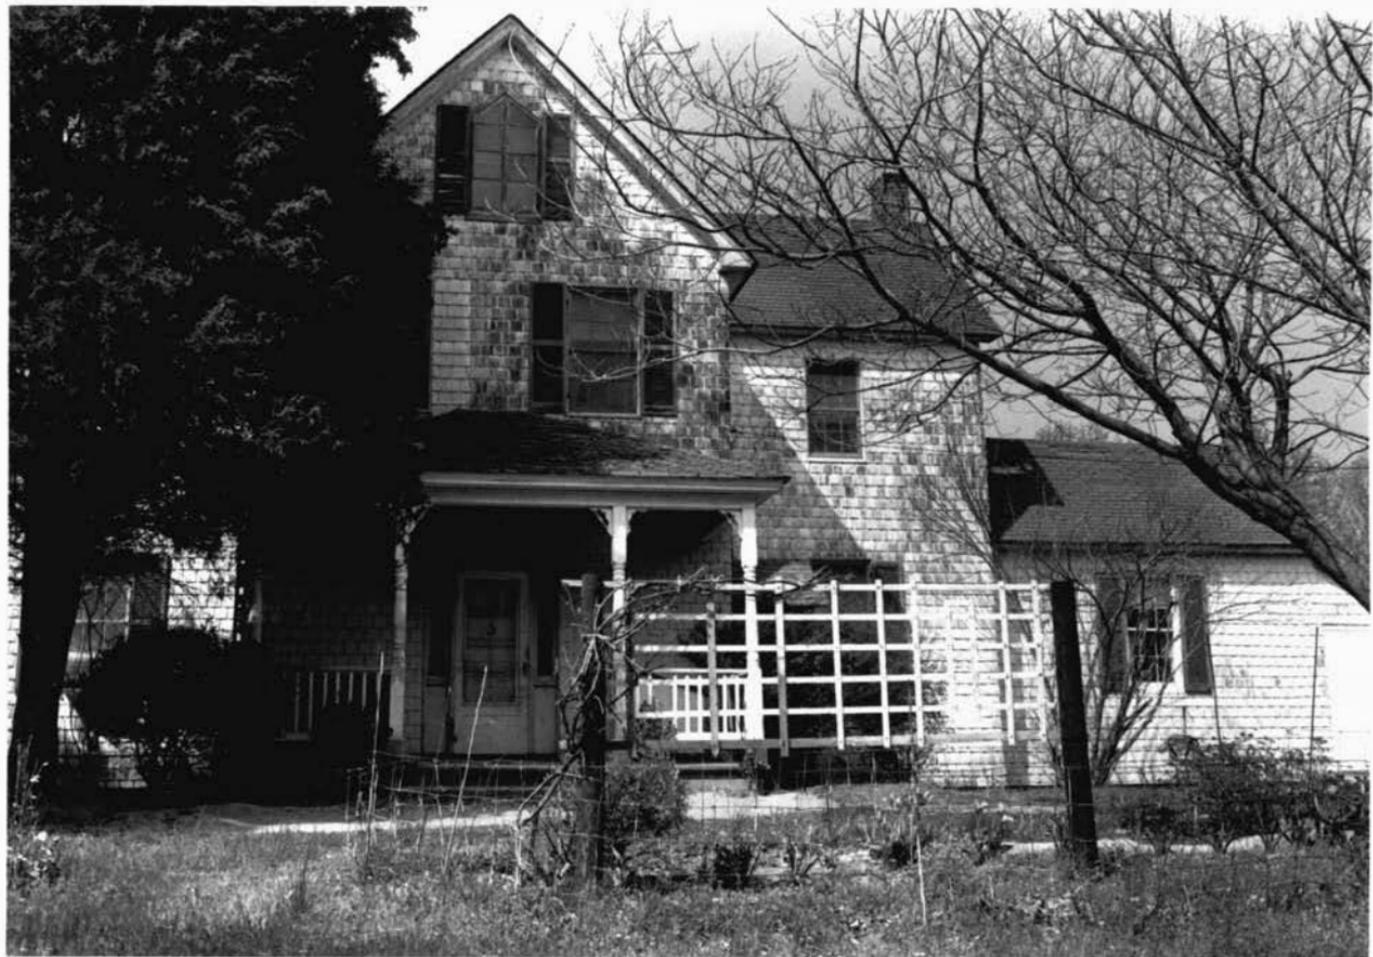
P.G. #86A-8

St. Thomas' Rectory
Prince George's County, MD.
Susan G. Pearl
April 1985
South elevation
Neg: Md. Hist. Trust, Annapolis, MD.

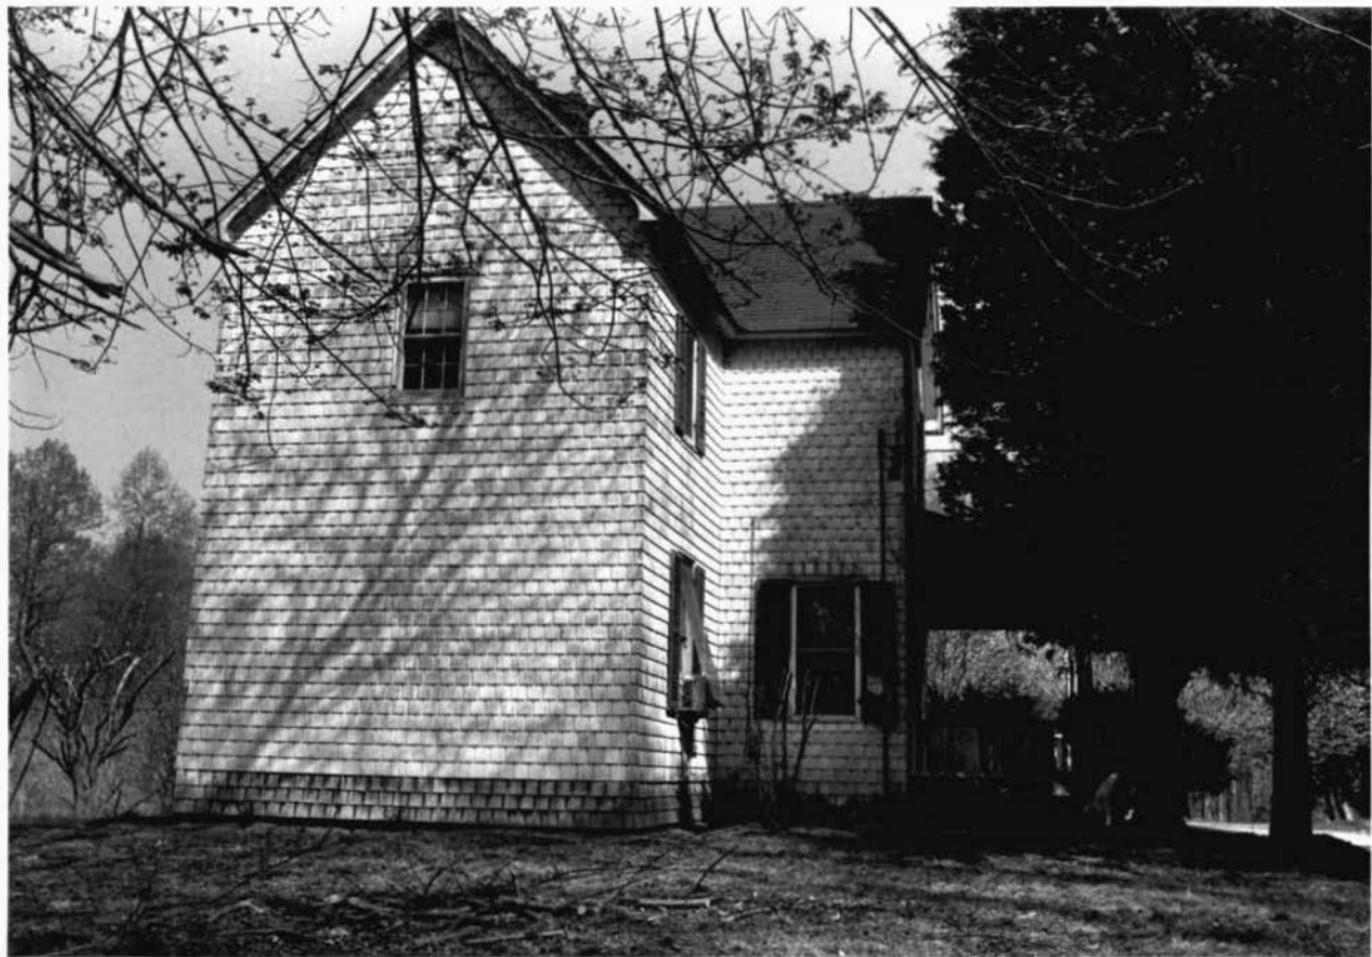
P.G. #86A-8

St. Thomas' Rectory
Prince George's County, MD.
Susan G. Pearl
April 1985
West elevation
Neg: Md. Hist. Trust, Annapolis, MD.

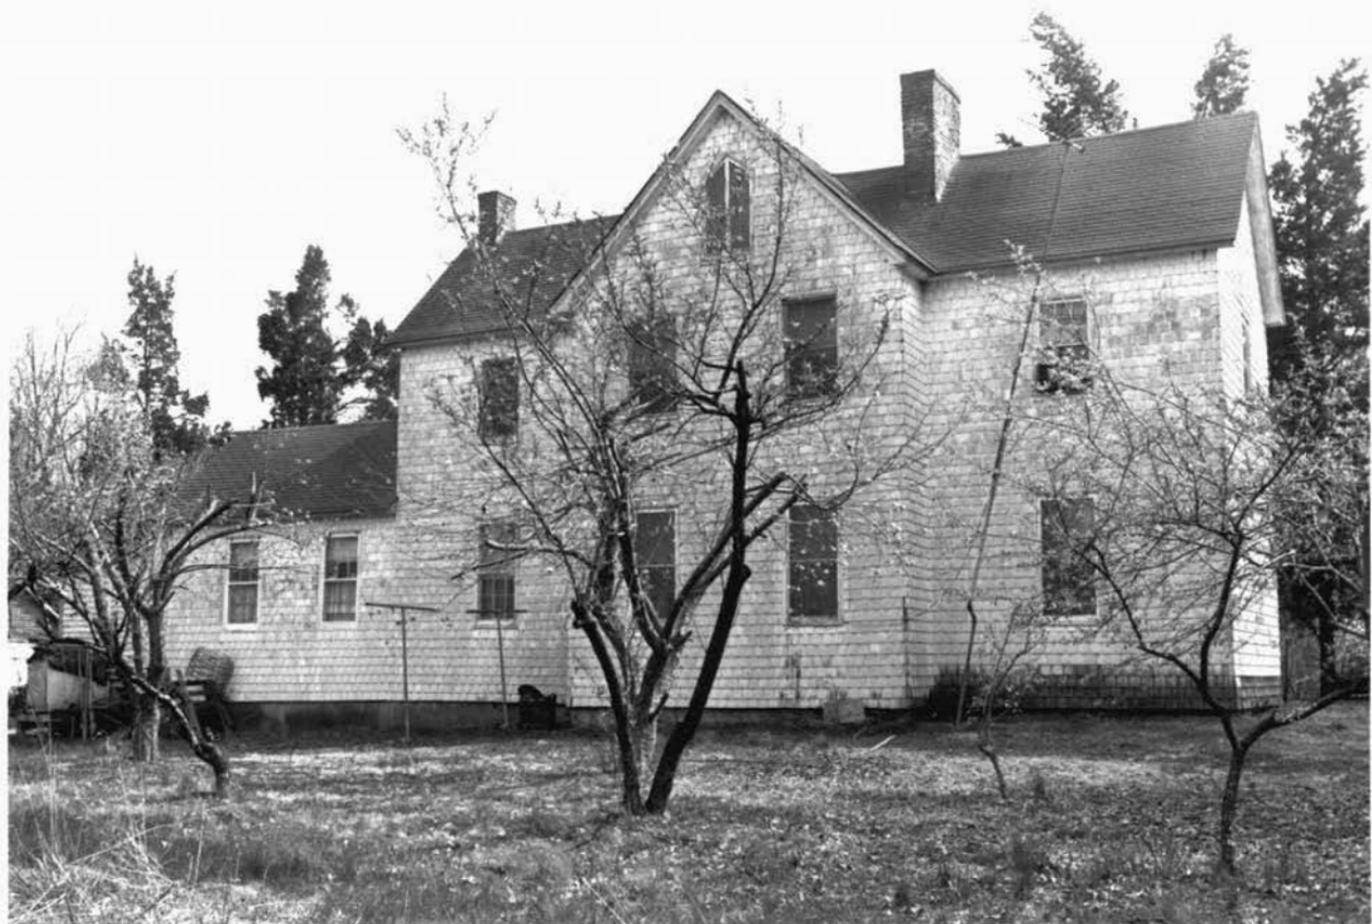
P.G. #86A-8

St. Thomas' Rectory
Prince George's County, MD.
Susan G. Pearl
April 1985
North elevation
Neg: Md. Hist. Trust, Annapolis, MD.
