PRINCE GEORGE'S COUNTY
HISTORIC SITE SUMMARY SHEET

Survey P.G. #86B-19 Building Date: ca. early 19th century
and 1870's

Building Name: Horsehead Tavern

Location: 17505 Aquasco Road, Baden

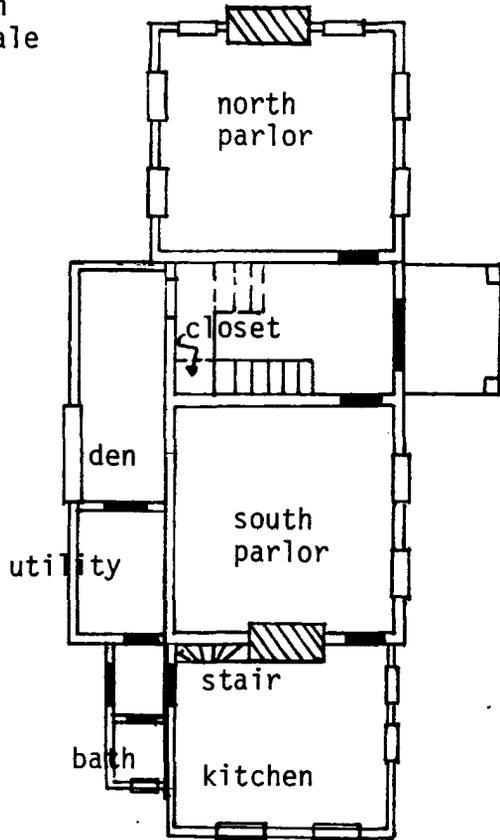
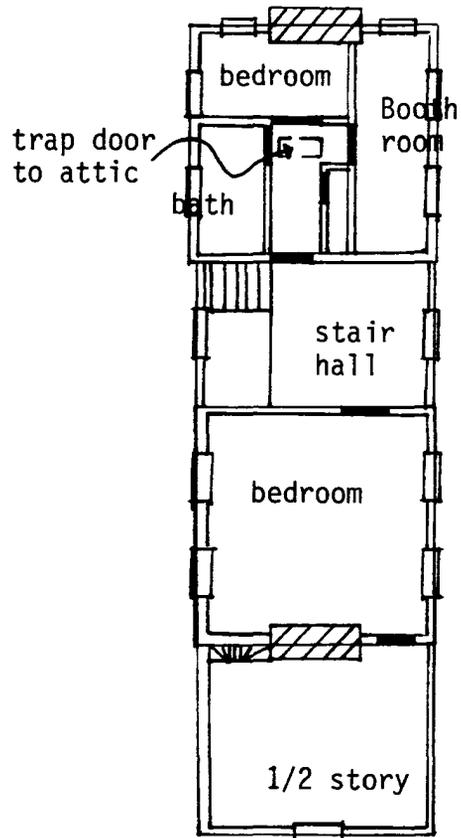
P.G.#86B-19
Horsehead Tavern
Floor plan
Not to Scale

The interior of the Horsehead Tavern has an "I" house plan, with a central stairhall flanked by a north and a south parlor. The kitchen is in a low one-and-one-half story wing attached at the south end of the main block. The whole interior was extensively altered during the early 1970's. Most door and window surrounds have been removed. The ceilings have been lowered and are covered with tile or spackled, and the walls have been covered with synthetic paneling.

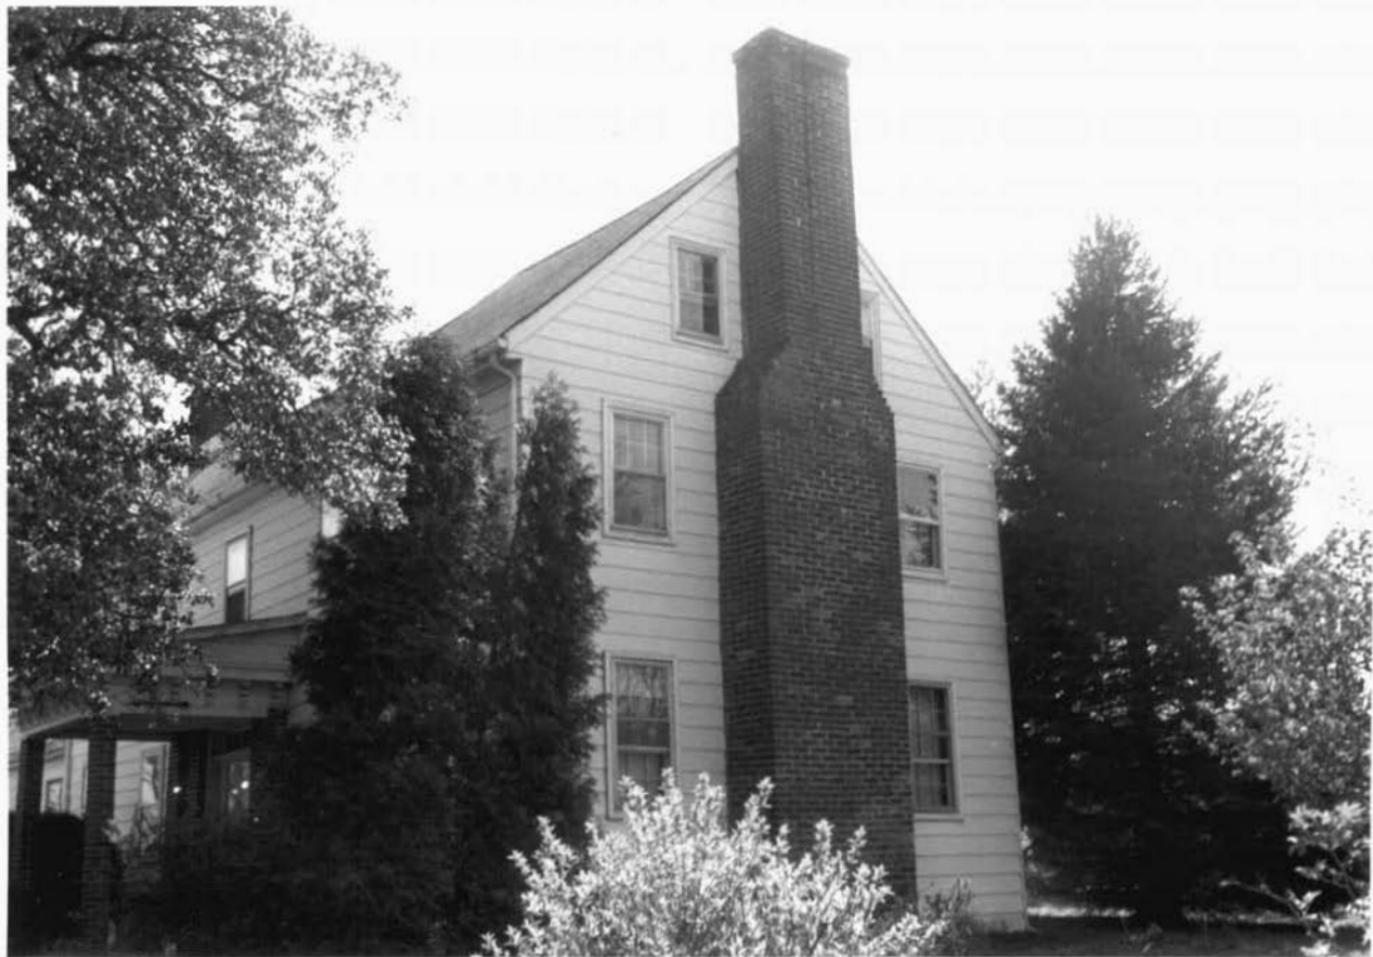
P.G. #86B-19

Horsehead Tavern
Prince George's County, MD
Marina King
April 1987
North elevation
Neg: MD Historical Trust
Annapolis, MD

The two-bay north gable end has a central exterior chimney laid in American bond with a row of header bricks every eighth row. The chimney has stepped weathering at the second story level. The stack above the weathering appears to be rebuilt, of a light-colored brick laid in common bond. There are two windows at first, second and third story levels on the north gable end. The west (rear) facade is five bays, with the two north bays set in a section of the building that projects slightly and is slightly higher than the south three bays. There is a break in the roof-line on the rear facade that is not visible on the front. The central bay on the second story is a window set slightly lower than the others, which lights the main stair landing. A one-story shed-roof addition with a central picture window covers the south three bays on the first story.

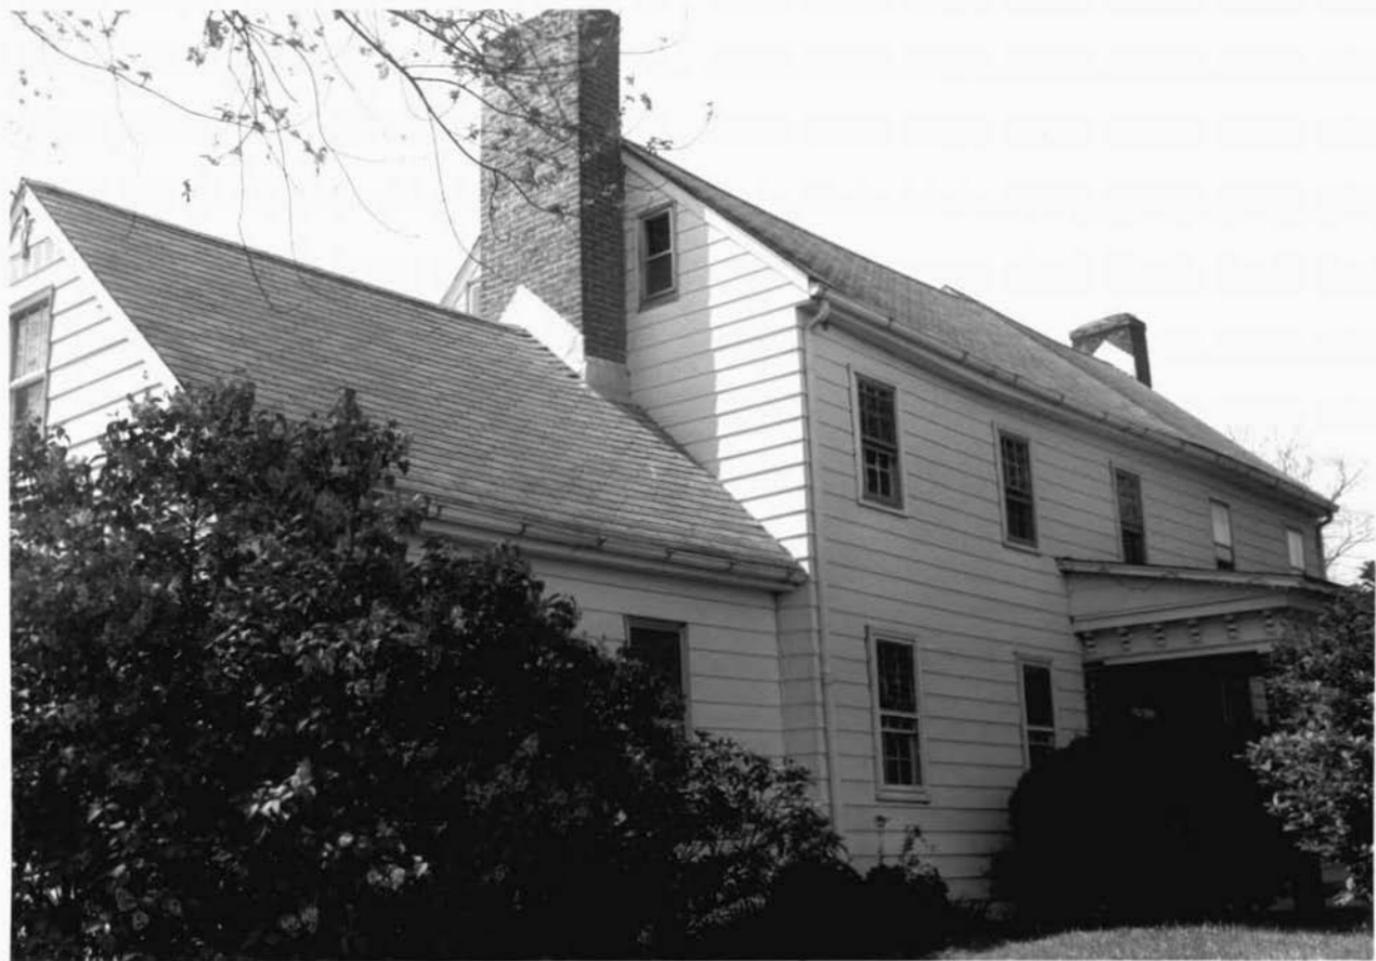
P.G. #86B-19

Horsehead Tavern
Prince George's County, MD
Marina King
April 1987
Southeast elevation
Neg: MD Historical Trust
Annapolis, MD

The five bay east (main) facade fronts on Aquasco Road. The central entrance, dating to the middle of the 19th century, is a four-panel door with three-light sidelights above wainscot panels, surmounted by a rectangular five-light transom. The entrance is sheltered by a one bay, one-story entrance porch also dating to the mid-19th century. The porch has a square roof, originally flat, but now with a shallow shed-roof top, probably altered during the ca. 1970's remodeling of the house. The porch roof has a wide frieze with multiple curving brackets, and a wide crown molded cornice. It is supported on two red brick posts, a ca. 1970's alteration. There are brick pilasters where the roof meets the wall, and a brick veneer applied to the wall area around the entrance door. The porch floor is a low cement pad. The windows on the first story of the front facade are 9/6 double-hung wood sash. Those throughout the rest of the building are 6/6 sash, with narrow wood surrounds. The north two bays of the building have a slightly higher gable roof ridge, which is visible from the east (main) facade.

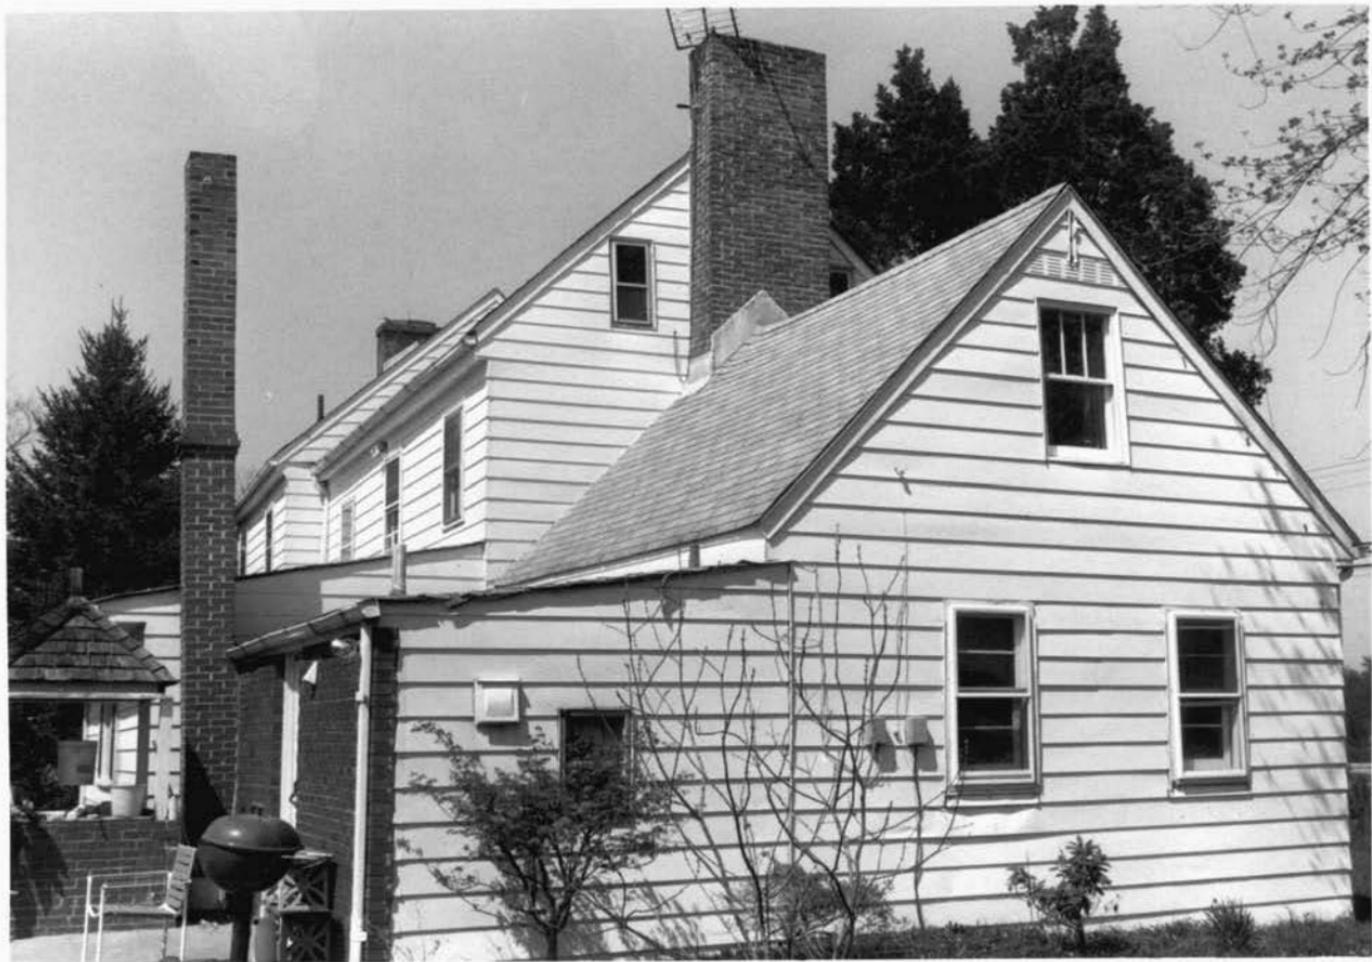
P.G. #86B-19

Horsehead Tavern
Prince George's County, MD
Marina King
April 1987
Southwest elevation
Neg: MD Historical Trust
Annapolis, MD

The south gable end has a central exterior brick chimney and small 4/4 sash windows at attic level. The one-and-one-half story south kitchen wing is centered on the south facade, enclosing the south chimney. The wing is sided and roofed with the same material as the main block. The kitchen has all new windows, two on its east elevation and two on the first story of the south gable end. A 3/1 sash window is centered at loft level on the south gable end. The west, rear two bays of the kitchen wing are covered by a shed roof lean-to addition with a central entrance. The west elevation of the lean-to is brick veneered.

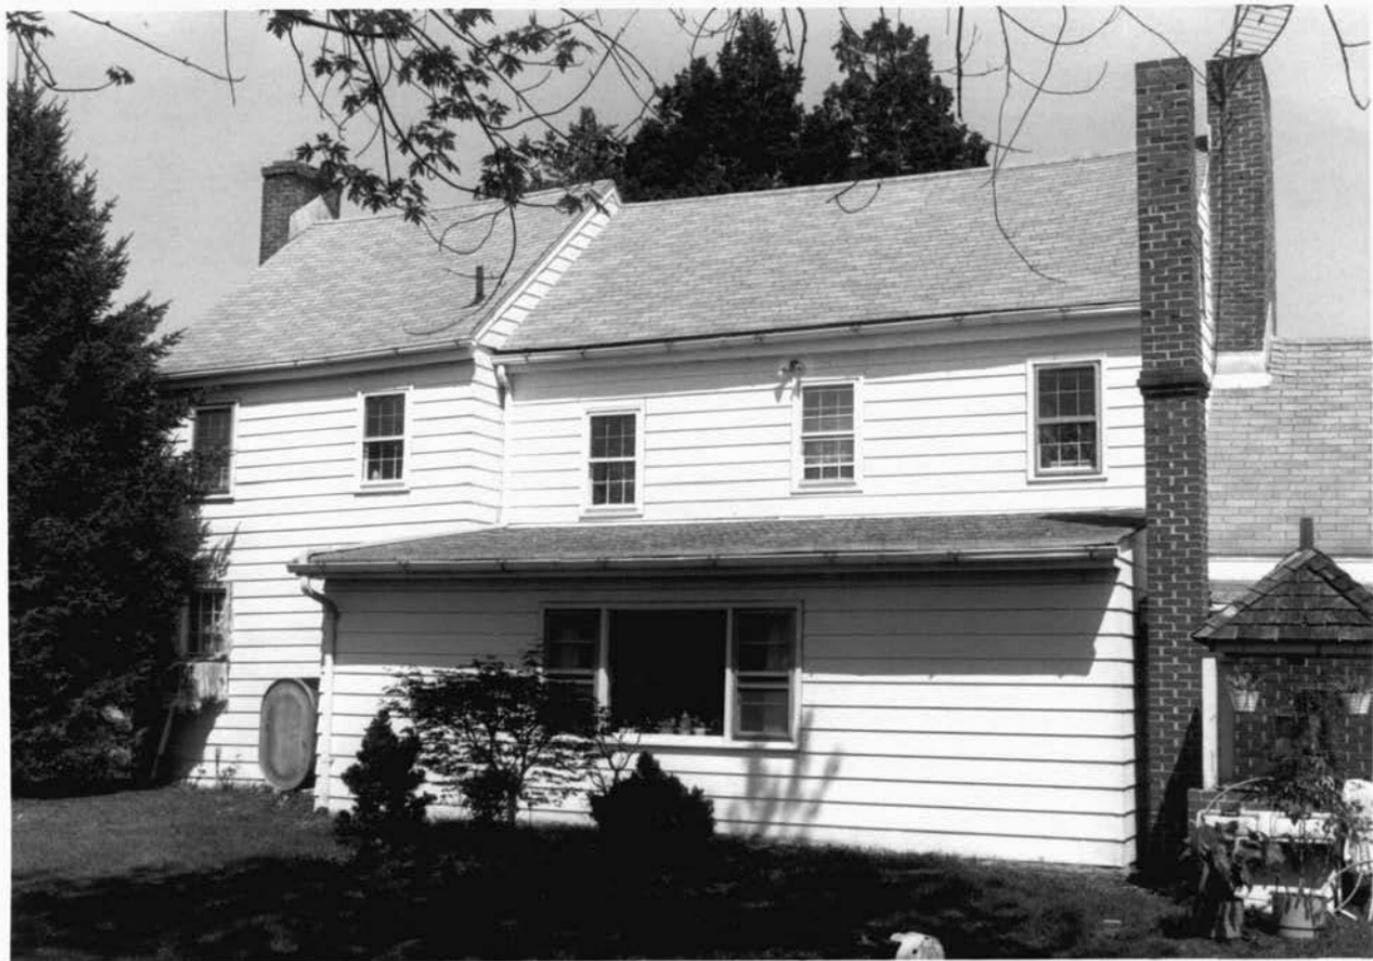
P.G. #86B-19

Horsehead Tavern
Prince George's County, MD
Marina King
April 1987
West elevation
Neg: MD Historical Trust
Annapolis, MD

A one-story addition which runs the length of the west (rear) side of the main block was added ca. 1950. It is entered from the west end of the main stair hall and contains a "den" or family room. The one-story lean-to addition on the west (rear) side of the kitchen wing contains a bathroom and laundry facilities. It has a west entrance from the outdoors, and connects to the kitchen and the family room addition.

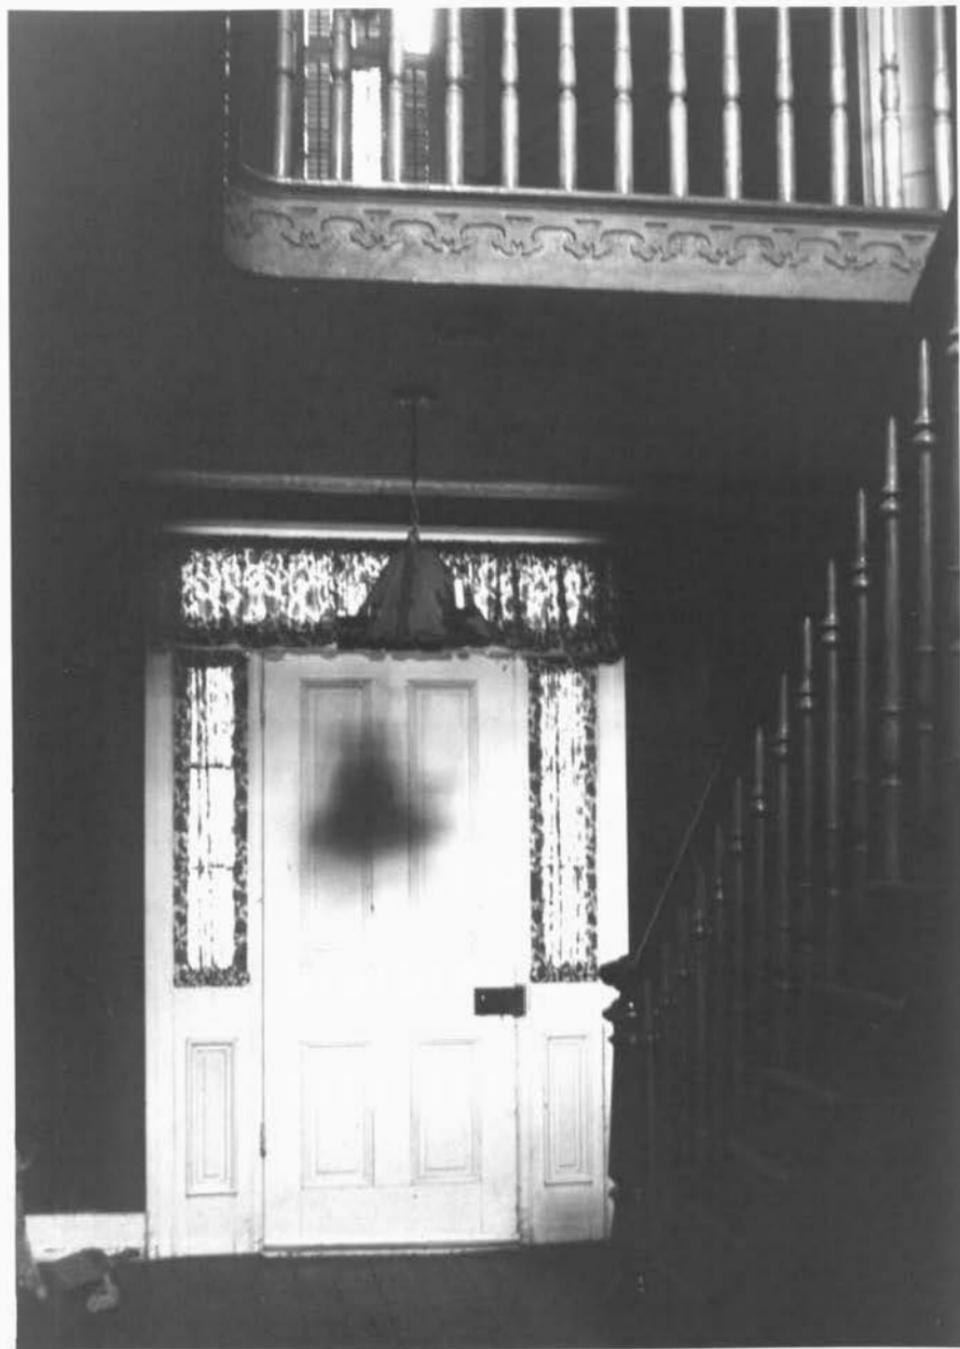
P.G. #86B-19

Horsehead Tavern
Prince George's County, MD
Marina King
April 1987
Stairhall, looking east
Neg: MD Historical Trust
Annapolis, MD

The main stairhall and south parlor were probably constructed in the 1870's. The main entrance door dates to that period. It is a four-panel door with an interior iron box lock and ceramic knob. There are three-light sidelights above a wainscot panel, and a five-light transom. The door surround is a one-step architrave surround. The baseboarding in the entry hall is a plain board. The flooring is old, of boards approximately 5 inches in width, stained dark brown. The open string stairway was not altered, as much of the interior was. It rises along the south wall of the hall, turns 90° at a landing between first and second floors, then turns 90° once again and rises along the north wall of the hall to the second story. The stair ends have jigsaw brackets. There are two balusters to a step, the slender tapering circular balusters have a turned section at their lower and upper ends. The heavy turned newel post is set on a seven-sided base block. The stair moldings are of varnished rather than painted wood. There is a four-panel door leading to a closet beneath the stair. The arched opening at the west (rear) of the hall leads to a modern one-story addition.

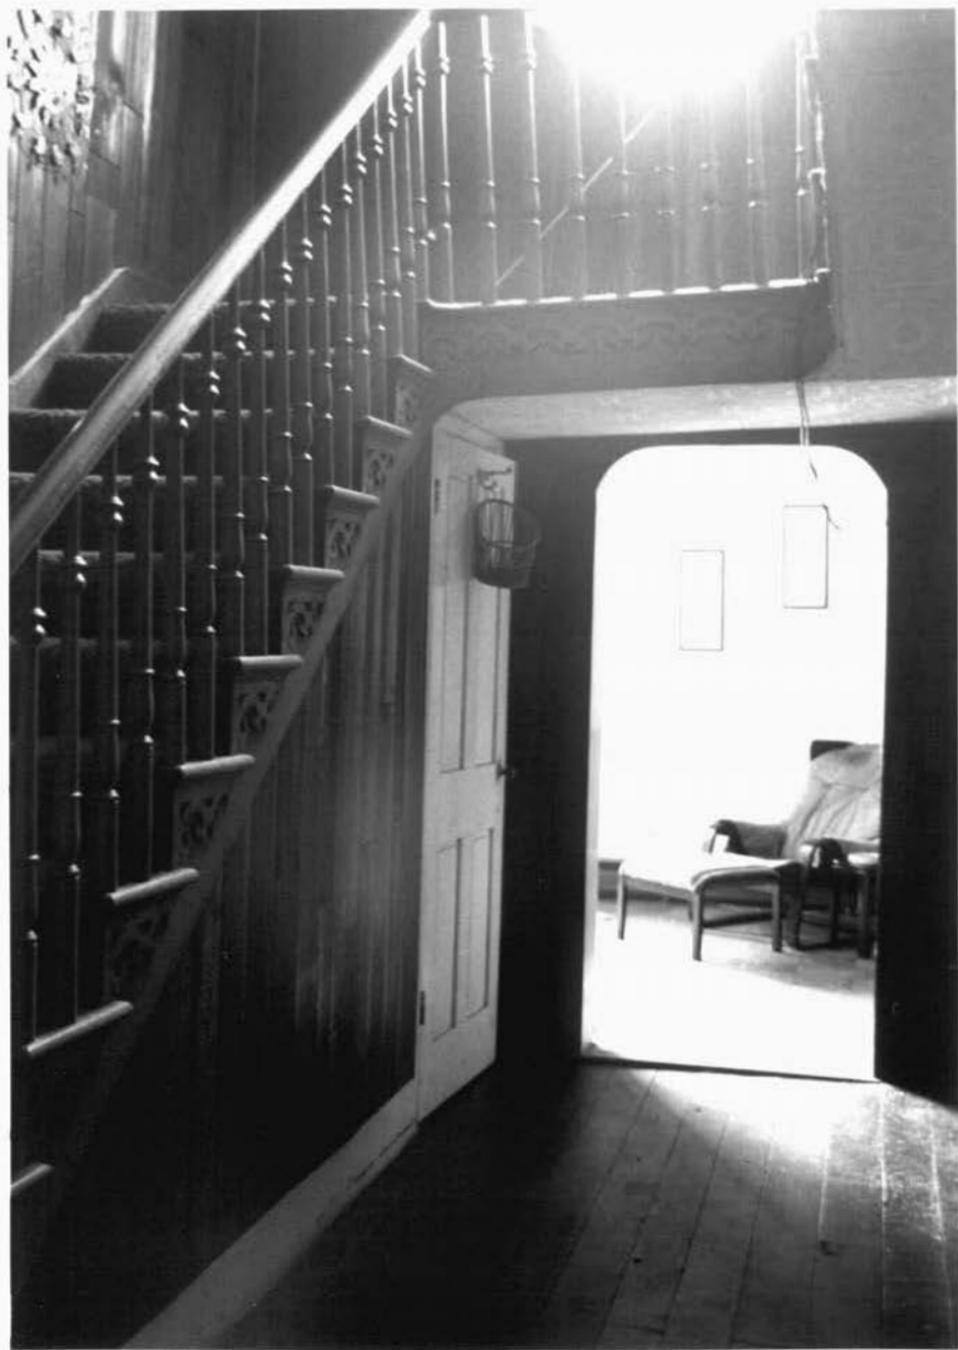
P.G. #86B-19

Horsehead Tavern
Prince George's County, MD
Marina King
April 1987
Stairhall, looking west
Neg: MD Historical Trust
Annapolis, MD

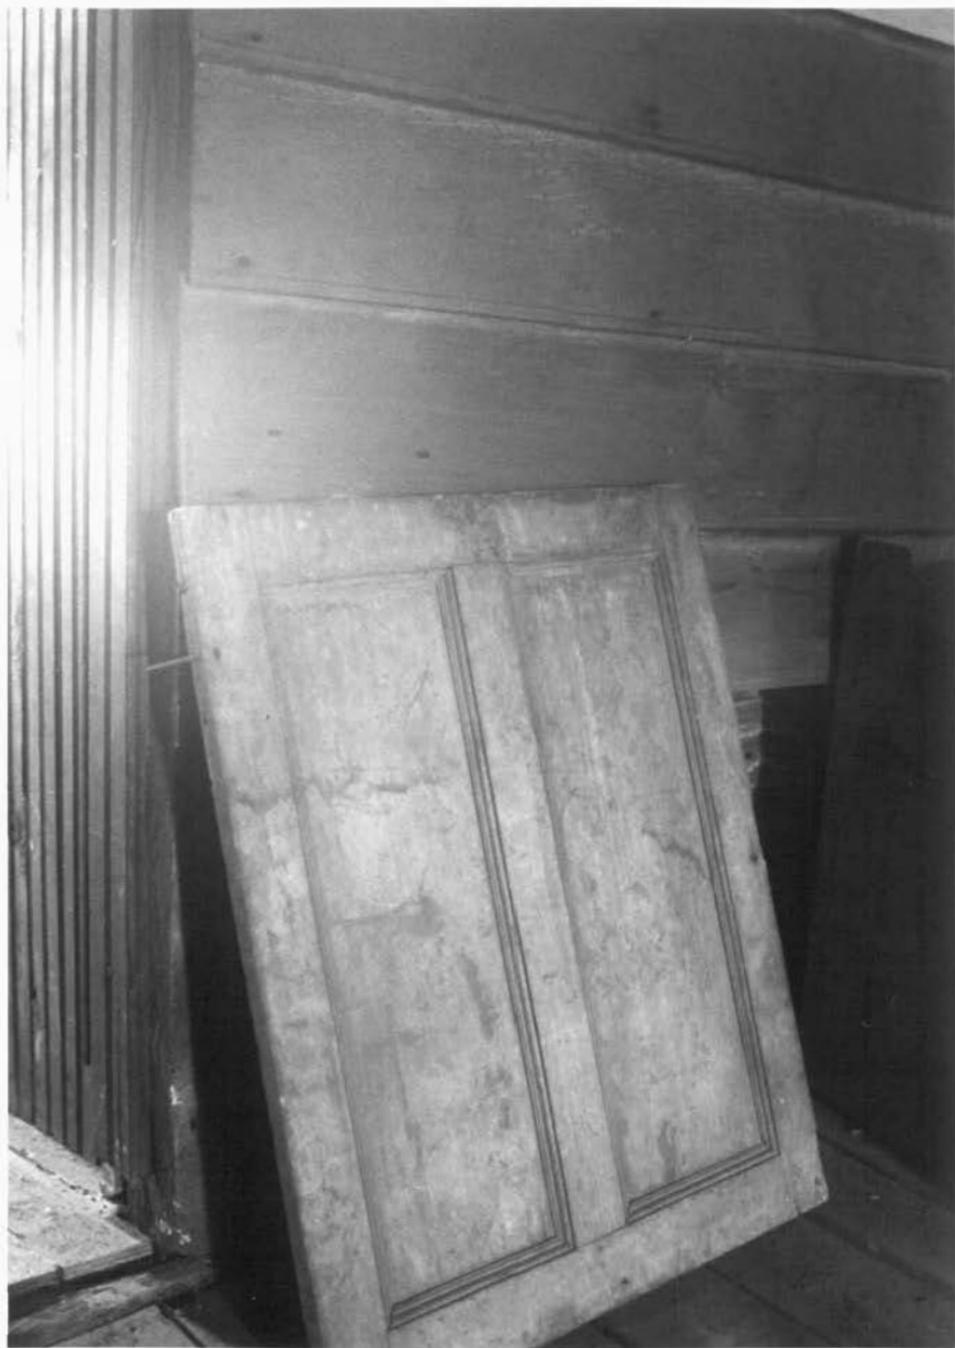
P.G. #86B-19

Horsehead Tavern
Prince George's County, MD
Marina King
April 1987
Attic, siding detail
Neg: MD Historical Trust
Annapolis, MD

The flooring in this north attic section is varied, from 5-1/2 to 10 inches in width. A doorway from the hall leads to the large, open south section of the attic, which appears never to have been finished. The wall between the north and south sections of the attic has several sections of lapped wood siding on its south side. The siding has the remains of white paint, and is fairly regular in width with a lower bead. It is held on with square cut nails. There were no handwrought nails found in the attic. The lathes for the plaster were hand-riven but also nailed with square-cut nails.

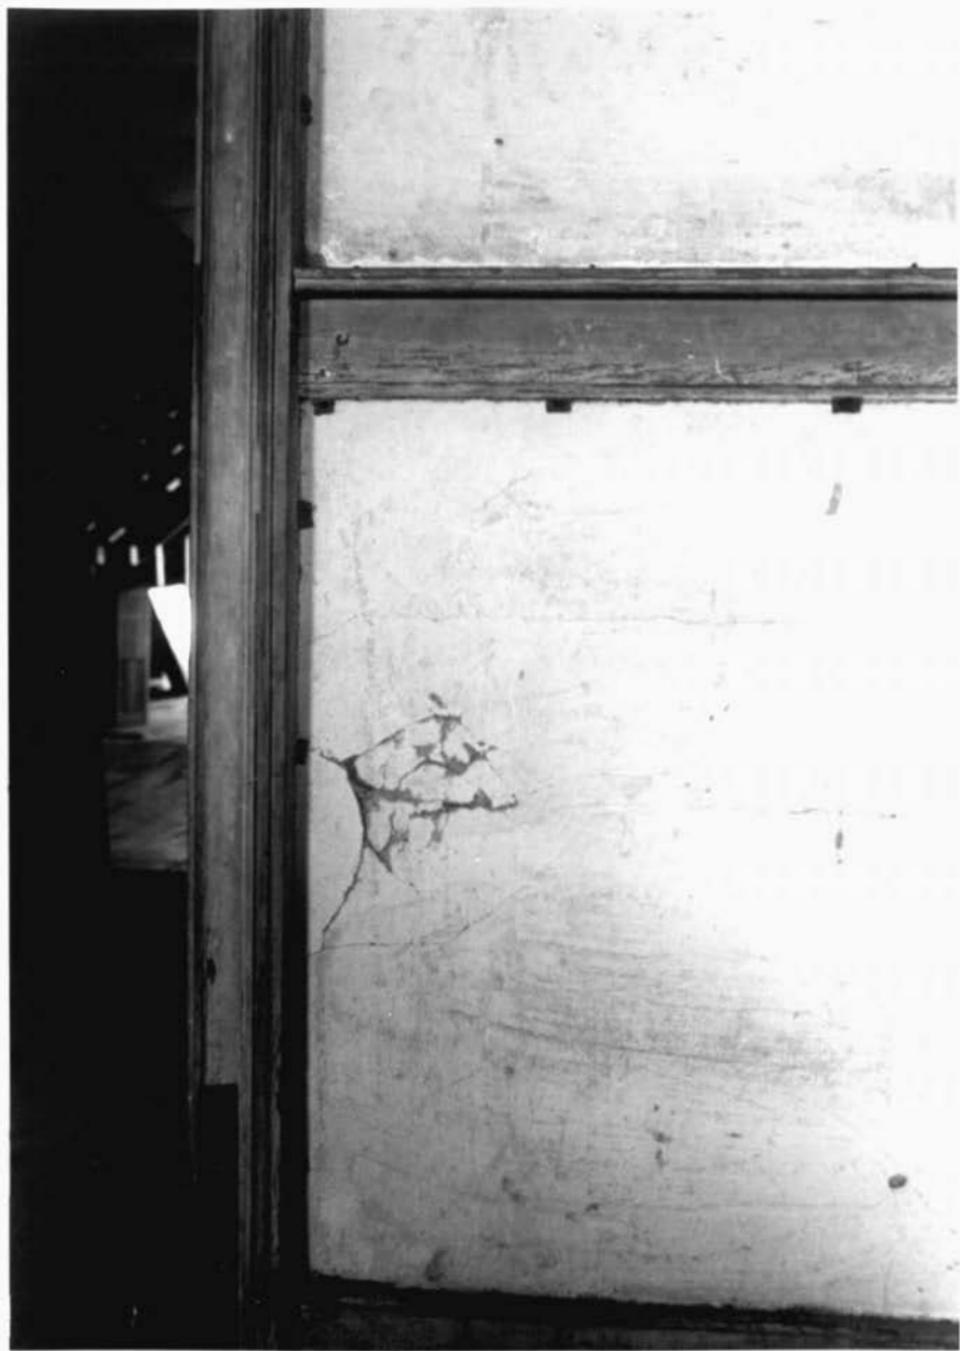
P.G. #86B-19

Horsehead Tavern
Prince George's County, MD
Marina King
April 1987
Attic, molding detail
Neg: MD Historical Trust
Annapolis, MD

The small hall is also partially plastered. There is a closet on the east side, with interior walls of old plaster and a beaded baseboard. On the west is the top section of an old balustrade and a square hole in the floor, indicating a stairway that has been closed off. The balustrade is of slender rectangular balusters with a plain square newel post with a square flat cap; and a rectangular handrail with a cap and lower bead.
