National Register of Historic Places Inventory—Nomination Form

historic St. Mary's Rectory

St. Mary's Rectory
Prince George's County, Maryland

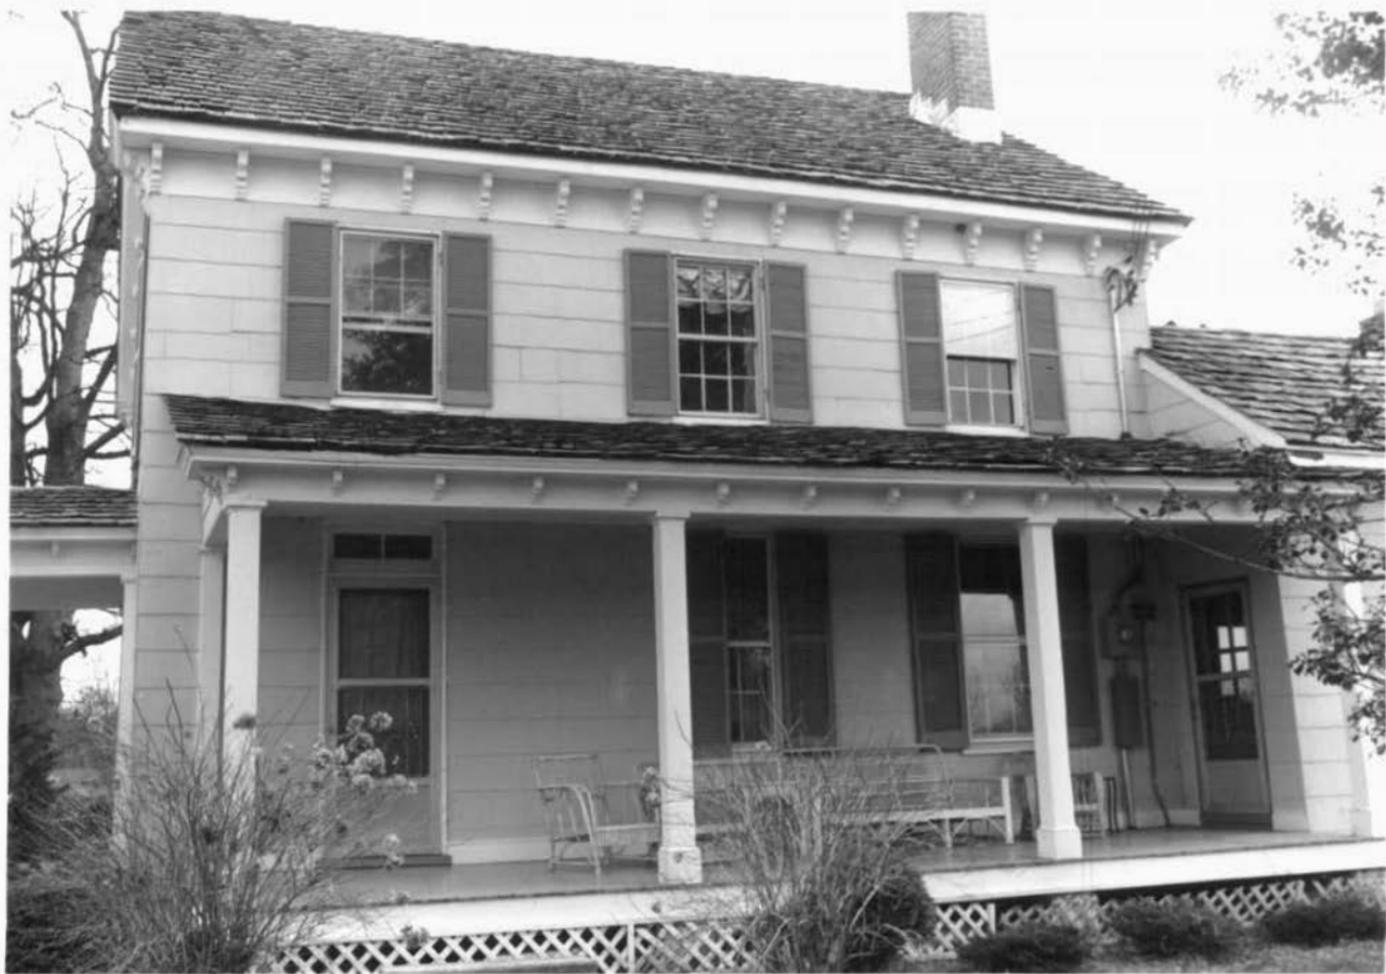
P.G.#87B-8a

Old St. Mary's Rectory
Aquasco, Prince George's County, MD
Marina King
April 1986
West elevation
Neg: MD Hist. Trust, Annapolis, MD

The three bay west facade, twenty-nine feet in length, is also a formal entrance facade. It faces St. Mary's Church across what is now a wooded lot. Entrance is in the north bay, through a door with two lower square panels and an upper glass light, surmounted by a two-light transom and having a narrow wood surround. The first story is sheltered by a three-bay shed roof entrance porch, the wood floor set on brick piers interspaced with wood lattice. The porch posts, frieze and cornice treatment are the same as that on the north entrance porch. Windows on the second story are not as long as those on the first level story. This size difference is repeated on all elevations save for the north (main) elevation.

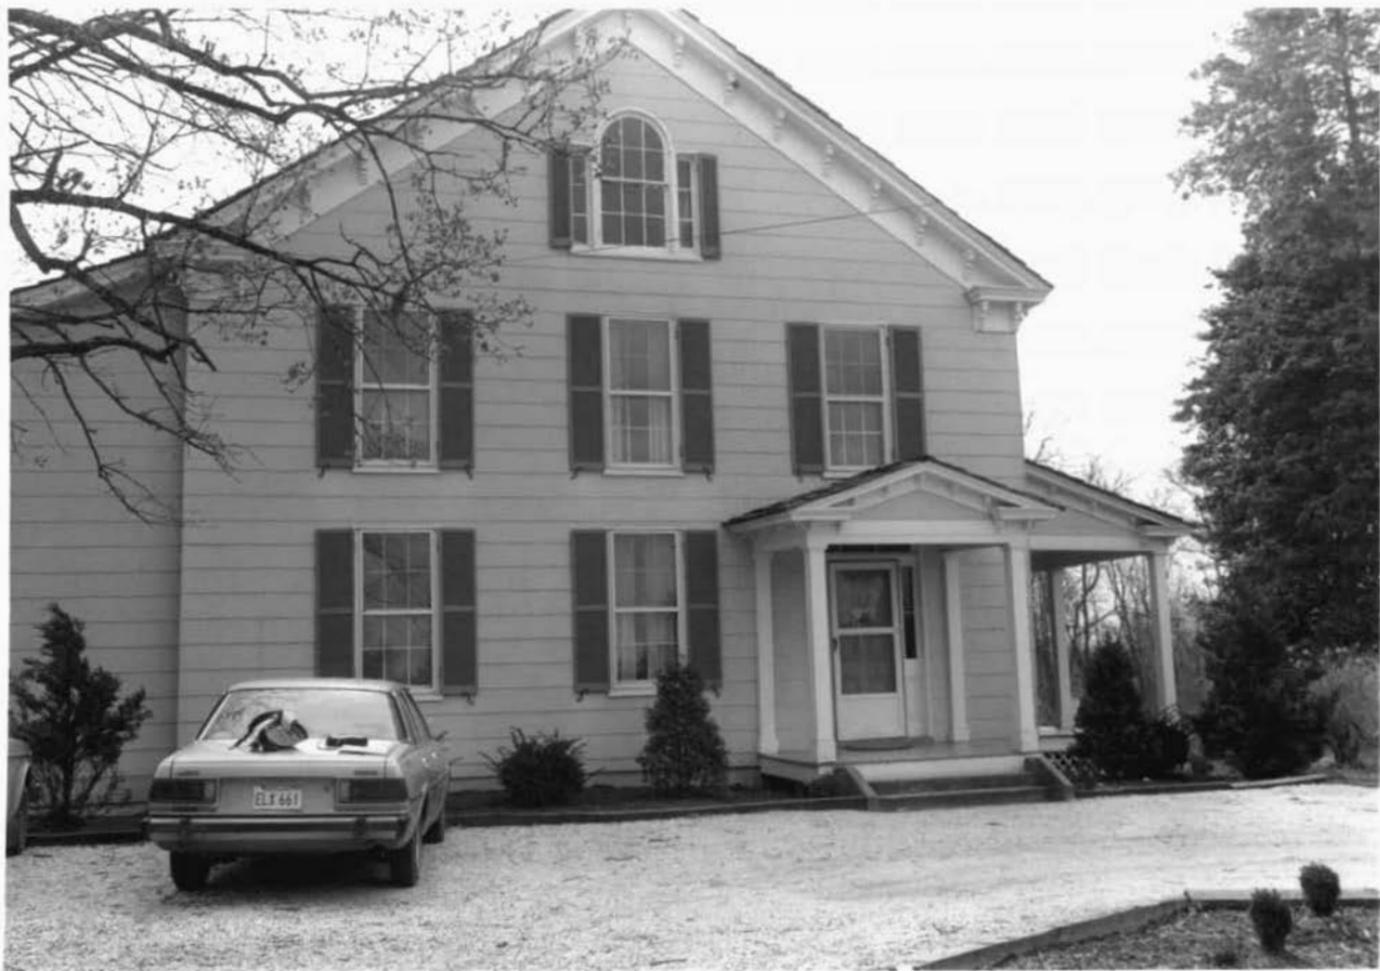
P.G.#87B-8a

Old St. Mary's Rectory
Aquasco, Prince George's County, MD
Marina King
April 1986
North elevation
Neg: MD Hist. Trust, Annapolis, MD

The three bay north (main) facade is a gable end, measuring thirty-two feet in length. Entrance is in the third bay through a four panel door, the upper two panels having round arch heads. There are two-light sidelights above wainscot panels and a three-light transom. A two inch wood surround with a raised outer molding and an inner bead encloses the sidelights and transom. Shading the entrance is a one-bay, gable roof porch having a wide plain frieze and a boxed overhanging crown molded cornice supported on Italianate brackets and having returns in the front gable. There is a raking frieze band and a bracketed raking cornice. The cedar shake porch roof is supported on square wood posts with base blocks and capital molding. Pilasters with the same base block and capital molding mark the point where the roof meets the wall surface. The wood floored porch is reached by two concrete steps.

The windows on the facade are large wood framed double-hung-sash with six-over-six lights and louvered blue-painted wooden shutters held by "S" shaped iron hooks and having the same narrow surround as that around the entrance door. Centered in the upper gable, at third level, is a Palladian window composed of a round arch central double-hung-sash window of six-over-six lights, flanked by two narrow three-light windows. There are narrow louvered shutters on the flanking windows.

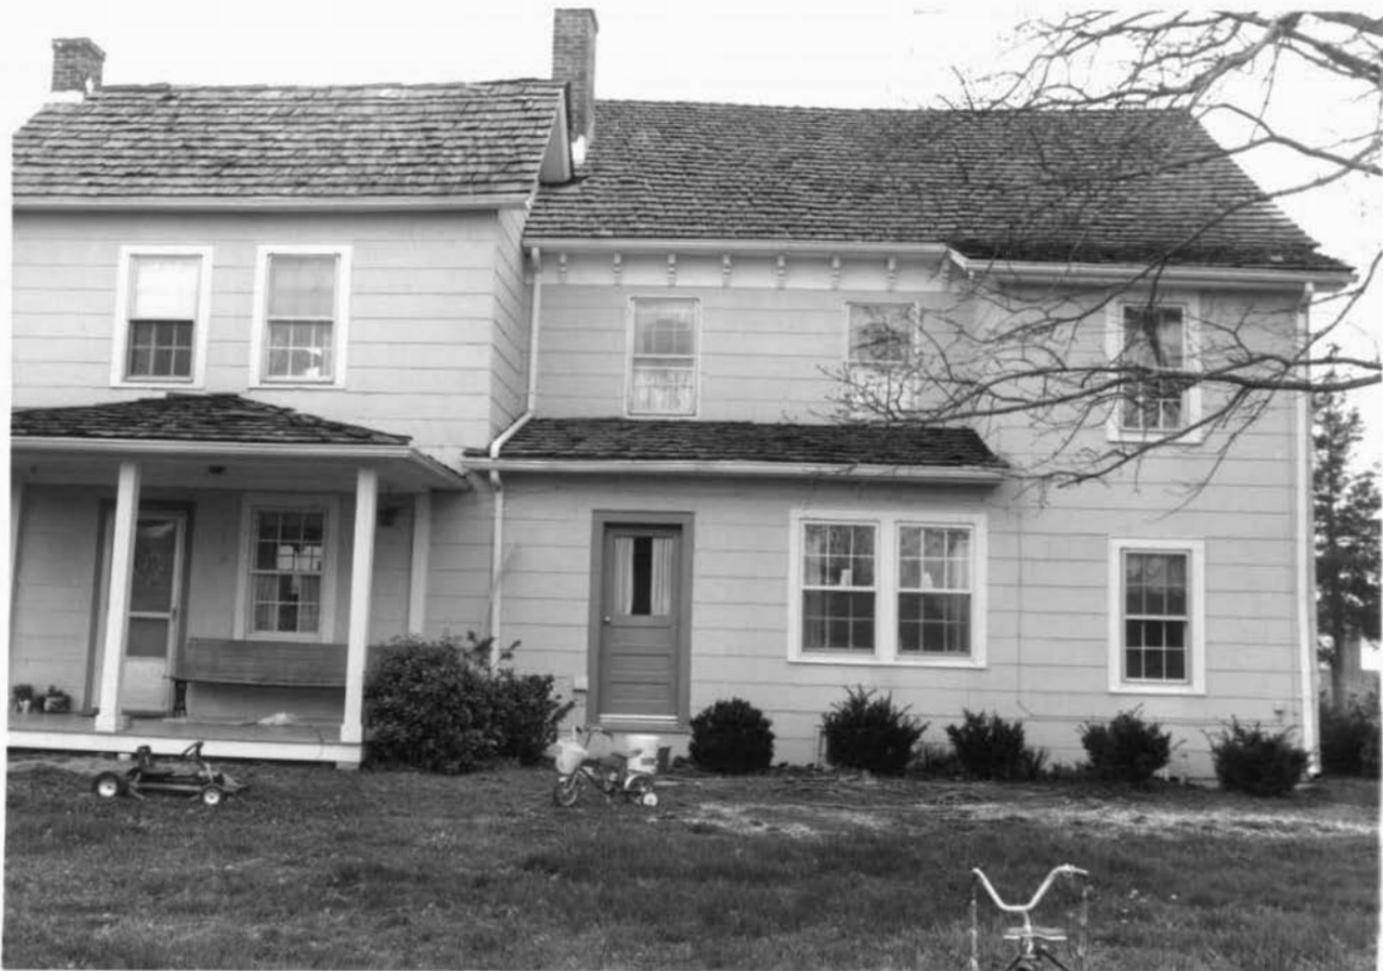
P.G.#87B-8a

Old St. Mary's Rectory
Aquasco, Prince George's County, MD
Marina King
April 1986
East elevation
Neg: MD Hist. Trust, Annapolis, MD

The east facade of the main block is all but obscured by three additions. Visible on the main block are the first and second bays at second level and the cornice above these two windows. The treatment is the same as those details throughout the building.

The additions on the east facade consist of a 1921 two-story, one-bay shed roof addition on the northeast corner of the facade, which contains bathrooms on the first and second level. A shed roof two-bay, one-story addition centered on the facade has an entrance and a double-hung-sash window of six-over-six lights. The window provides light into a dining room alcove, and the entrance is into an adjoining pantry. A two-by-two-bay, a two-story gable roof addition at the southeast corner of the building is a late 19th century kitchen addition with a bedroom on the second level. It measures seven-teen-by-fifteen feet and has an east entrance sheltered by a two-bay, hipped-roof porch, rebuilt since 1980 by the present owners.

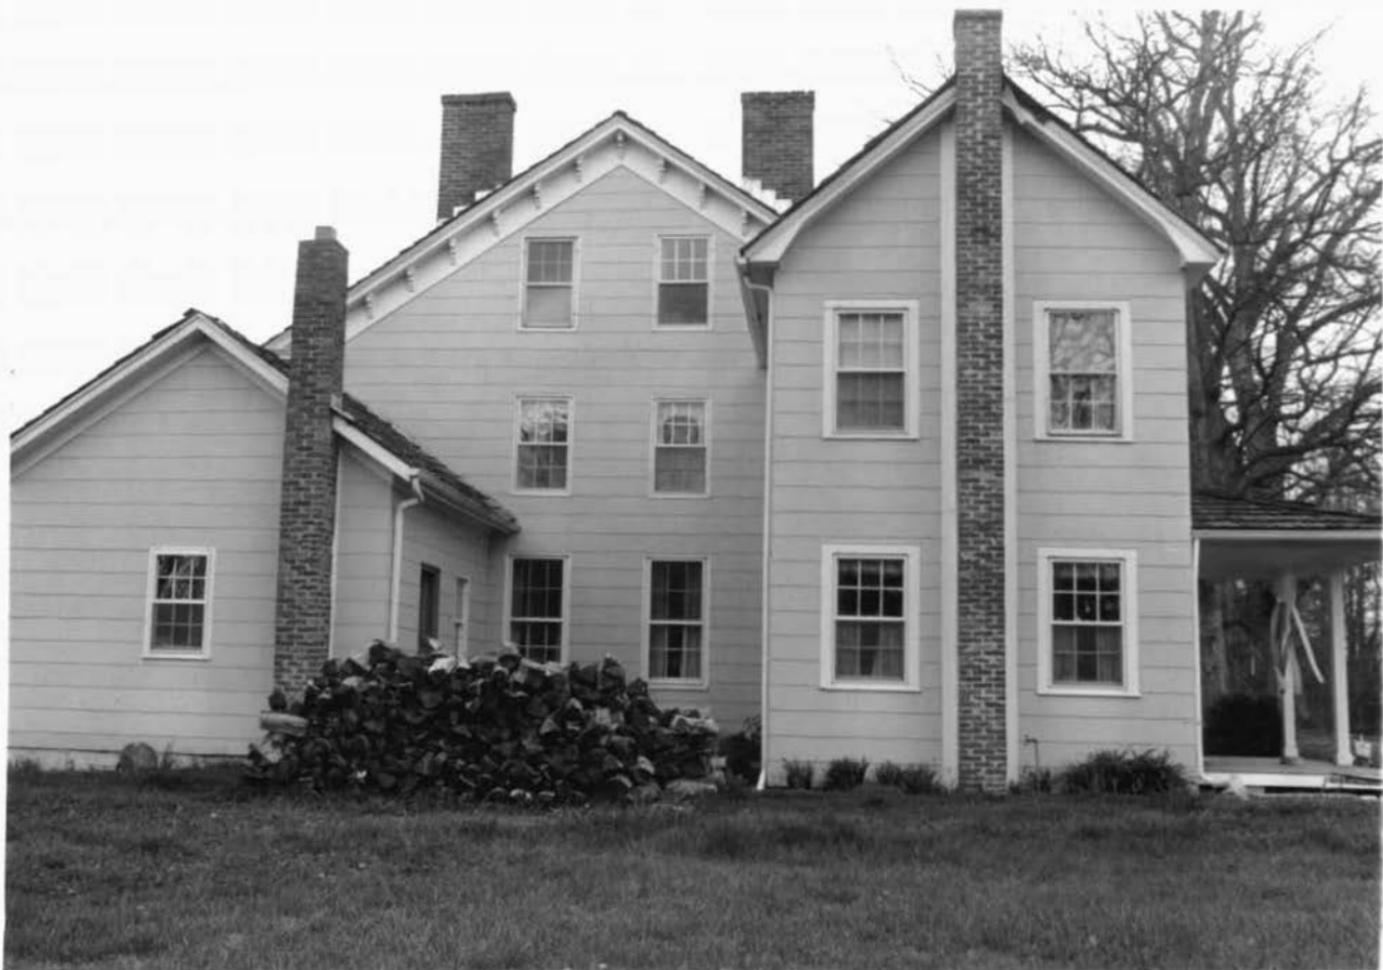
P.G.#87B-8a

Old St. Mary's Rectory
Aquasco, Prince George's County, MD
Marina King
April 1986
South elevation
Neg: MD Hist. Trust, Annapolis, MD

The south gable end is dominated by two gable roof additions, one on the southwest and one on the southeast bays of the facade. Two center bays are visible on the main block, composed of 6/6 sash windows on first through third levels. The two central bays are flanked by corbelled brick interior chimneys rising from the east and west slope of the roof. The bracketed, crown molded cornice treatment is the same as that on the main facade. There is a bulkhead cellar entrance beneath the second bay.

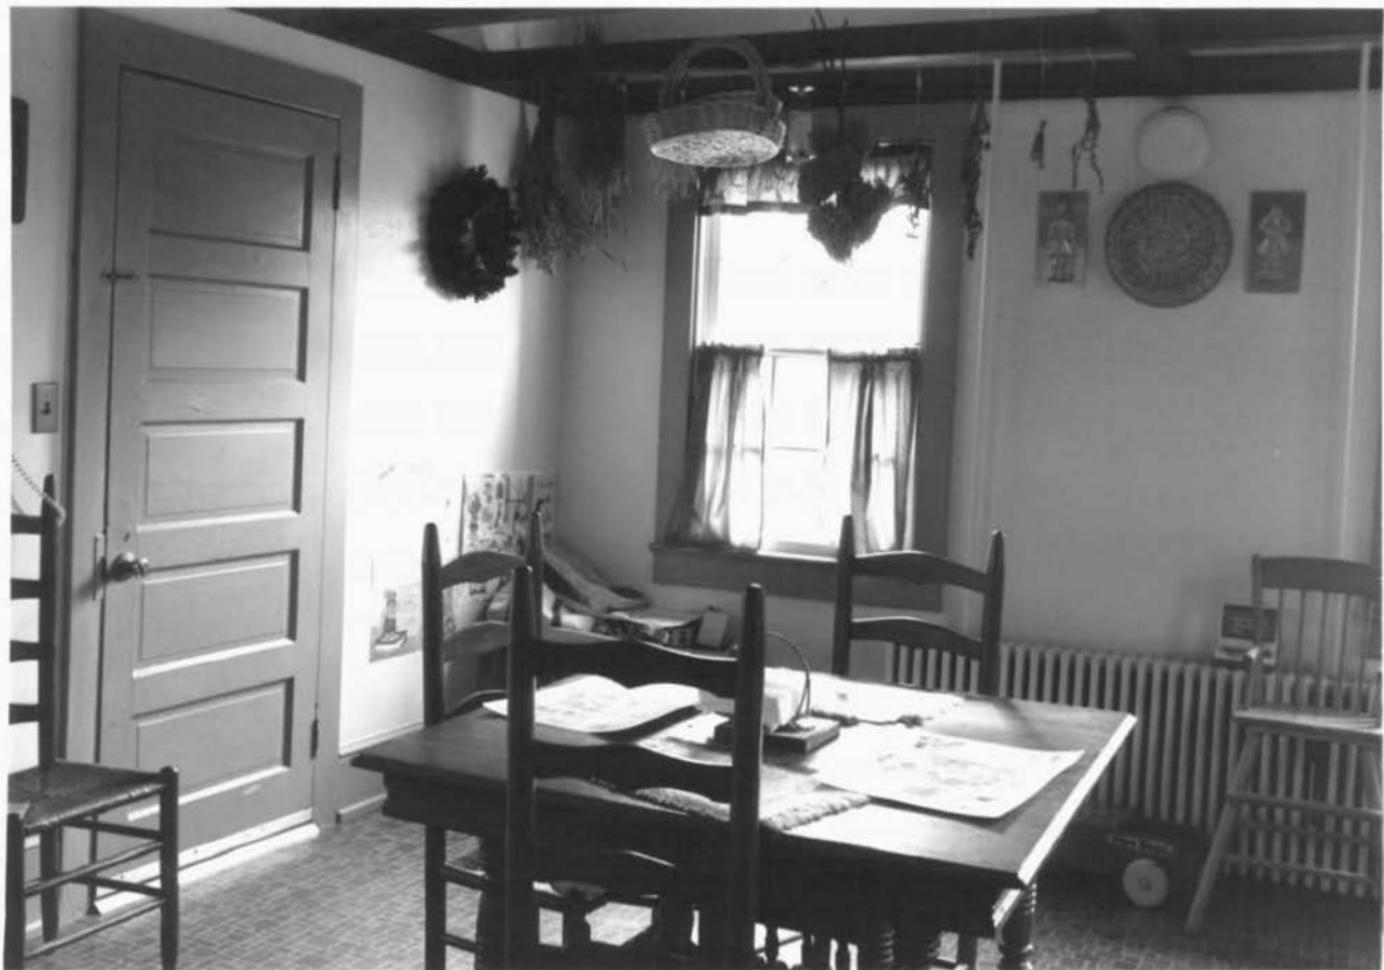
P.G.#87B-8a

Old St. Mary's Rectory
Aquasco, Prince George's County, MD
Marina King
April 1986
Kitchen
Neg: MD Hist. Trust, Annapolis, MD

The kitchen has a wide plain board surrounds around the doors and windows. There is a wide baseboard. A six-panel door in the east wall leads to a two-bay east side porch. The porch is new, replacing in kind an old porch which had deteriorated.

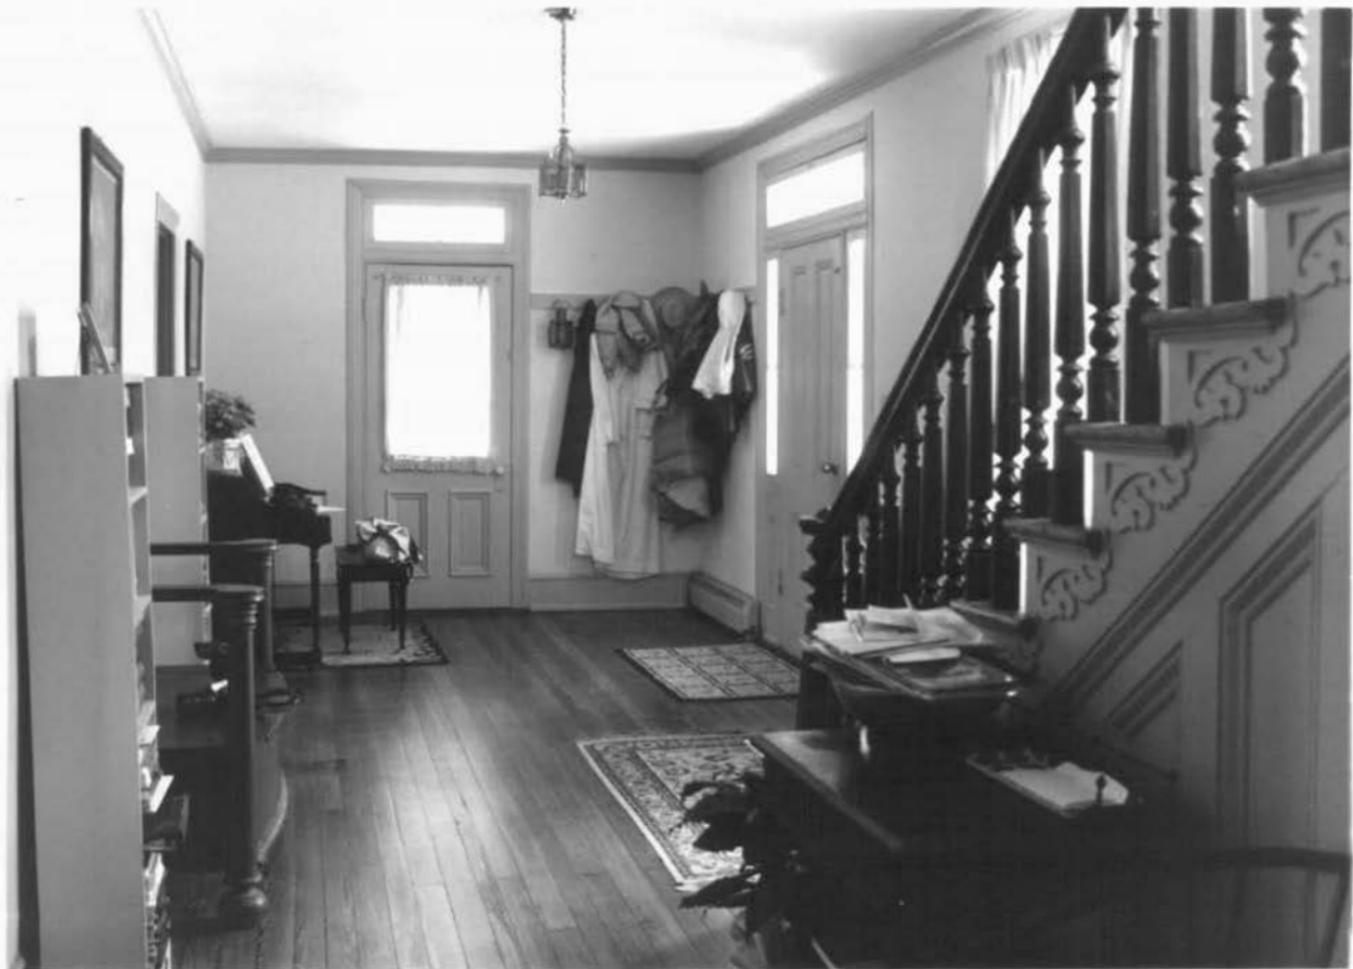
P.G.#87B-8a

Old St. Mary's Rectory
Aquasco, Prince George's County, MD
Marina King
April 1986
Hall, looking west
Neg: MD Hist. Trust, Annapolis, MD

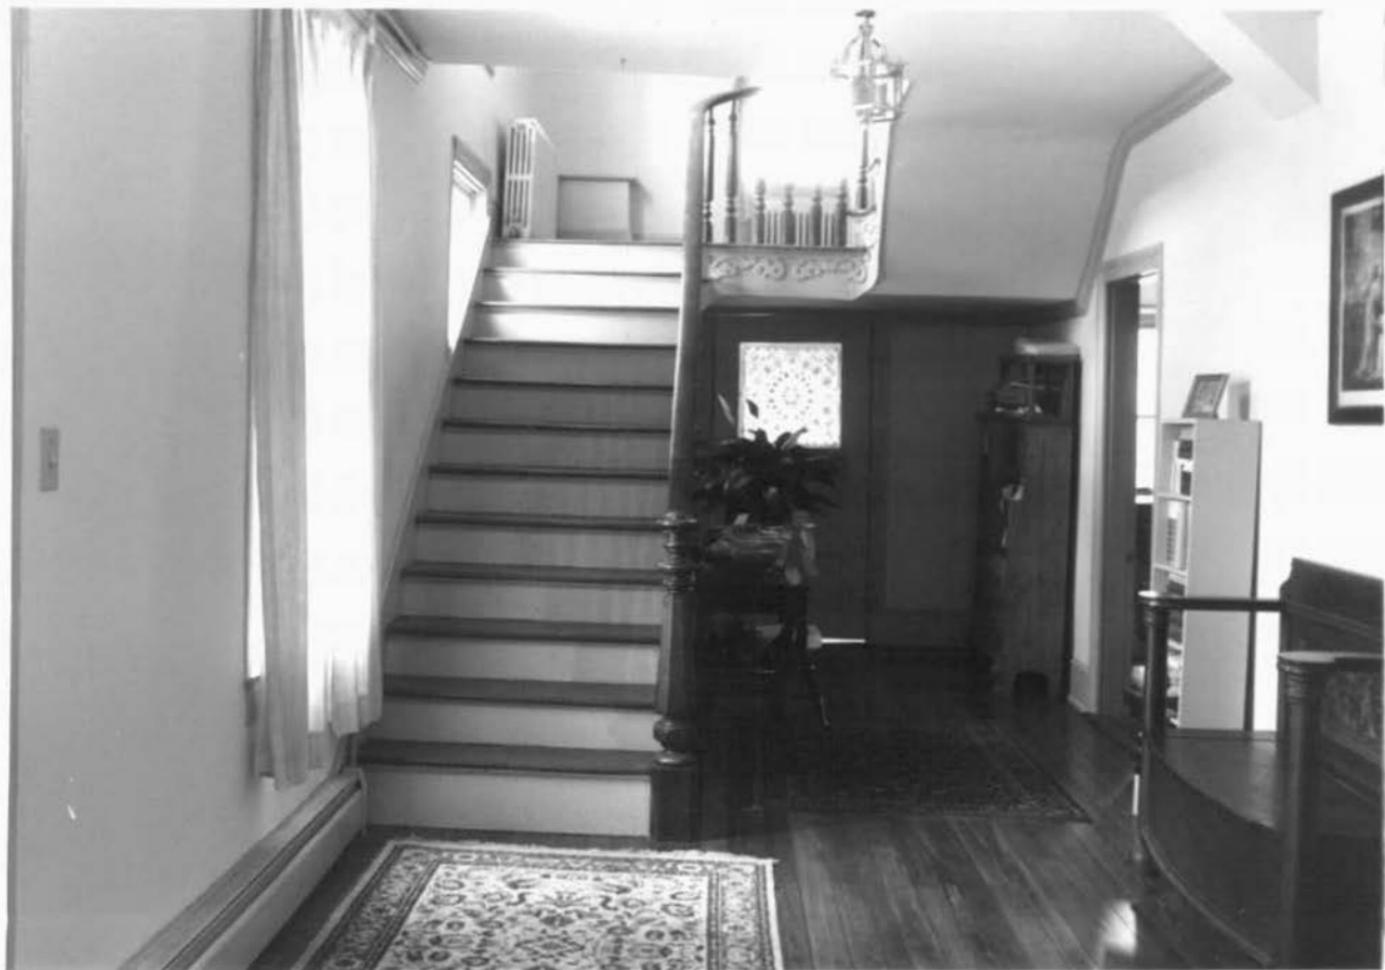
P.G.#87B-8a

Old St. Mary's Rectory
Aquasco, Prince George's County, MD
Marina King
April 1986
Hall, looking east
Neg: MD Hist. Trust, Annapolis, MD

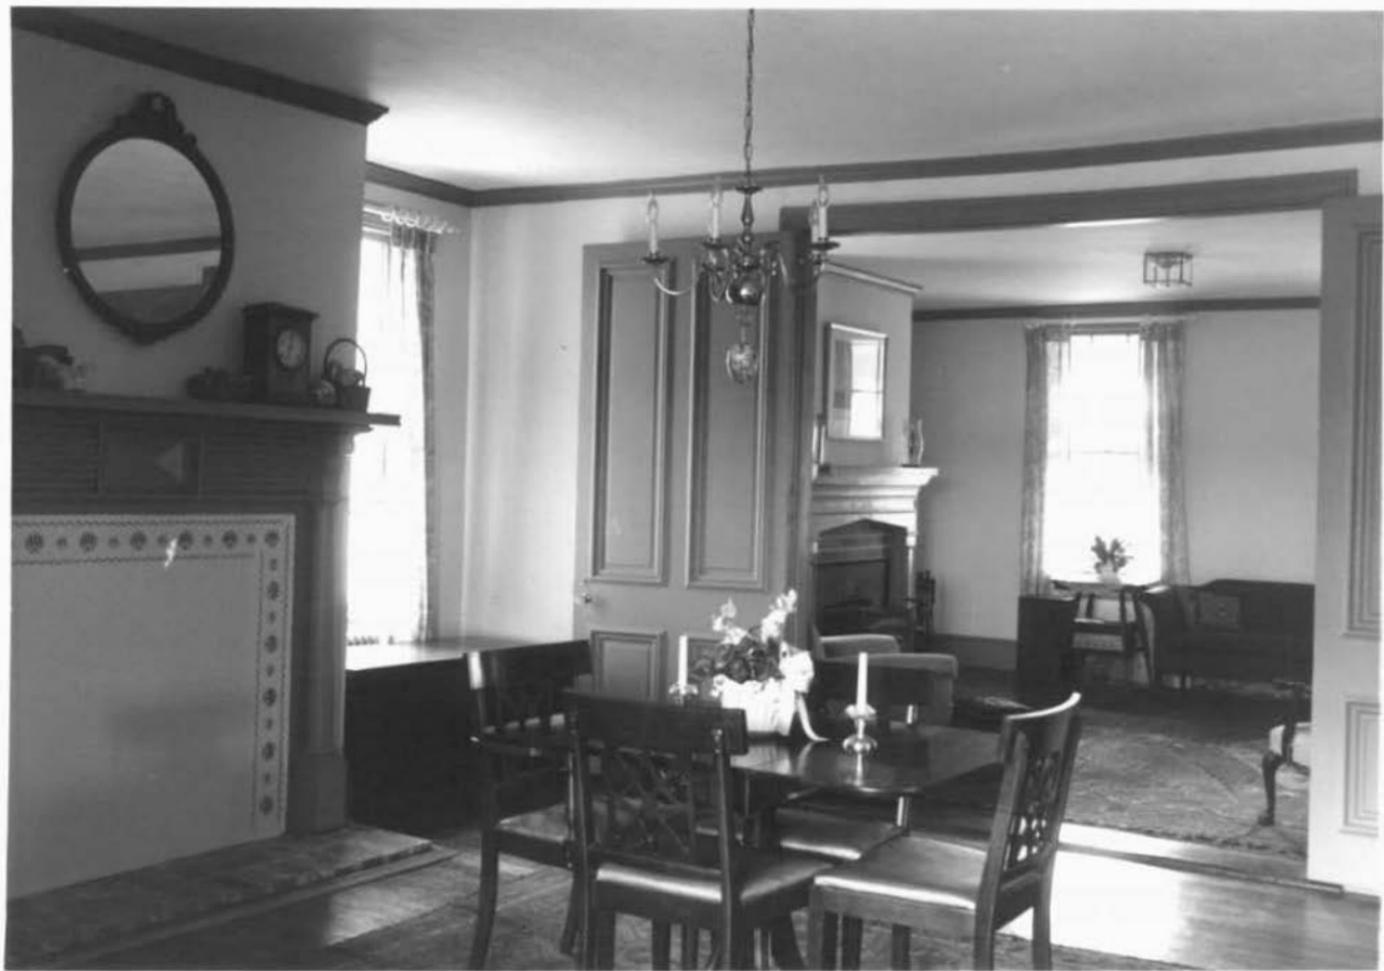
P.G.#87B-8a

Old St. Mary's Rectory
Aquasco, Prince George's County, MD
Marina King
April 1986
Dining room and west parlor
Neg: MD Hist. Trust, Annapolis, MD

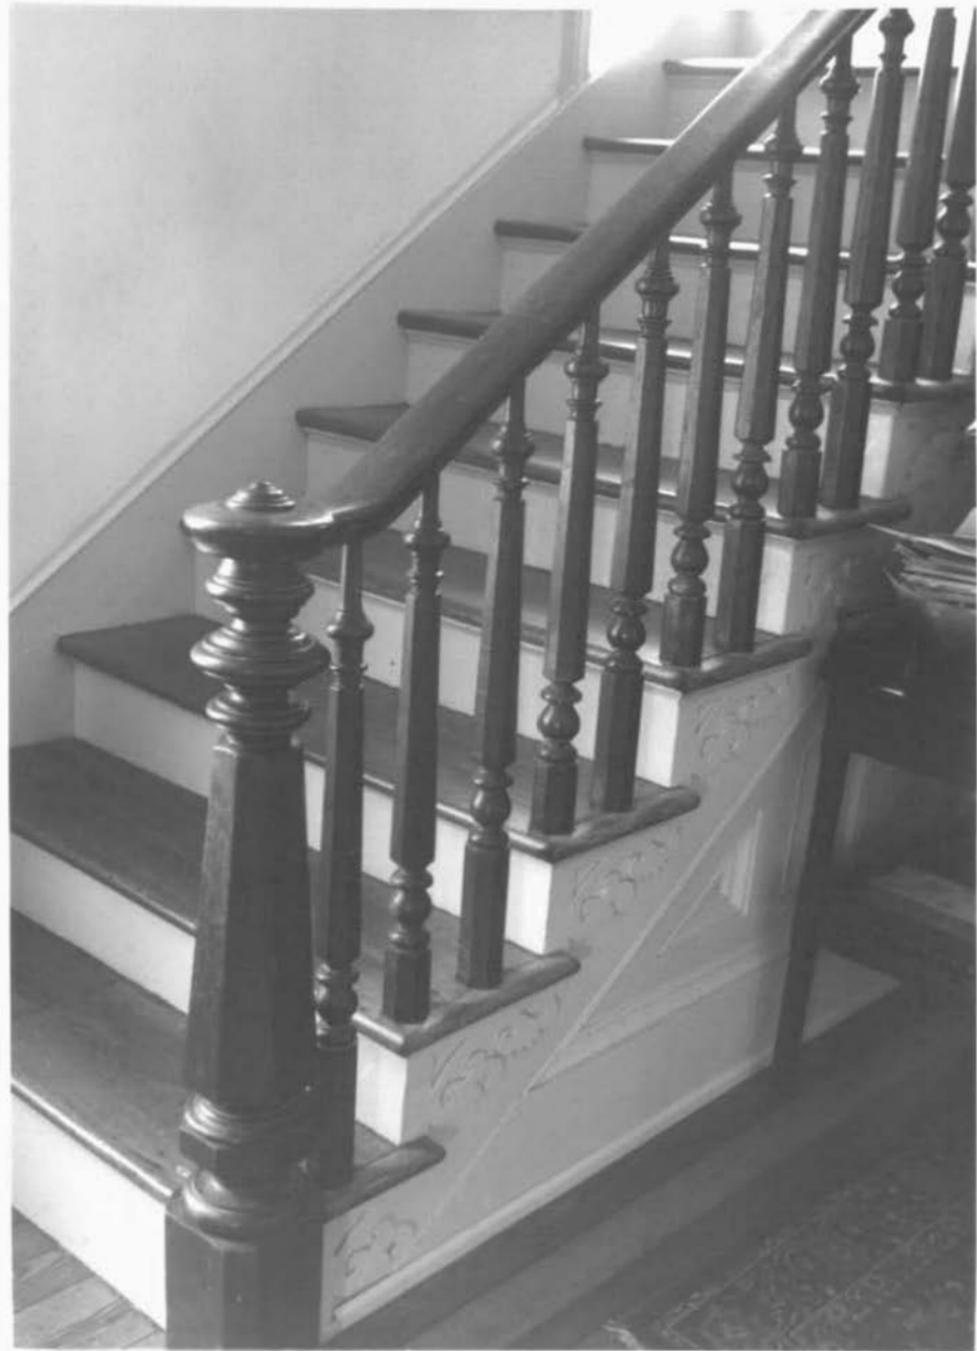
P.G.#87B-8a

Old St. Mary's Rectory
Aquasco, Prince George's County, MD
Marina King
April 1986
Newel post and stair
Neg: MD Hist. Trust, Annapolis, MD

The open string stair rises along the north wall of the hall, crossing the northeast, first level window. The lower portion of the window lights a closet beneath the stair. A stair landing crosses the east end of the hall. The stair turns 90° and there is a second run along the south wall, to the second story. The stair continues to the finished third level. It has decorative bracketed stair ends and tapering turned balusters with an octagonal center section. The newel post is turned, has an octagonal center section and a round flat newel cap with a raised central bull's eye. The spandrel has inset vertical rectangular paneling.

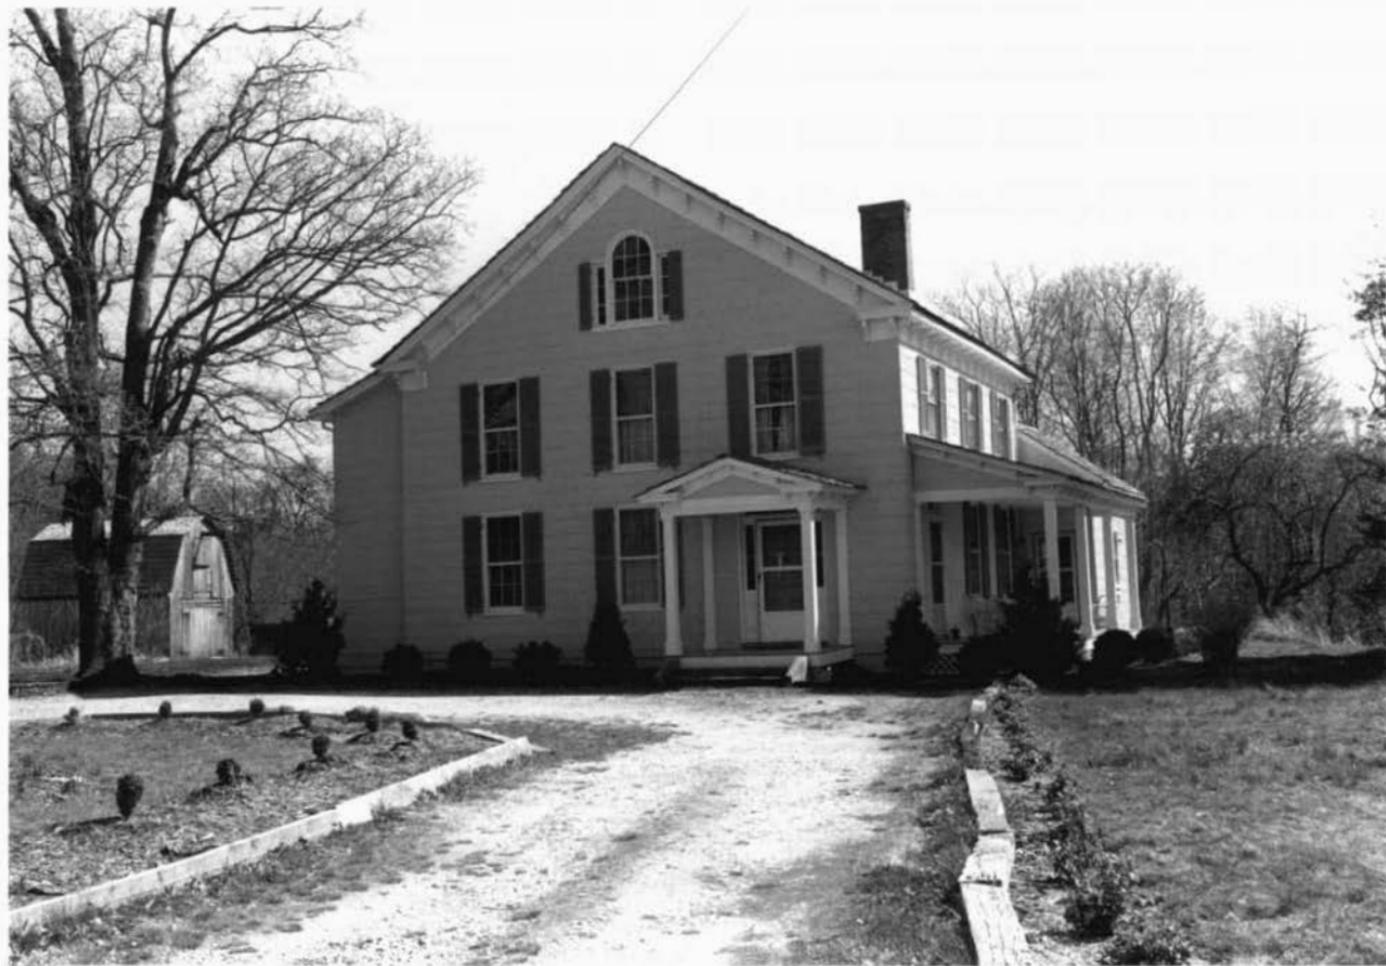
P.G. #87 B-8

St. Mary's Rectory
Prince George's County, MD.
Marina King
April 1985
North elevation
Neg: Md. Hist. Trust, Annapolis, MD.

The old rectory of Saint Mary's Church is now a private residence. It is situated on a town lot, directly south of St. Mary's Church Road. The church is west of the house, just visible across a wooded lot. The house is a large two-and-one-half story gable roof frame structure with a rectangular plan to which additions have been made. It is covered with wood shingle siding and rests on a cement foundation.

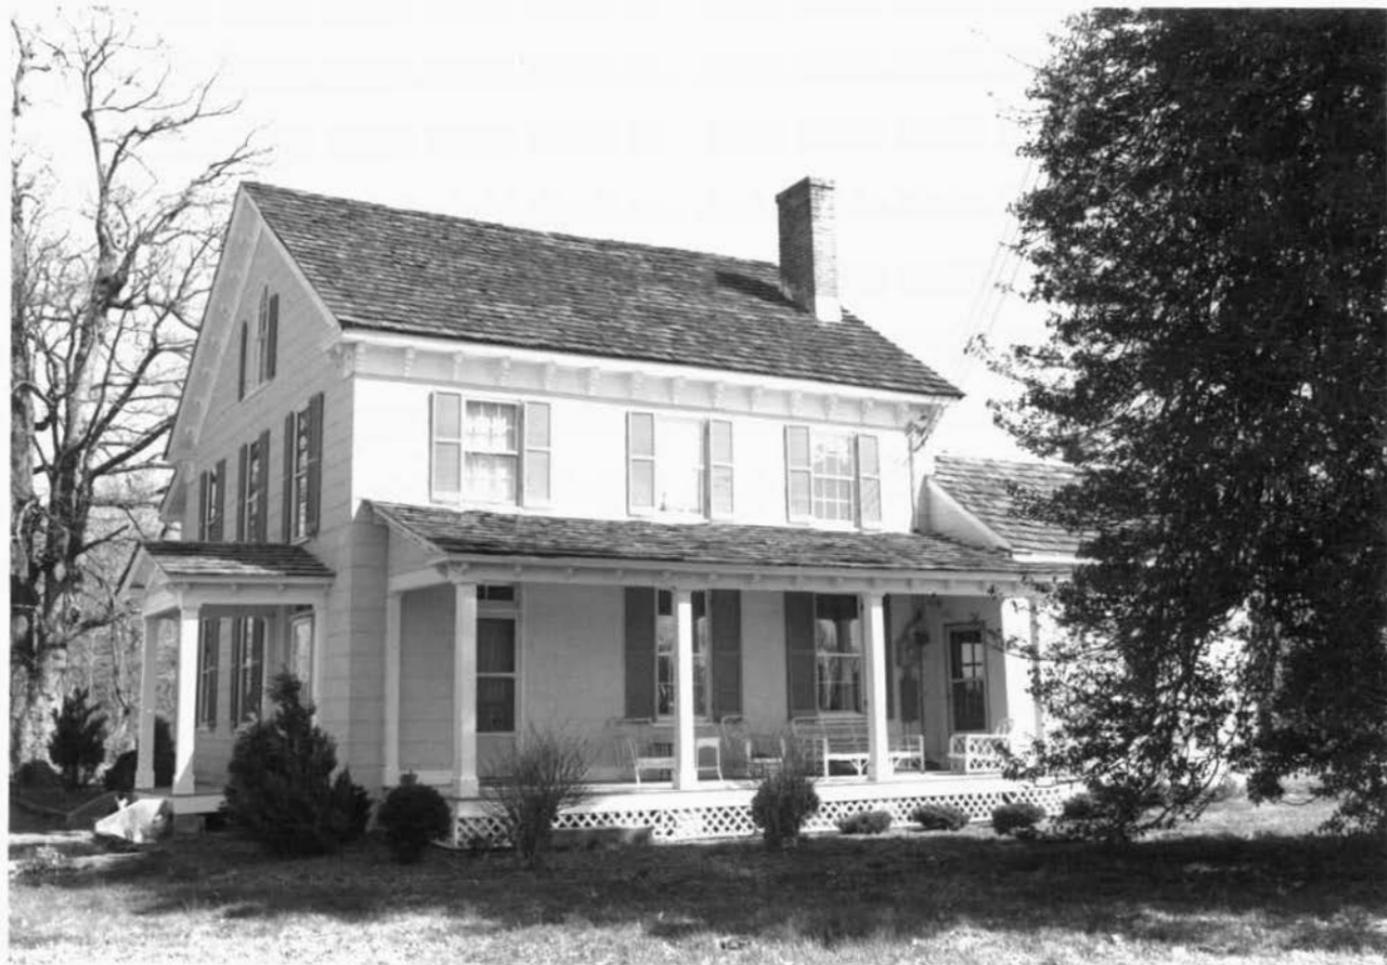
P.G. #87 B-8

St. Mary's Rectory
Prince George's County, MD.
Marina King
April 1985
East elevation
Neg: Md. Hist. Trust, Annapolis, MD.

The east facade of the old rectory is five bays. It is a complex facade due to three separate additions. The first two bays are in the two story southeast addition. It has a two bay porch with a shallow hip roof. There is a one story, two bay addition across the center of the facade and a two story, one bay addition on the north east corner of the facade. All additions have simple boxed cornices with crown molding, wood shingle roof and rest on cement block foundations.
