National Register of Historic Places Registration Form

historic name Lexon
other names/site number Burris-Brockmeyer Farm OA-107

street & number Corsica Neck Road N/A not for publication
city, town Centreville vicinity
state Maryland code MD county Queen Anne's code 035 zip code 21617

Lexon is a third quarter eighteenth century two story brick house with a gable roof, center passage single pile plan, and Federal and Greek Revival interior decorative detailing resulting from changes in the first half of the nineteenth century. The house stands on the south side of Corsica Road with a string of twentieth century domestic and agricultural outbuildings lined perpendicular to the south of the house. Reoriented in the first half of the nineteenth century, the present facade or north elevation, asymmetrical in arrangement, was the original back elevation. The structure has simple brick details; a square section water table, jack arches, and no belt course. The interior of the first floor and the east room on the second floor have Federal and Greek Revival mantels, stairs, and decorative detailing. The west side of the second floor has one paneled chimney wall dating from the first peri

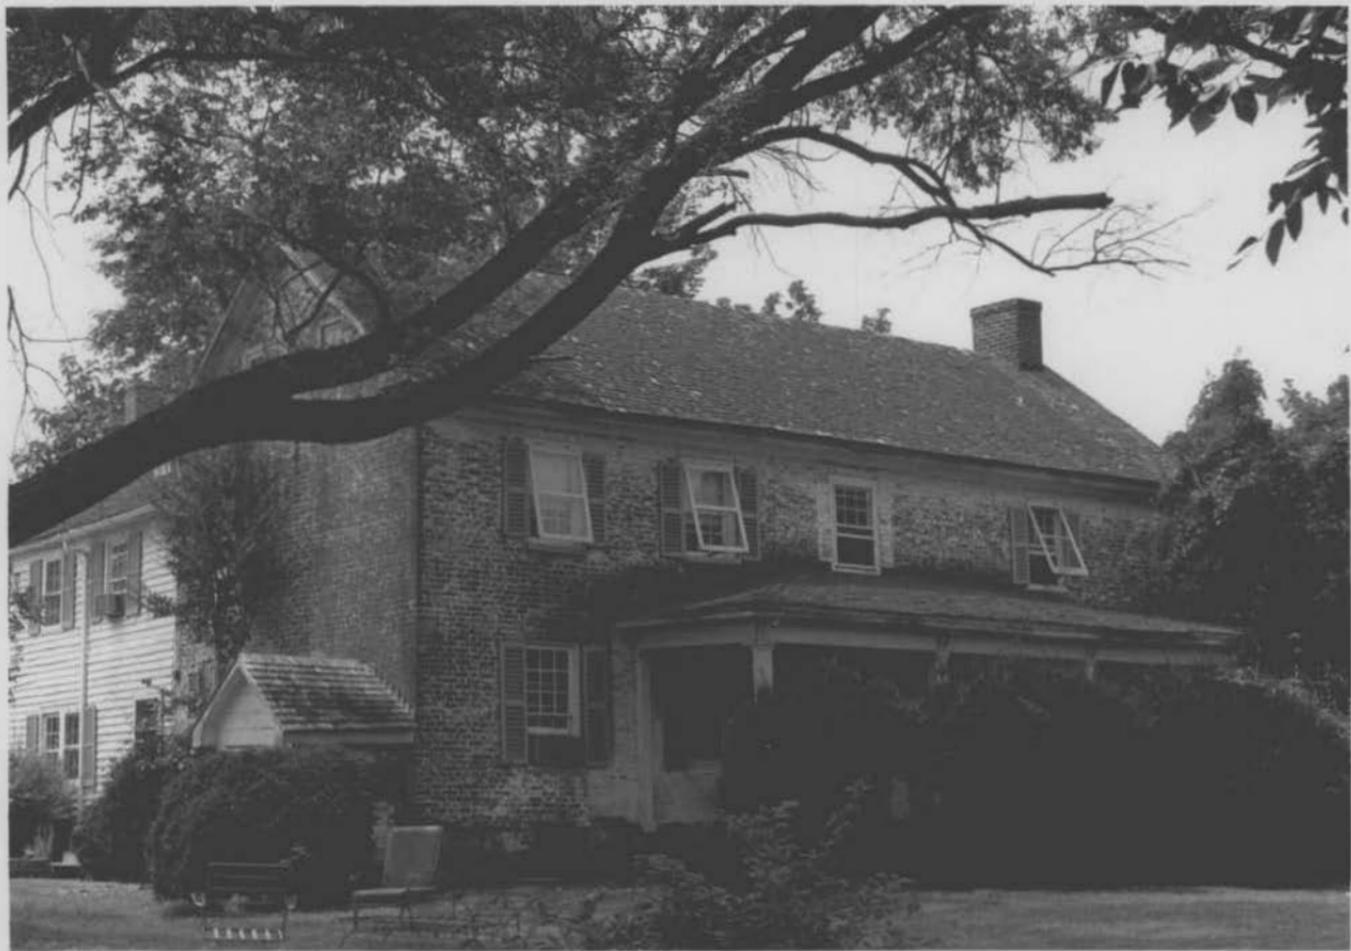
1/8

N.E. elevations

The north facade, which is now the front facade, faces the road. It is of Flemish bond above a plain water table. The door which is in the center bay has no transom. Two 9/6 windows are to the left of the door and one is to the right so the fenestration is not balanced. All have rowlock lintels. The same pattern exists on the second story with 6/6 lights and rowlock lintels. The center window is not downset. The cornice and roof are the same. A one-story late nineteenth century porch with chamfered posts and small double brackets below soffit, above each post, stops 7-8 degrees from each gable end. Of particular interest are surviving early louvered shutters with very wide beveled louvers set in pegged wooden frames. These are the first recorded example in Queen Anne's County and may be original, but certainly are early 19th century. Two cellar windows flank the door.

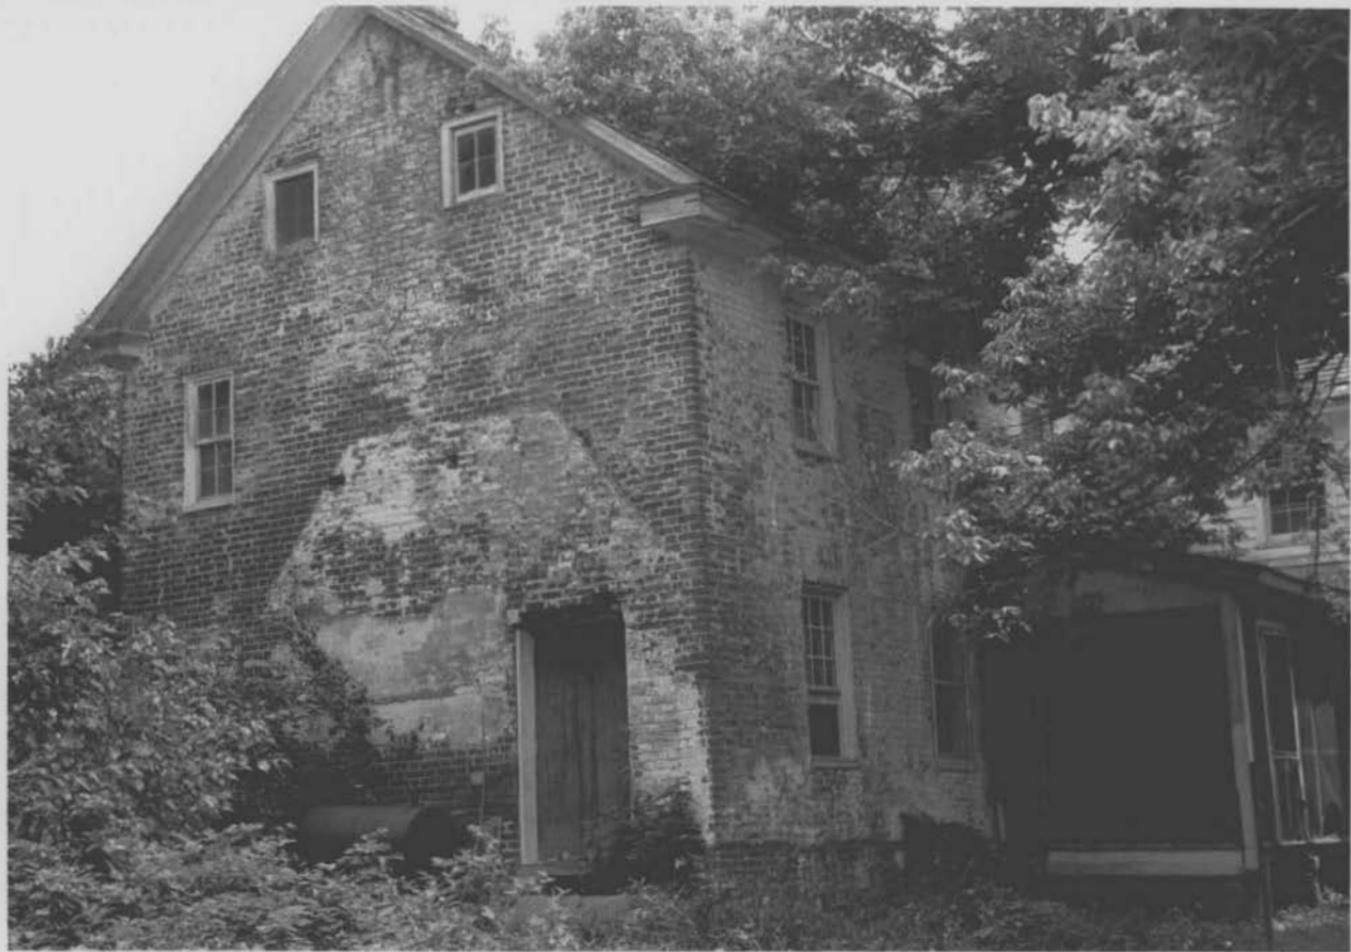
3/8

S.W. elevations

Lexon is a two story brick house with a two story frame ell built late in the nineteenth century covering one third of the south facade. This was originally the front facade, however the house was reoriented in the first half of the nineteenth century to face the county road to the north. A large, six-panel door with a three-light transom occupies the center bay. There are two 9/6 windows to the left of the door and one window close-set to the right between the door and the wall of the wing. This window was evidently cut in when the wing was added. The same fenestration pattern exists on the second floor with 6/6 lights. There is one cellar window in the second bay from the west. First floor windows have splayed jack arches, one which is brick, with row-lock course below suggesting that the windows were possibly taller originally, but not necessarily.

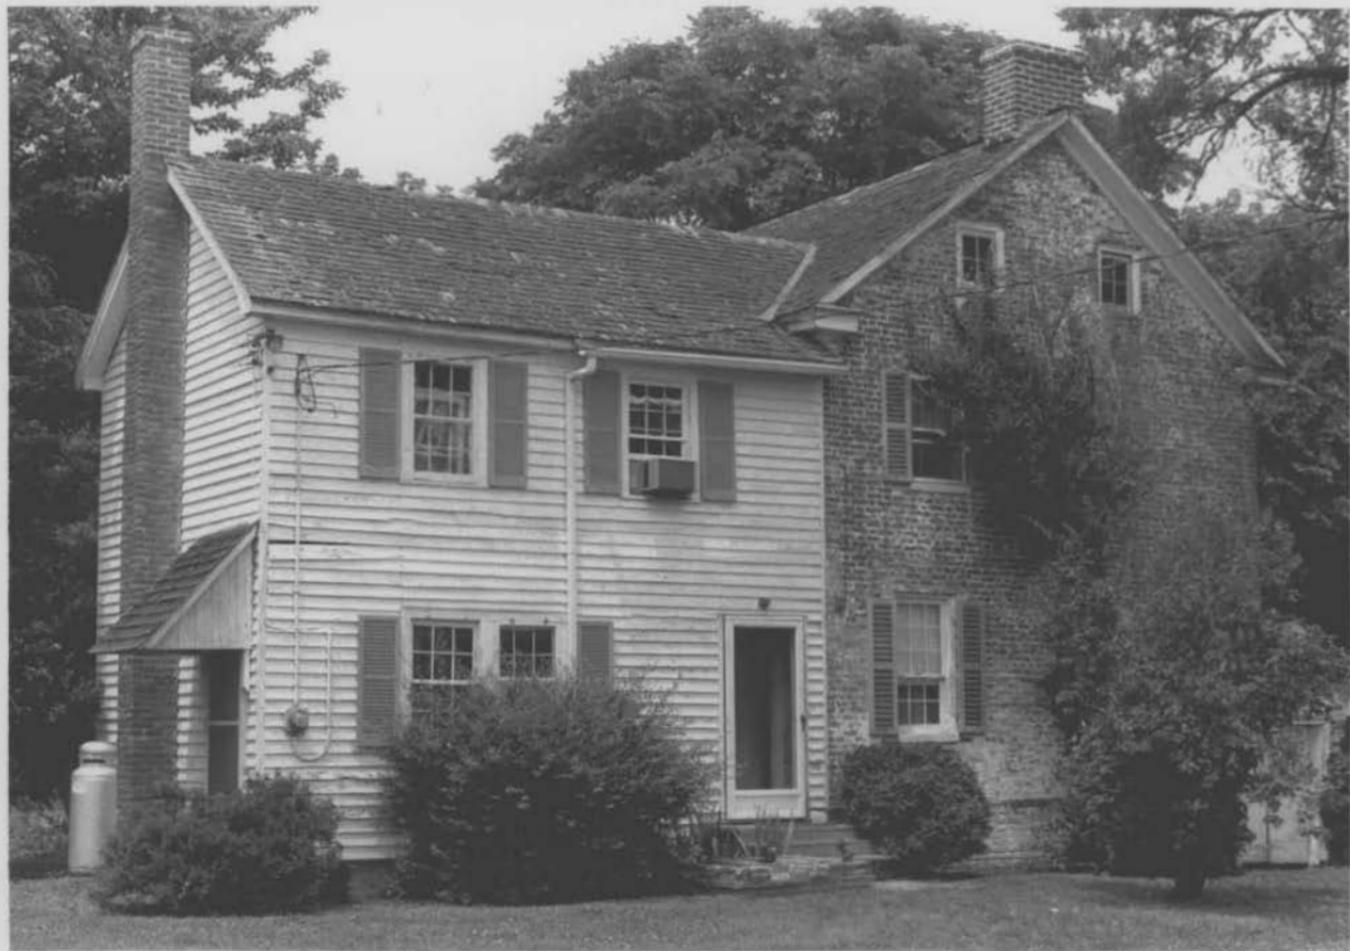
2/8

S.E. elevation

The east gable has the same brick work and cornice and has a water table. There is one 9/6 window in the south bay on the first floor, one 6/6 window on the second floor. A pair of 4 light attic windows flank the flush chimney. A bulkhead cellar exterior entrance is at the north end of the gable. First and second floor windows are fitted with the same shutters but the openings may not be original. Lintels have been rebuilt but the joints are concealed by bolted shutters. The cellar entrance is covered by a brick gable roofed shed of common bond which is not bonded to main wall but appears to be from the first quarter of the 19th century. Its doors are beaded batten. The gable siding is beaded and secured with double struck nails. The cornice has been rebuilt to match the house.

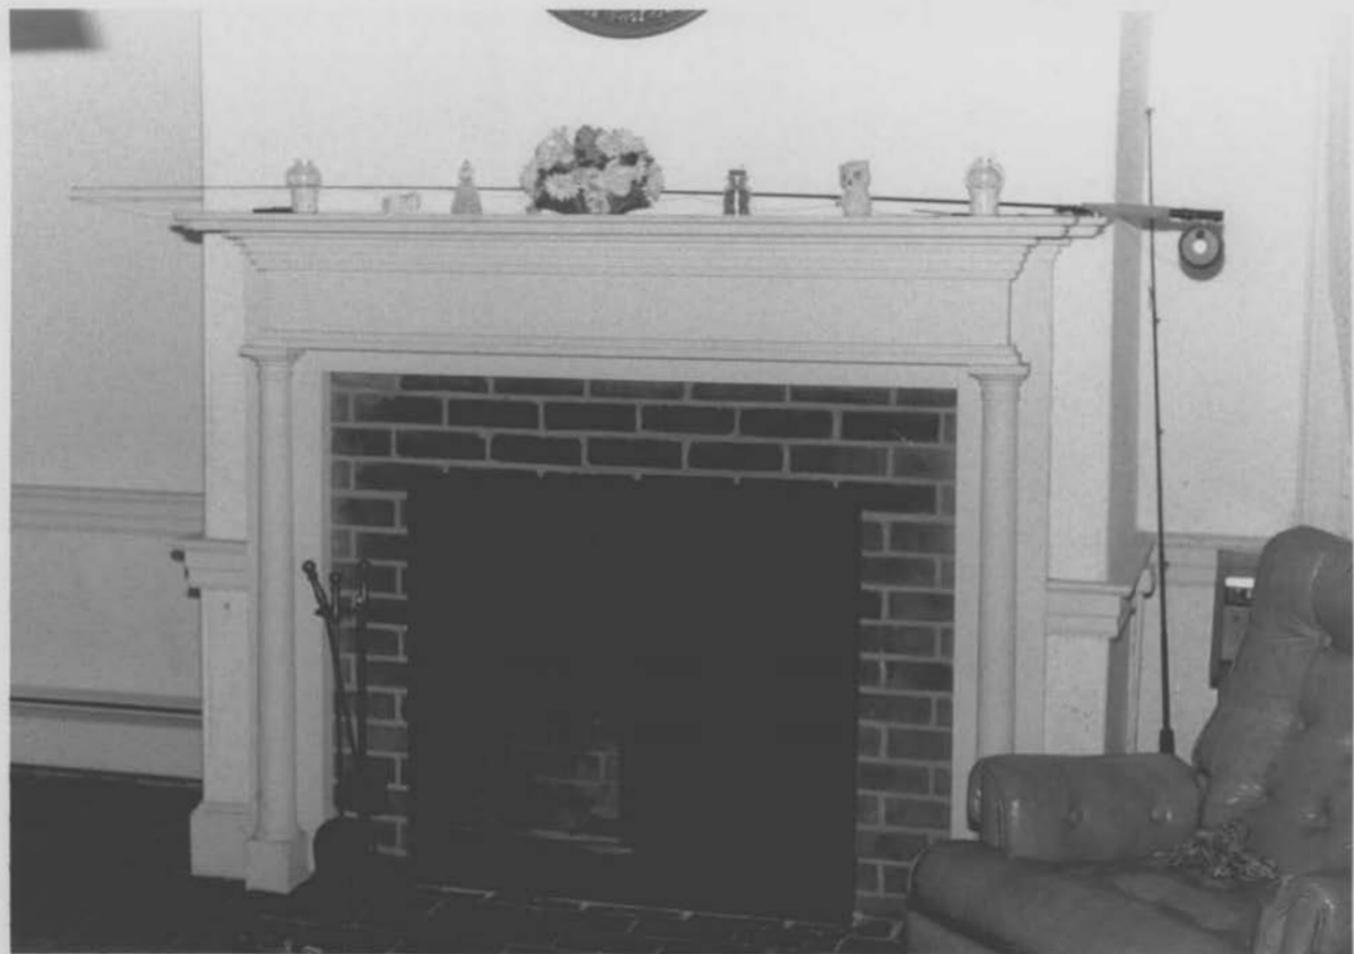
4/8

First Floor east parlor mantel

The east parlor is slightly larger than the west parlor. The fireplace is centered on the gable wall. A large Federal mantel survives. Plain board surround with plain Doric columns support a plain frieze with band of molding below, and a very heavily molded shelf. There are no blocks; the shelf breaks back about 1 1/2 inches from each end. The mantel is actually more Greek; the columns and moldings are dominated by three different Greek profiles. Molded baseboard and chairrail are the same as in the hall. The windows have splayed jambs but are not paneled. The sash is set in beaded and channeled frames. The architrave is in Federal cove/astragal, against beaded fascia.

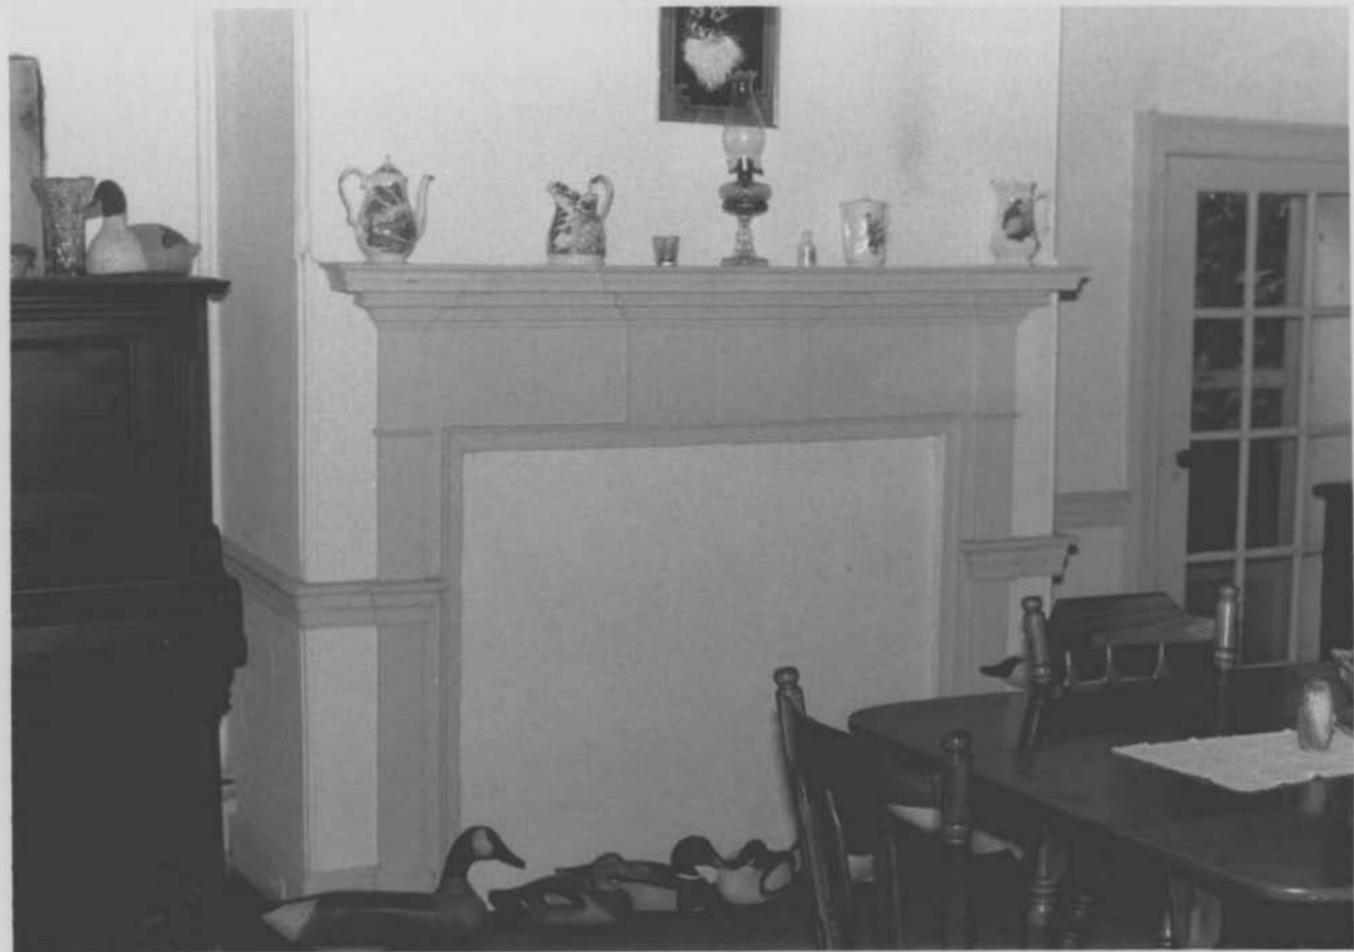
5/8

First Floor west parlor mantel

The west parlor also has a centered fireplace with Federal mantel, board surround with plain pilasters, side and center blocks, and plain frieze. The molding sets off the opening and the shelf is heavily molded which breaks forward above all three blocks. Chairrail and baseboard are the same as the rest of the first floor, but the chairrail on the north wall is solid field, still with the same shelf and astragal. Window architraves on the south wall are cove/astragal. The window on the north wall has ogee/astragal that matches the door architrave to the right of the fireplace. The blocked door is to the left of the fireplace but the chairrail crosses the opening, so the door must have been blocked in the second quarter of the 19th century.

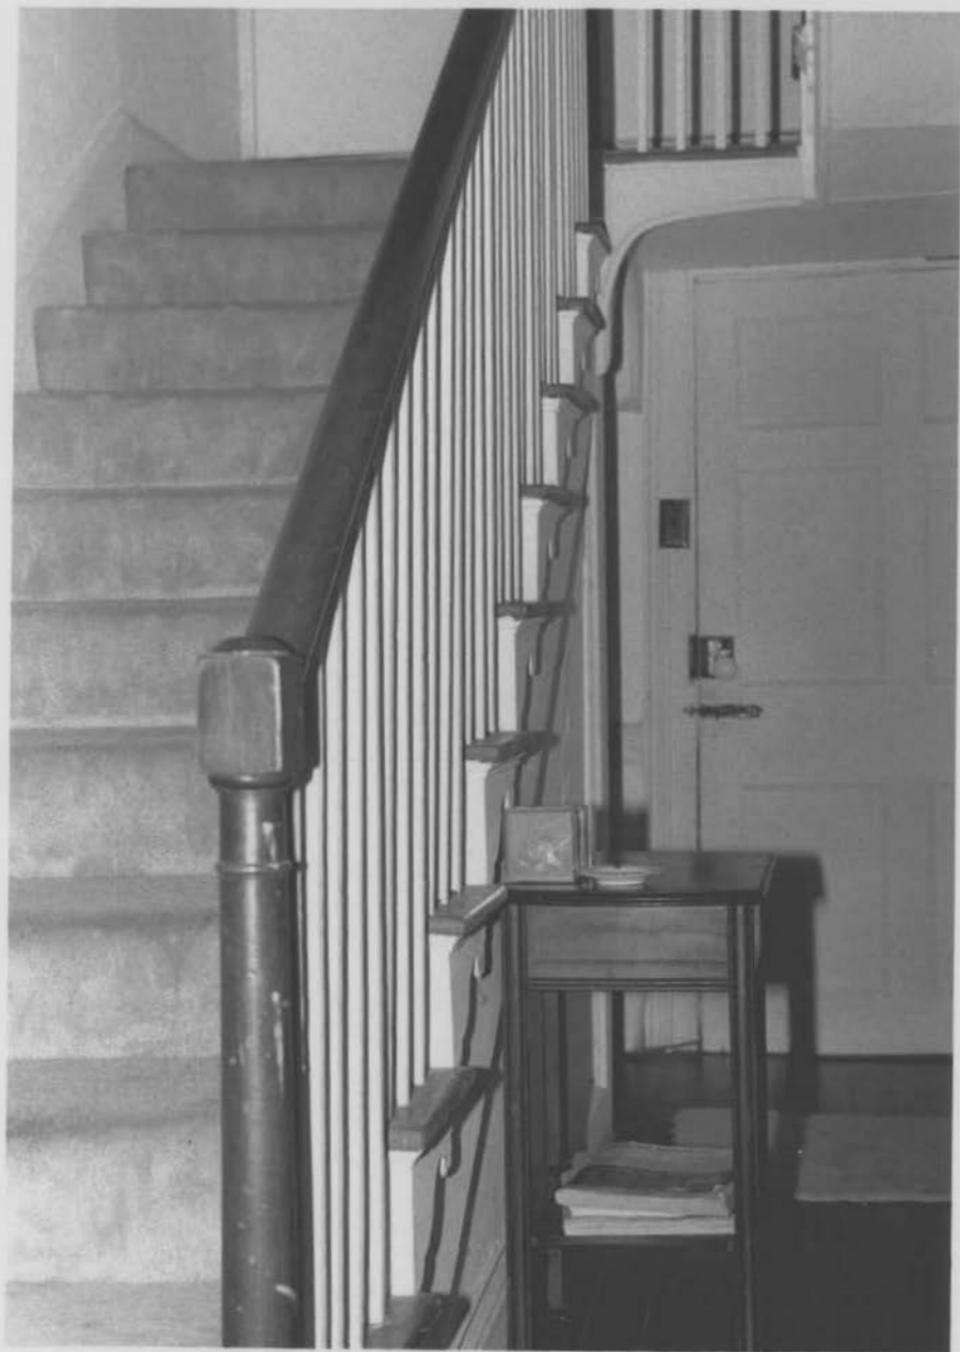
6/8

First Floor staircase

The interior has a first floor, center hall plan with single nicely proportioned parlors on either side. The stair hall is slightly wider than usual and has an open string stair rising against the west wall. The newels are delicately turned with a simple block cap. The rail is molded and the ballusters are square with a very fine bead on each corner. There are scrolled solid brackets on beaded carriage and plaster panel below. The baseboard is molded. The very fine, six-paneled door on the north end of the hall has boldly raised panels (late 18th century or earlier) and ogee panel molds.

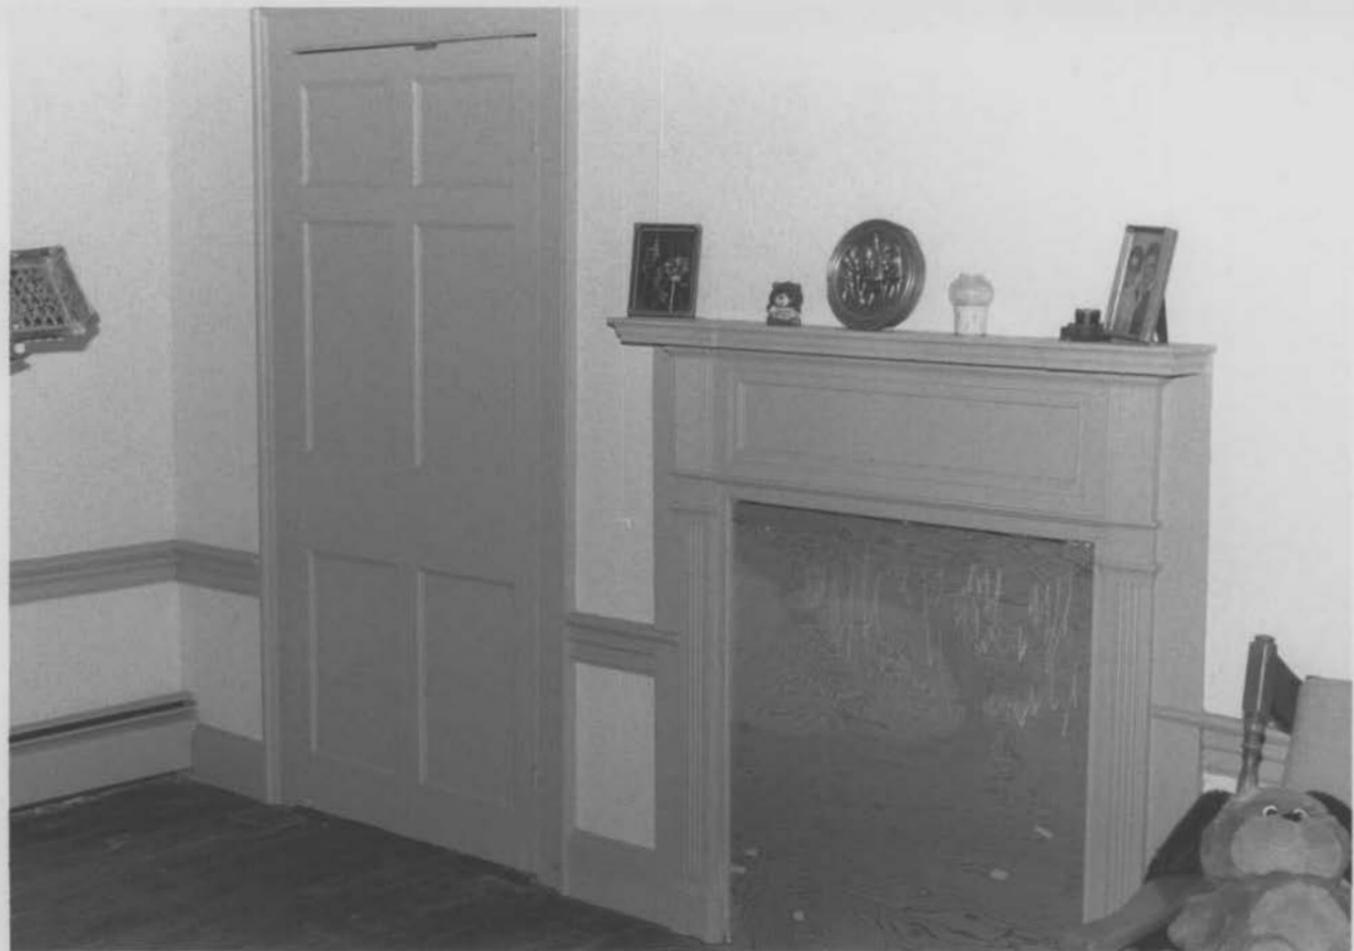
7/8

2nd Floor, east chamber mantel

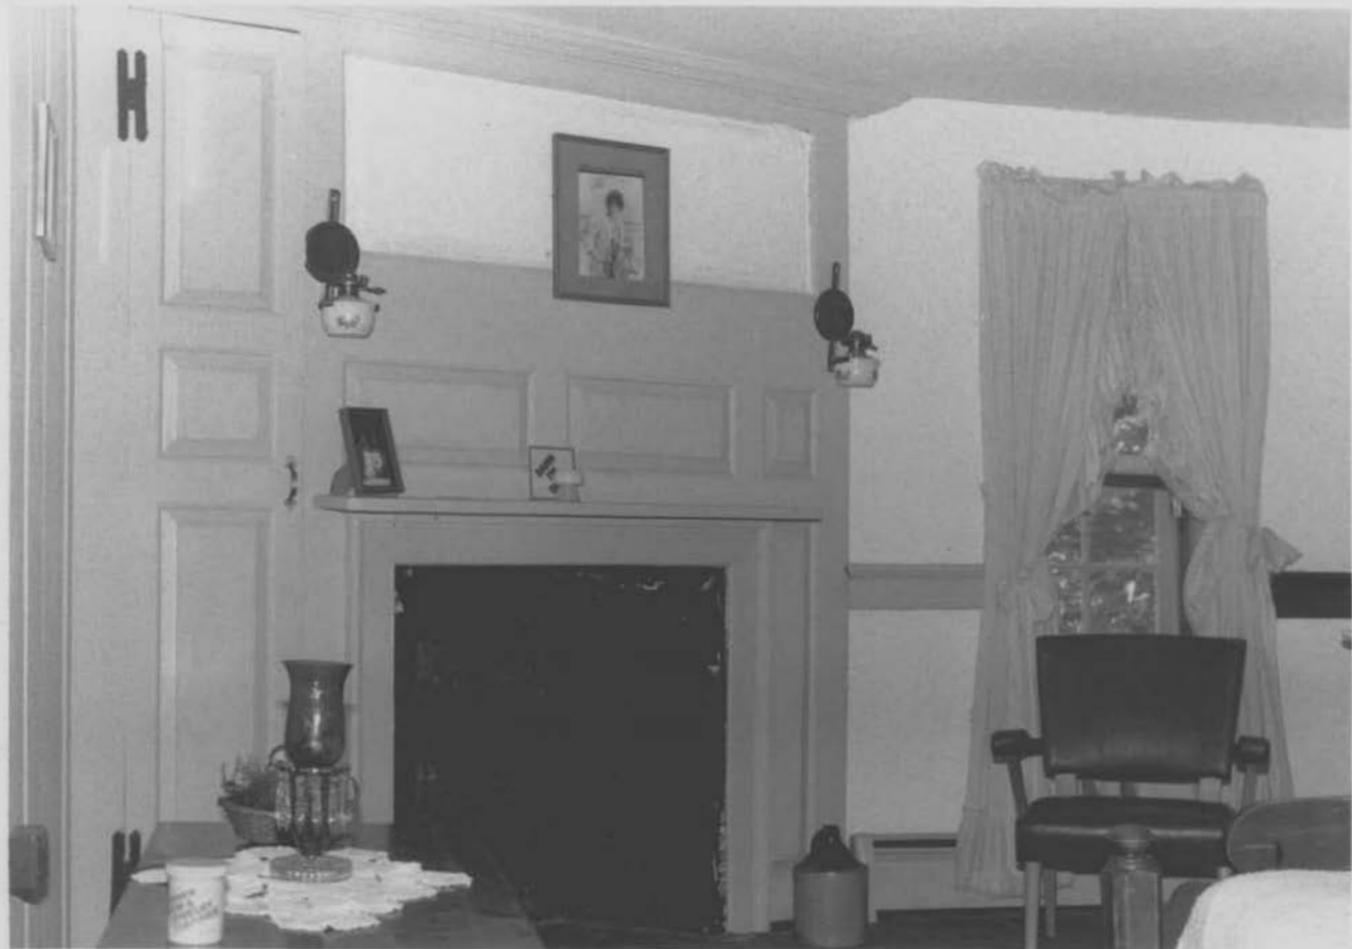
8/8

2nd Floor, N.W. Chamber mantle
and paneled wall.

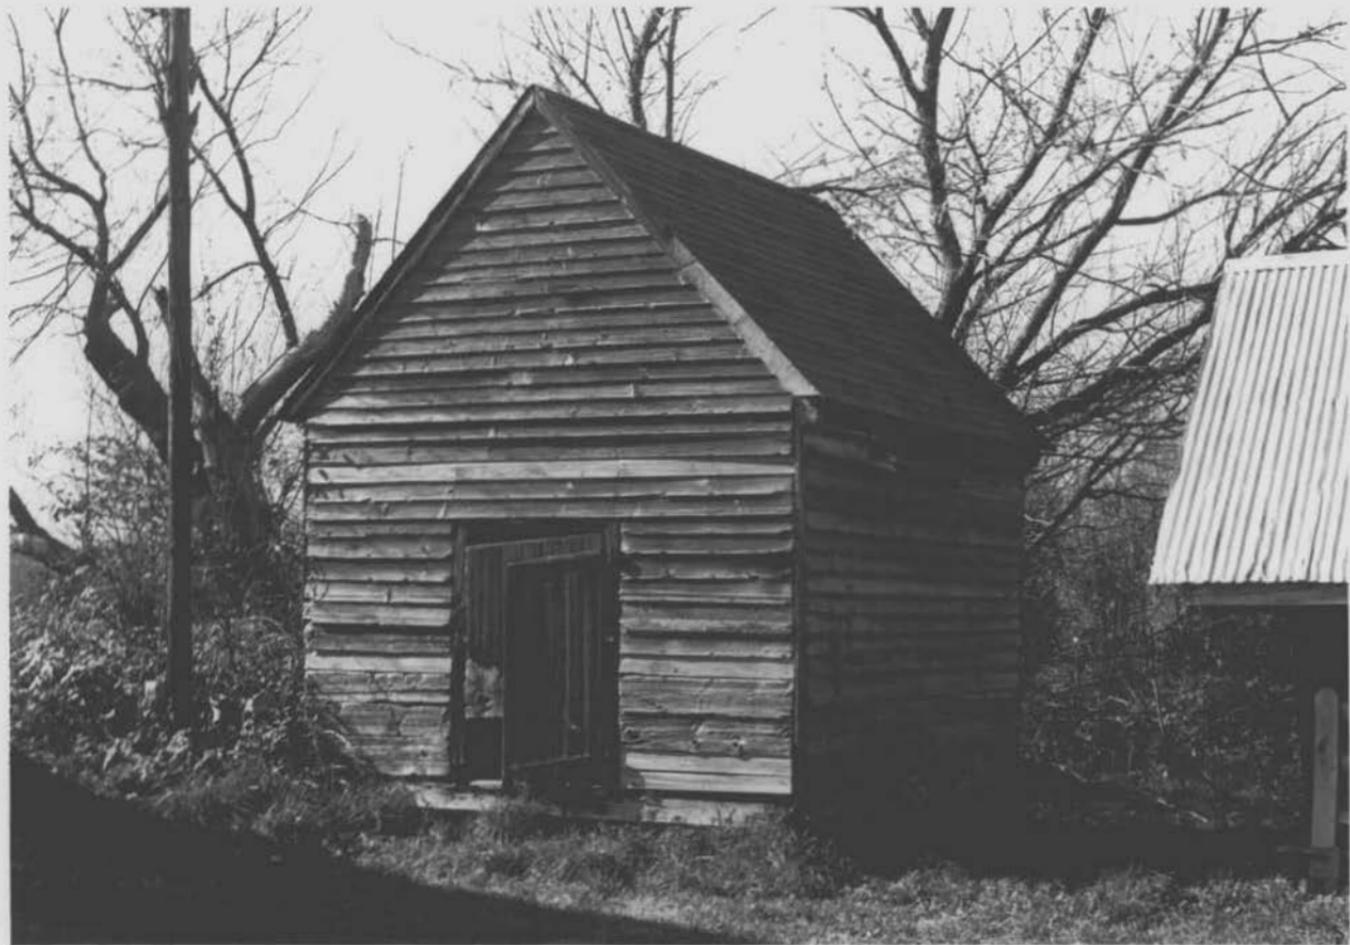
Frame meat house

The meat house is of heavy timber frame construction, measures 12 feet deep and 14 feet long, with steeply pitched gable roof. The building rests on L-plan brick piers and is covered with plain horizontal siding secured with mature machine nails. The only opening is a door centered on the east gable. This door is the most distinctive feature of the building. It is constructed of vertical boards (probably originally beaded but now heavily weathered) on the exterior face secured to horizontal boards on the interior face with dozens of hand-wrought nails placed in a decorative pattern. The door is hung on hand-wrought strap hinges and is set in a beaded frame. Beaded corner boards and beaded and tapered rakeboards provide additional decorative elements to the building.

The interior of the building was modified sometime after about 1885 to accommodate grain storage. Horizontal boards were nailed to the interior face of the wall framing with wire nails to permit loose storage of grain. The original use of the building is clearly evident, however. The framing is typical of meat houses in this region and the roof includes two sets of collar beams to facilitate hanging meat. The interior walls and roof are blackened with smoke from the curing process. The wood floor appears to be original and there is no clear evidence of how the fire for smoking meat was contained in the building, but most likely a single stove was used as needed.

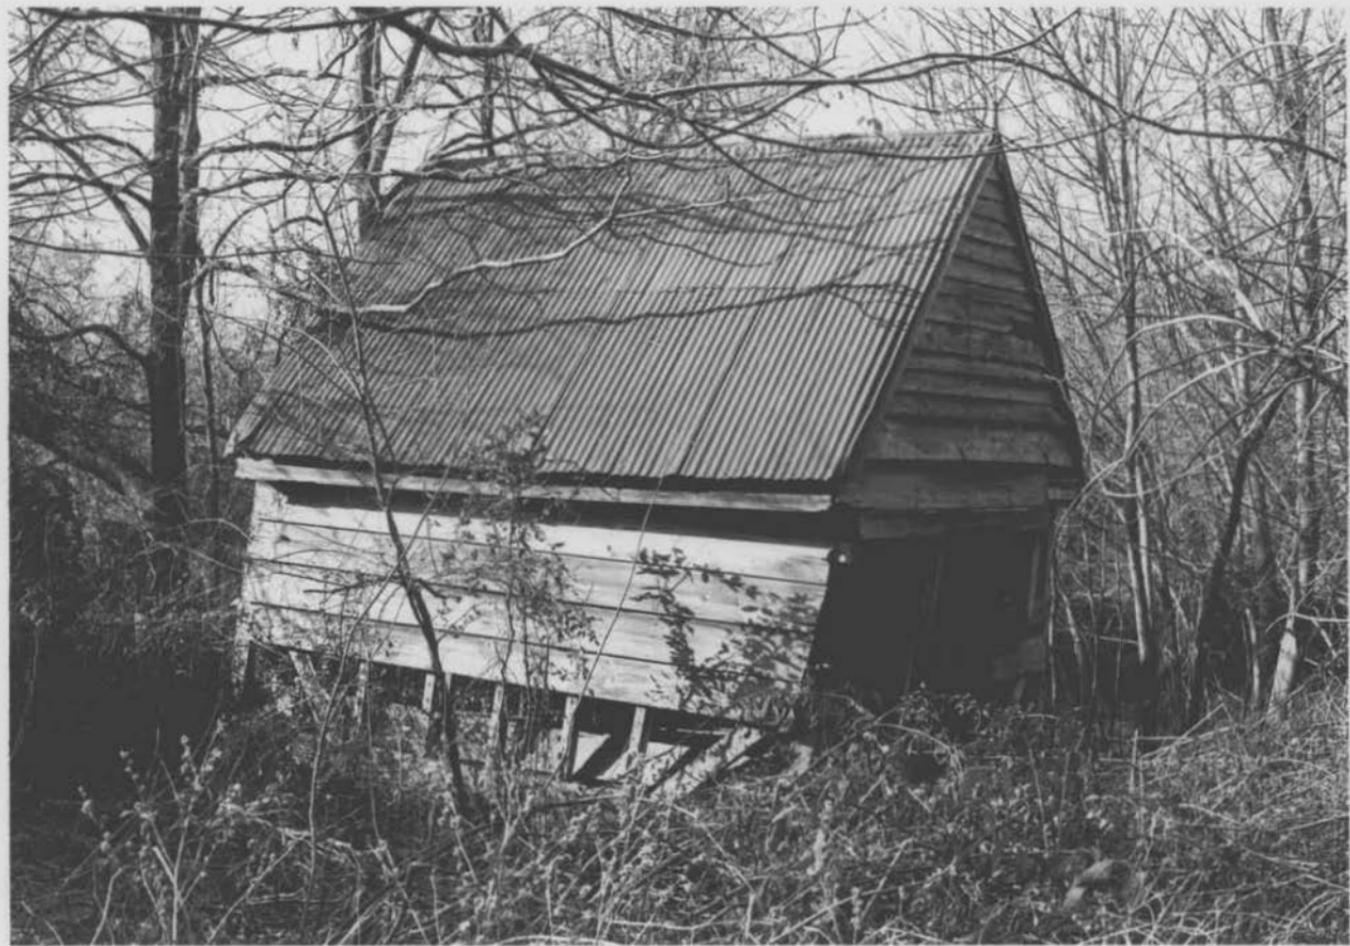
Meat house to west of house

This early 19th century frame meat house was moved to this property at an unknown date earlier in the twentieth century. It is sited in line with an implement shed and a corn house along the west edge of the cultivated land to the southwest of the house.
