QA-110  
Walnut Grove  
Centreville vicinity  
Private

INVENTORY FORM FOR STATE HISTORIC SITES SURVEY

HISTORIC  
Walnut Grove  
AND/OR COMMON

Orlando Ridout V, Historic Sites Surveyor

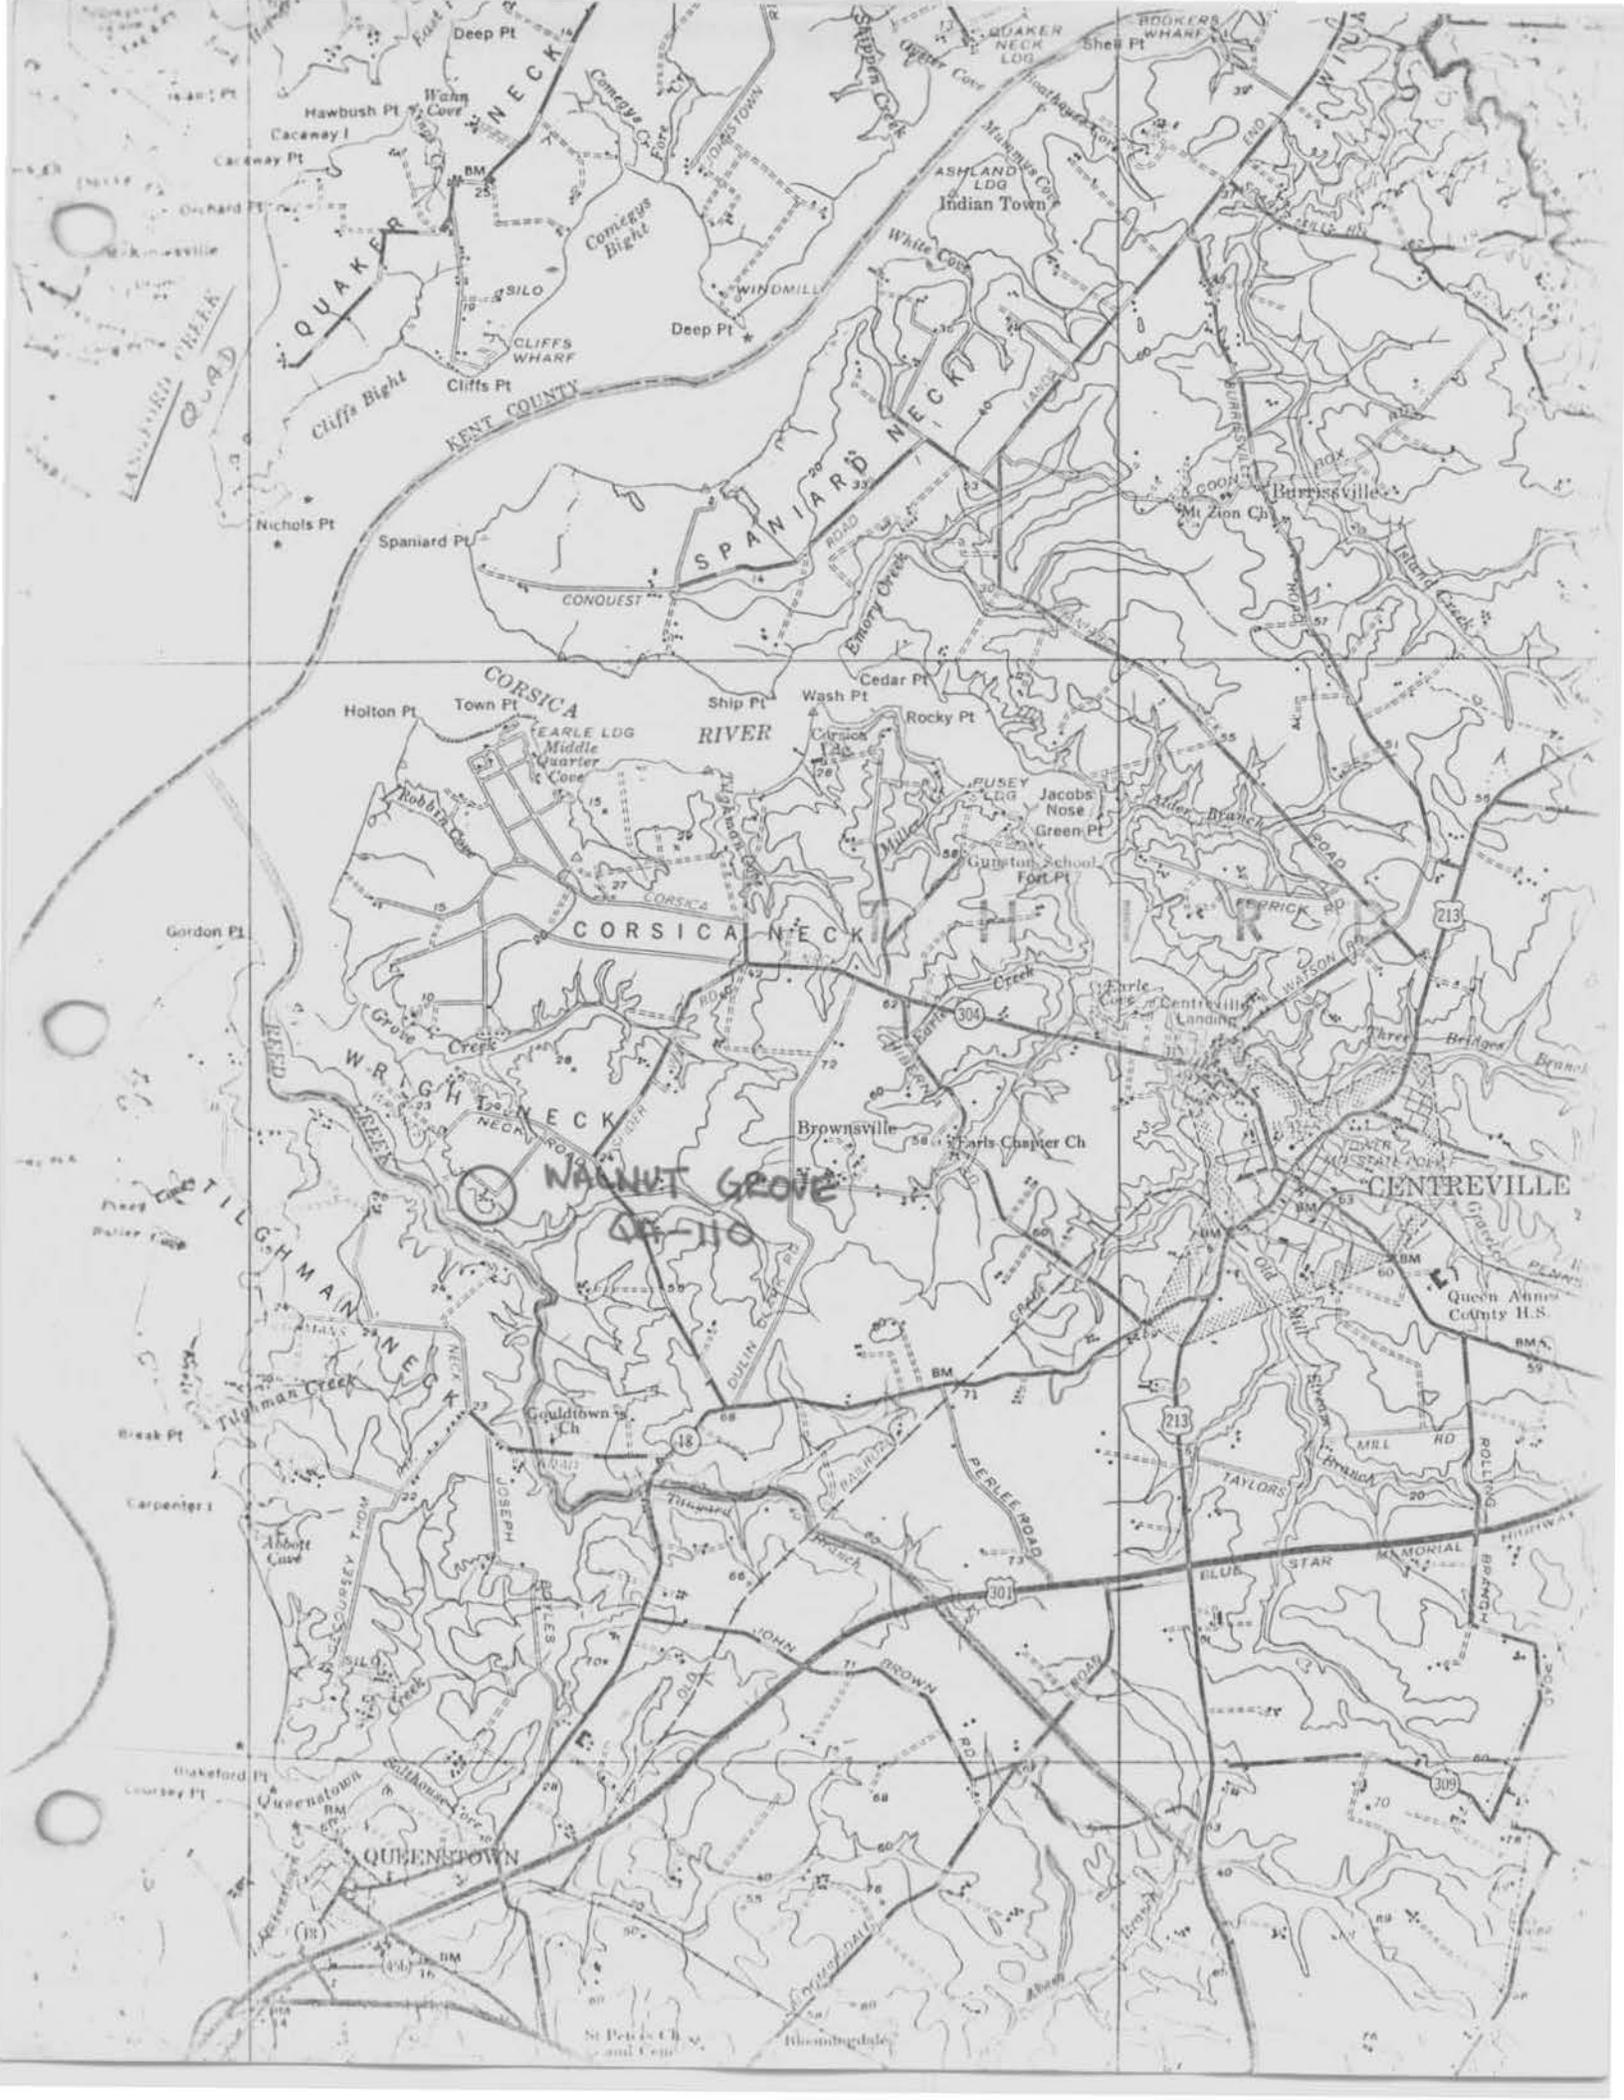
QA-110

WALNUT GROVE  
WRIGHT'S NECK, MARYLAND

JUNE 12, 1978.

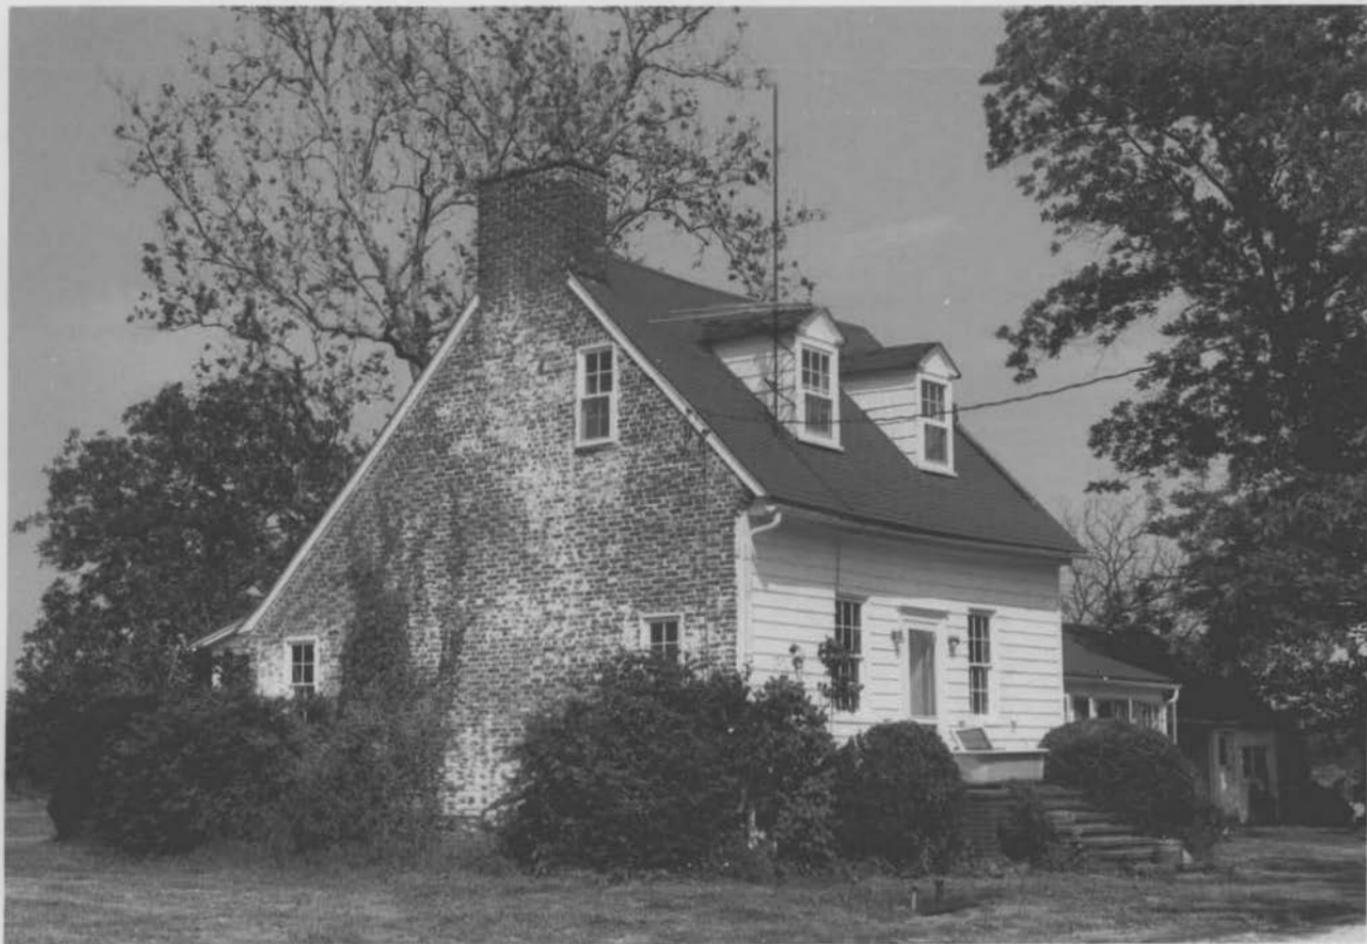
QA-110 Walnut Grove  
Centreville vicinity  
Orlando Ridout V, 1978 (MHT)  
View from west

The principal facade faces southwest, toward Reed's Creek. There is a door in the center bay, flanked by a pair of six-over-six windows. These are shifted toward the central door, rather than falling in a more symmetrically balanced bay system. On the second floor, there are two six-over-six gable roof dormers. The exterior siding is asbestos shingle, while the eave is finished with a box cornice with crown mold and bed mold. The corner boards and rakeboards are modern replacements. The high brick foundation had several repairs and alterations. The westernmost corner has been rebuilt, and the two cellar window openings have

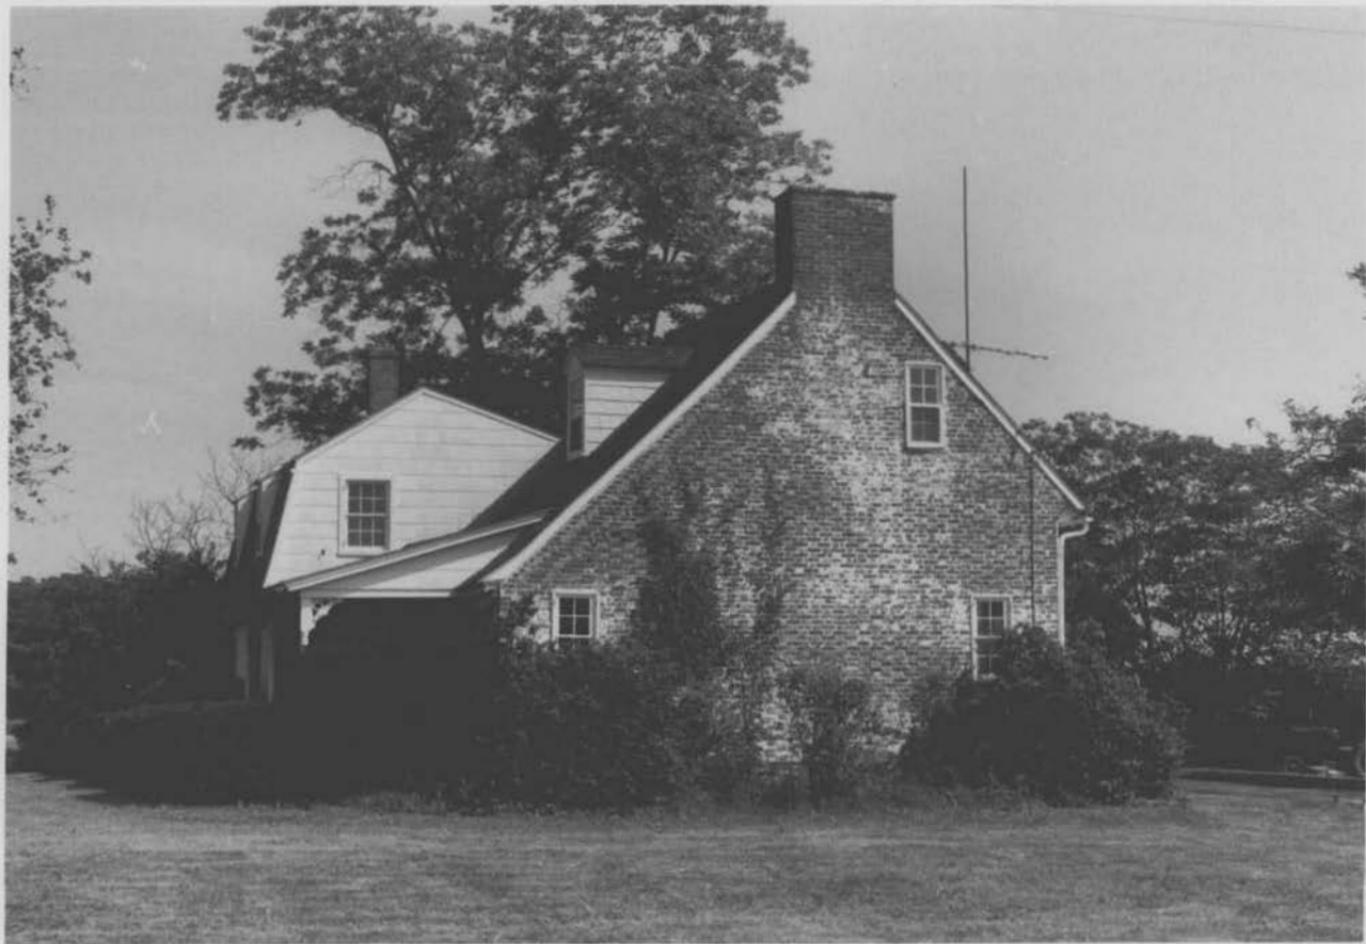
QA-110 Walnut Grove  
Centreville vicinity  
Orlando Ridout V, 1978 (MHT)  
NW gable, camera facing SE

The northwest gable is brick, laid in Flemish bond with random glazed headers throughout and carefully laid glazed chevrons carried up the gable eaves. A single flush chimney at the apex of the roof serves all four of the interior fireplaces. Until recently the chimney cap displayed a plastered band of necking, but the cap is now gone, apparently knocked down in a storm. There are two tall, narrow, four-over-four windows on the first floor, one at each corner. On the second floor, a single four-over-four window is located to the right of the chimney. The lower window openings have queen closers on both jambs and are therefore original. The upper opening has queen closers only on the right jamb. The brickwork is somewhat rough, and it is possible this opening was originally smaller.

The foundation on this wall has also had considerable repair, and it is clear that several courses have been replaced altogether.

Of particular interest on this gable is the treatment of the eaves. The front and rear cornice is terminated

against a corbeled brick stop, quite similar to the eave detail at Pear Valley, an early 18th Century house in Northampton County, Virginia. Also of note is the distinct flare to the rear eave at Walnut Grove.
