**QA-119
Bryan Farm
200 Wye Harbor Drive
Queenstown vicinity
Queen Anne's County**

**Constructed ca. 1848, and ca. 1870
Private**

Maryland Historical Trust Maryland Inventory of Historic Properties Form

Inventory No. QA-119

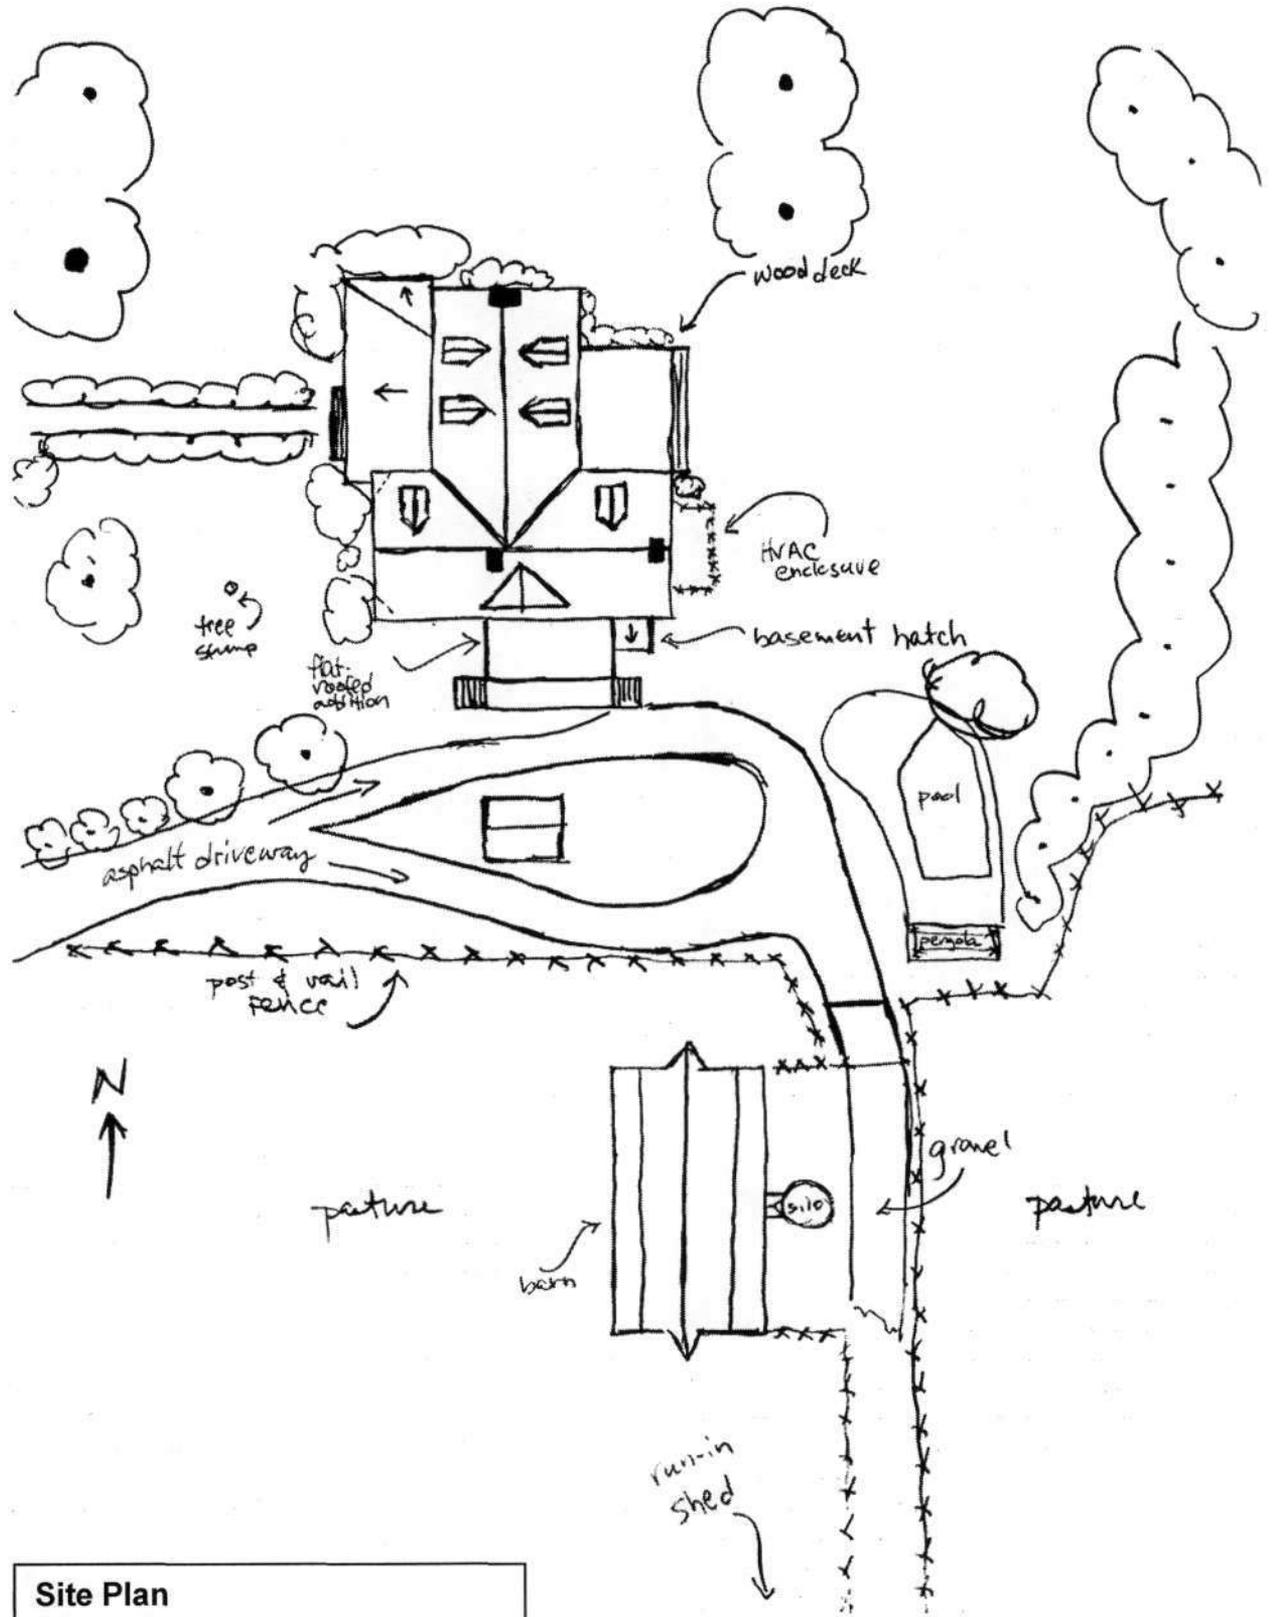
Site Plan
 QA--119
 Bryan Farm
 200 Wye Harbor Drive
 Queenstown vicinity
 Queen Anne's County, Maryland

The sixteen-acre property is located approximately one-quarter mile northeast of Bennett Point Road on the southeast side of Wye Harbor Drive. An asphalt driveway extends north from Wye Harbor Drive, turns east to create a loop around the meathouse located just south of the house, and then turns southeast to become a farm lane to other outbuildings that are surrounded by fenced pastures. A swimming pool lies east of the driveway and southeast of the house. Set on a small rise, the house is located at the highest point on the farm, with the land sloping down to the outbuildings. A grassy yard with scattered mature trees surrounds the house, and a hedge-lined walk provides access from a small parking area west of the house to the entrance in the house's west elevation. The Wye Harbor subdivision, composed of multi-acre lots carved from the historic farm acreage, surrounds the farm and extends to the Wye River on the east.

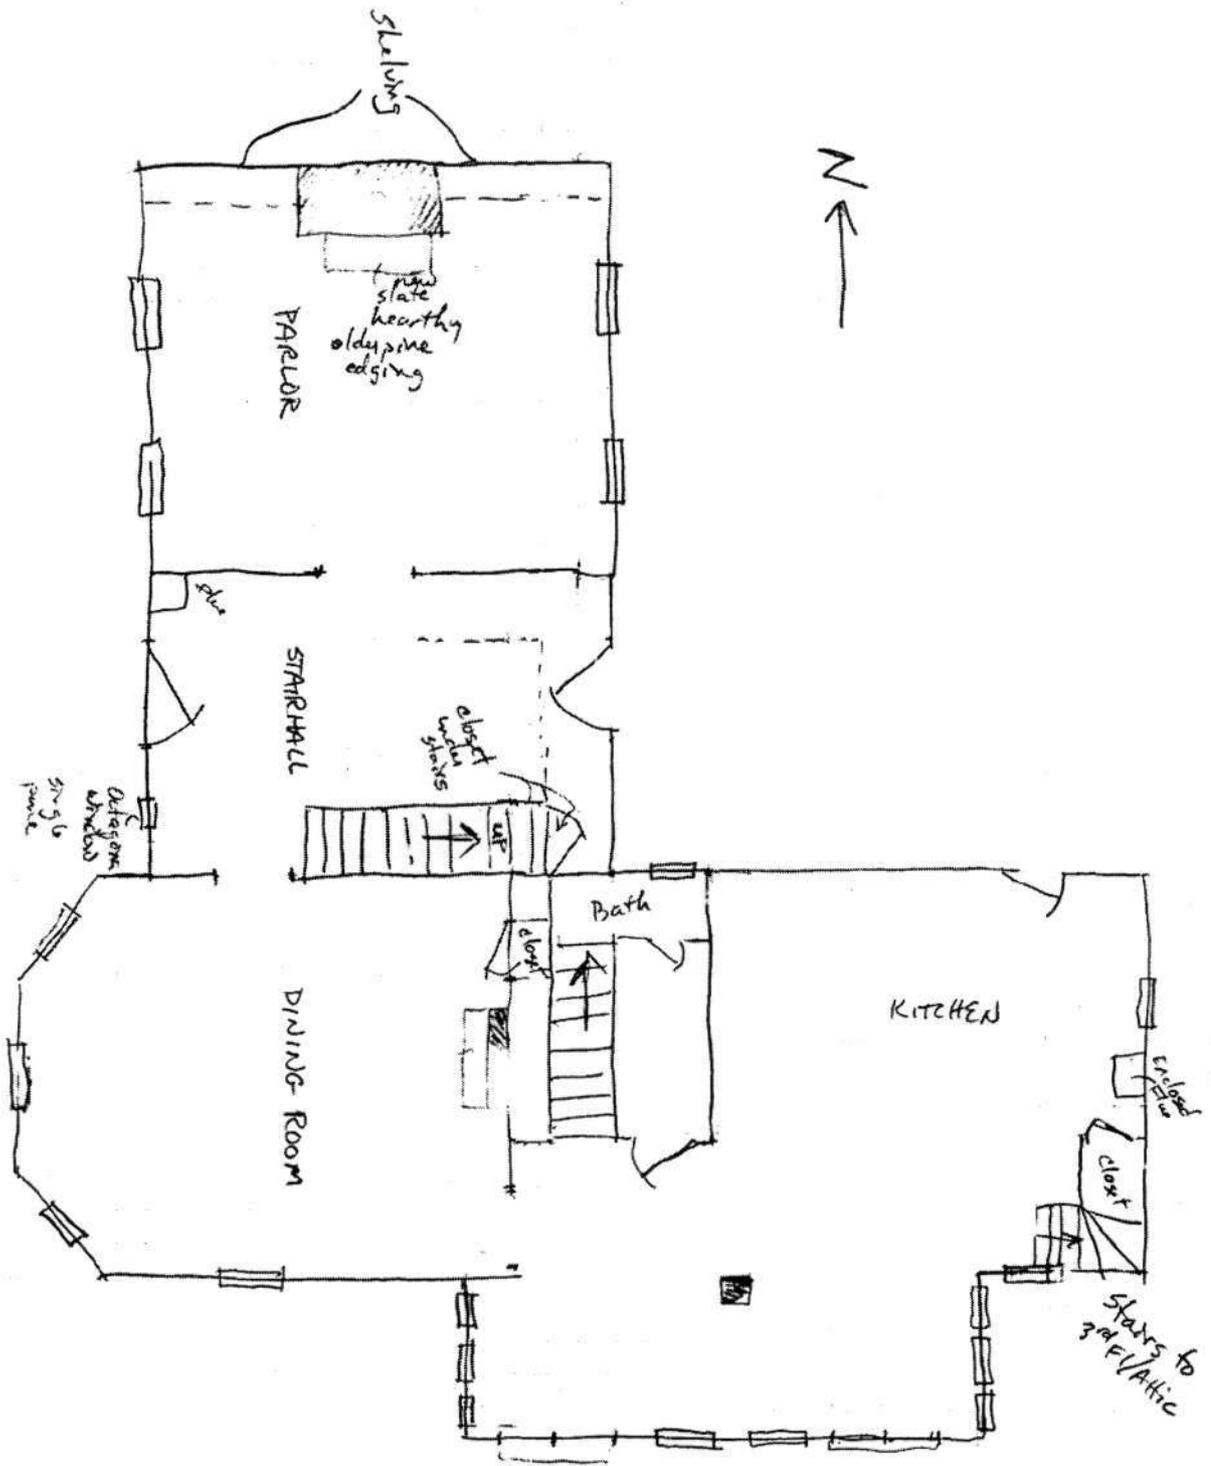
Floor Plan
 QA-119
 Bryan Farm
 200 Wye Harbor Drive
 Queenstown vicinity
 Queen Anne's County, Maryland

The circa 1840 side-gable portion appears to be the earliest section of the house. In its side-hall, single-pile plan, the stairhall is situated south of the parlor. The front-gable addition consists of two phases of construction. The circa 1870 first phase includes the front room, now used as a dining room, and an area to the rear or east that contains a back staircase. The late-nineteenth- to early-twentieth-century second phase added a back hall/storage area, bathroom, and kitchen to the east. The last section added to the house is the early-twenty-first-century breakfast room that opens directly into the kitchen.

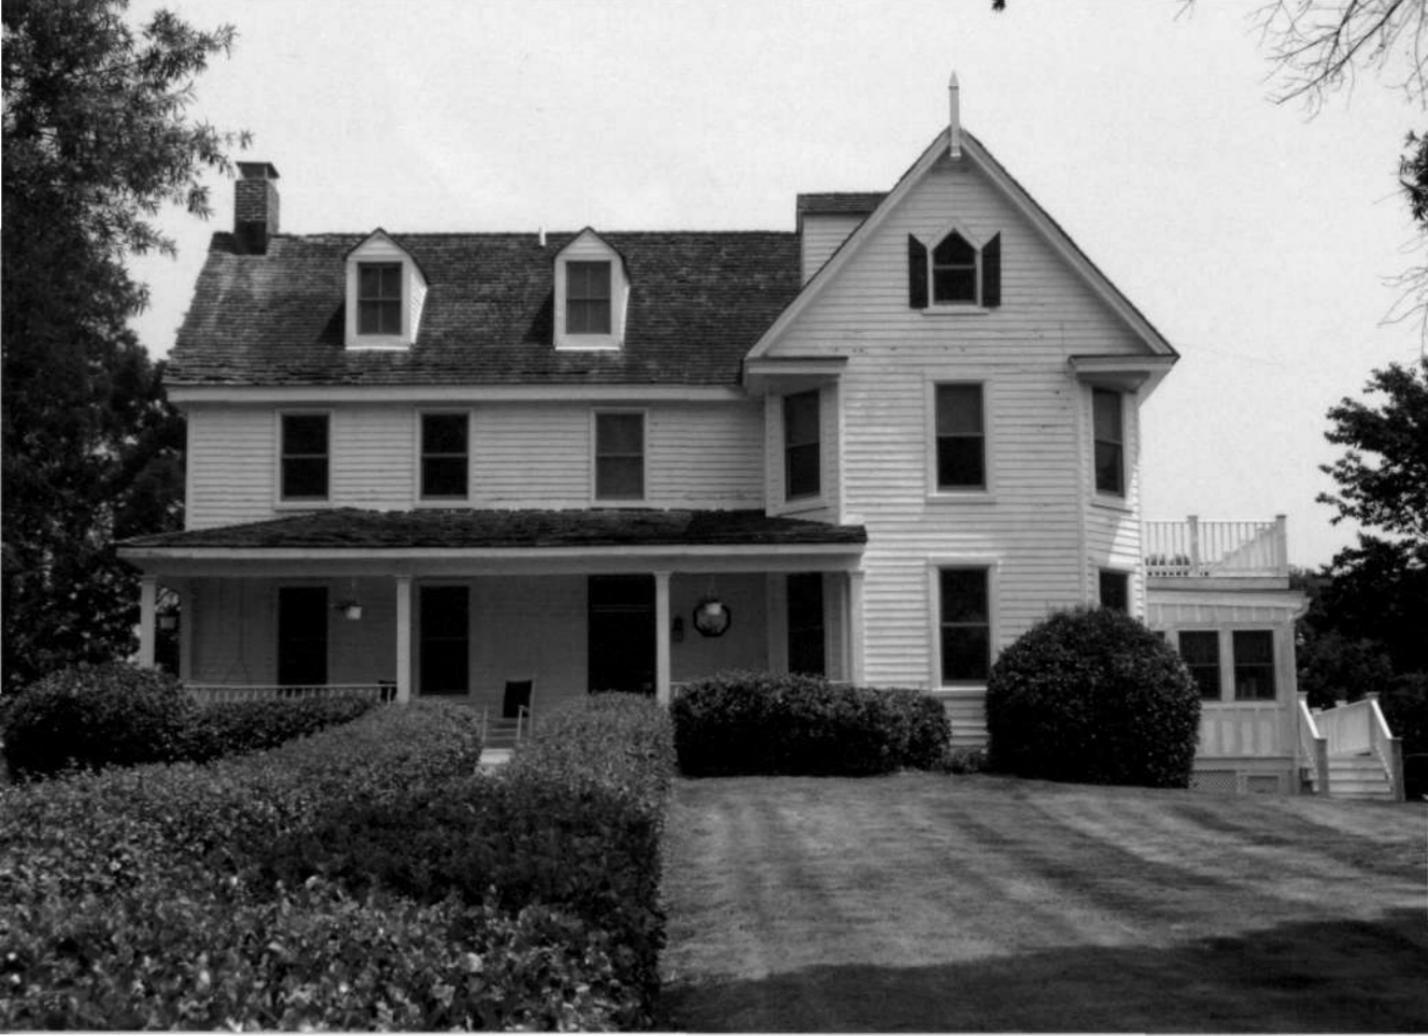
1 of 24

The three-bay façade (west elevation) of the side-gable main block features a six-panel wood door with a four-light transom. Narrow, molded wood trim surrounds the door, which is located south of two, one-over-one, double-hung, vinyl windows with vinyl trim. A small octagonal, single-pane window is located between the front door and the front-gable addition. Three, one-over-one, double-hung, vinyl windows on the second story align with the three bays of the first story. Two dormers pierce the roof and are symmetrically placed along the length of the side-gable section. Each dormer holds a two-over-two, double-hung, vinyl window.

West elevation (facade)

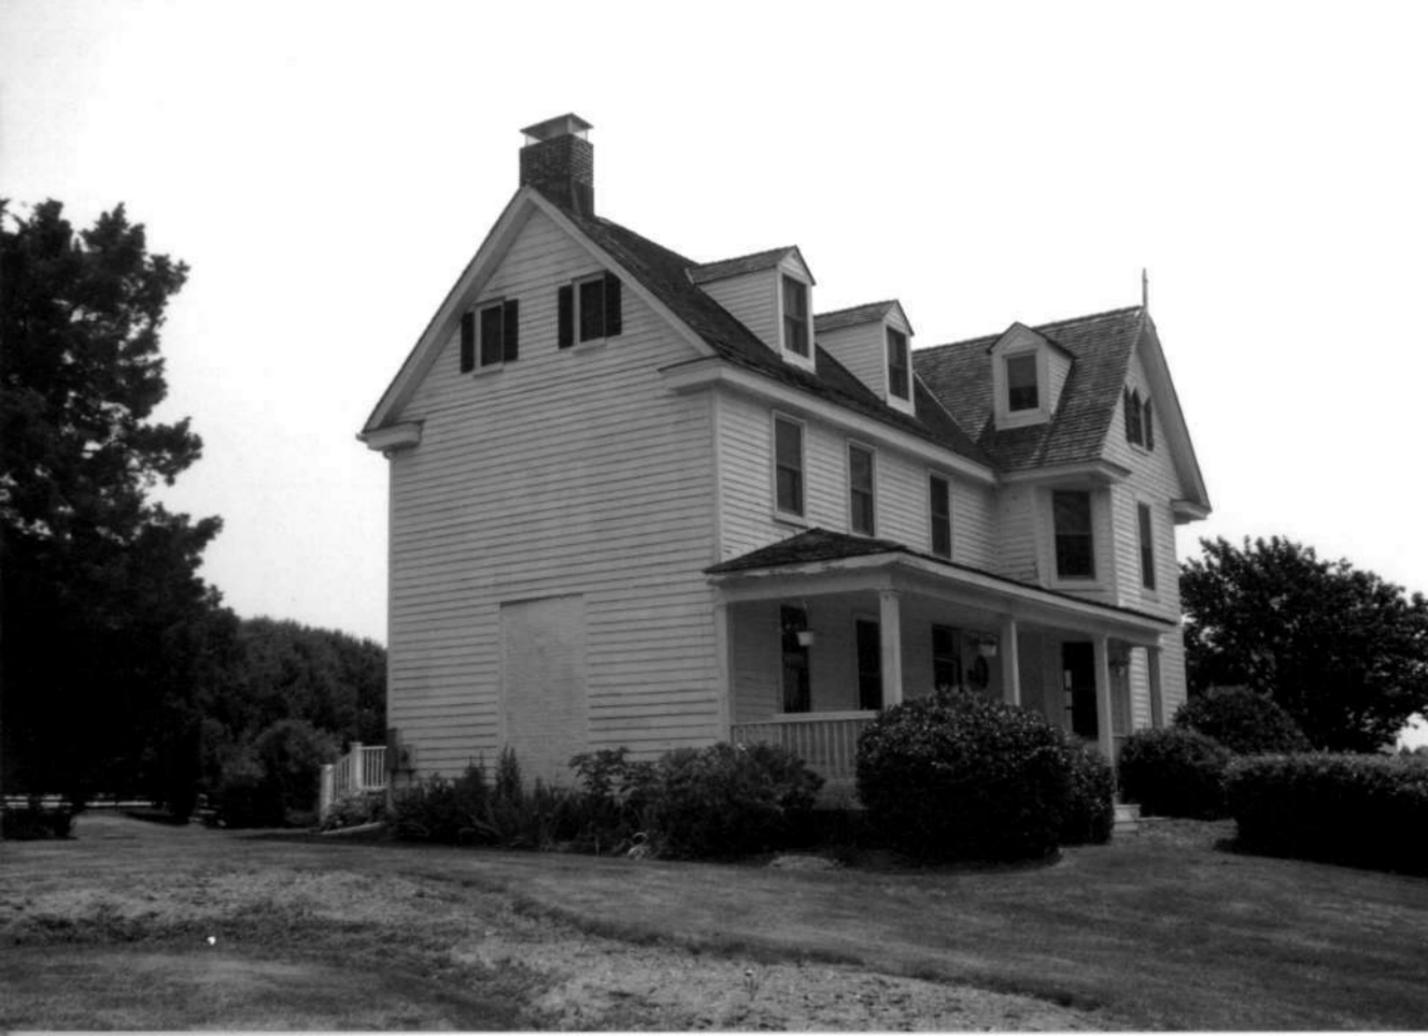
2 of 24

An interior brick chimney is centered in the north elevation and appears as brick framed by wood weatherboard on the first story; it is covered by weatherboard at the upper stories. The chimney stack appears to have been rebuilt. Two single-light windows with block sills are symmetrically placed in the gable under the eaves; each has a pair of shutters. The three-bay, east elevation consists of a six-panel wood door to the south of two, two-over-two, double-hung, wood sash windows containing old, perhaps original, glass. The door and windows are surrounded by narrow, molded trim that is similar to that on the front doorway. The windows have a plain block sill and their original shutter hardware, but no shutters. The three windows on the second story align with the three bays on the first story and feature the same glass and trim as on the first story; the south window over the door is set lower than the other two, at the level of an interior stair landing. Two dormers similar to those on the façade pierce the roof on the east elevation. A non-historic wood deck supported by square posts and featuring a vinyl railing along the east side fills the corner between the side-gable and front-gable sections. The deck replaced an enclosed front-gable vestibule pictured in the 1979 MHT site survey photographs.

North + west elevations, looking SE

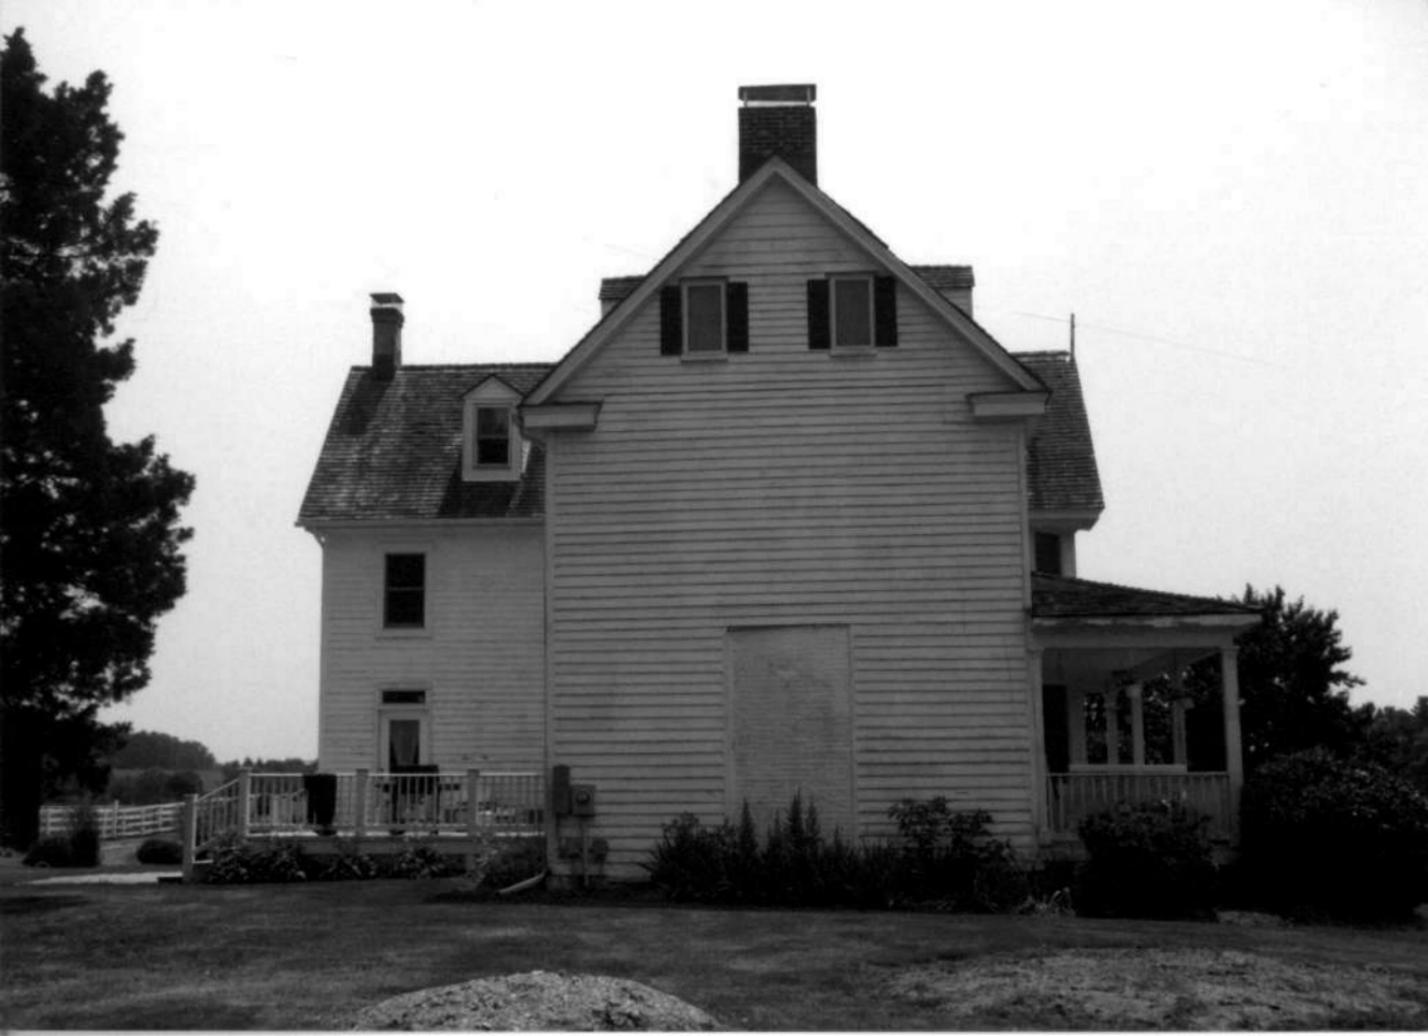
3 of 24

North elevation

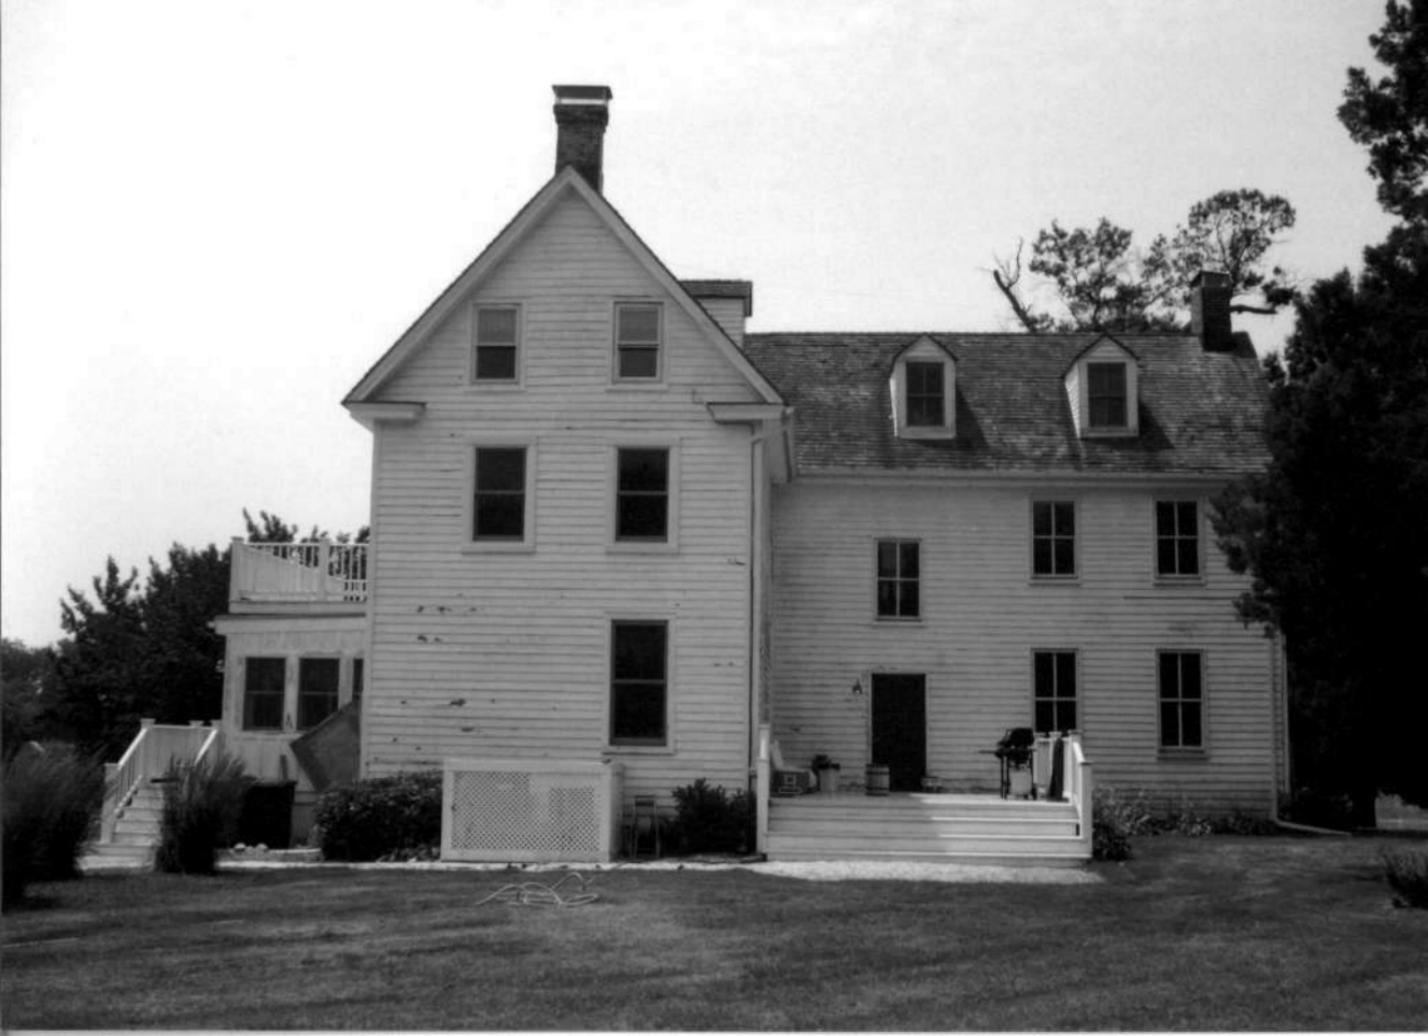
4 of 24

The east elevation has a single window located north of center in the first story; two symmetrically placed windows on the second story; and two symmetrically placed windows in the gable. The one-over-one, vinyl windows decrease in size from first to second to third stories. Square-edged wood trim surrounds the first and third-story windows, while the second story windows have vinyl trim. The north elevation of the addition has been altered since 1979. On the first story, a glass-paneled door with a single-light transom occupies the east bay, which formerly contained a window. A one-over-one, double-hung, vinyl window with square-edged wood trim and drip cap is placed close to the side-gable structure. This window is smaller in size than the other first story windows. A similarly sized, four-over-four, double-hung, wood window with square-edged trim and wood drip cap is placed directly over it on the second floor. A one-over-one, double-hung, vinyl window with vinyl trim sits above the door.

East elevation

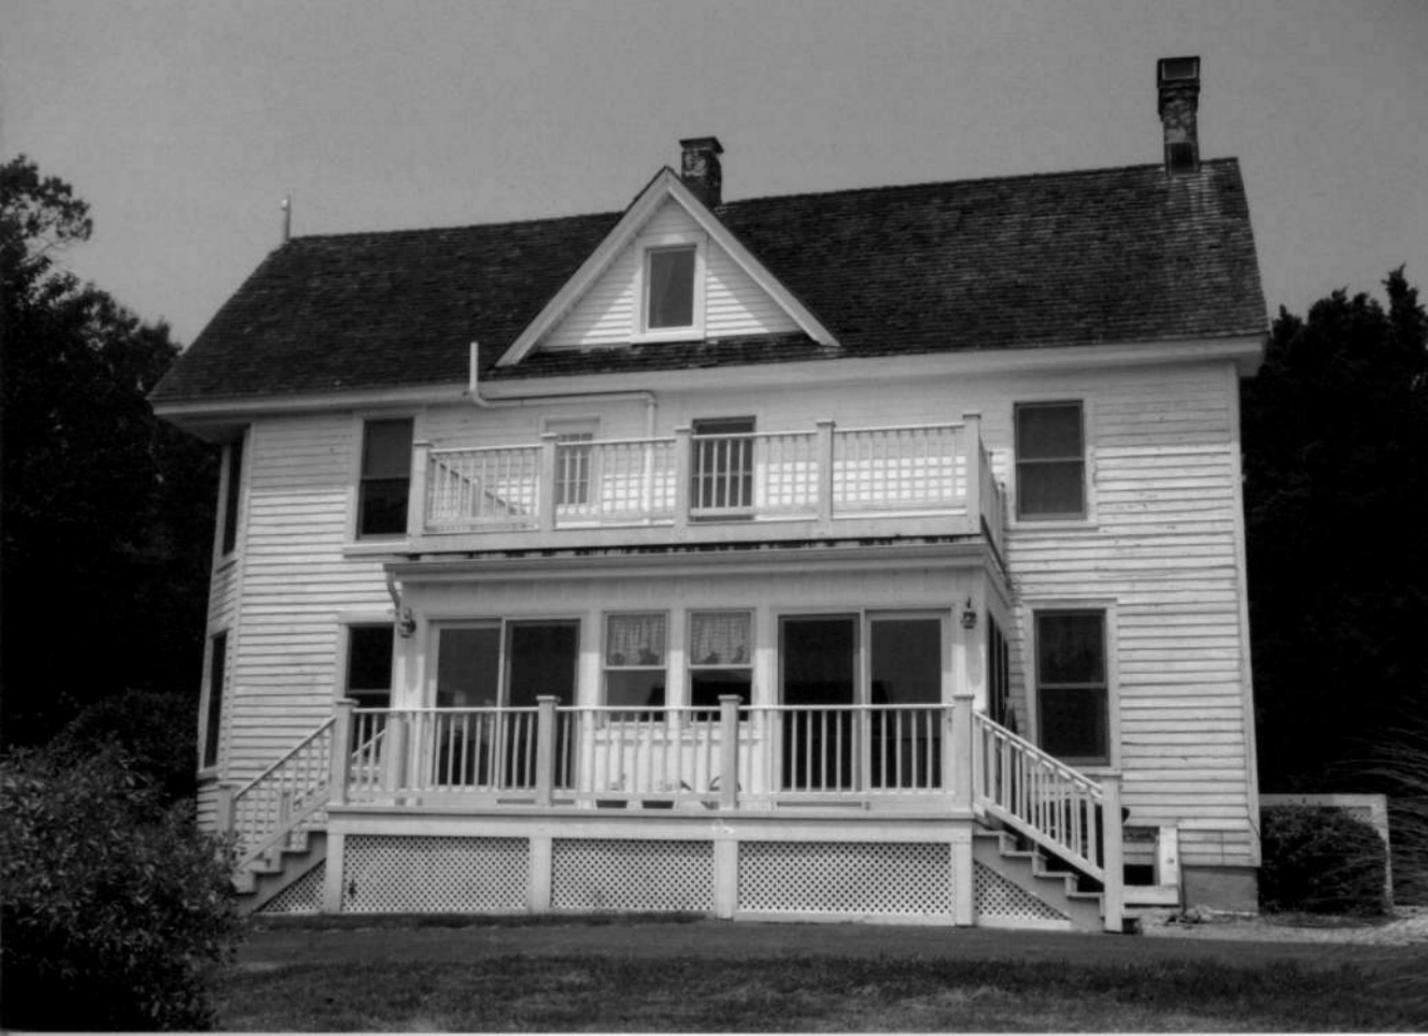
5 of 24

The asymmetrically arranged, four-bay, south elevation features a one-story enclosed porch that was built by the current owners. The west bay on the first floor contains a one-over-one, double-hung, vinyl window with vinyl trim like the front façade; a one-over-one, double-hung vinyl window with square-edged wood trim and drip cap occupies the first-floor east bay. Between the two windows is the enclosed porch, which consists of sliding glass doors on both sides of paired one-over-one, double-hung vinyl windows. Triple vinyl windows occupy the west and east elevations of the porch. Clad in board and batten siding, the porch has a plain fascia, and a flat roof surrounded by a balustrade composed of square vinyl posts, balusters and railings. On the east side of the porch, a single bulkhead door provides access to the basement. Steps on the east and west sides provide access to a deck that extends across the south side of the porch. The addition's second story contains (west to east) a one-over-one, double-hung, vinyl window; a door onto the deck of the porch; and two, one-over-one, double-hung, vinyl windows with wood trim. A front-gable dormer pierces the center of the roof and contains a single-pane vinyl window. Two interior brick chimneys with corbelled caps extend through the roof; one is placed in the center of the structure to the south of the roof ridge, and one is inset at the east end.

South elevation

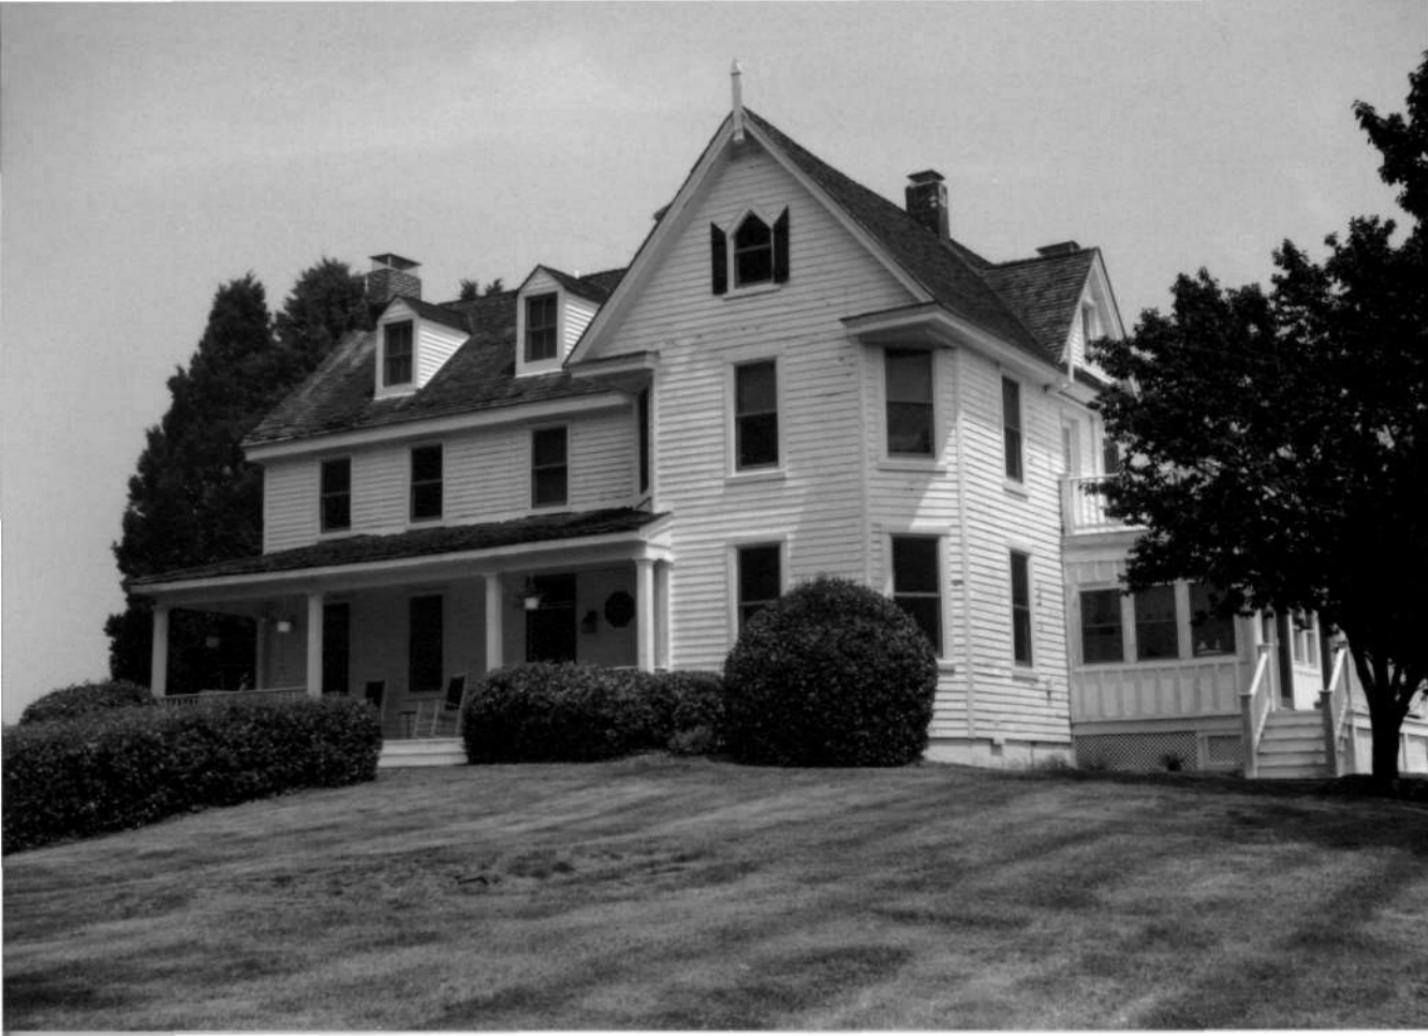
6 of 24

The three-bay façade (west elevation) of the projecting, two-and-one-half-story, front-gable addition features cut-away corners on the first and second stories. Each of the three facets or bays on both stories of the elevation contains a one-over-one, double-hung, vinyl sash window with vinyl trim. The gable is not cut away; the flat façade of the gable features cornice returns that extend to the outer edge of the center facet, and a centered one-over-one, double-hung vinyl window with a plain block sill and square-edged trim. The

West + south elevations, looking NE

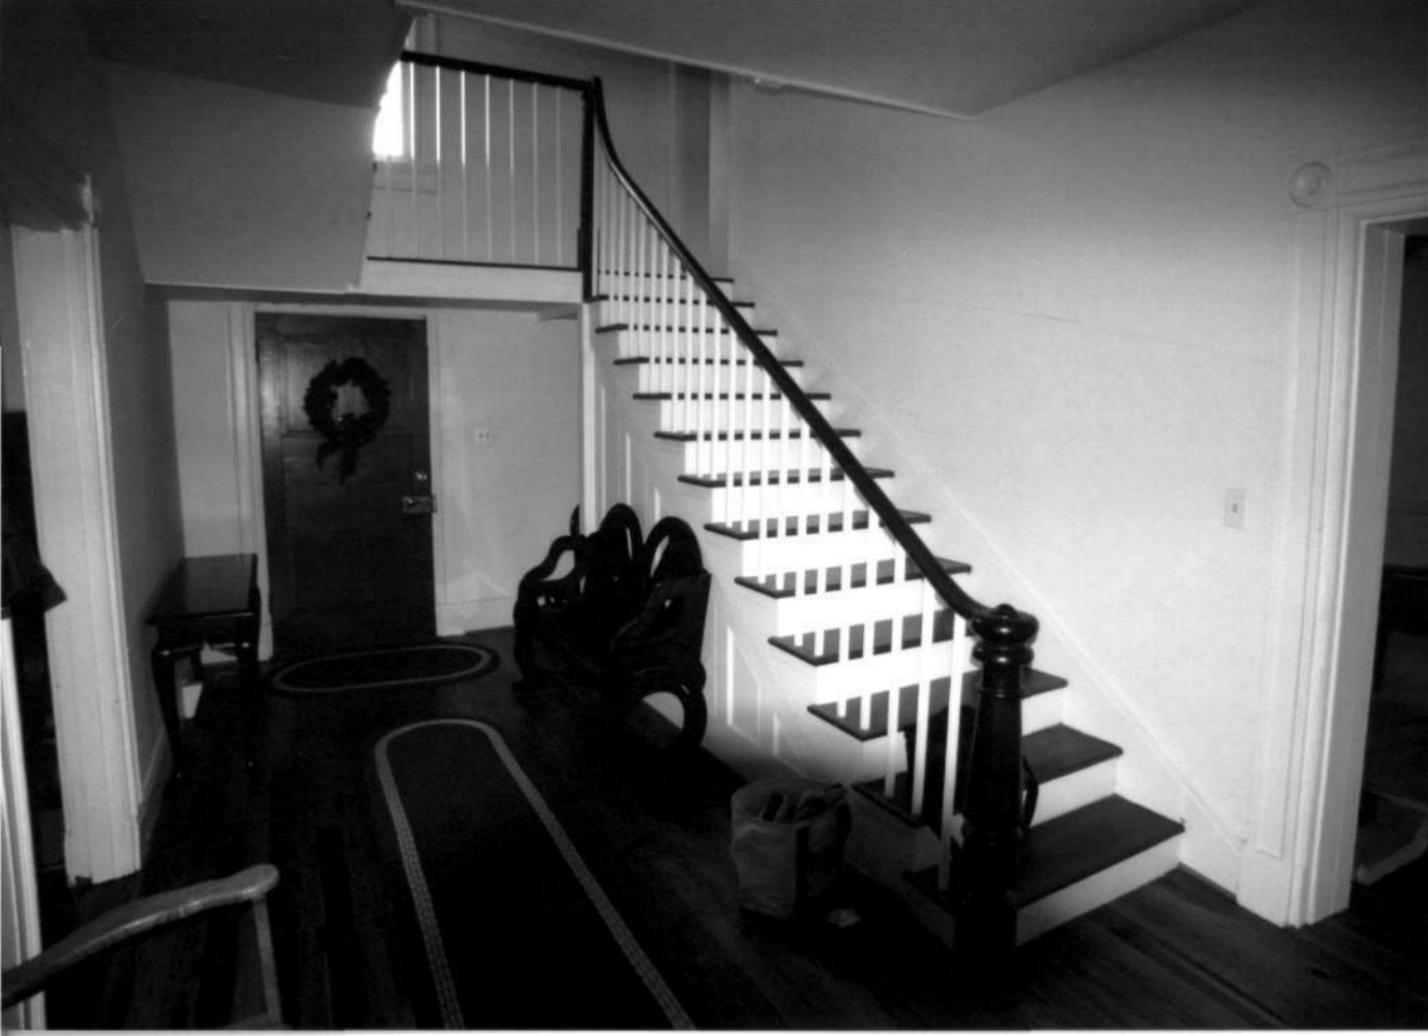
7 of 24

The stairhall contains even-width pine flooring, five-inch baseboards with a cavetto-molded cap, and molded door trim with bullseye blocks at the corners. The trim around the door at the rear (east) end of the stairhall is cut off at the top to fit under the stair landing. Dogleg stairs extending from the first to the third floors feature a turned newel post, oblong handrail, and square balusters with a mitred, unadorned spandrel. Six vertical wood panels form the staircase wainscoting. The masonite-lined closet under the stairs is accessed through a six-panel wood door. The parlor features narrower, even-width wood flooring, and the same baseboard and door trim as the stairhall. The window trim is the same as the trim surrounding the doors, and includes a paneled apron. Centered on the north wall, a fireplace with an unadorned Tuscan mantel and surround includes an overmantel composed of a mirror trimmed with turned columns under a straight cornice with dentil molding. A wood stove sits on the slate hearth, which is framed with mitred wood. The ceilings in the parlor and stairhall are eight feet ten inches high.

stairhall, looking east

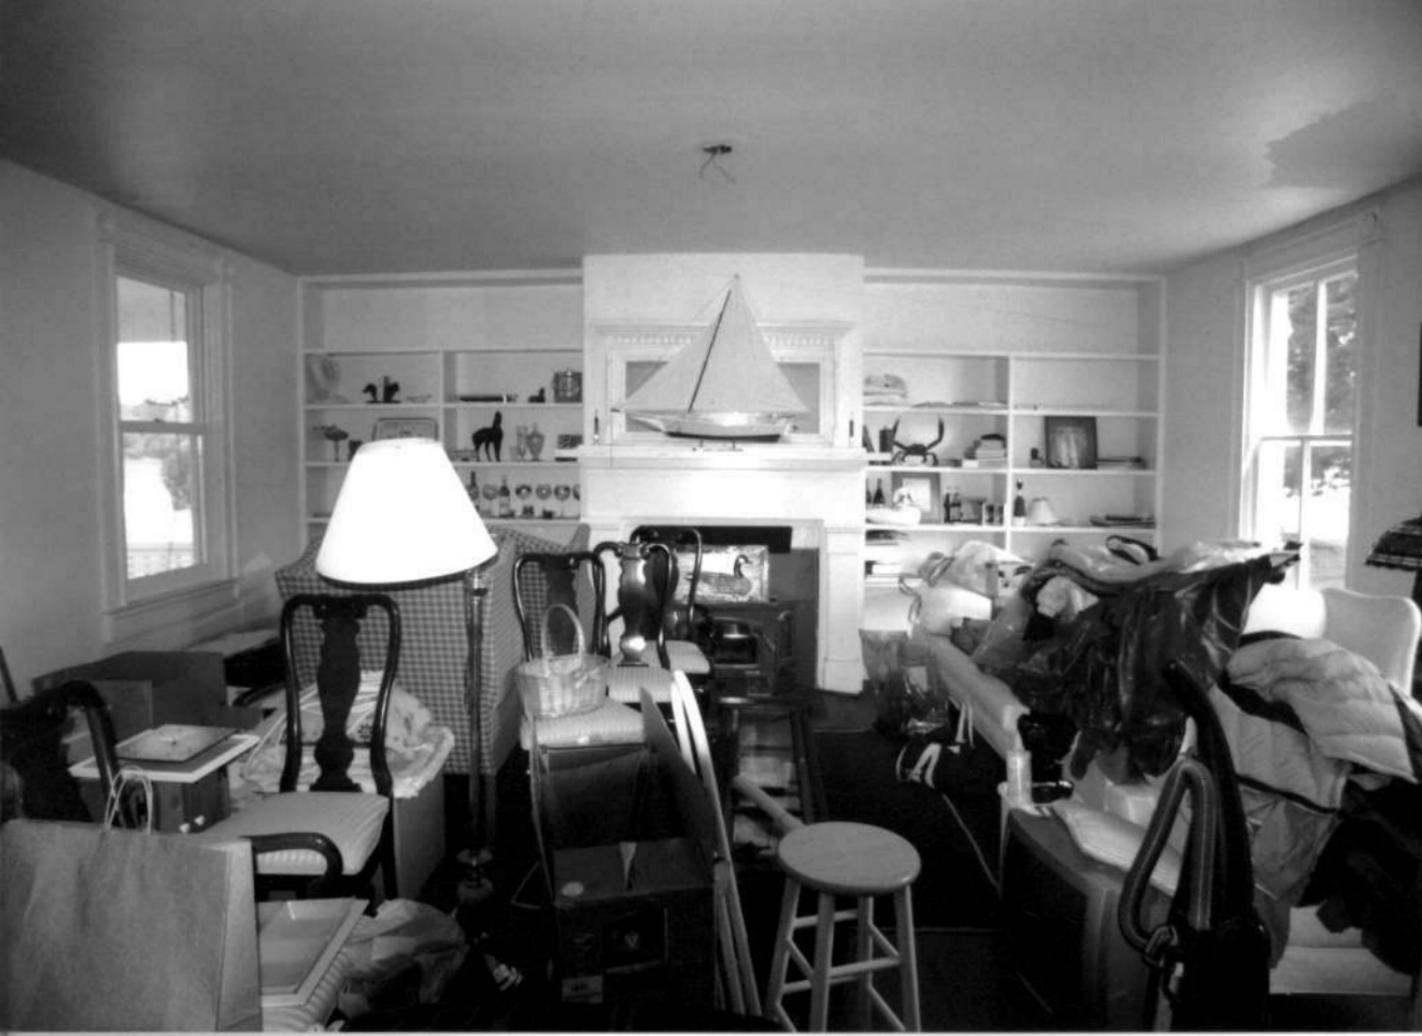
8 of 24

Parlor, looking N

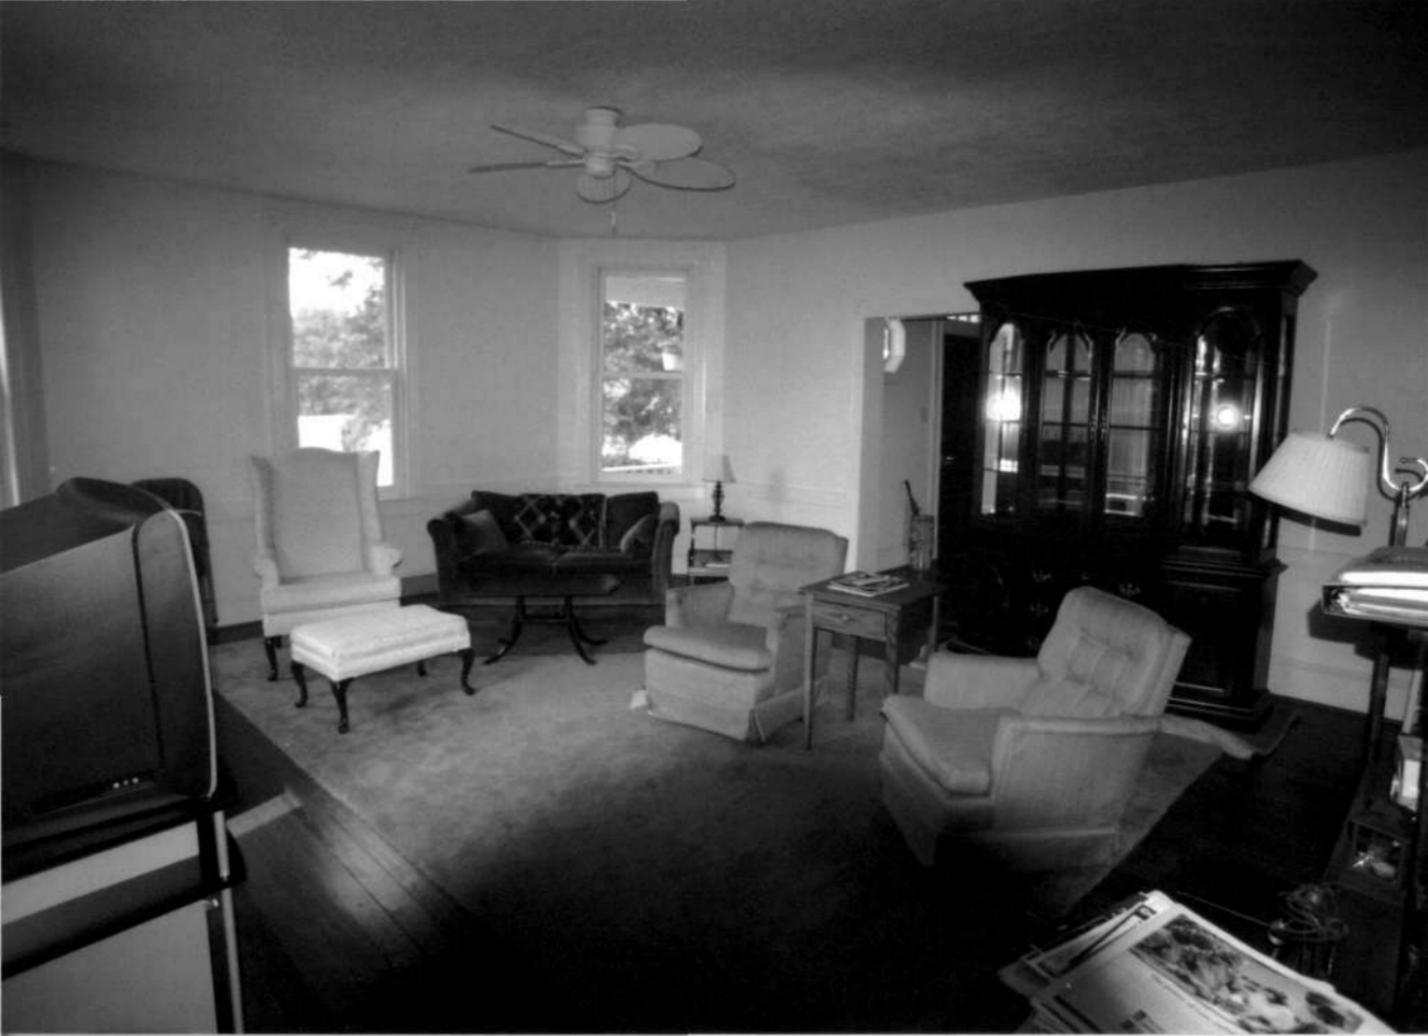
9 of 24

Built circa 1870, the dining room in the front-gable section displays interior finishes that are similar but not identical to those in the side-hall section. The dining room features even-width pine flooring that is narrower than the parlor floor, ogee-molded wood baseboards, and a molded wood chair rail. The door and window trim differs in detail from the earlier portion: the bullseye blocks have less delicate carving; the center of the trim is molded rather than flat; and there are no panels under the windows. The east wall features a centered fireplace with unadorned wood mantel, slate tile hearth set in a mitred wood frame, and a wood stove set into the firebox. A built-in closet to the north of the fireplace has a four-panel wood door. Behind (east) of the fireplace wall is an enclosed staircase that leads to the first landing of the main staircase in the side-gable section. Set into the upper wall between the fireplace and the staircase is a built-in closet with a beadboard door.

Dining Room, looking NW

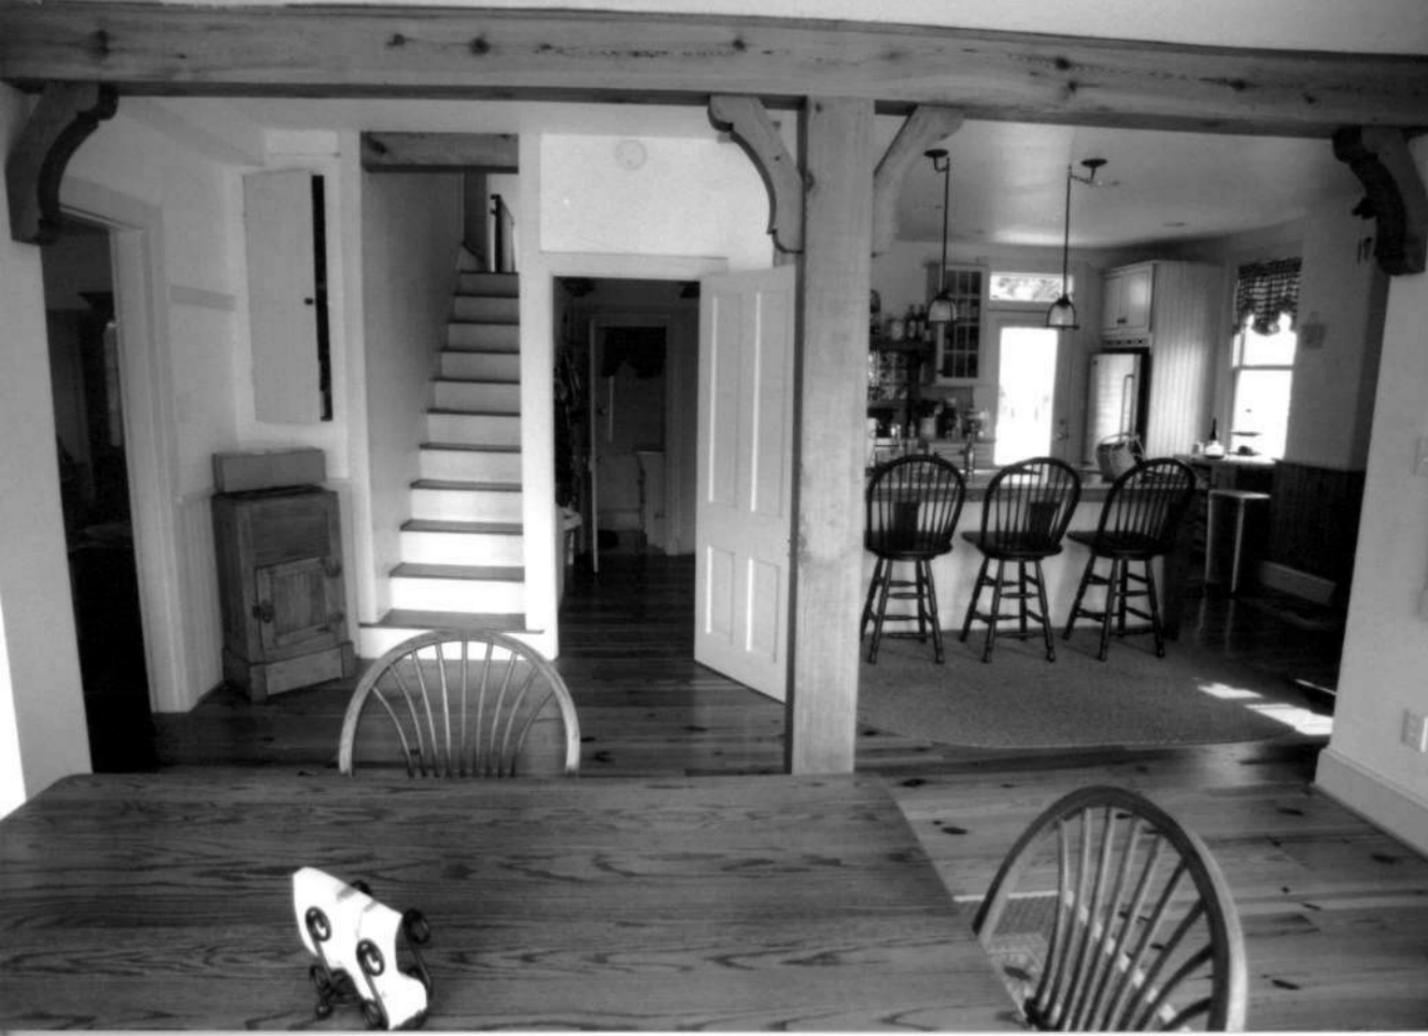
10 of 24

stairs to stairhall landing, hall to bathroom + kitchen, from
enclosed porch, looking N

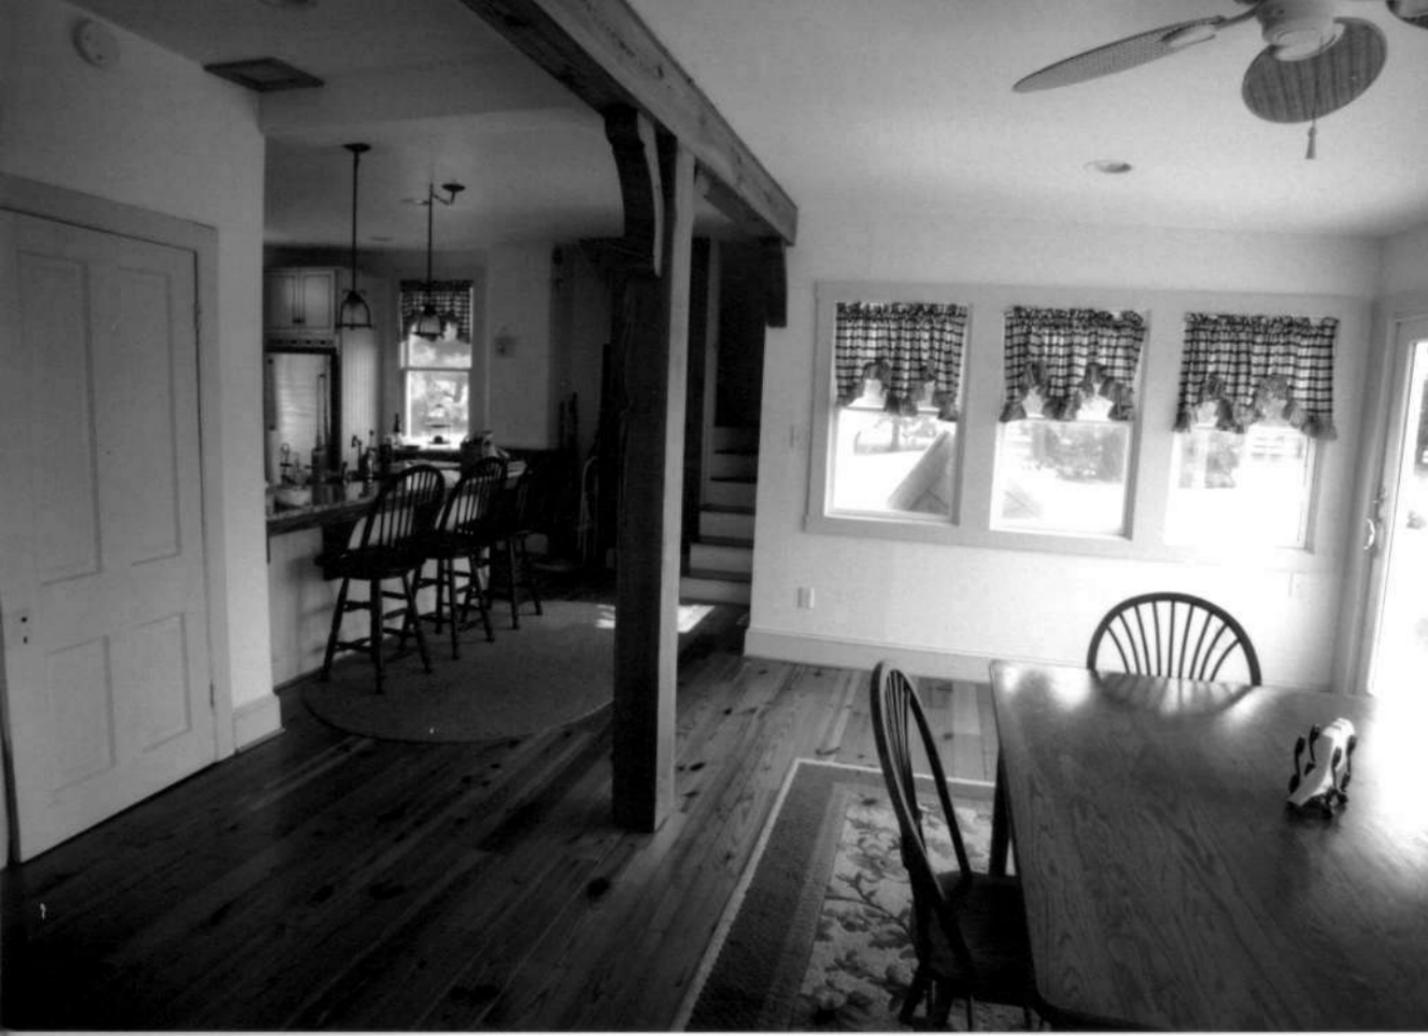
11 of 24

Completed in the late nineteenth to early twentieth century, the second phase of construction begins at the east wall of the staircase and extends to the east wall of the front-gable addition. An enclosed hall extends along the east wall of the staircase to a bathroom located under the staircase and along the north wall. The hall includes open storage under the stairs. The four-panel wood doors into the hall and the bathroom match the dining room closet door. The wood flooring matches the random-width pine floorboards of the kitchen area, and horizontal wood siding lines both walls. The kitchen features an ogee-molded baseboard and square-edged window and door trim with a beaded inner edge. The boxed winder staircase in the southeast corner bypasses the second floor, leading directly to the third floor; it has a vertical board door at the kitchen level. Other kitchen trim and cabinets are non-historic.

Kitchen + enclosed porch, locking E
