**QA-119
Bryan Farm
200 Wye Harbor Drive
Queenstown vicinity
Queen Anne's County**

**Constructed ca. 1848, and ca. 1870
Private**

Maryland Historical Trust Maryland Inventory of Historic Properties Form

Inventory No. QA-119

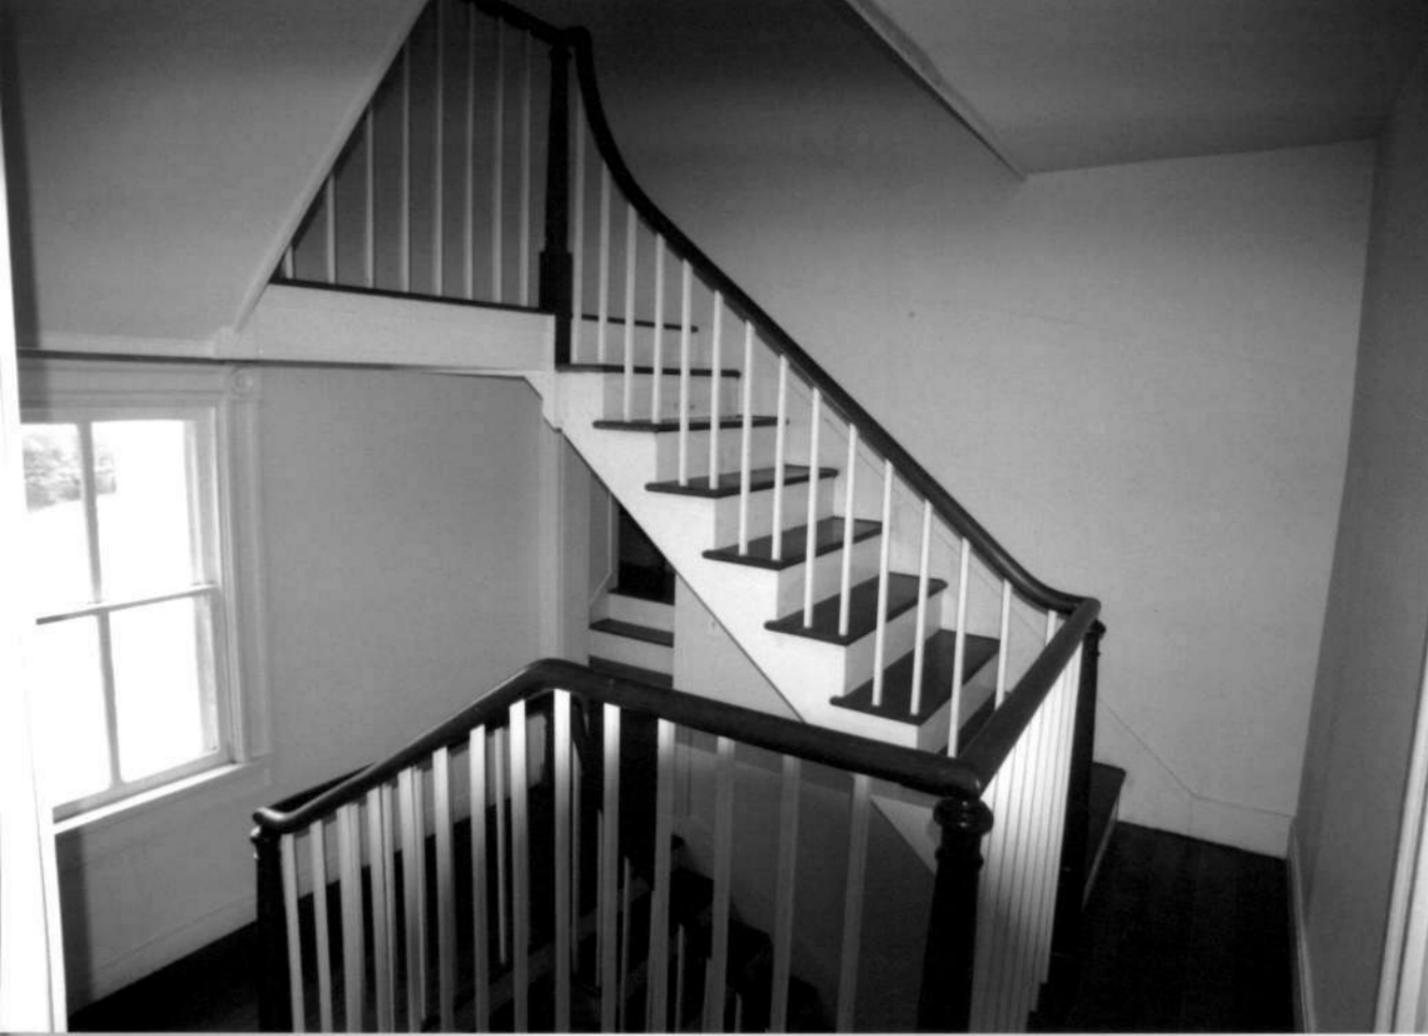
12 of 24

The second floor plan of the side-gable section echoes the first floor, with a stairhall and one bedroom above the parlor. The window and door trim and the mantelpiece in the bedroom match that on the first floor. The only differences in finish between the first and second floors are the random-width pine flooring on the second floor, and a brick fireplace surround, firebox, and a brick hearth in the bedroom. The third floor/attic contains a bedroom with non-historic finishes except for four-panel wood doors.

Stairhall, 2nd Floor level, Looking SE

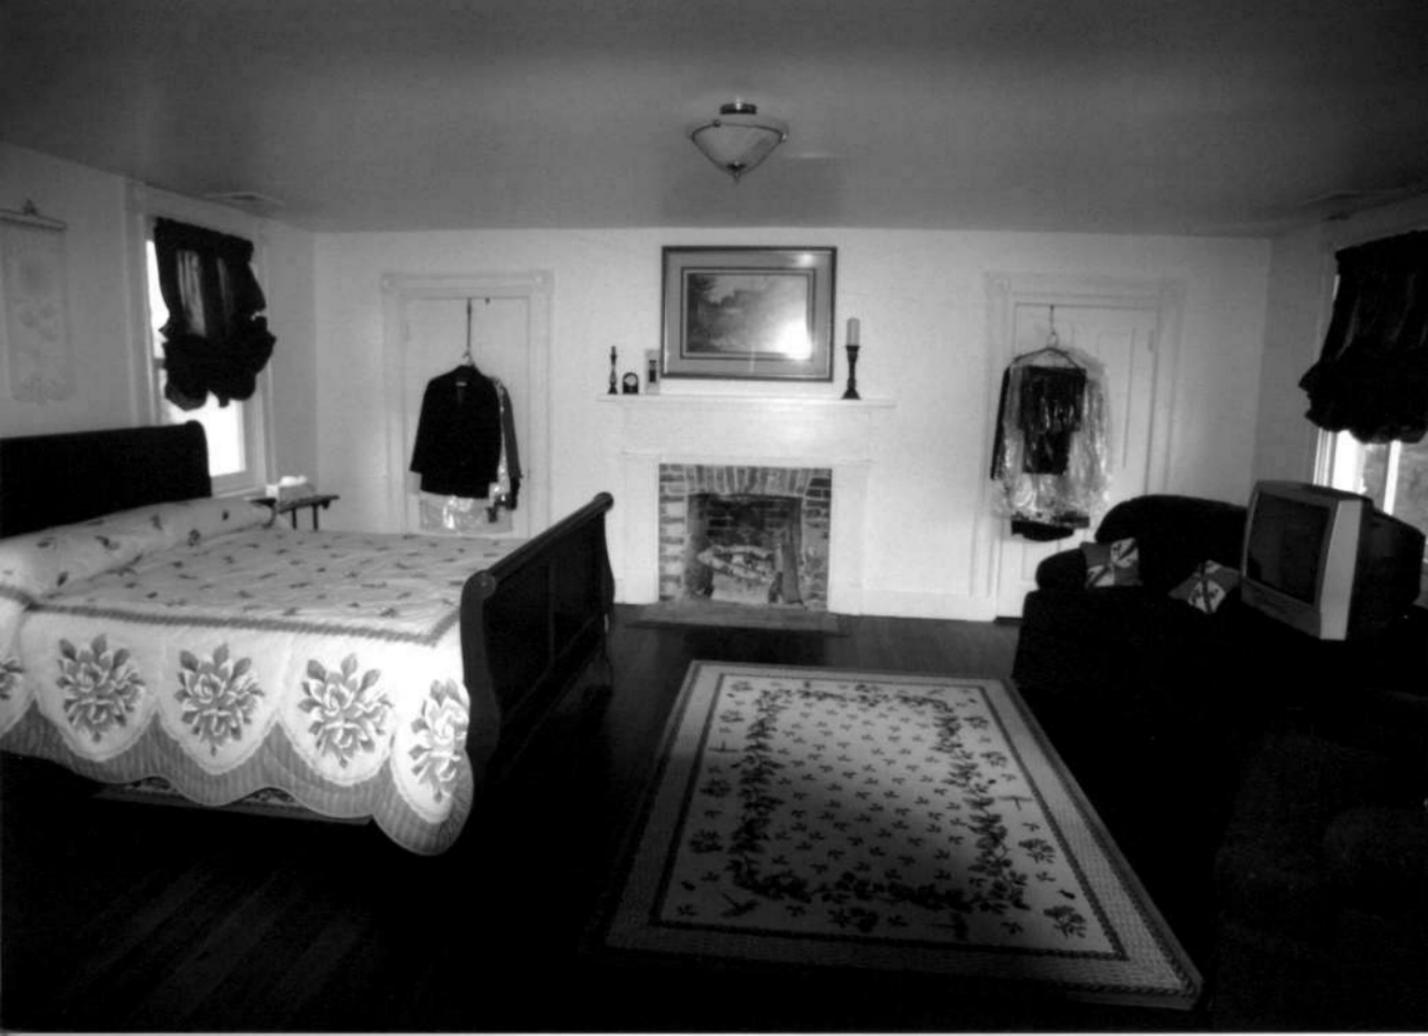
13 of 24

Bedroom above parlor, looking N

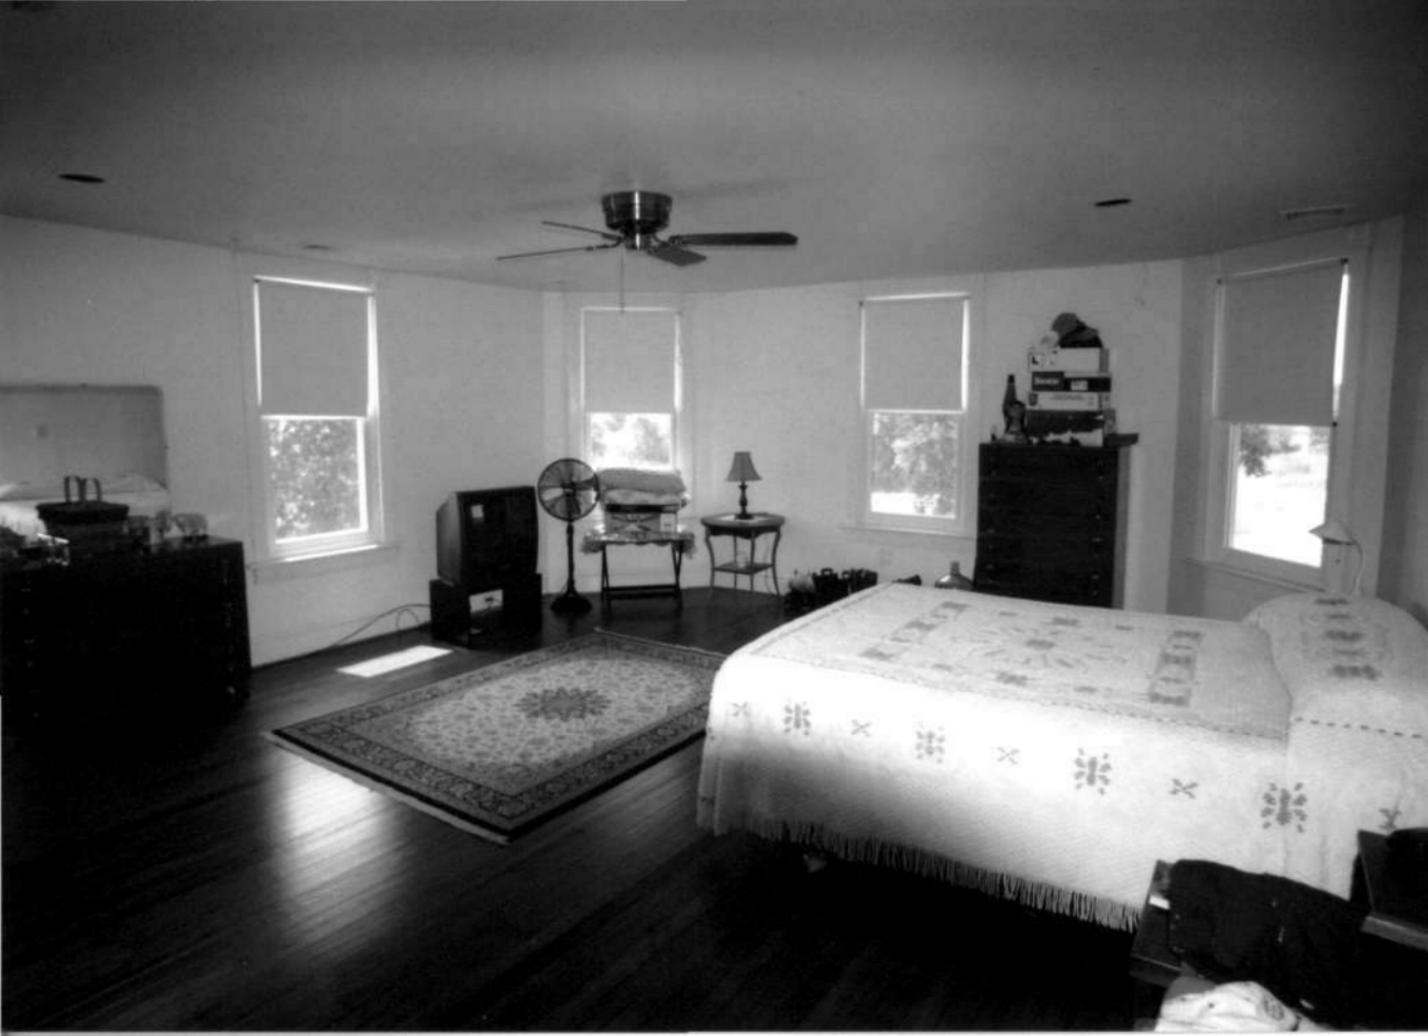
14 of 24

The second-floor room over the dining room contains even-width pine flooring and bullseye block window trim with fluted surrounds that differ from the dining room trim. A flue pipe projects into the room. The bathroom located to the east of this bedroom features an unfinished wood beam that bisects the bathroom and marks the east wall of the circa 1870 section; the bathroom was enlarged and renovated by the current owner circa 2005, as were a bedroom and a laundry area situated over the kitchen.

Bedroom above Dining Room, looking SW

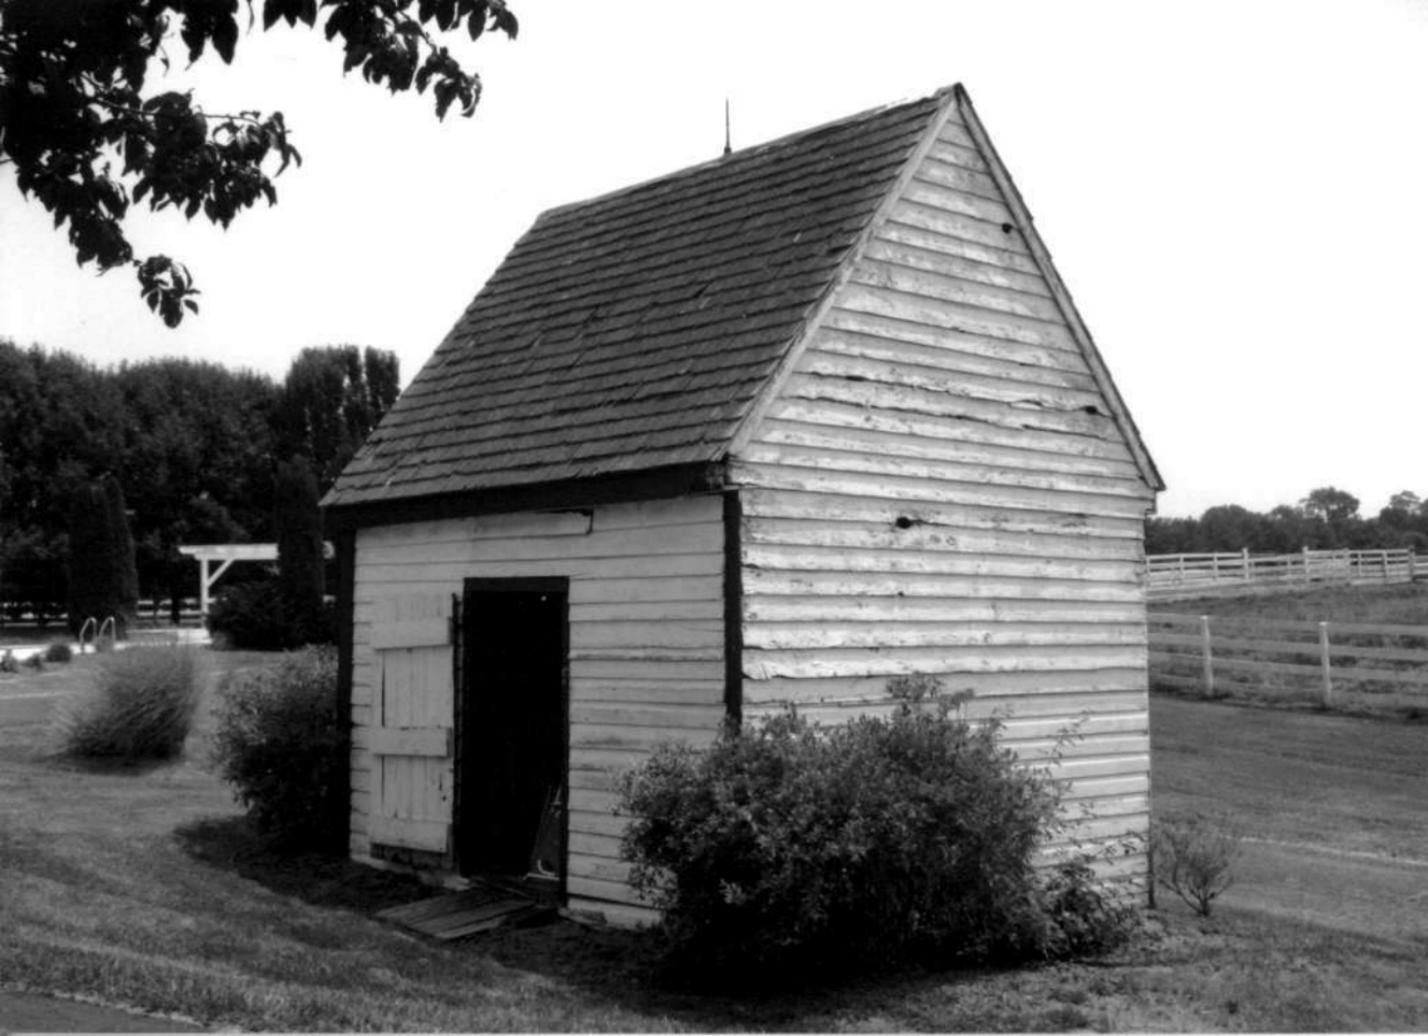
15 of 24

Located south of the house and within a loop formed by the driveway, the one-story, side-gable, post-and-beam meathouse was likely built in the mid-nineteenth century at approximately the same time that the sidehall section of the house was constructed. Clad in wood weatherboard with a wood shingle roof, the structure has wood corner boards, a plain fascia, and enclosed rafters. The north elevation contains the only opening to the structure, which is occupied by a centered plank door on strap hinges with a flat wood surround. The frame construction is visible on the interior; corner posts are tied to the plates with pegged mortise-and-tenon joints. The floor is composed of random-width wood planks.

Meathouse, north+west elevations, looking SE

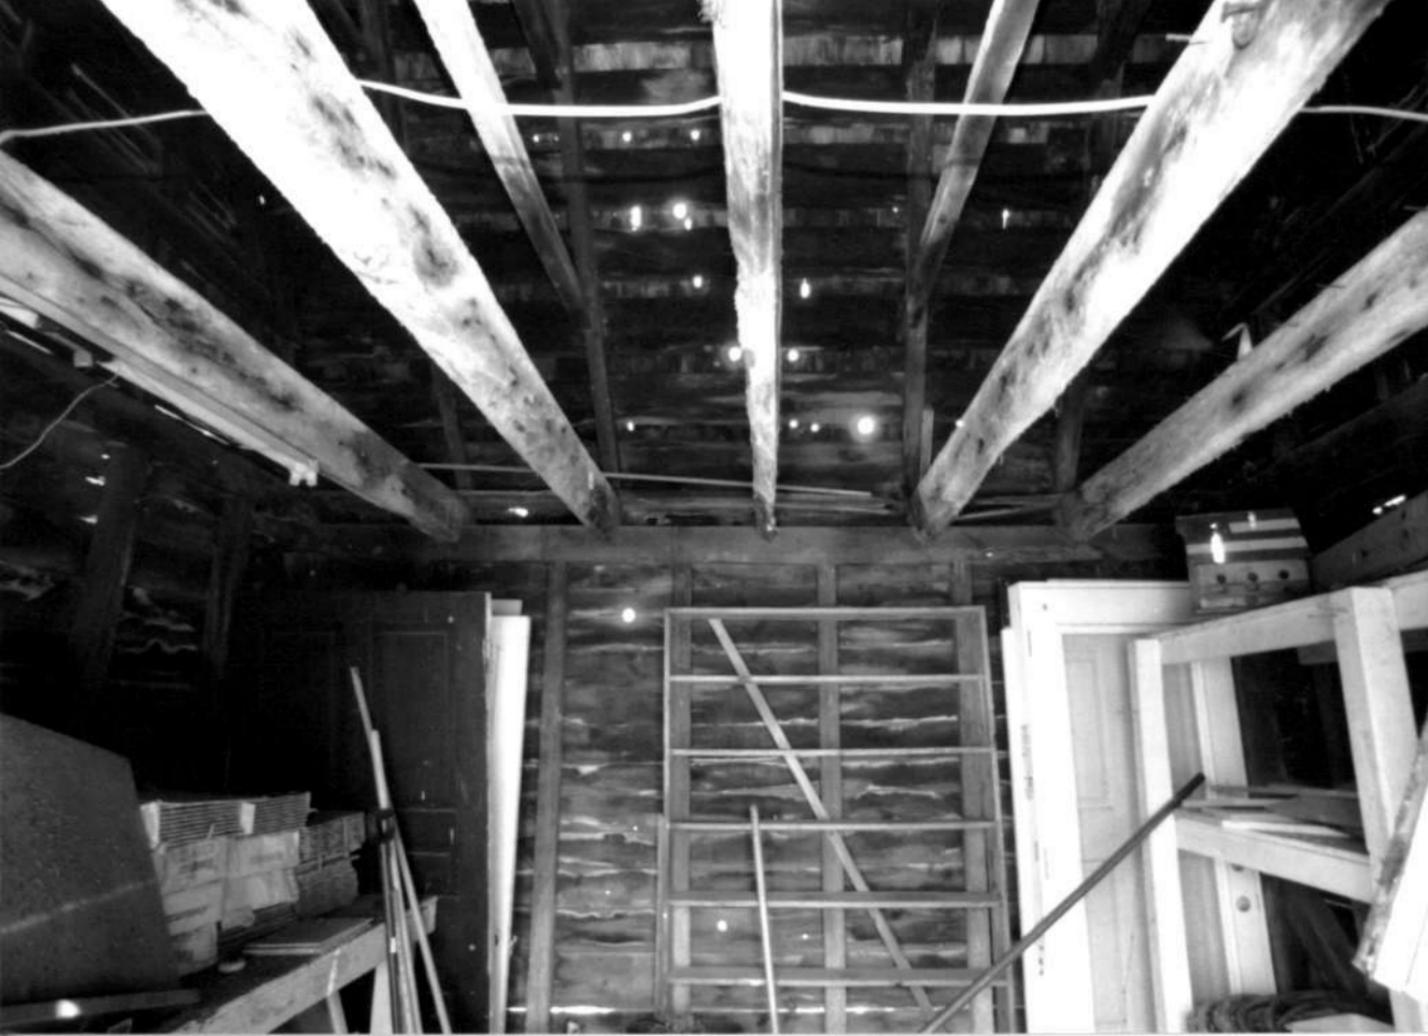
17 of 24

Meat house interior, looking S

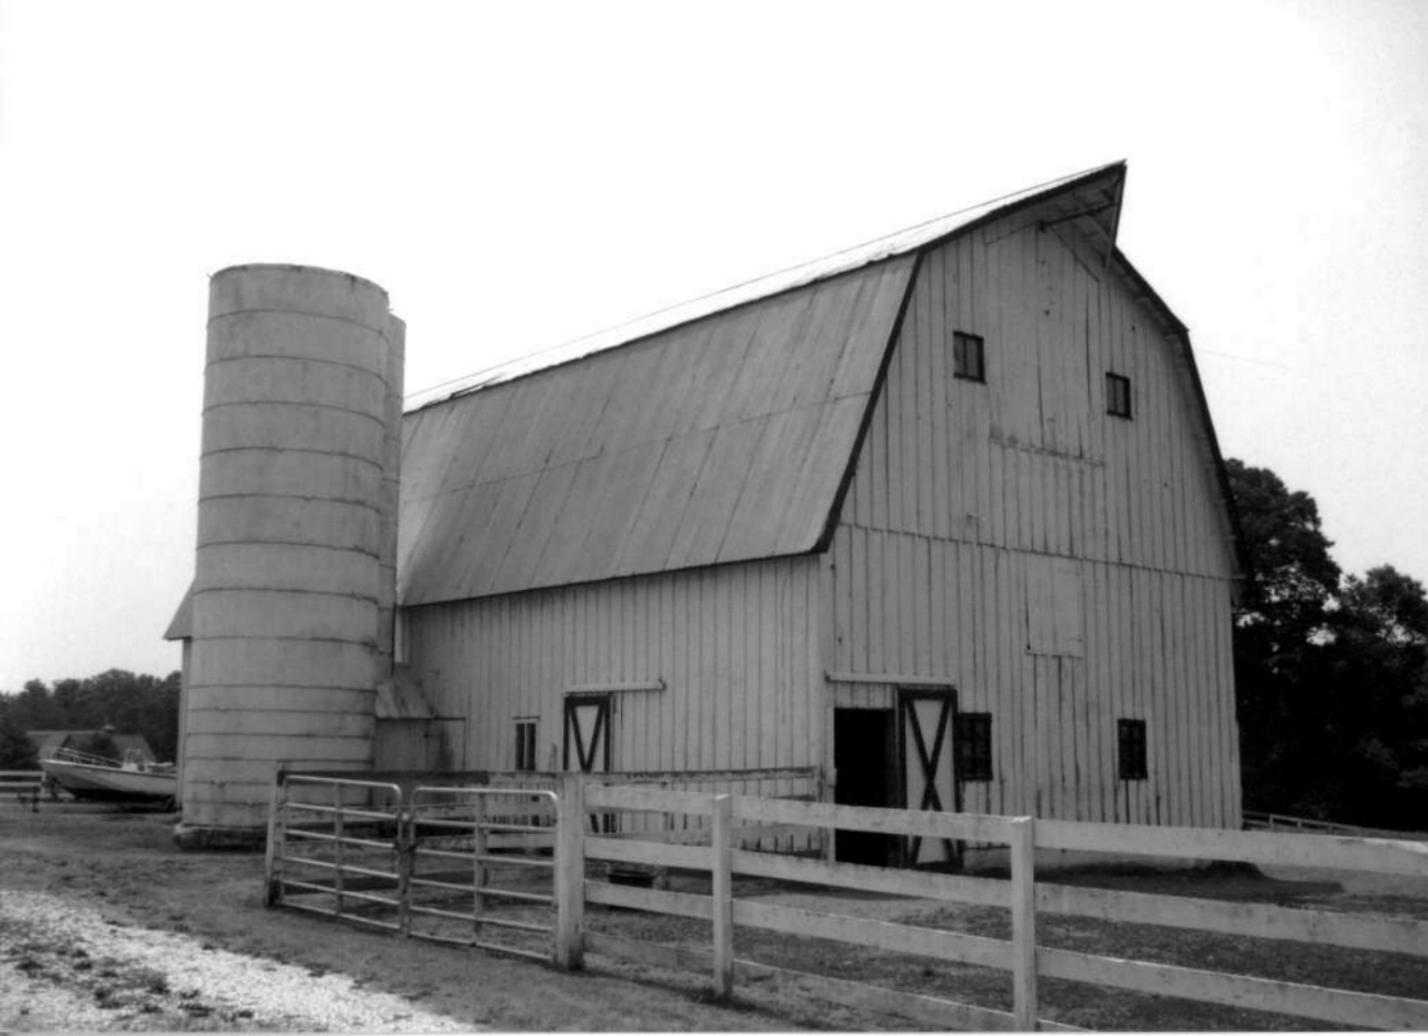
18 of 24

Located south of the meathouse, the 1930s two-story, gambrel-roof dairy barn with attached silo has been partially fitted with horse stalls. Clad in board-and-batten wood siding, the barn has a corrugated metal roof, boxed rafters and a poured concrete foundation. The first story of the north elevation incorporates a sliding wood door on the east end and two, symmetrically placed, six-light, fixed windows on the west. An opening in the center of the first story above the window level contains a vertical plank, wood door. The second story features two small, two-light, fixed wood sash windows aligned with the first-story windows and positioned on each side of a centered pair of large, vertical-board doors beneath the hay hood. The doors are hinged at the bottom and pointed at the top to fit under the roof. The west elevation encompasses three sliding doors alternating with two, nine-light windows in the north half of the elevation and seven wood hopper windows with missing glass panes in the south half. The south elevation is identical to the north elevation. A concrete silo with poured concrete foundation dominates the east elevation and is connected to the center of the elevation

Dairy Barn, North + east elevations, looking SW

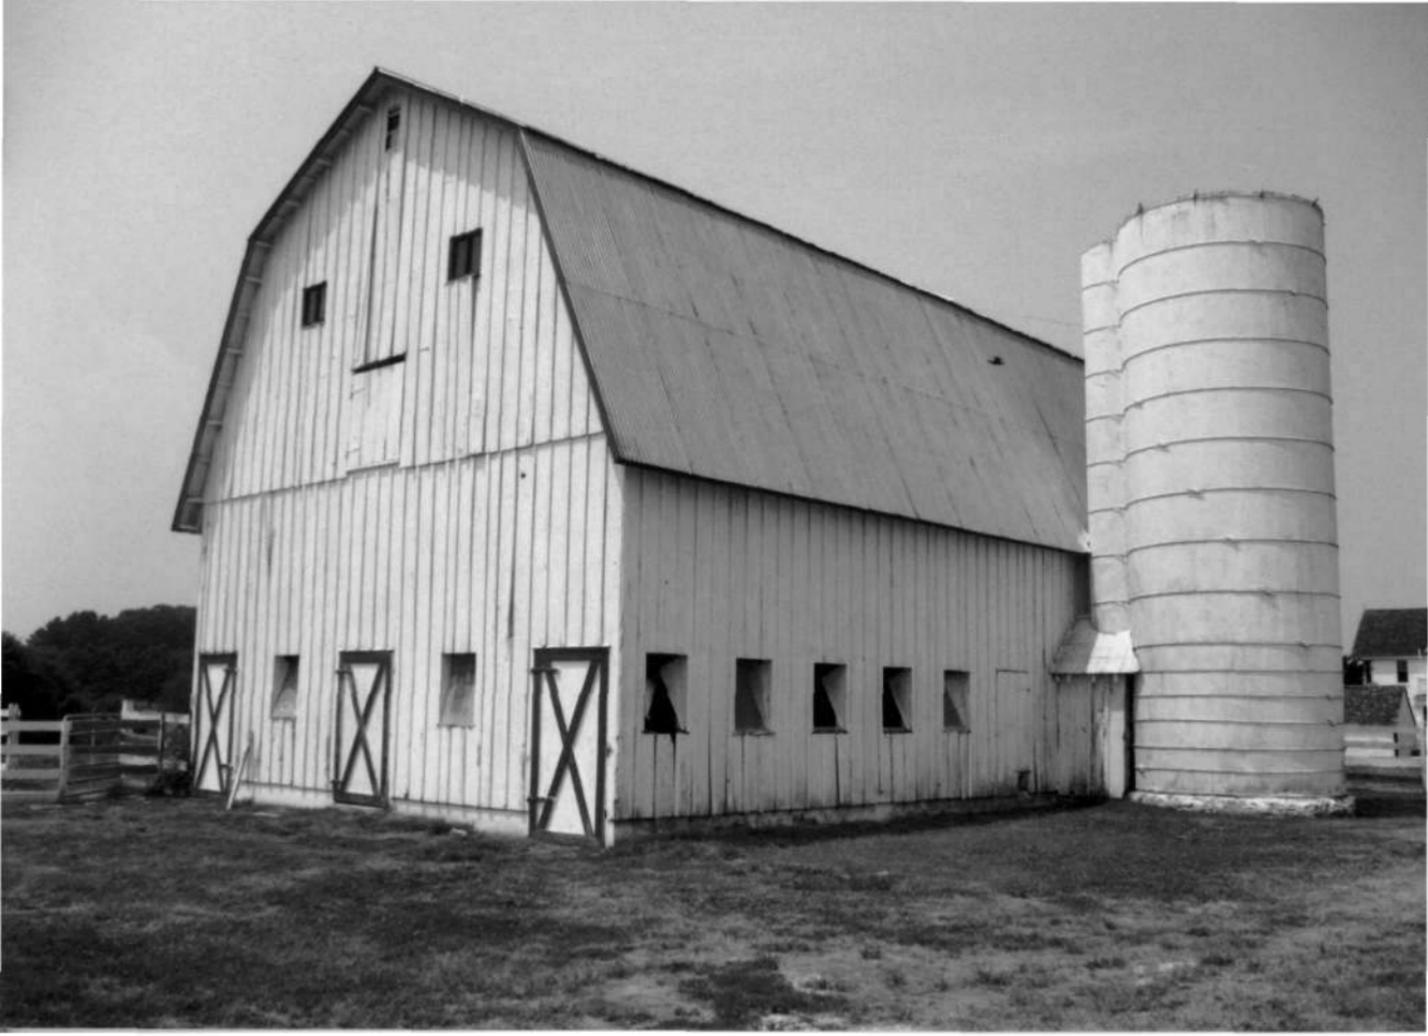
190P 24

by a gable-roofed, frame hyphen with board-and-batten siding. South of the silo, the east elevation contains five hopper windows and a plank door on strap hinges. A plank door, a small, two-light window and a single, sliding door are located north of the silo.

Dairy barn, south + east elevations, looking NW

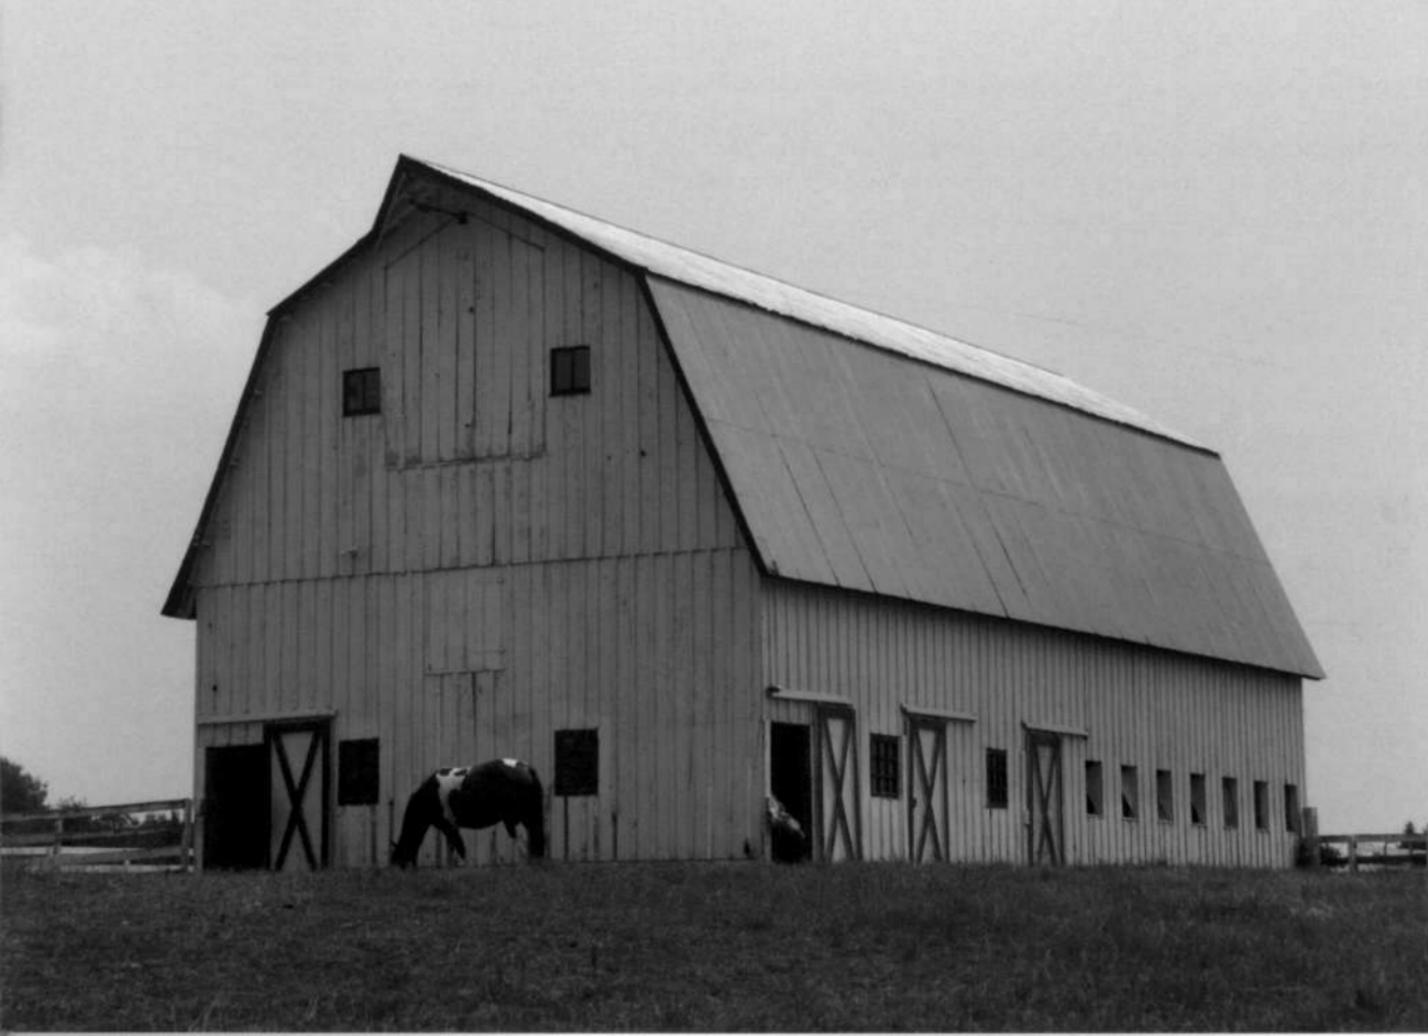
20 of 24

Dairy Barn, north + west elevations, looking SE

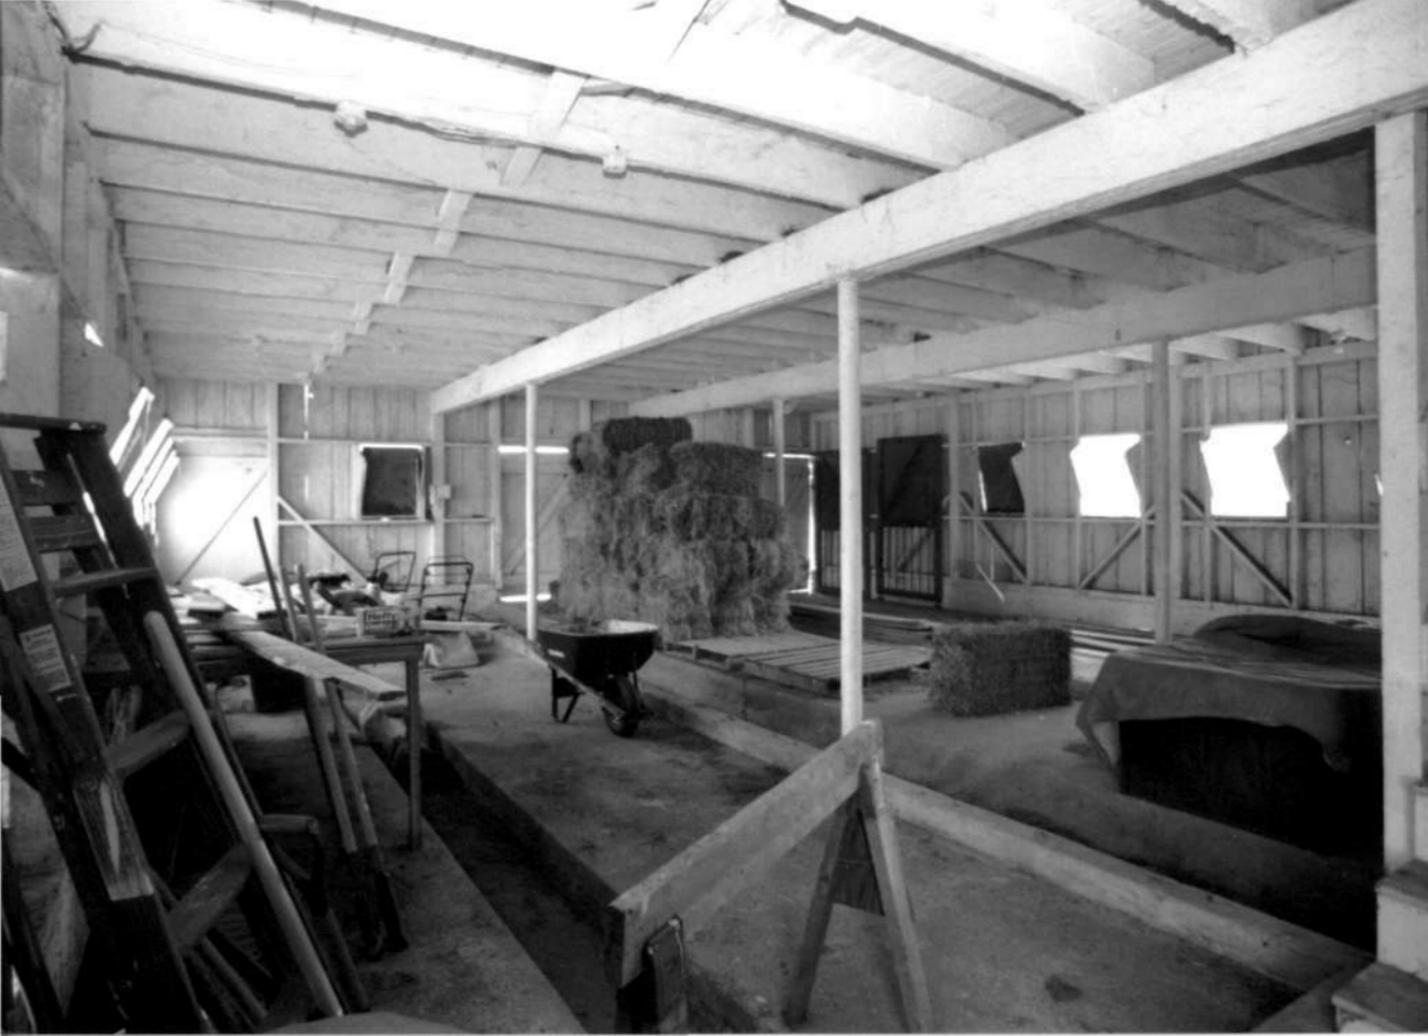
21 of 24

The south half of the barn's interior retains features associated with a dairying operation, including a poured concrete floor with feed and manure troughs on each side of a raised center area. The north half is delineated by a beadboard wall across the middle of the barn. Three stalls with vertical board siding, side and center aisles, and a dirt floor occupy the north half. Stairs to the second floor are centered in the partition wall between the north and south sides. The second floor is open except for railings around the stair opening.

Interior of Dairy Barn, south area, looking SW

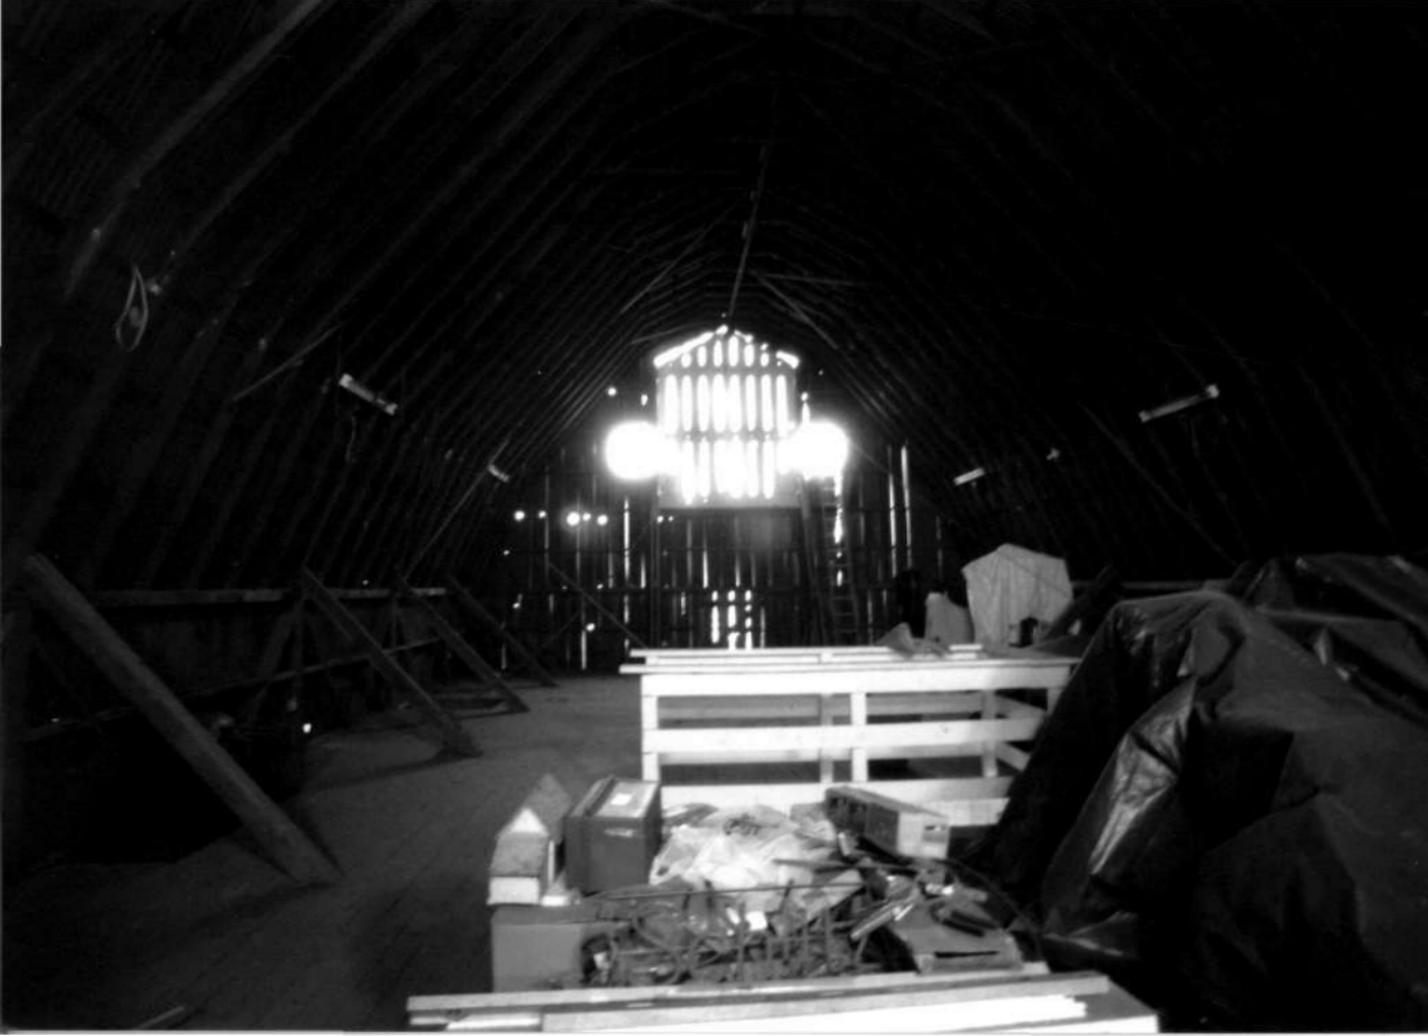
22 of 24

Interior of Dairy Barn, 2nd floor, looking S

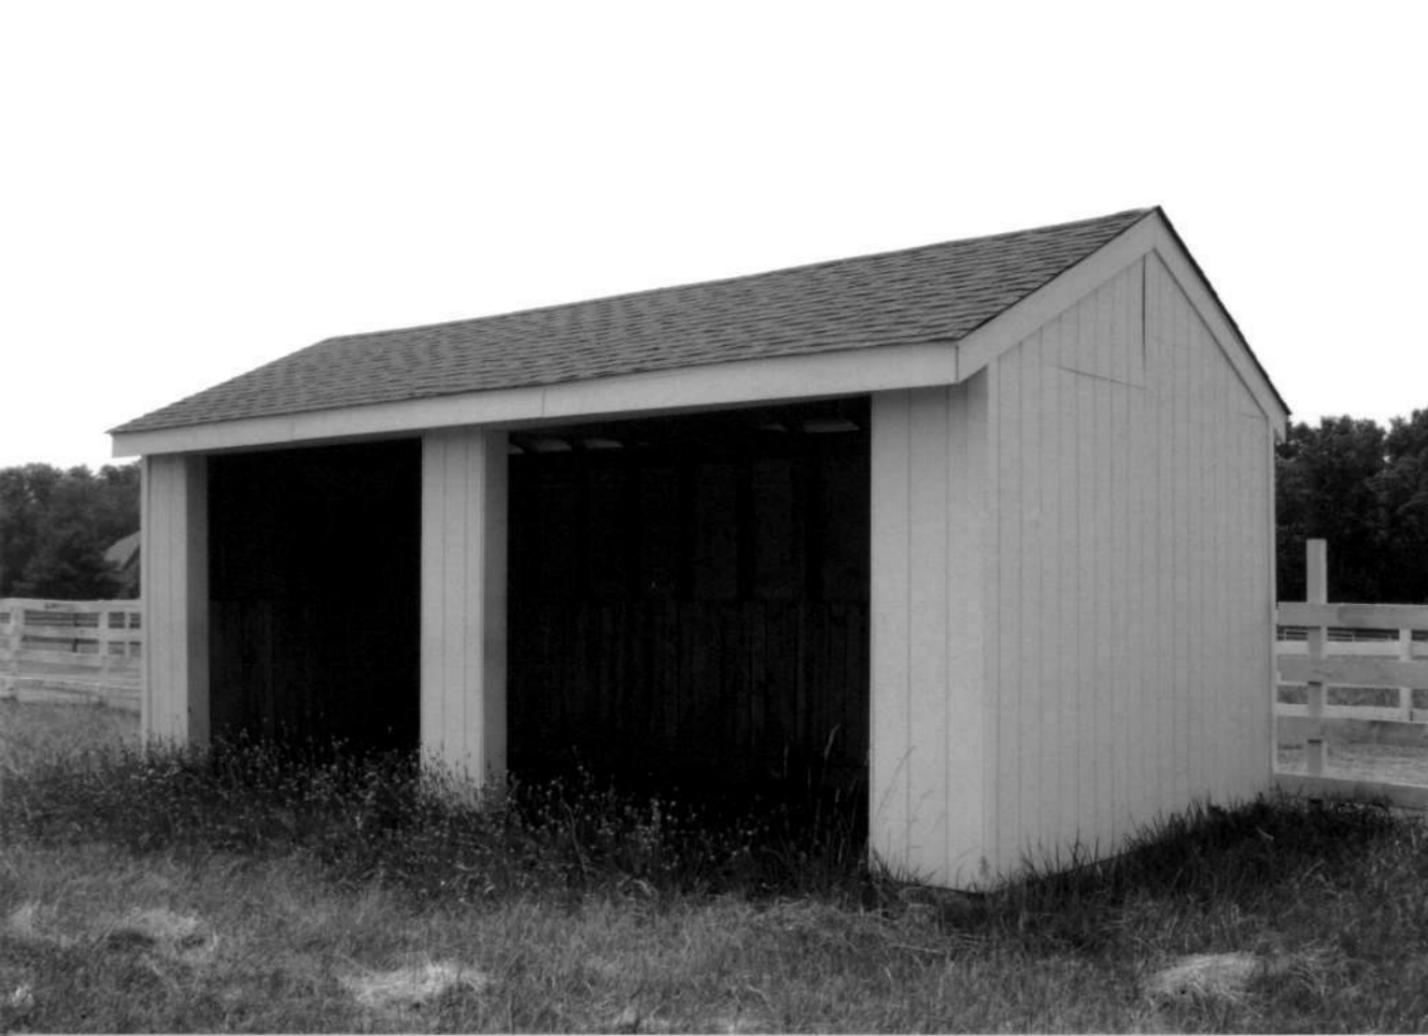
23 of 24

Located southeast of the barn in a pasture across the farm lane, a non-historic, one-story, side-gable, frame loafing barn provides a horse shelter. It has T-lil siding, an asphalt-shingle shed roof, and corner boards. Its two-bay interior is open to the east.

Loafing shed, looking SW

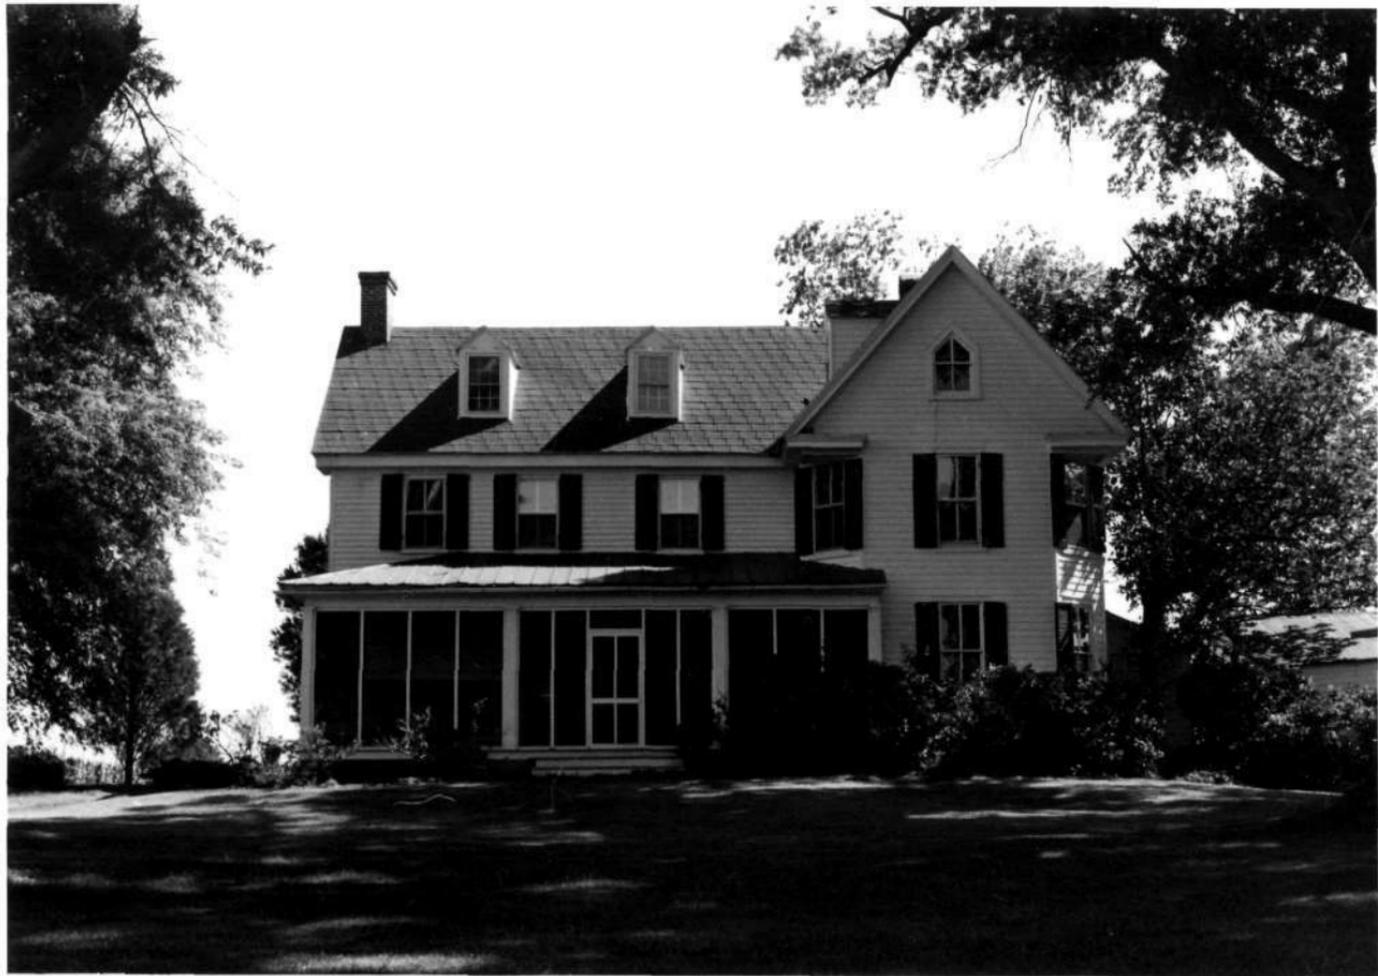
Bryan Farm
Grasonville vicinity
Orlando Ridout V 1979
Front facade from Southwest

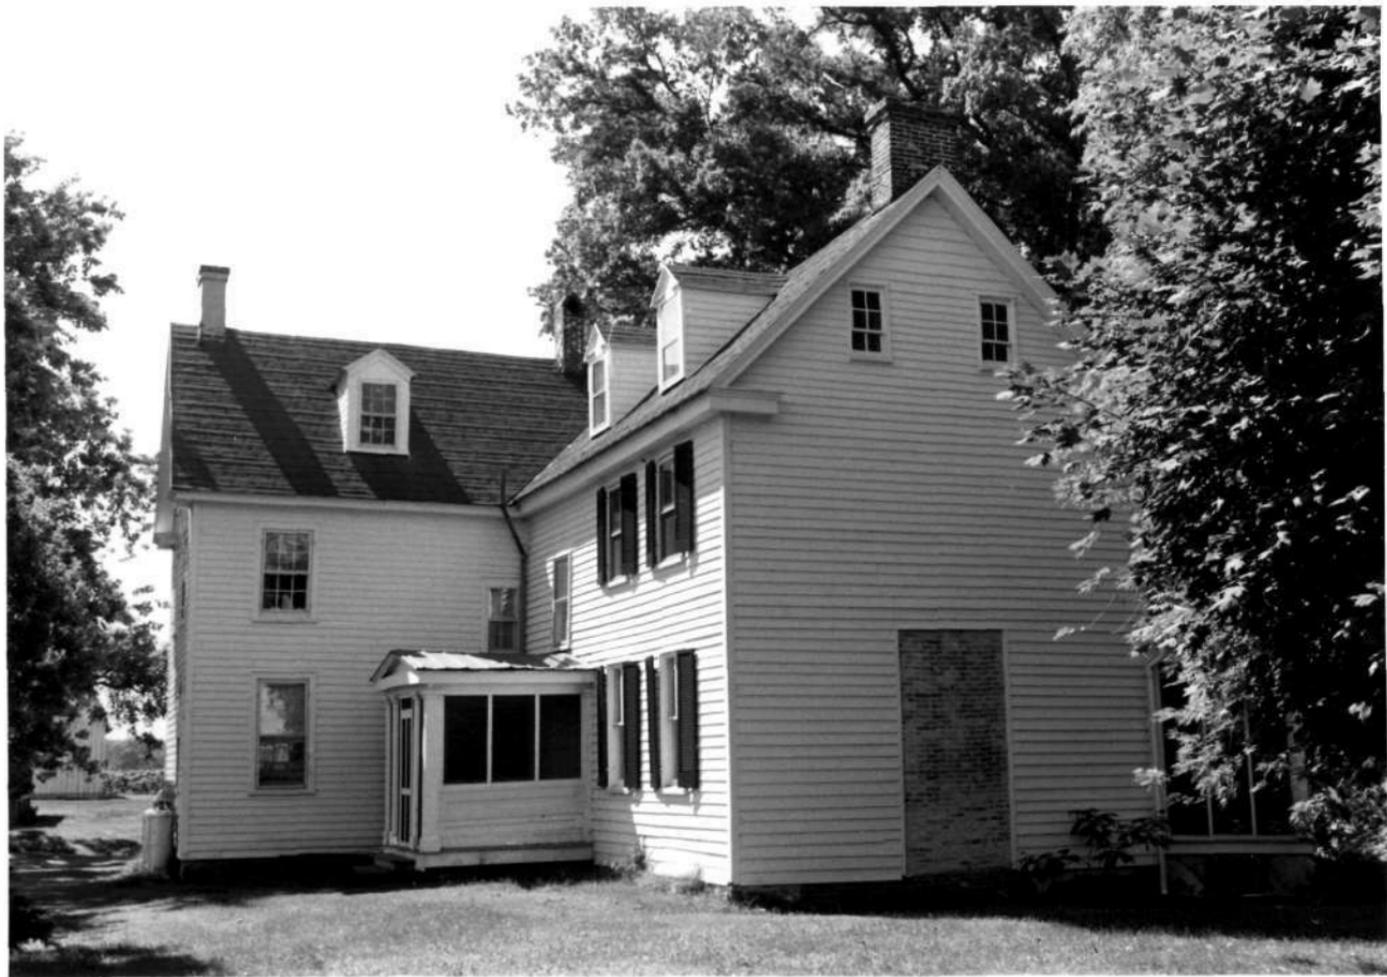
Bryan Farm
Grasonville vicinity
Orlando Ridout V 1979
View from Northeast^{west}
