INVENTORY FORM FOR STATE HISTORIC SITES SURVEY

Reed Leaverton Farm

Grange Hall Road

QA-128

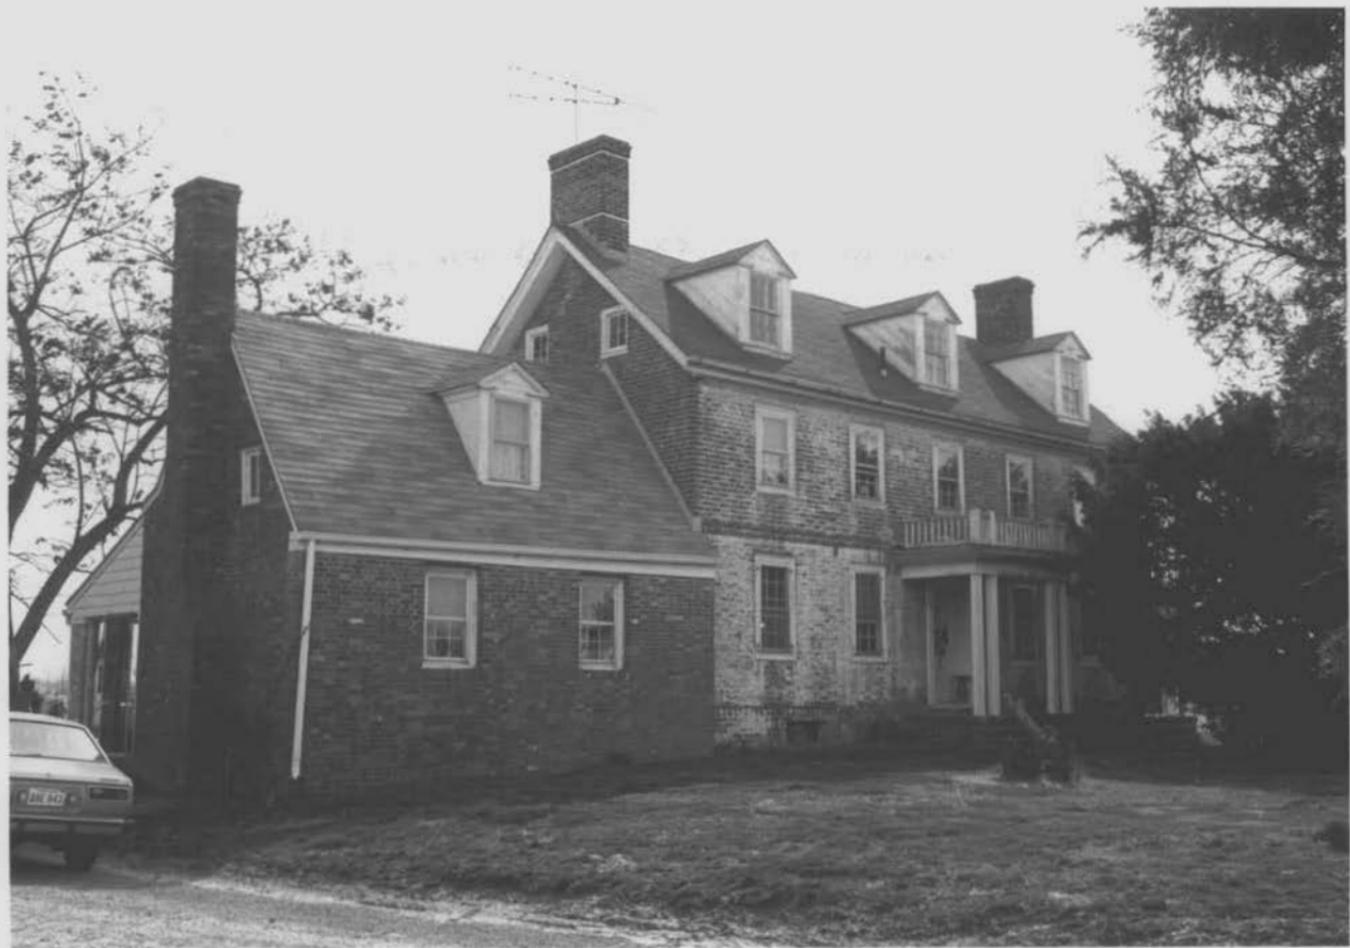
QA-128 Reed Leaverton Farm
 Queen Anne vicinity
 Orlando Ridout V 1981
 Front facade from Northeast

The front facade faces north toward the road. The principal entrance is located in the center bay of the first floor, flanked by two 9/6 windows on each side. Five 6/6 windows are ranged across the second floor, and three 6/6 pitched roof dormers have been added on the third floor in the 20th century. A pair of cellar window openings have been fitted with modern three-light metal sash. The brickwork is laid in Flemish bond above a plain water table and a three-course bond foundation. A two-course Flemish bond belt

course is carried across the facade and stops short of the gable corners. The eaves are boxed in and trimmed with a complex crown mold and bed mold; the roof is asphalt shingle. The cornice is carried up the gable eaves and appears to be post-Civil War in date. A one-story entrance porch in the center bay is a 20th century replacement for an earlier porch that evidently extended across the center three bays on the first floor. Other details of interest include the molded window frames and the shutter hooks and hinges for shutters on the first floor windows.

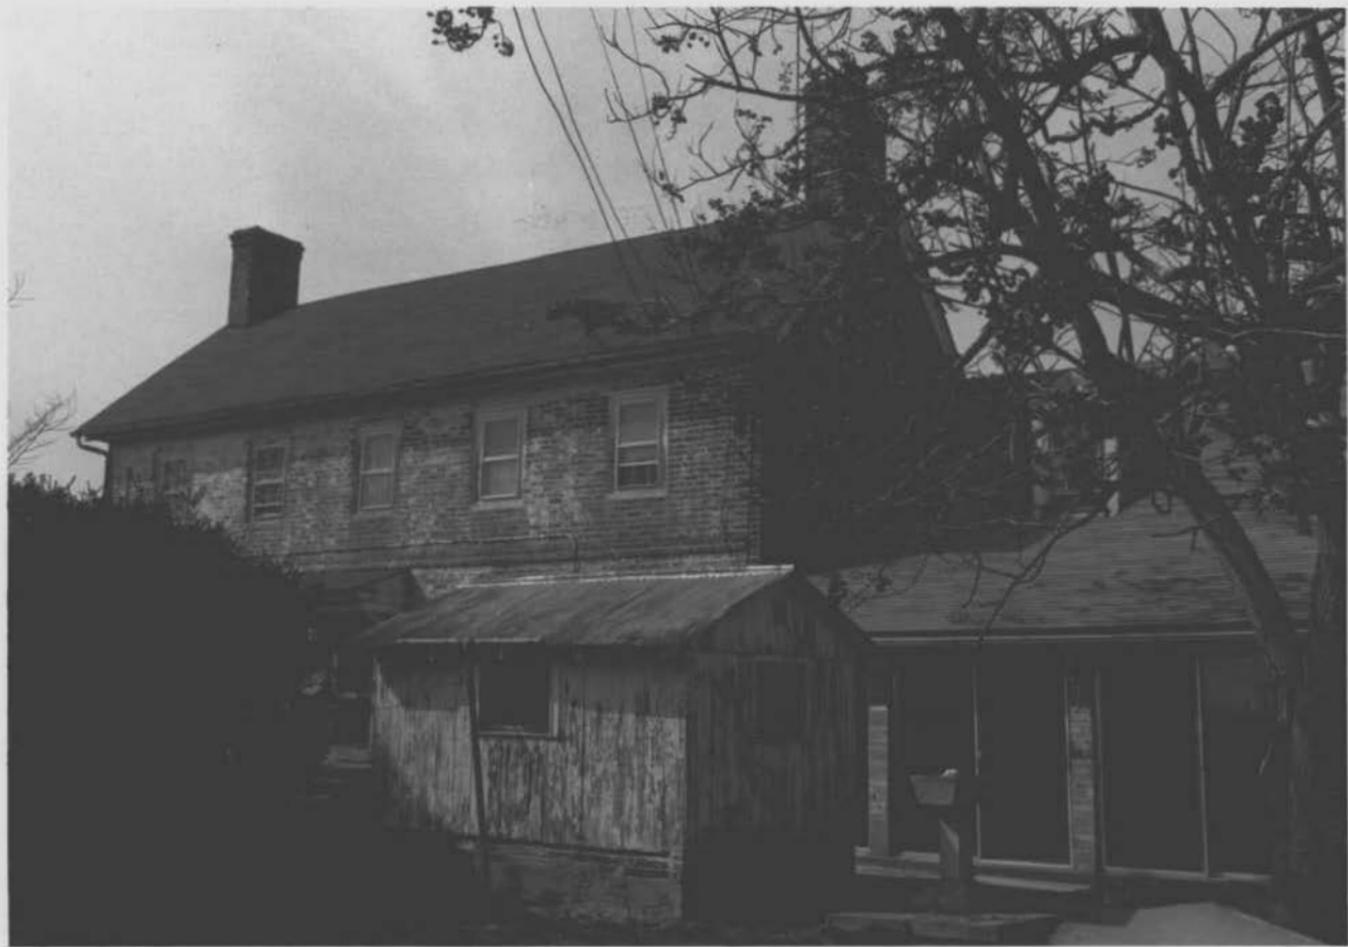
QA-128

Reed Leaverton Farm
Queen Anne vicinity
Orlando Ridout V 1981
Rear facade from Southeast

The rear facade, facing south, is virtually identical to the front facade. The door is located in the center bay flanked by two 9/6 windows on each side. There are five 6/6 windows on the second floor and no dormers on the third story. The brickwork and cornice are identical, including the two-course belt course and plain water table. Early trim survives on all window openings, but the door has been replaced.
