QA-129
Callahan Farm
Queenstown vicinity
Private

RE: Site visit to Philip Callahan Farm (QA-129)

INVENTORY FORM FOR STATE HISTORIC SITES SURVEY

Callahan Farm

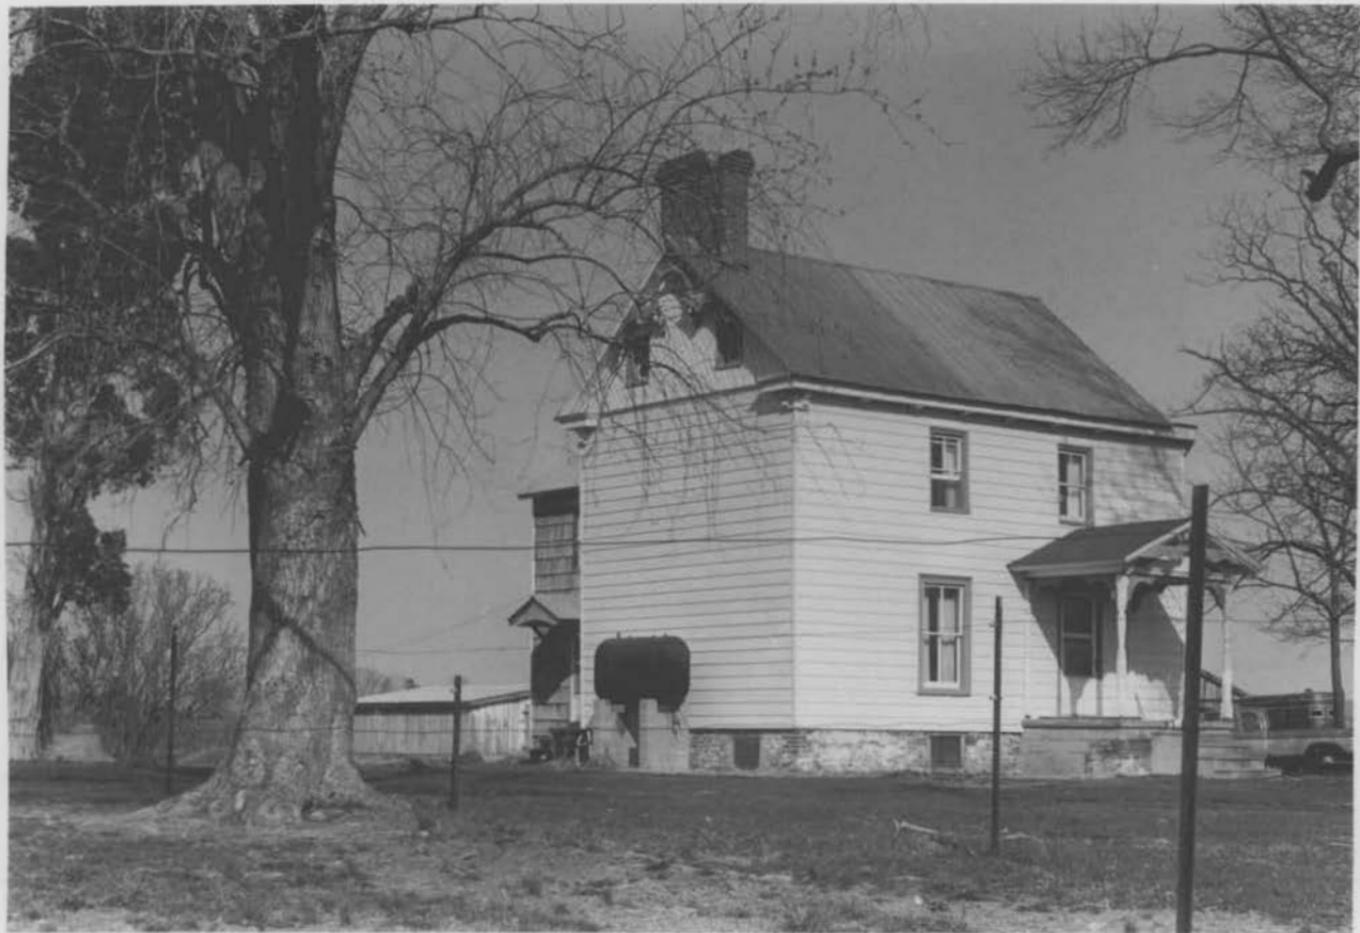
QA-129

The principal facade faces approximately south. There is a door in the east bay and a large 2/2 window in the west bay on the first story and two smaller 2/2 windows similarly placed on the second story. One cellar window is visible in the west bay; there are no dormer windows on the standing seam metal roof. The house rests on a brick foundation and is covered with aluminum siding. The eaves are boxed in and supported with scrolled brackets. A handsome Victorian gable roof porch at the east end of this

House from Southwest

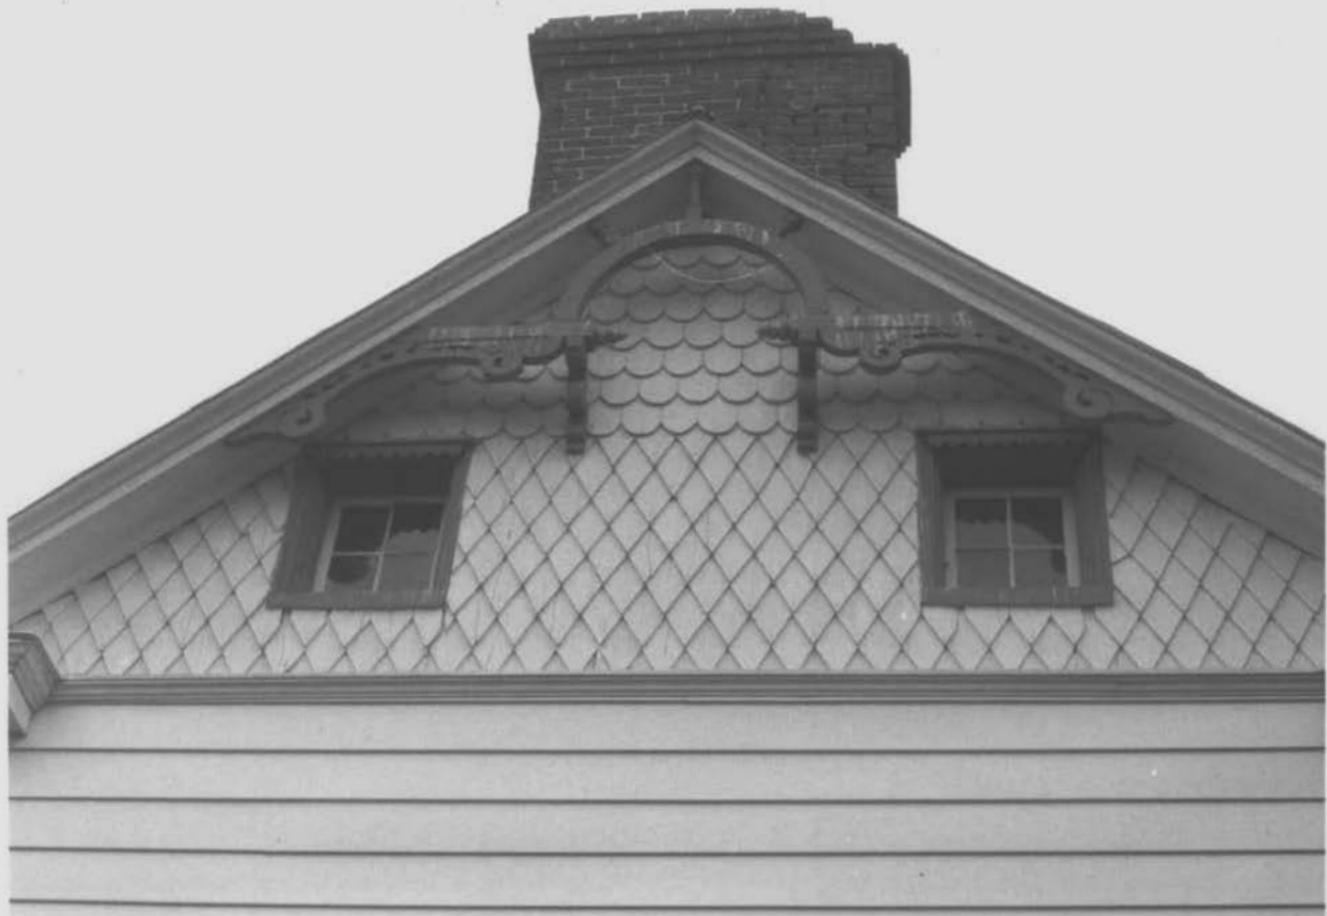
QA-129

The only openings in the west gable are a pair of cellar windows and two four-light windows flanking the chimney in the upper gable. The Victorian period cornice remains intact in the upper gable, with decorative wood shingle siding and elaborately scroll-sawn decorative work in the gable peak. The large corbeled chimney remains largely intact and is a clear indication that the house predates the Victorian period.

A pair of small windows in the upper gable are the only openings in the west gable facade. The aluminum siding is carried up to the top of the second story cornice, which returns at the corners. Decorative wood shingle siding survives above this point. The gable eaves are boxed and trimmed with a complex crown mold and decorative scrollwork verge boards enhance this portion of the house.

Callahan Farm
Queenstown vicinity
Rita Suffness, April 1979
Detail of west gable
