QA-169

Morgan's Enclosure  
Kent Island  
Private

INVENTORY FORM FOR STATE HISTORIC SITES SURVEY

**Morgan's Enclosure**

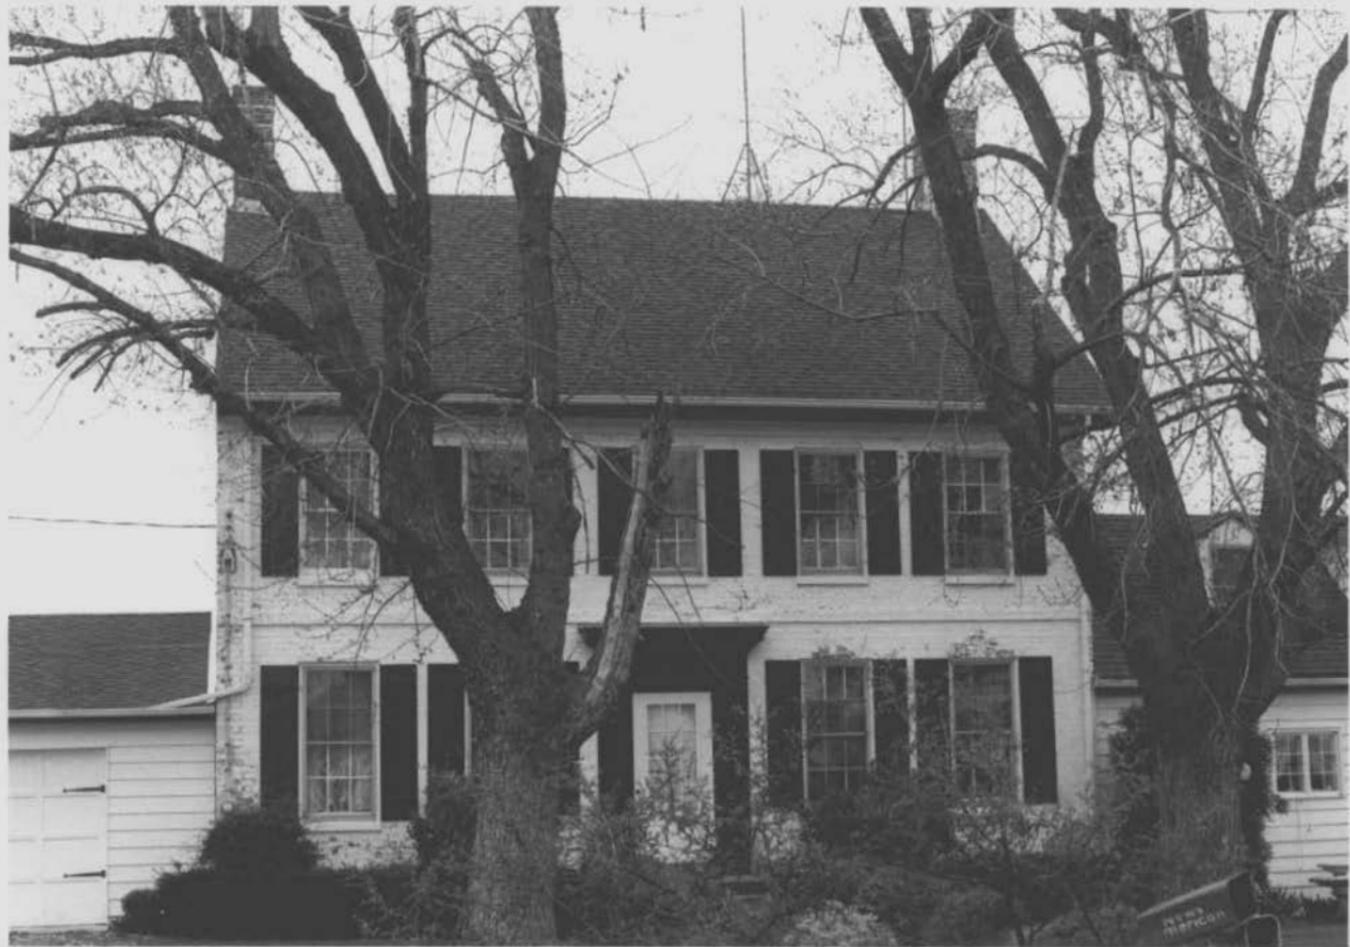
QA-169

6/6 windows on the second floor. Cellar windows are centered below each first floor window. The ornate door surround on the west facade and the box cornices on both facades are 20th century.

Morgan's Enclosure  
Romanceke  
Kent Island  
Orlando Ridout V 1980  
West facade

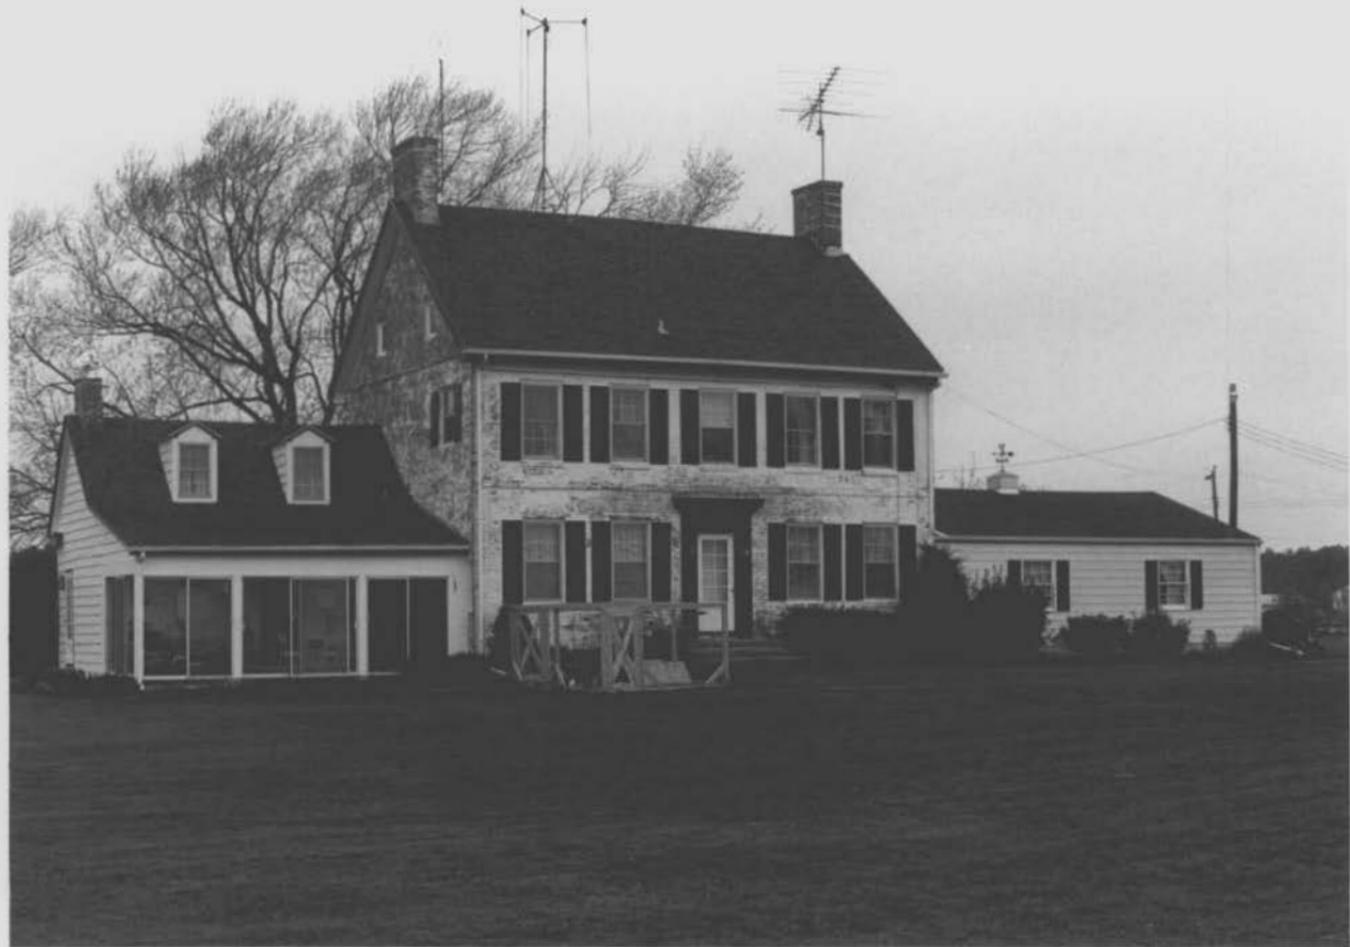
QA-169

East facade
