INVENTORY FORM FOR STATE HISTORIC SITES SURVEY

Horace Holden Farm

QA-17

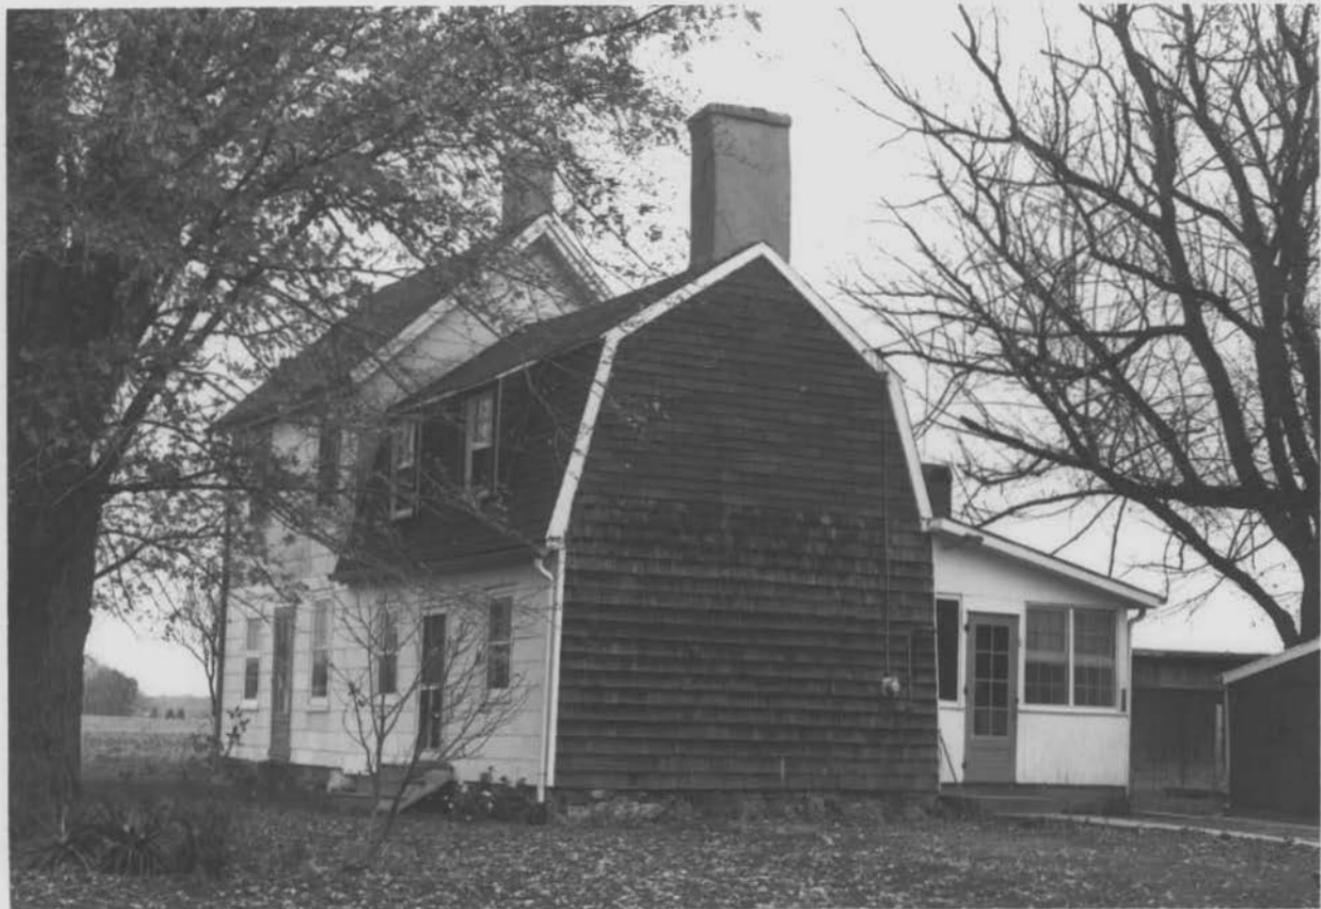
QA-17 Horace Holden Farm
Church Hill, Maryland
Orlando Ridout V 1981 *west*
Front facade from Southeast

The principal facade of the early house faces northwest to the road. The door is located in the center bay, flanked by single 2/2 windows on each side, presumably replacing original 6/6 sash. There are two shed roof dormers on the second story, one with 6/6 sash, the other with 2/2 sash. The building rests on a continuous brick foundation

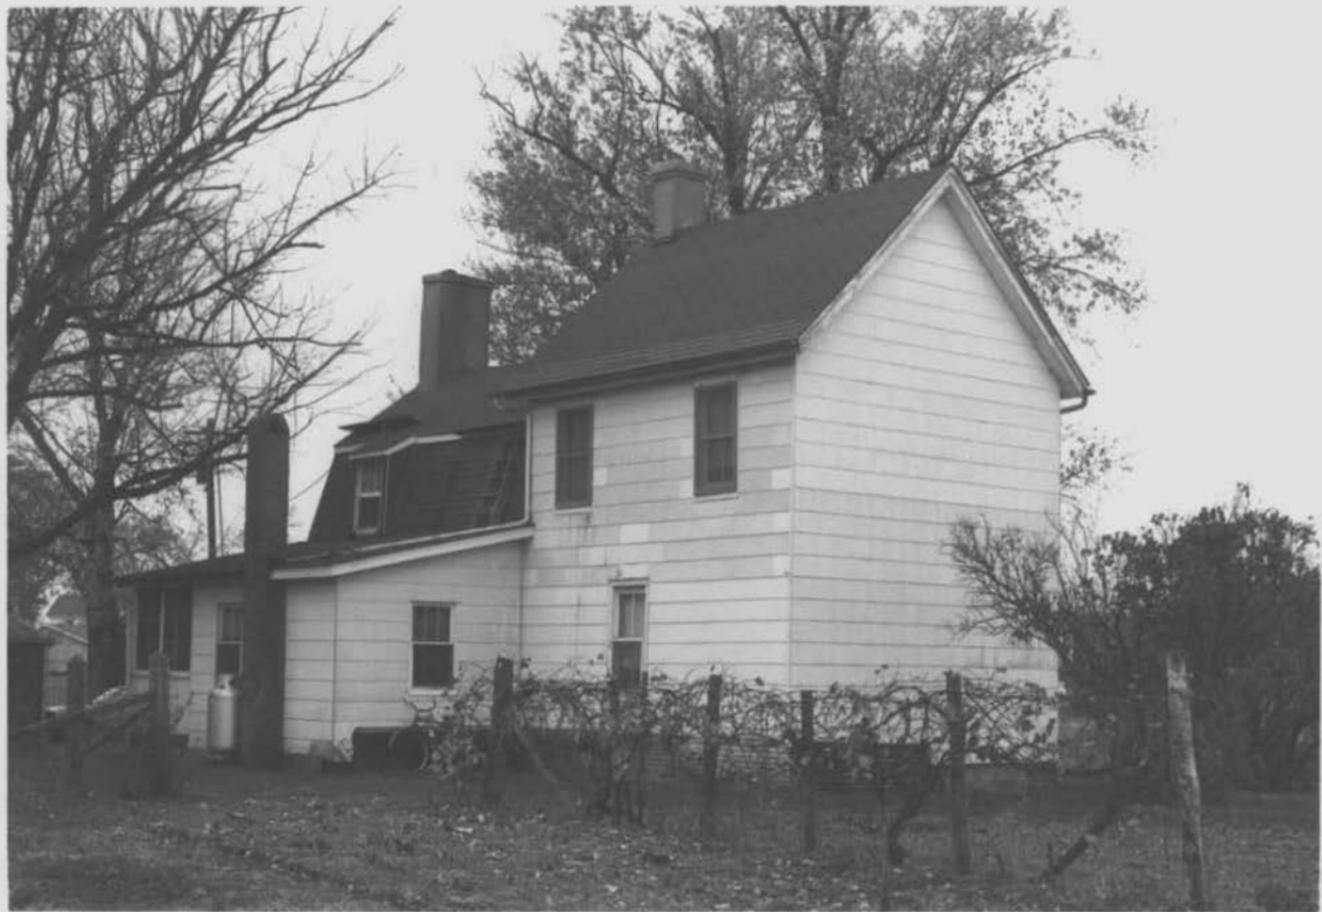
QA-17 Horace Holden Farm
Church Hill, Maryland
Orlando Ridout V 1981
Rear facade from northeast

A one story lean-to addition covers most of the rear facade. A door in the center of the first floor opens into the lean-to. There is one 6/6 shed roof dormer in the south bay of the second story. Plain horizontal siding survives intact on one section of the rear wall now protected by the lean-to.
