QA-24
McGinnes Farm
Crumpton
Private

INVENTORY FORM FOR STATE HISTORIC SITES SURVEY

McGinnes farm, Schumann farm, Thomas McGinnes Farm

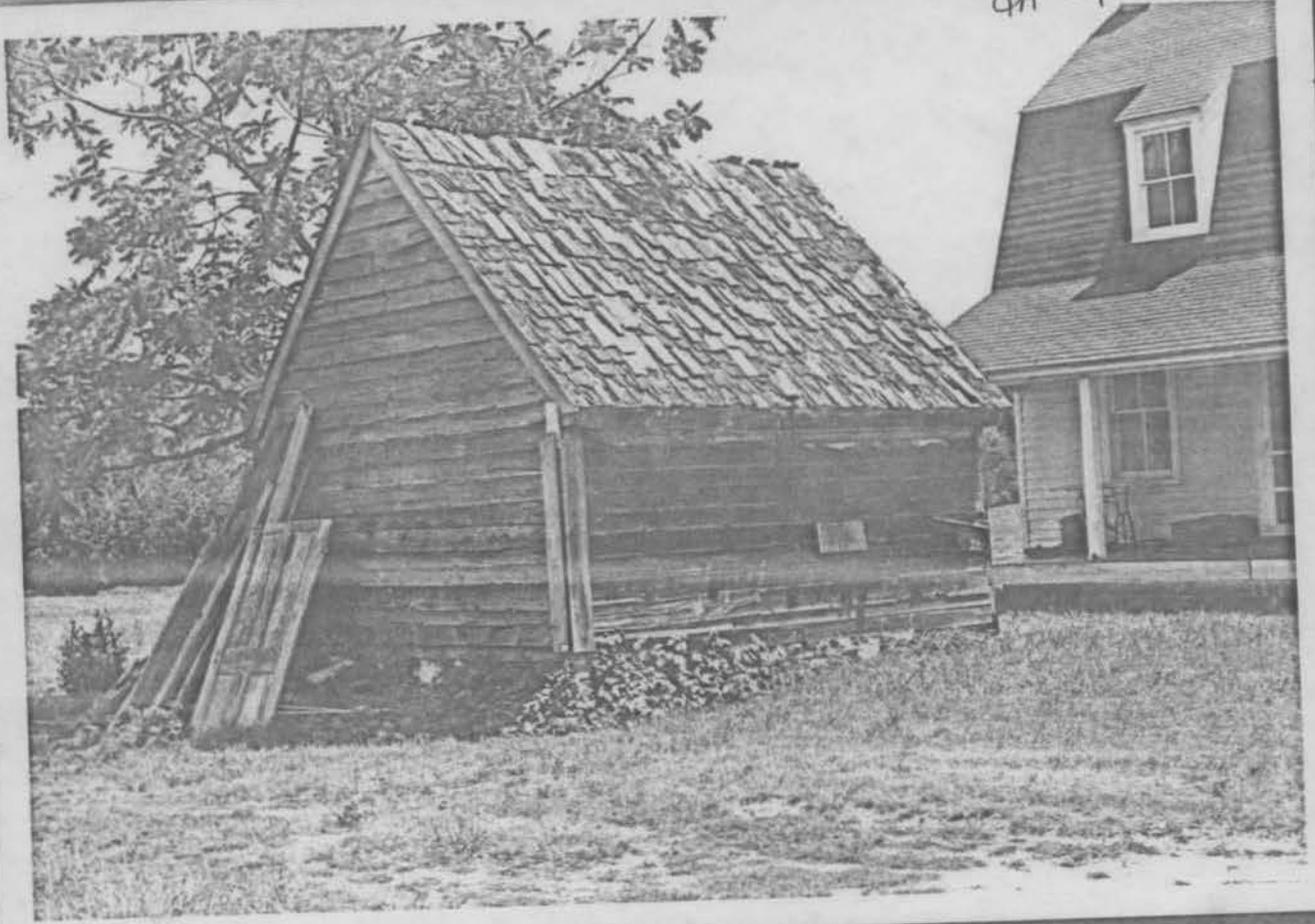
QA-24
Thomas McGinnes Farm

Mary McCarthy
Spring/Summer 2003
Digital color photo on file at MHT

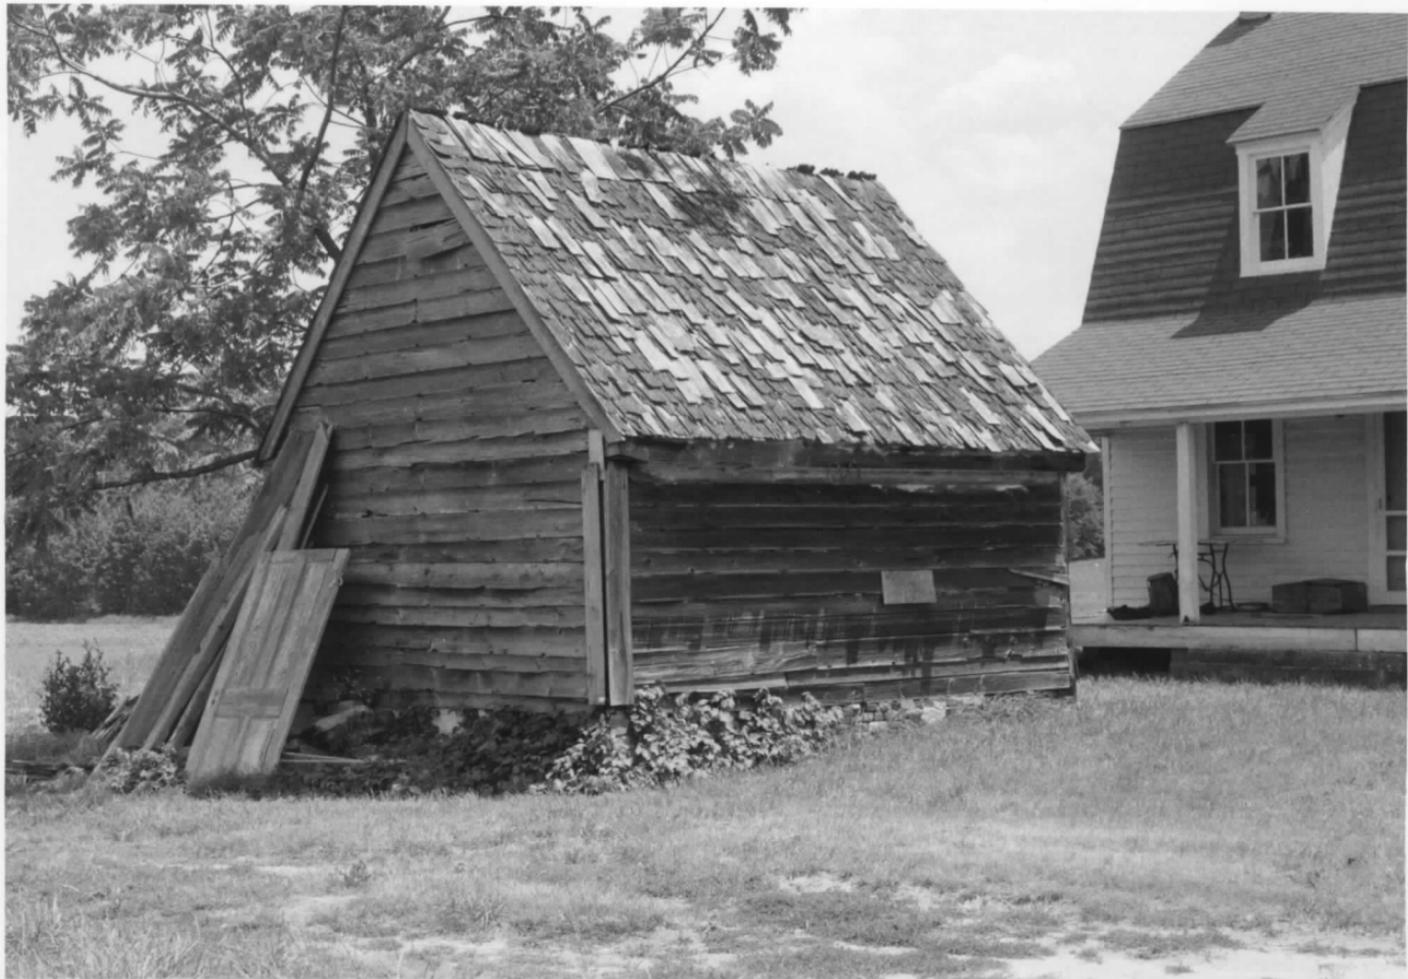
QA-24

McGuinness House, smokehouse
(Ford Schumann farm)

The post-and-plank smokehouse adjacent to the house is of particular interest. Although approximately two dozen examples of post-and-plank construction have been recorded in Tidewater

Maryland, this is only the second example in which the planks are secured using a dovetail joint rather than the more common mortise-and-tenon joint.
