**National Register of Historic Places
Inventory—Nomination Form**

historic Stevensville Bank

Stevensville Bank
Continuation sheet Queen Anne's County, MD Item number 7 Page 1

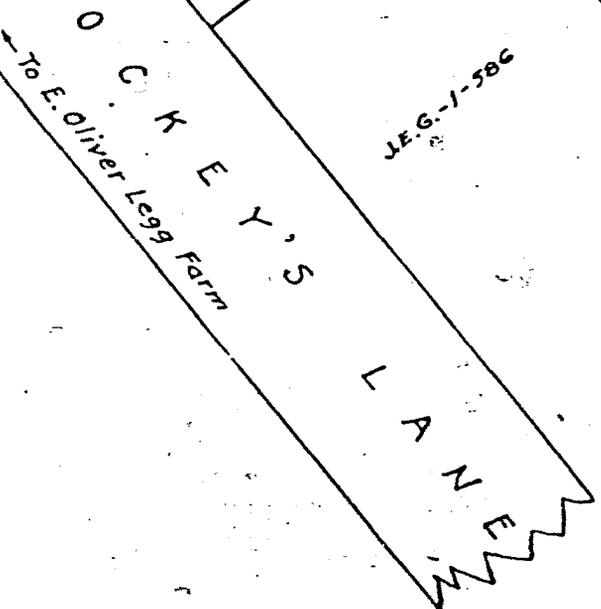
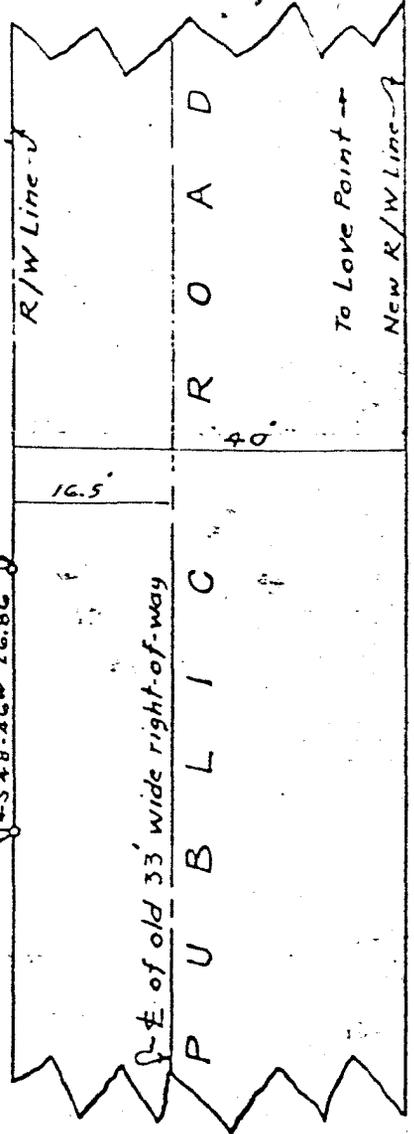
QA-264
STEVENSVILLE BANK
QUEEN ANNE'S COUNTY,
MARYLAND

MAP SHOWING SURVEY OF
A LOT OR PARCEL OF LAND
FOR
THE STEVENSVILLE BANK OF MARYLAND
Stevensville, Queen Anne's Co., Md.
Scale: 1"=20' 2-17-61 Shew & Bartlett, Engrs
Rc9-1676

Verbal boundary description and justification Boundaries are depicted on the attached plat and comprise the single town lot historically associated with the resource.
