INVENTORY FORM FOR STATE HISTORIC SITES SURVEY

Walker-Wagner House

Romancoke

QA-274

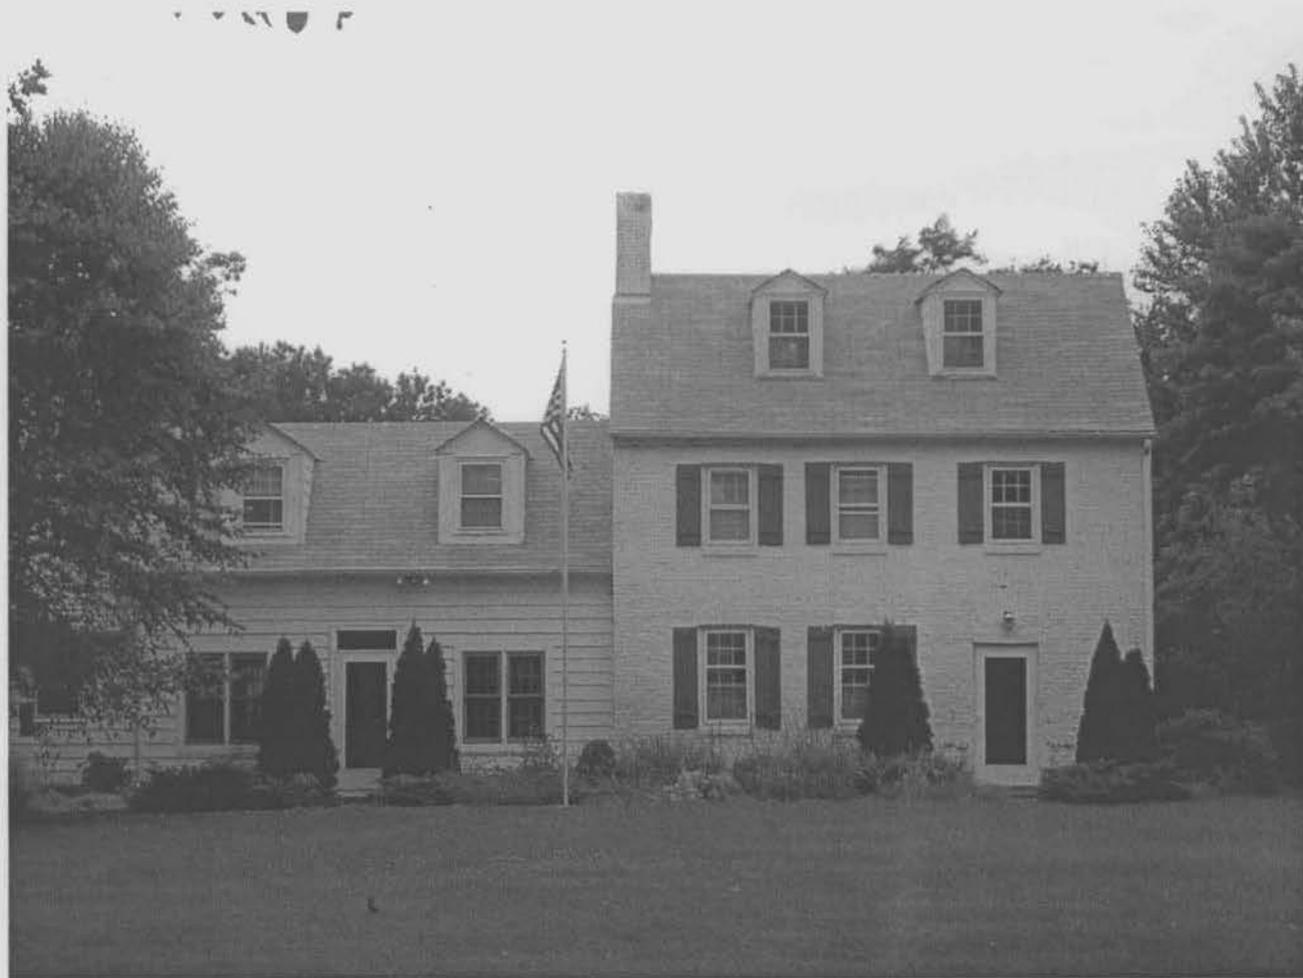
QA-274
Walker-Wagner House

Mary McCarthy
Spring/Summer 2003
Digital color photo on file at MHT

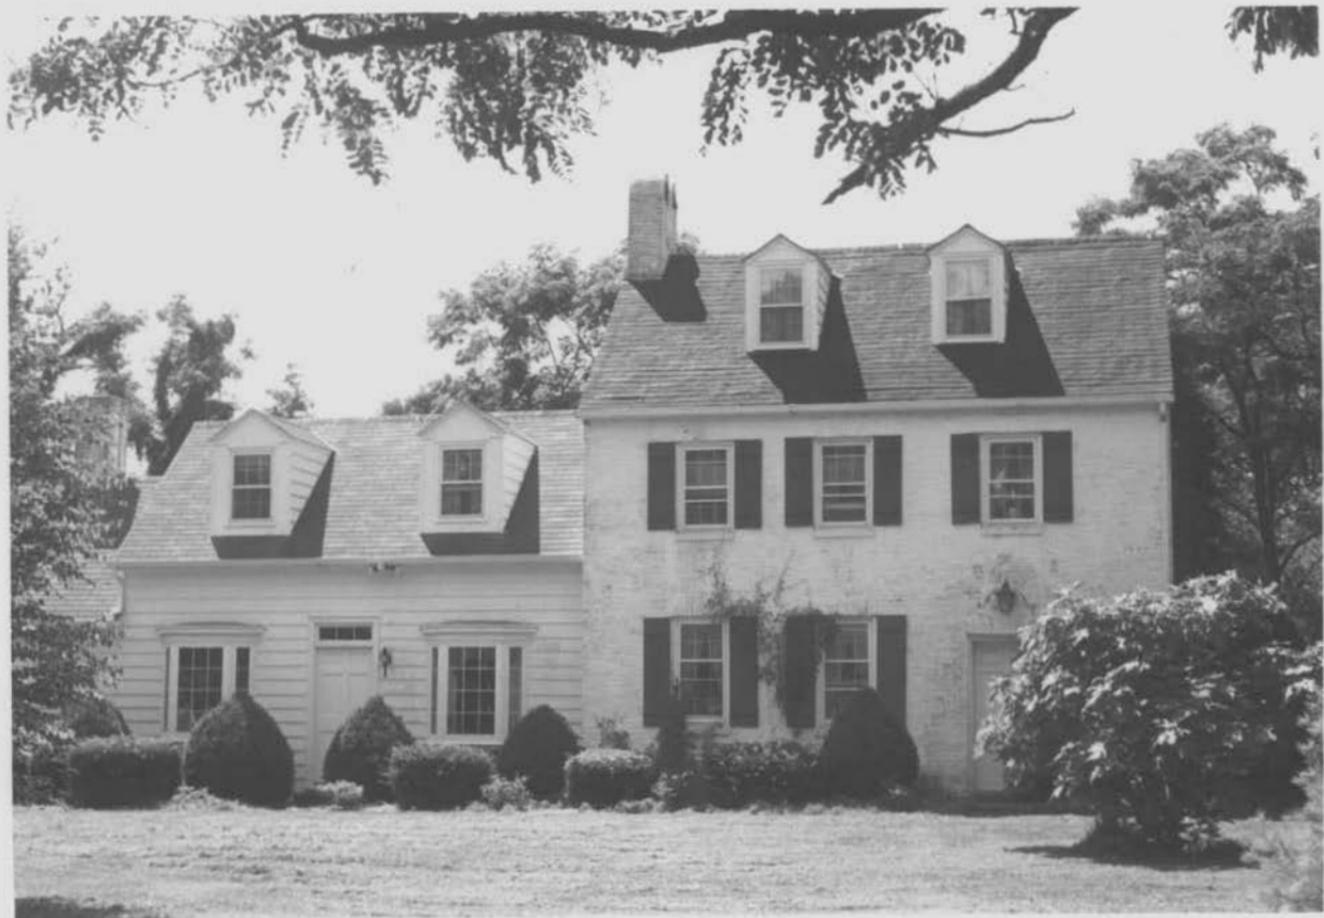
QA-274 Walker-Wagner House
Romanceke vicinity
Orlando Ridout V 1981
East facade

The front facade of the main house faces east toward Eastern Bay. The door is located in the north bay, with two 6/9 windows to the south, three 6/6 windows ranged across the second story and two 6/6 pitched roof dormer windows on the third story. The brickwork is laid in five- and six-course common bond with a two-course corbeled cornice. The first and second floor openings have splayed jack arch lintels. The roof is covered with asphalt shingles.

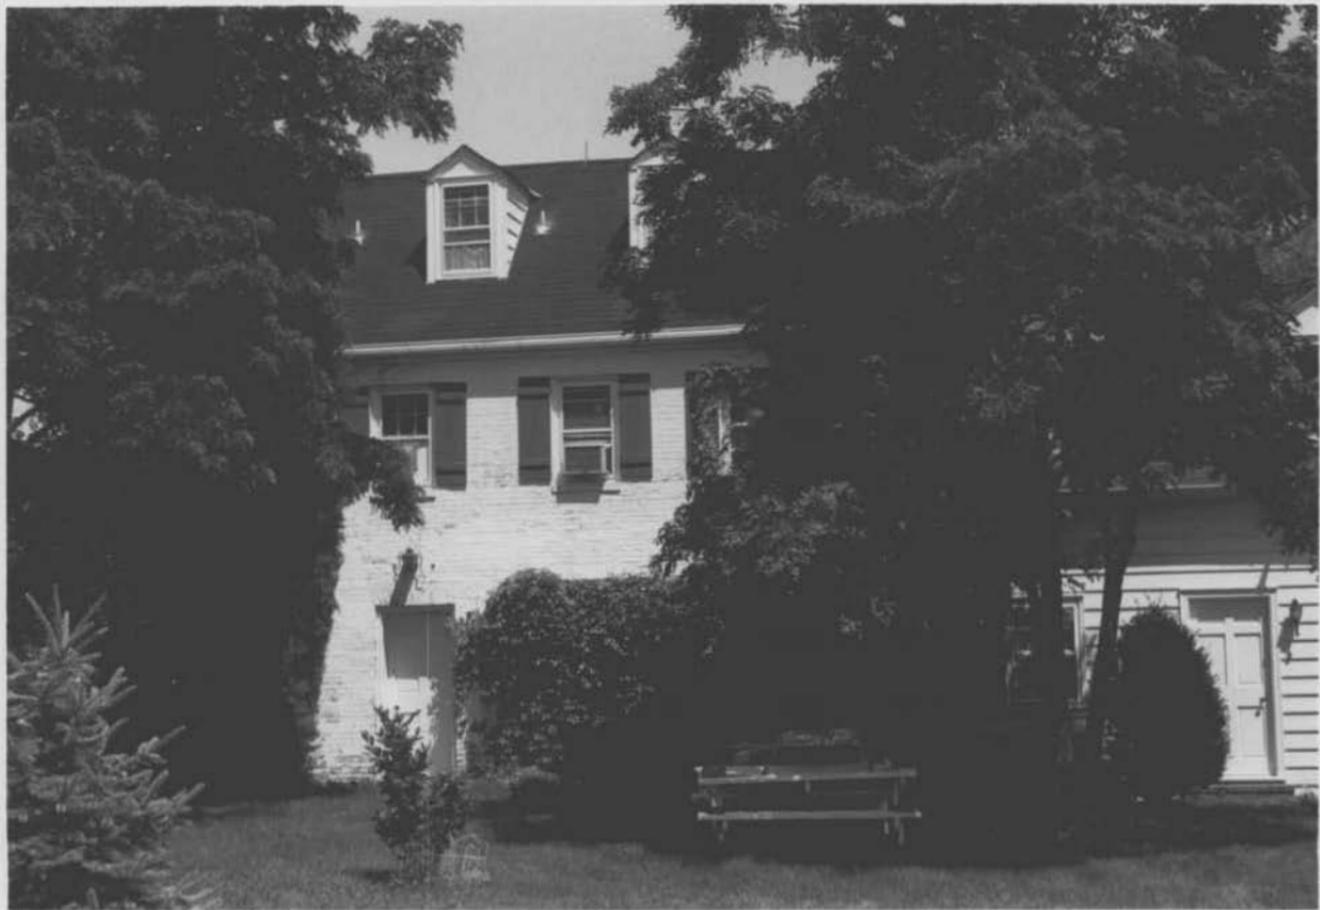
QA-274

Walker-Wagner House
Romanceke vicinity
Orlando Ridout V 1981
Rear facade from west

The west facade now serves as the rear facade, but in the 19th century may have been considered the front facade, as it faces the original driveway leading in from Route 8. The placement of the interior stair reinforces this possibility. The door is located in the north bay, with two 6/9 windows to the south, three 6/6 windows on the second floor and two 6/6 pitched roof dormers on the third story. The brickwork is random bond with a corbeled cornice and splayed jack arch lintels.
