INVENTORY FORM FOR STATE HISTORIC SITES SURVEY

part of Cloverfields

John Benton farm

Q4-2986 Benton Farm Smokehouse

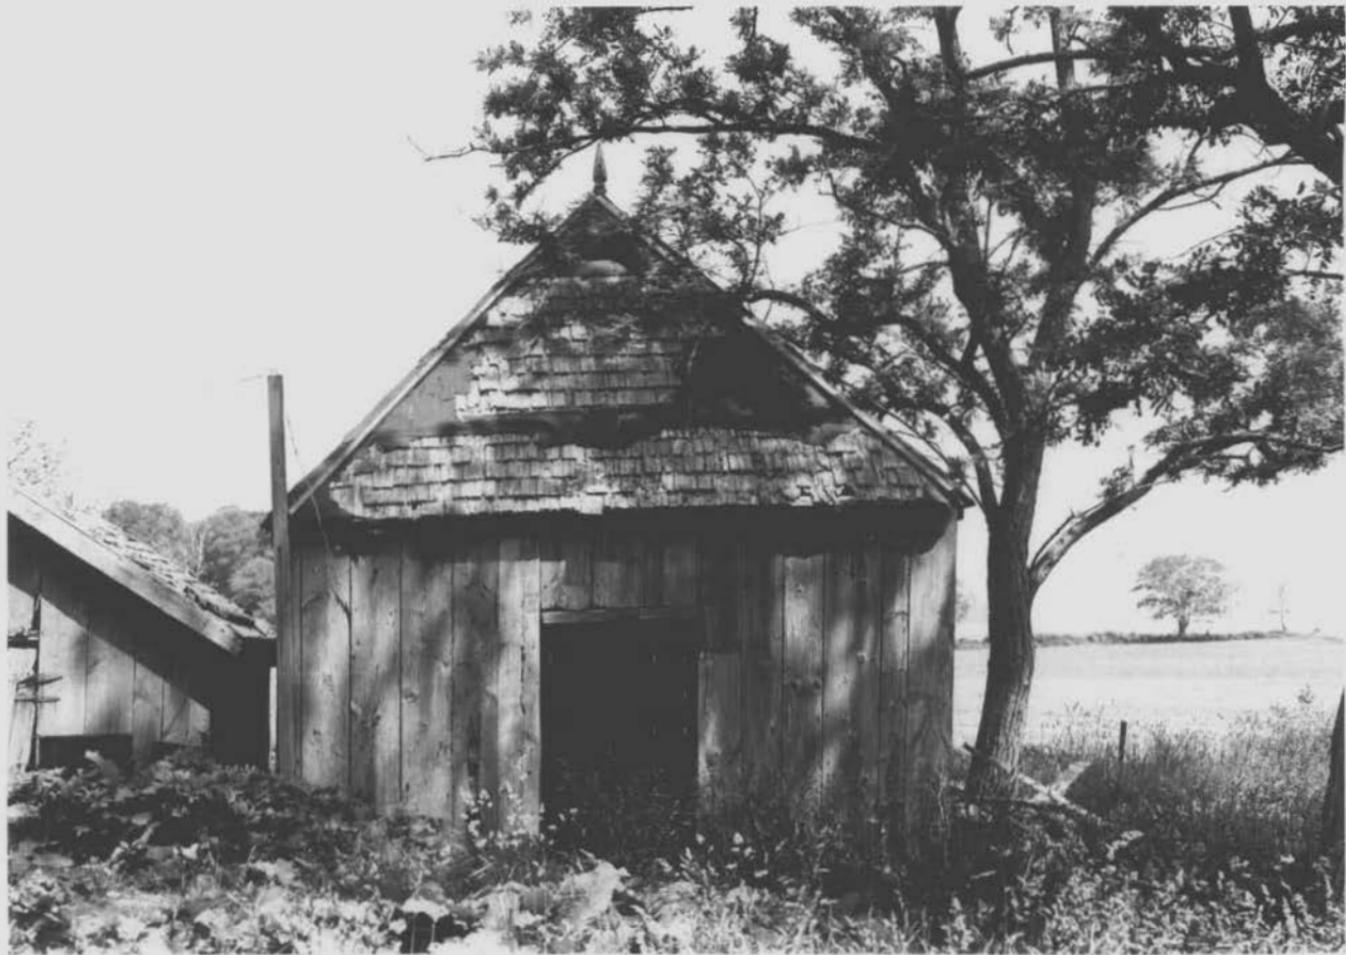
The smokehouse is located to the northeast of the house and faces south. It is fourteen feet square, with a pyramidal roof covered with weathered shingles and surmounted by a weathered, pyramidal finial. The exterior is covered with random width unbeaded boards secured with machine nails and later wire nails.

A crude foundation consisting of a single soldier course of bricks laid directly on the ground without mortar supports hewn 7 1/2 x 8 inch sills. The corner posts average 6 1/2 x 6 inches, and are mortised into the sill and top plate. The top plates run from corner to corner, with the side wall plates mortised into them. One intermediate post is centered on each wall except the front wall, where two intermediate posts flank the door. These are laid against the interior face of the sawn log planks, and are mortised into the sill and the top plate. The planks are laid horizontally, set into the corner posts in individual mortises, with a single peg driven into each corner post and intermediate post. The pegs are sawn off flush with the face of the intermediate posts, but the
