National Register of Historic Places
Inventory—Nomination Form

historic Kennersley

state Maryland code 24 county Queen Anne's code 035

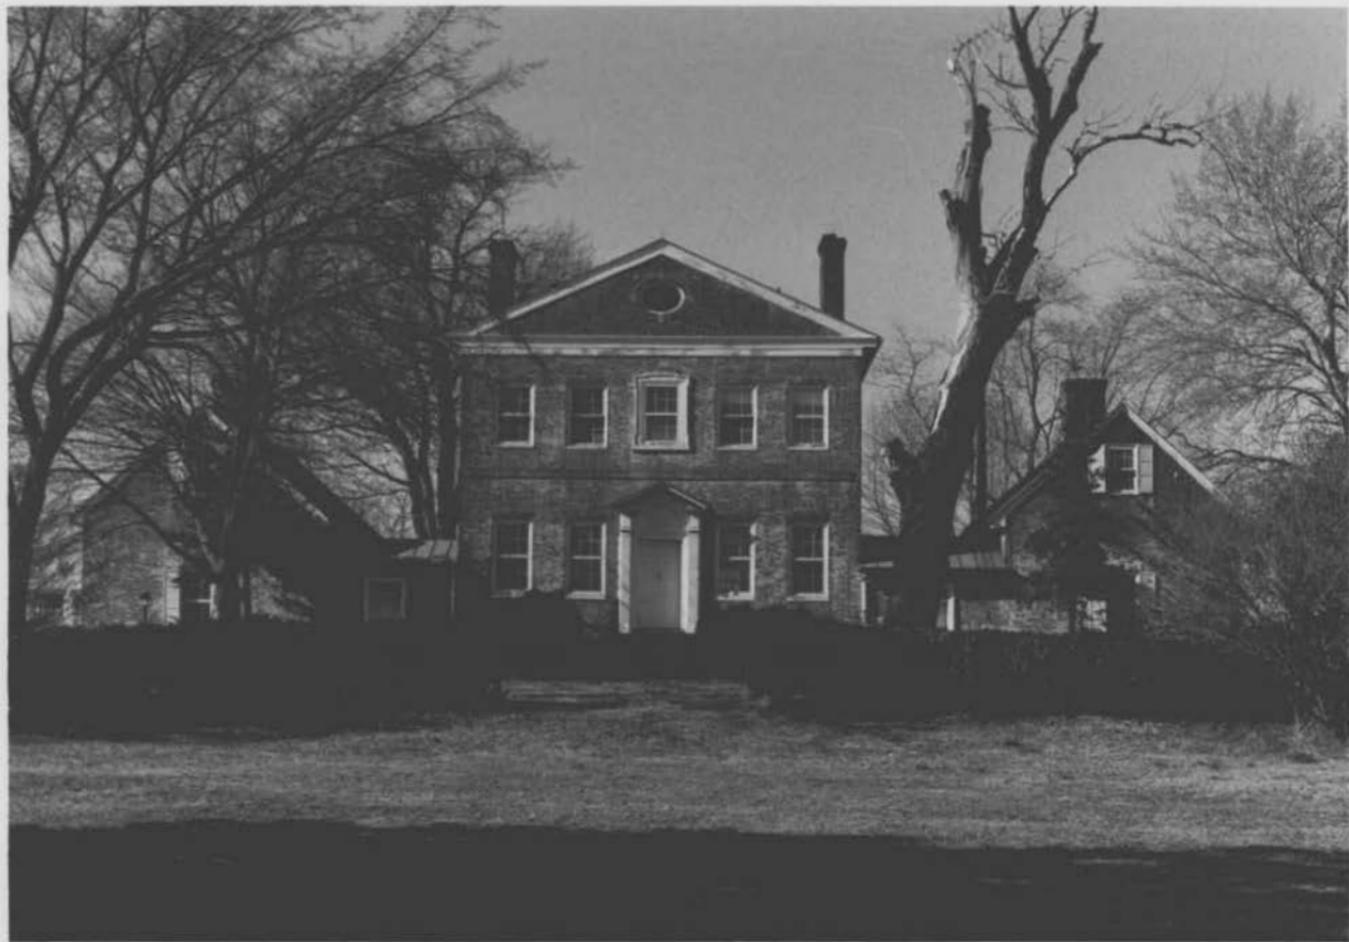
QA-3

Kennersley
Church Hill vicinity
Michael O. Bourne, 1968
Front Facade
(South)

The front or south facade of all five parts of the house are flush, with no set-backs to increase visual separation of the hyphens and/or the wings. The central block is five bays wide with a large entrance door in the center bay on the first floor and two large 6/6 windows flanking the door on either side. There are five 6/6 windows on the second floor, and a circular bullseye window in the upper gable. Four eight-light cellar windows are located directly below the first floor window openings, set in heavy wood frames with restored vertical diamond-section wood bars. The first floor door is framed with reeded pilasters supporting a classical pediment; the center window on the second floor is framed with a handsome crossetted surround.

The brickwork on this facade is laid in Flemish bond above a plain water table and a two- to four-course bond foundation. A three-course Flemish bond belt course stretches across the facade between the first and second story. The window openings have splayed jack-arch lintels one brick high. The upper gable is pedimented, with a simple, rebuilt box cornice and wide frieze carried across the base of the gable and wide beaded but untapered rakeboards carried up the gable eaves. The bullseye window in the center of the tympanum replaces a 6/6 sash window visible in photographs taken by Frances Benjamin Johnston in the 1930s. That window may have been an earlier alteration, however, as there is evidence of altered brickwork around the opening in the same photographs.

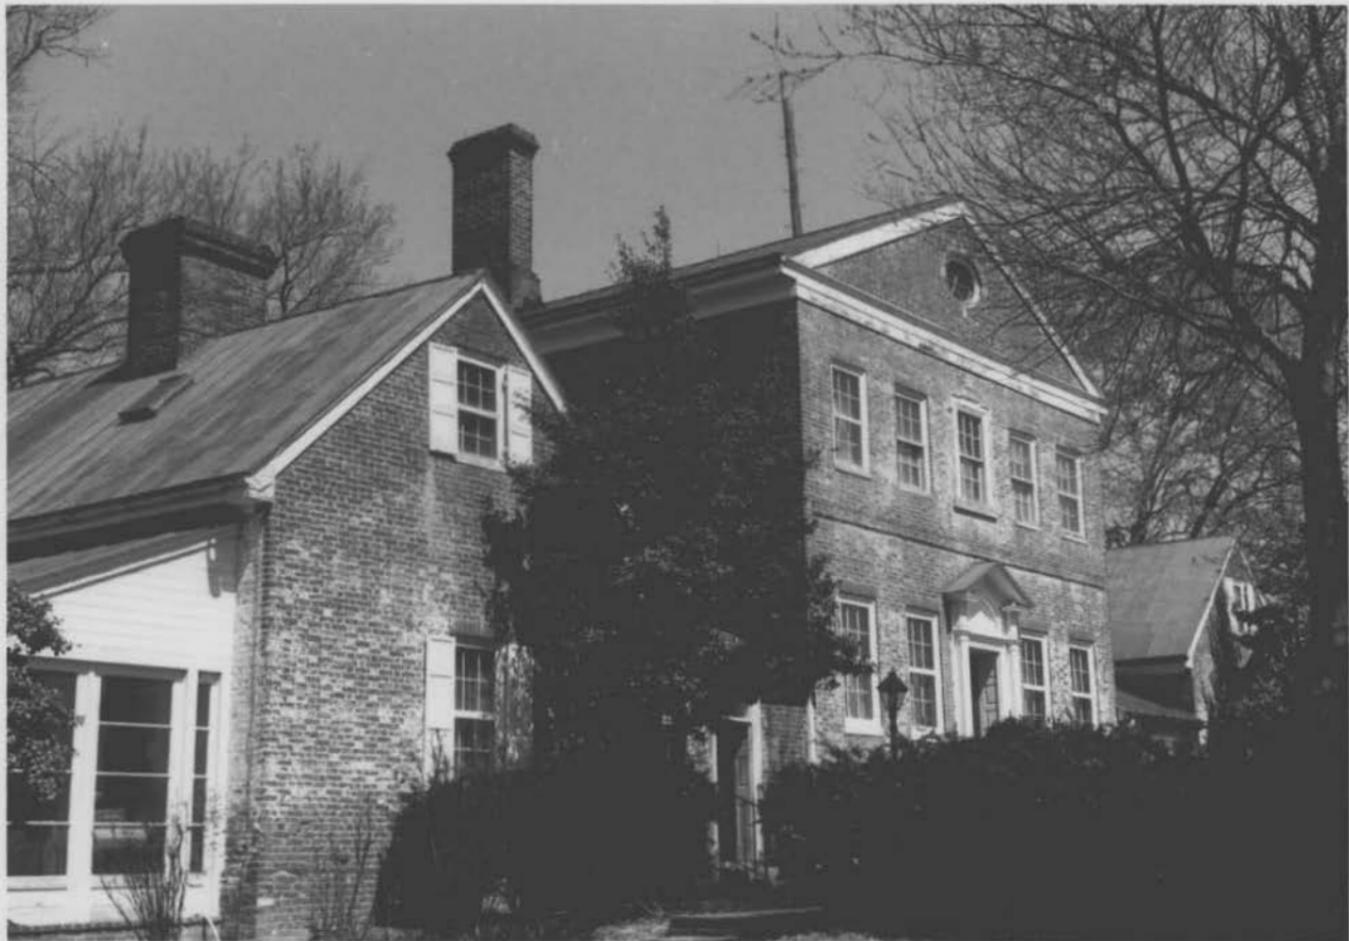
QA-3

Kennersley
Church Hill vicinity
Michael O. Bourne, 1968
View from Southwest

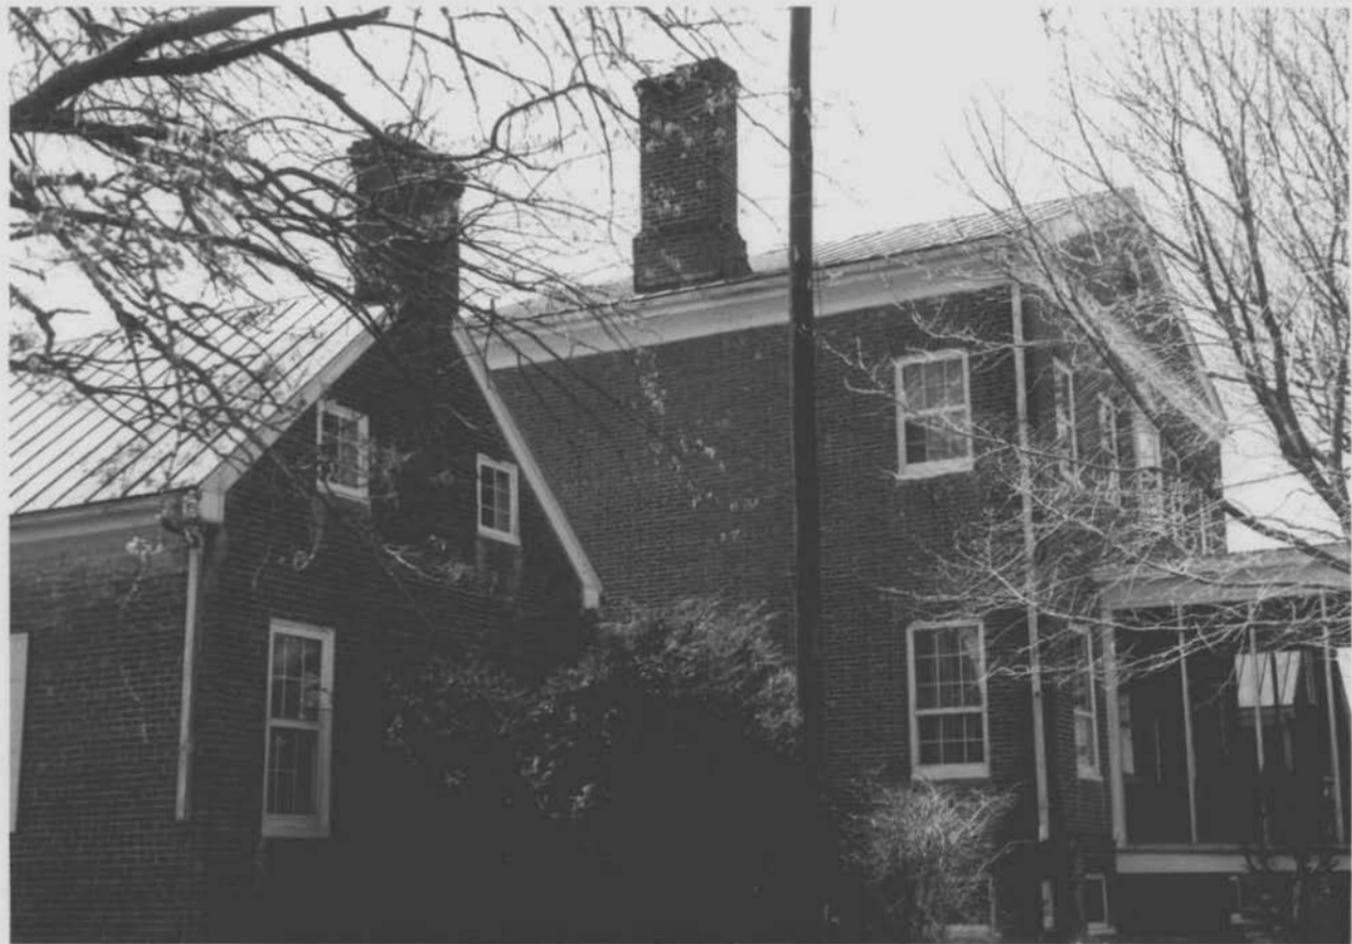
QA-3

Kennersley
Church Hill vicinity
Michael O. Bourne, 1968
View from Northeast

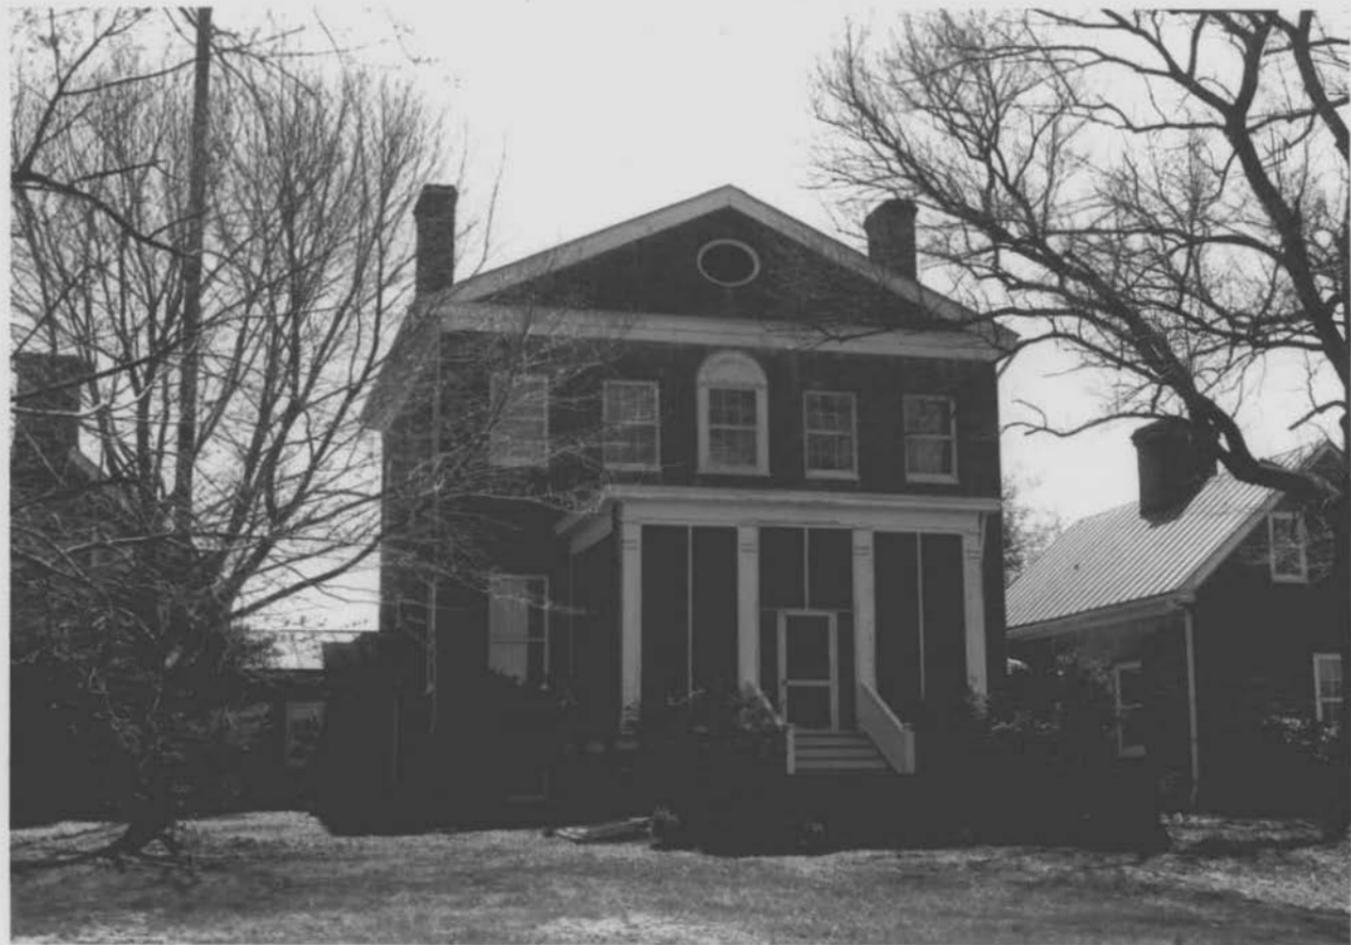
QA-3

Kennersley
Church Hill vicinity
Michael O. Bourne, 1968
? Rear Facade
(North)

The north facade is similar in composition to the south gable. A door is centered on the first story flanked by two large 9/6 windows on each side. There are five 6/6 windows on the second story, a 20th century bullseye window in the pedimented upper gable, and four eight-light cellar windows below the first floor windows. The first floor door has a segmentally arched opening with a single arched sash above the door; the center window on the second floor has an arched architrave with a carved fan above the lintel that matches the carved tympanum of the south door pediment.

The brickwork is laid in Flemish bond above a plain water table and three-course bond foundation. A three-course belt course is carried across the facade between the first and second story. The brickwork has been reworked in the upper gable. A one story porch, probably dating to the early 20th century, covers the three center bays on the first floor.

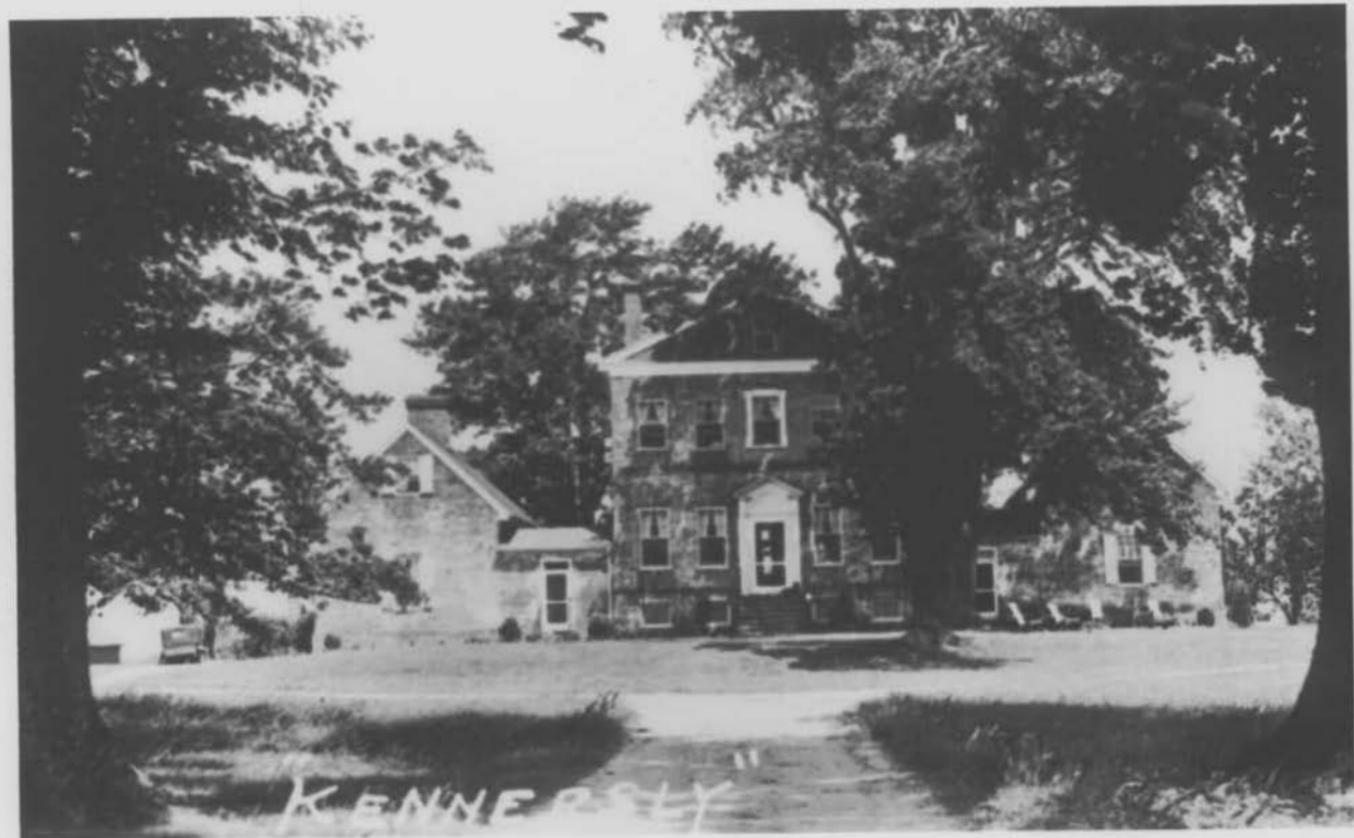
QA-3

Kennersley
Church Hill vicinity
Early 20th century
Photographer unknown
Southeast facade
