QA-305

Lands End Farm  
Church Hill vicinity  
Private

## MARYLAND HISTORICAL TRUST

## INVENTORY FORM FOR STATE HISTORIC SITES SURVEY

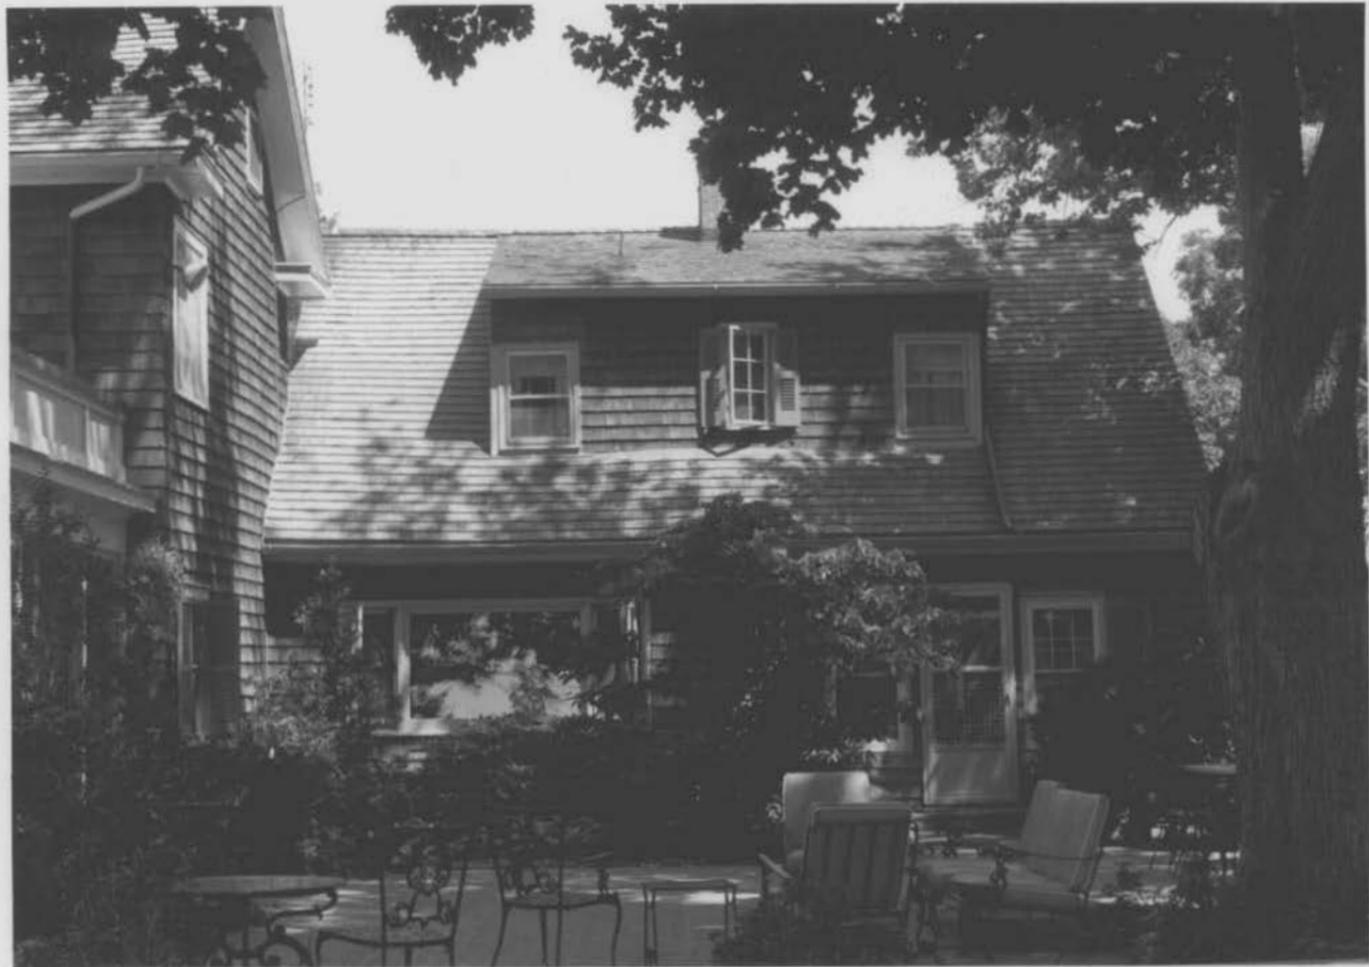
QA-305 Lands End Farm  
Church Hill vicinity, Md.  
Orlando Ridout V, 1978 (MHT)  
Early wing, NW facade

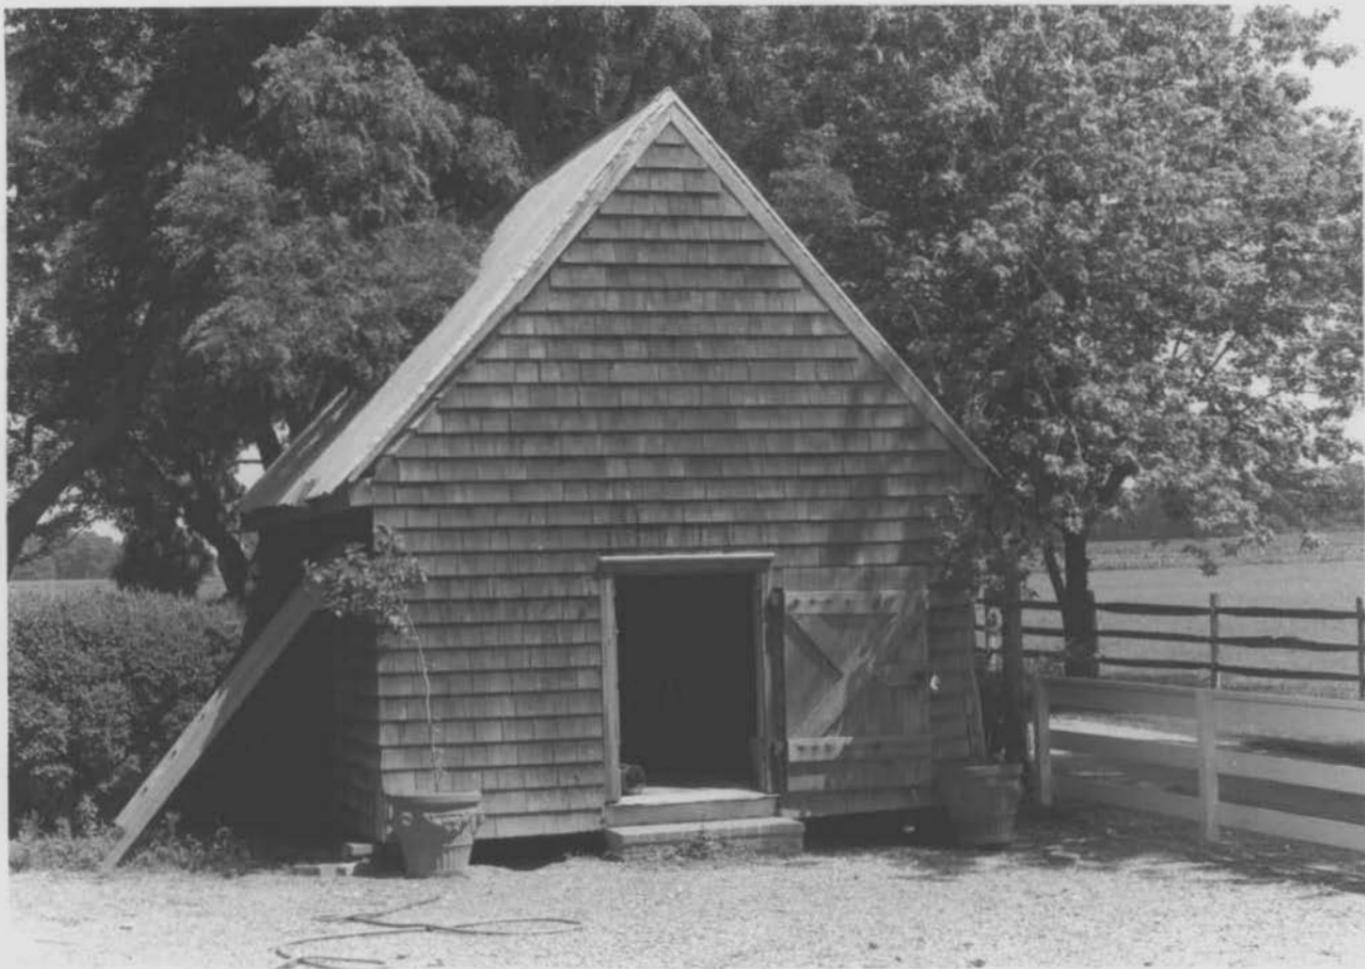
The meat house is approximately fourteen feet by sixteen feet, and rests on modern brick piers at the edge of the driveway. It is of post and plank construction, covered with wide vertical planks and wood shingles. The gable roof is approximately 45 degrees in pitch. There is one door in the center of the northwest gable. This is very wide and low, only four feet, eleven inches high. The door is not original, but is hung on large wrought iron strap hinges and pintels.

QA-305 Lands End Farm: Meathouse  
Church Hill vicinity, MD  
Orlando Ridout V, 1978 (MHT)  
NW Gable, camera facing SE
