INVENTORY FORM FOR STATE HISTORIC SITES SURVEY

John Hersey Hall House

224 Broadway

QA-346

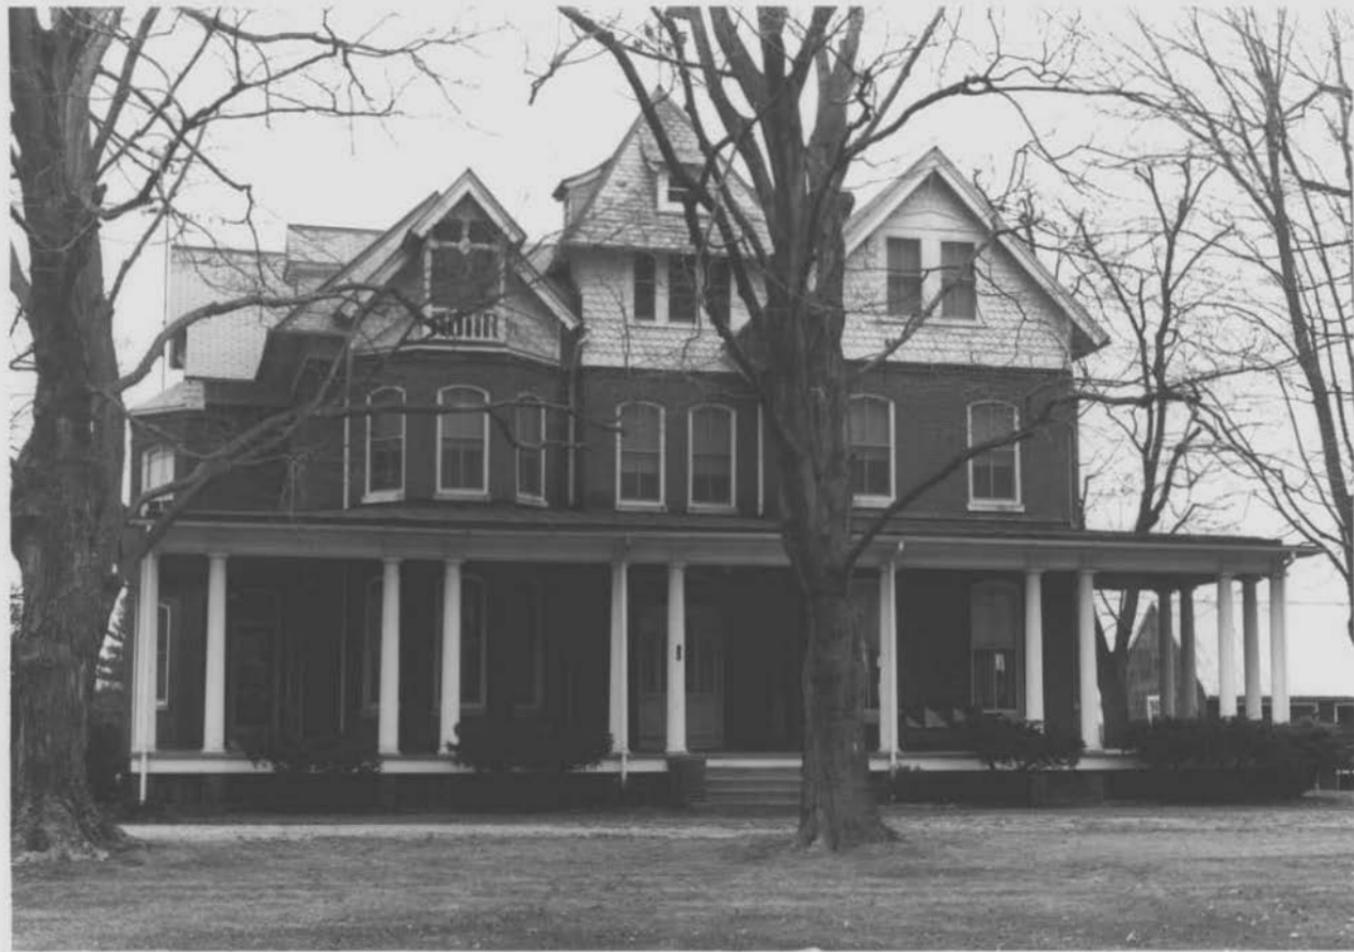
QA-340 John Hersey Hall House
Centreville, Maryland
Orlando Ridout V 1981
Front facade from Southwest

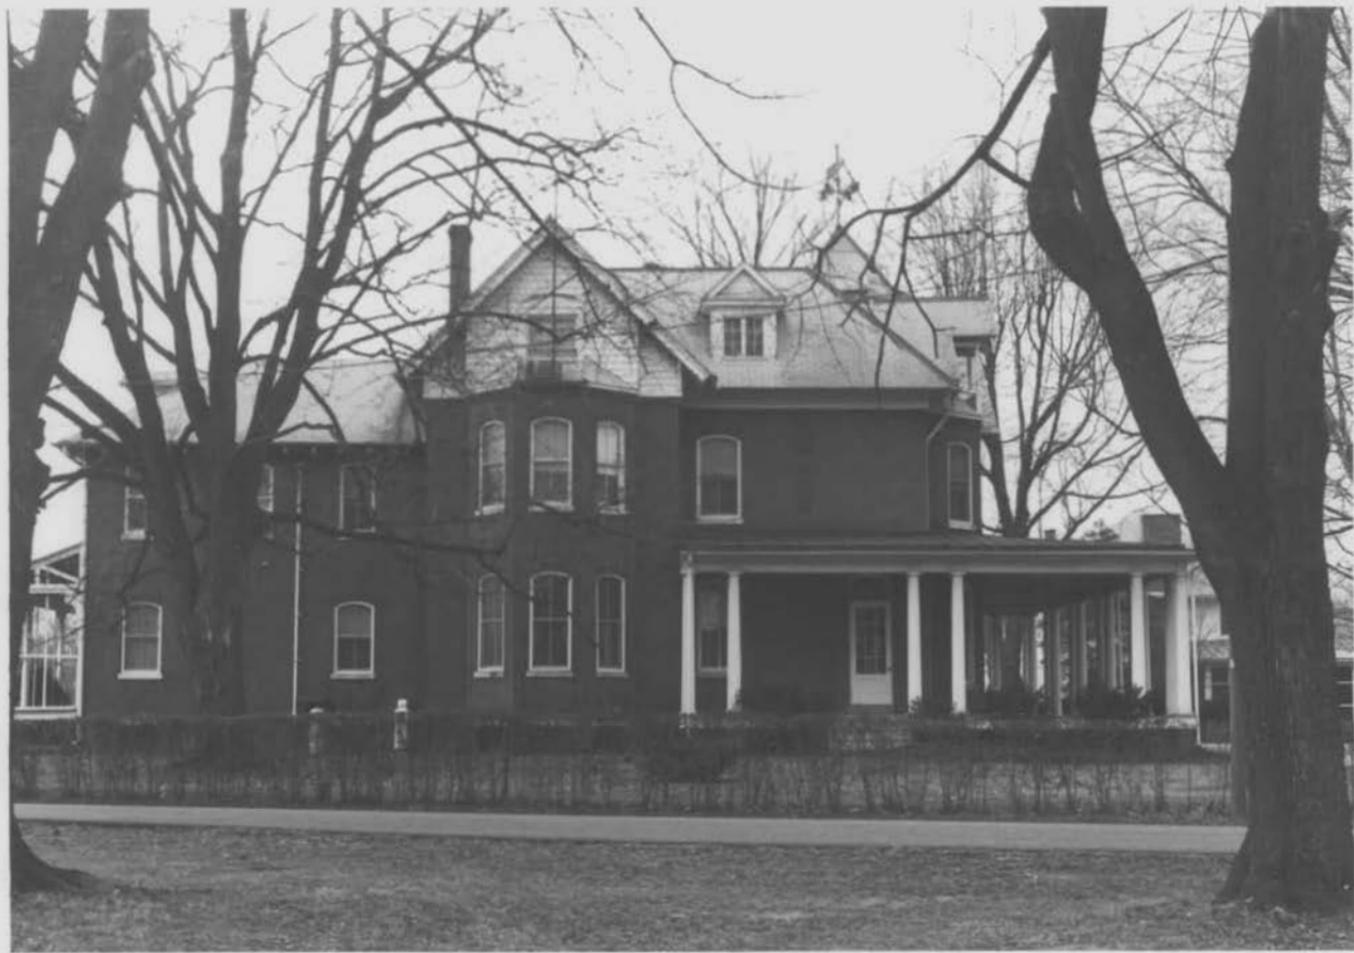
The west wall of the rear wing is approximately flush with the west gable wall of the main house, but a large cross wing projects out about five feet near the center of this end of the house. A two story semi-octagonal window bay projects from the center of this, matching the east gable wall in virtually every detail. The fine stretcher bond brickwork and decorative window treatment is carried across this entire end of the house, including the west wall of the wing. The hounds-tooth cornice and shingle siding are not necessary on the rear wing, which is only two stories high.

QA-340 John Hersey Hall House
Centreville, Maryland
Orlando Ridout V 1981
View from Northwest

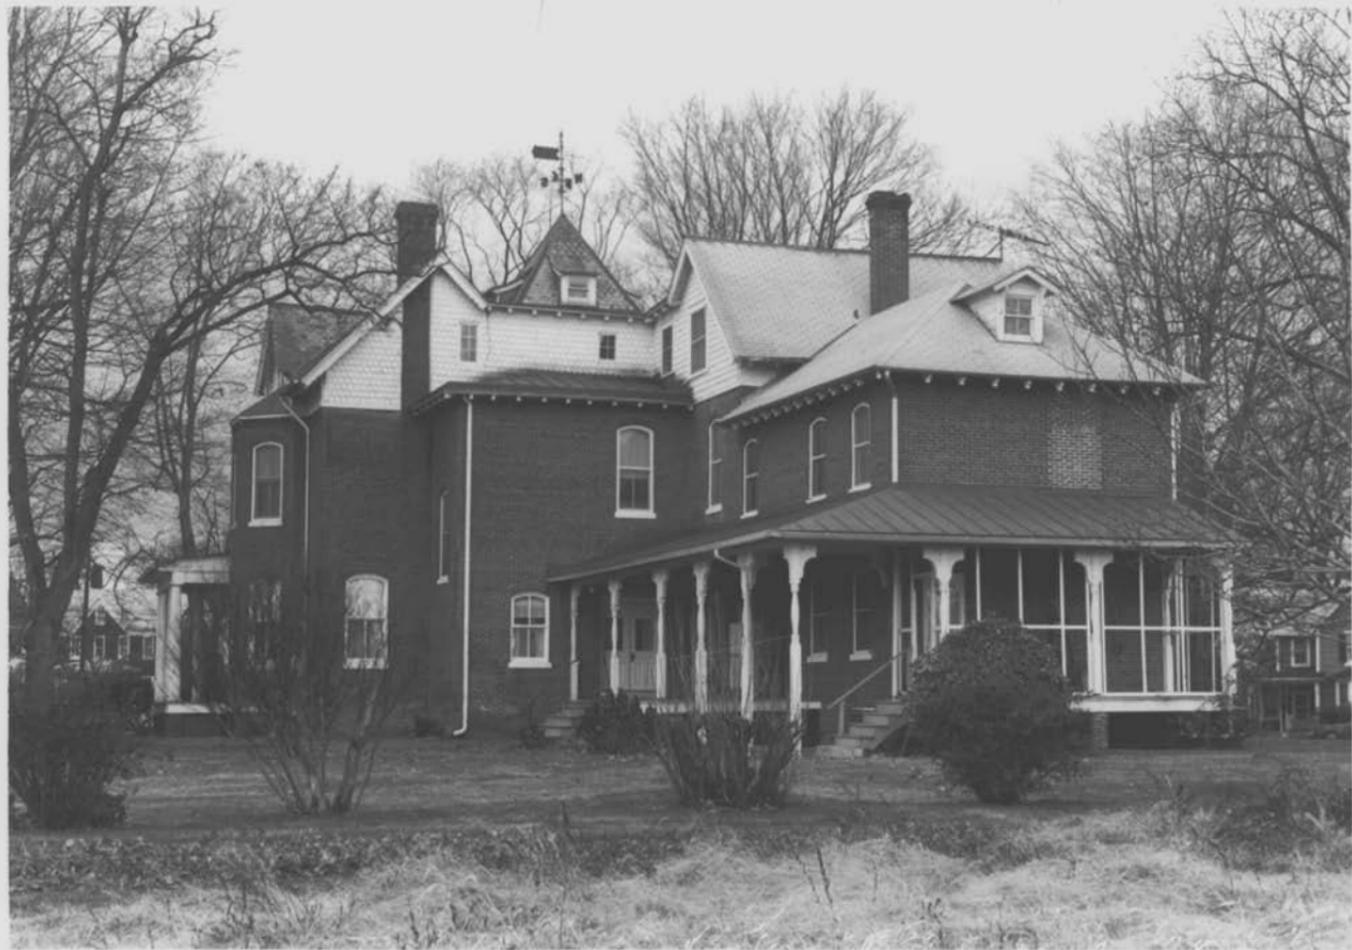
The north gable wall of the hip roof rear wing is quite plain, with a single door in the east bay of the first story and bricked-up window openings in the west bay of both the first and second story. The brickwork is laid in random common bond using common grade bricks and mortar. A pitched roof 2/2 dormer and the scrolled, exposed rafter ends enhance this wall, and an original one story Victorian porch with elaborate bracketed posts extends across this wall and

QA-340 John Hersey Hall House
Centreville, Maryland
Orlando Ridout V 1981
Rear facade from Northeast

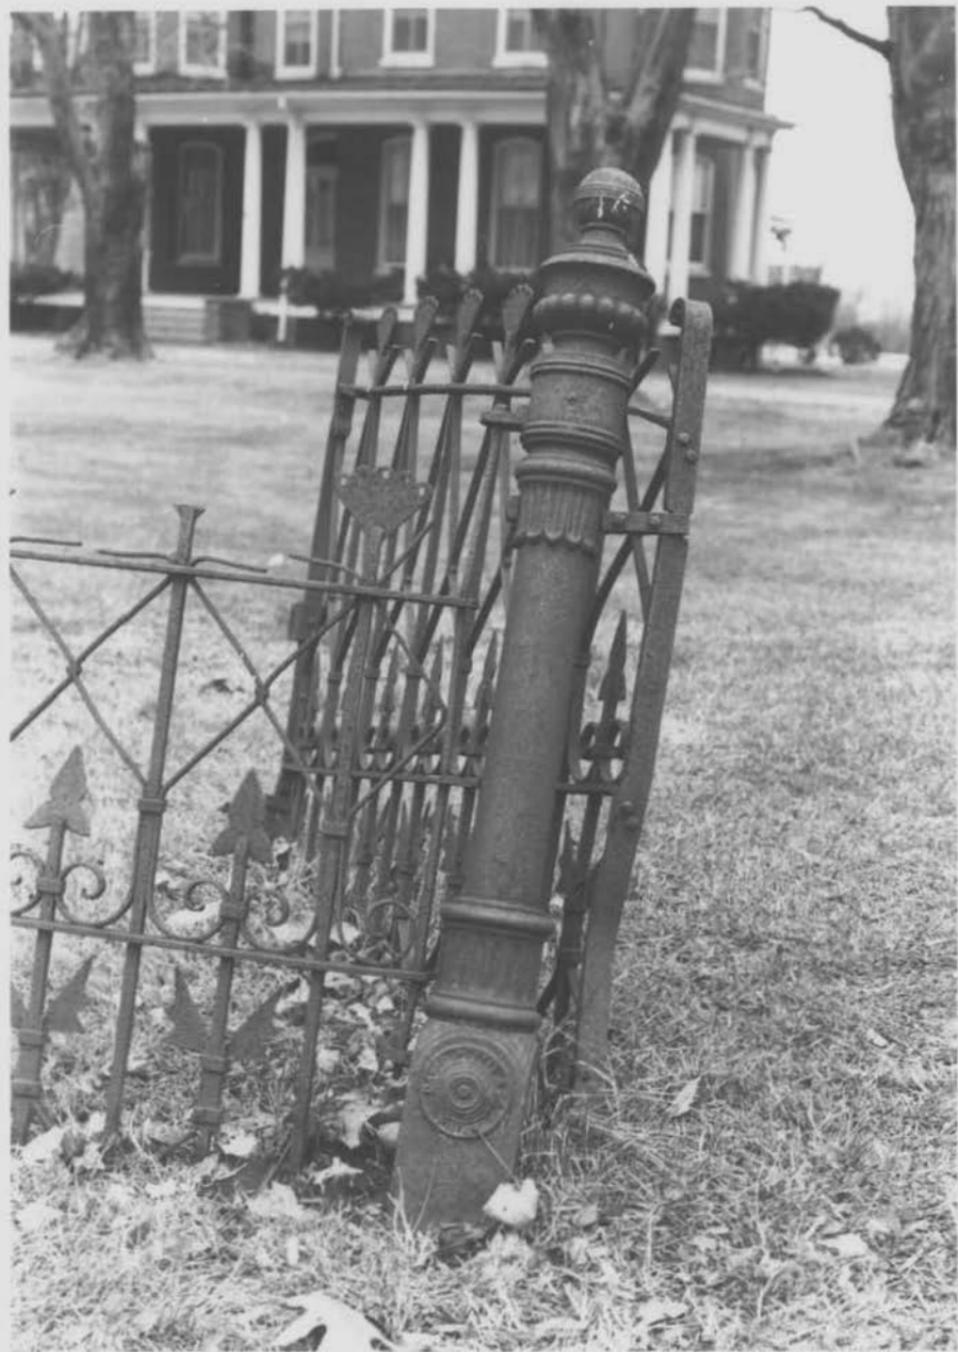
A handsome cast-iron Victorian fence stretches across the south side of the yard, facing Broadway and Chesterfield Avenue. Manufactured by David Petit of Philadelphia, this is probably the best surviving example of late 19th century iron fencing in Centre-ville.

QA-340 John Hersey Hall House
Centreville, Maryland
Orlando Ridout V 1981
Detail of Iron Gate Post
