QA-344
315 Chesterfield Avenue
Centreville
private

INVENTORY FORM FOR STATE HISTORIC SITES SURVEY

The Henry House or Barton House or 315 Chesterfield Avenue

Michael O. Bourne, Historic Sites Surveyor

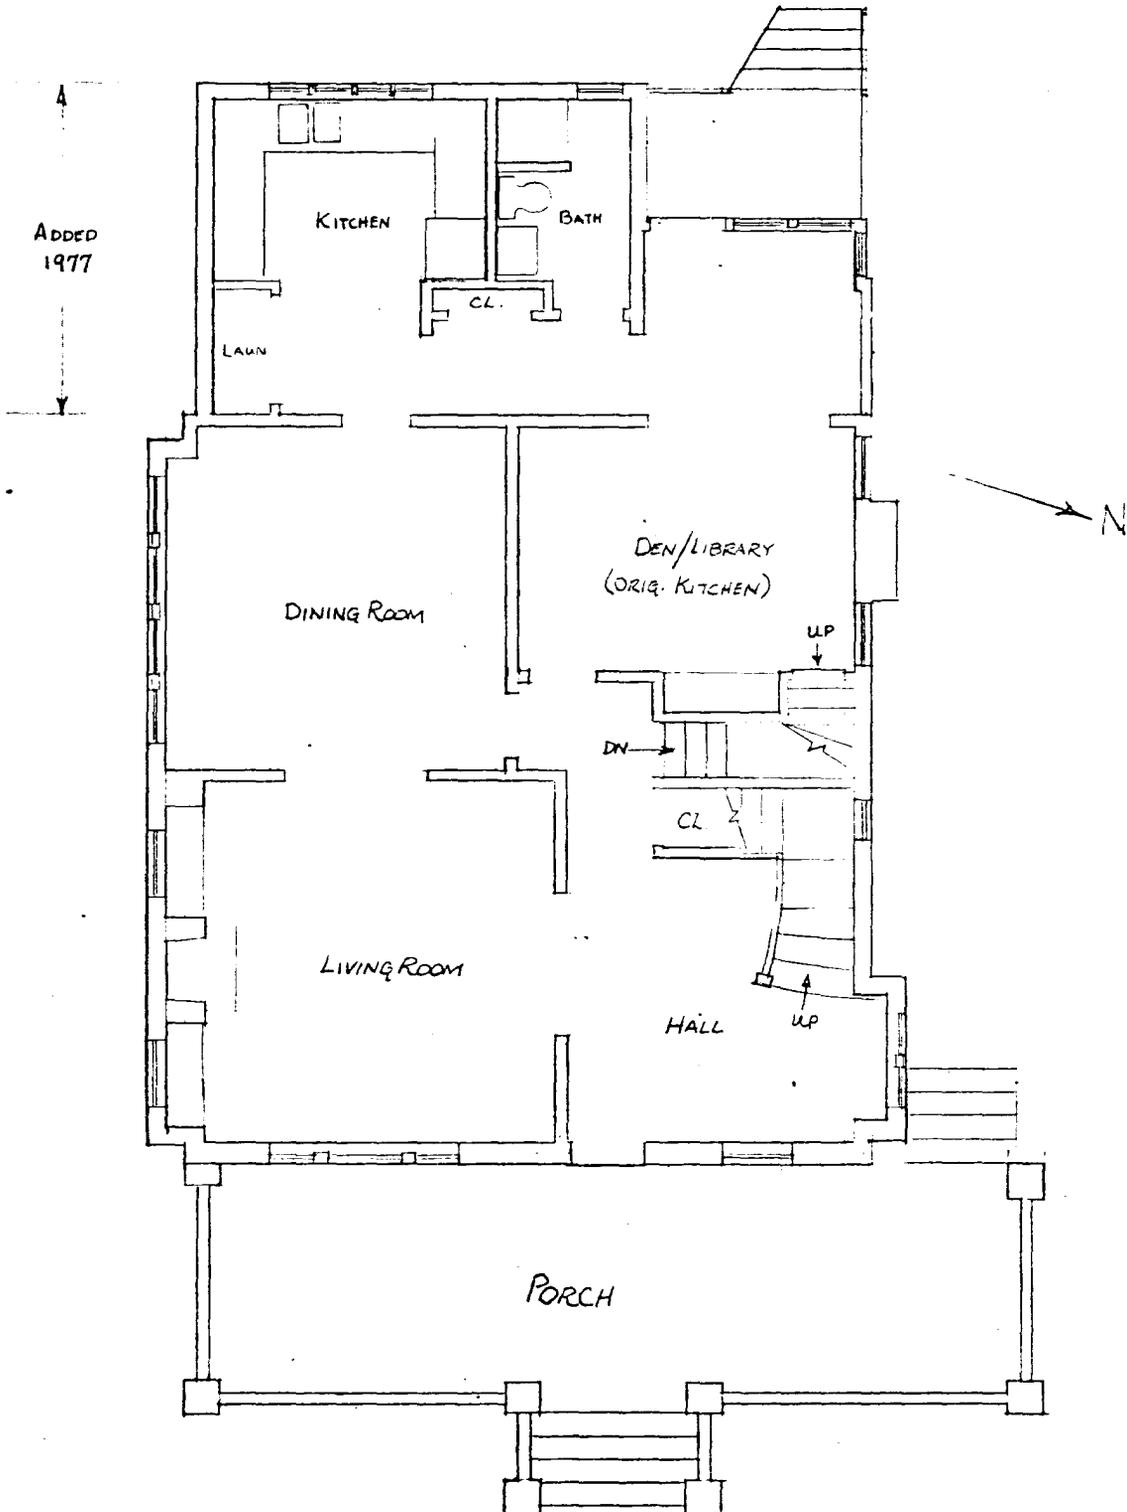
FIRST FLOOR PLAN

The interior floor plan is a widely used plan of the twentieth century. It is a basic four room plan, with the stair hall occupying one room and the others being living room, dining room and kitchen. Between the kitchen and stair hall is a back stair and basement stair. Originally, there was a small back porch off the dining room and a pantry/service porch off the kitchen separated by a basement bulkhead. These were removed in 1977 when the present wing was added.

The stair is a handsome open-string structure with the three lower steps flaring into the room. The large square paneled newel is set on a diagonal at the base of the flared steps. It rises against the north wall to a landing and from there at a right angle to the second story.

A wide opening exists between the hall/living room and the living room/dining room giving the impression of spaciousness. On the south wall of the living room is a fireplace flanked by low book cases beneath the windows. The mantel is quite plain with pilasters supporting wide plinths which in turn support the shelf.

With the four windows on the south, the dining room is very light. The existing glazed door originally opened to the back porch but now opens to the kitchen. The Den (formerly kitchen) retains two windows on the north wall and a door to the back stair (now a closet) on the east wall. Adjacent the door was a cabinet which is now book shelves. Two doors opened into the pantry and back porch respectively. These were replaced with a large opening to a new breakfast room in 1977.
