QA - 572
Church Hill Store and House
Church Hill
Private

INVENTORY FORM FOR STATE HISTORIC SITES SURVEY

Church Hill Store and House

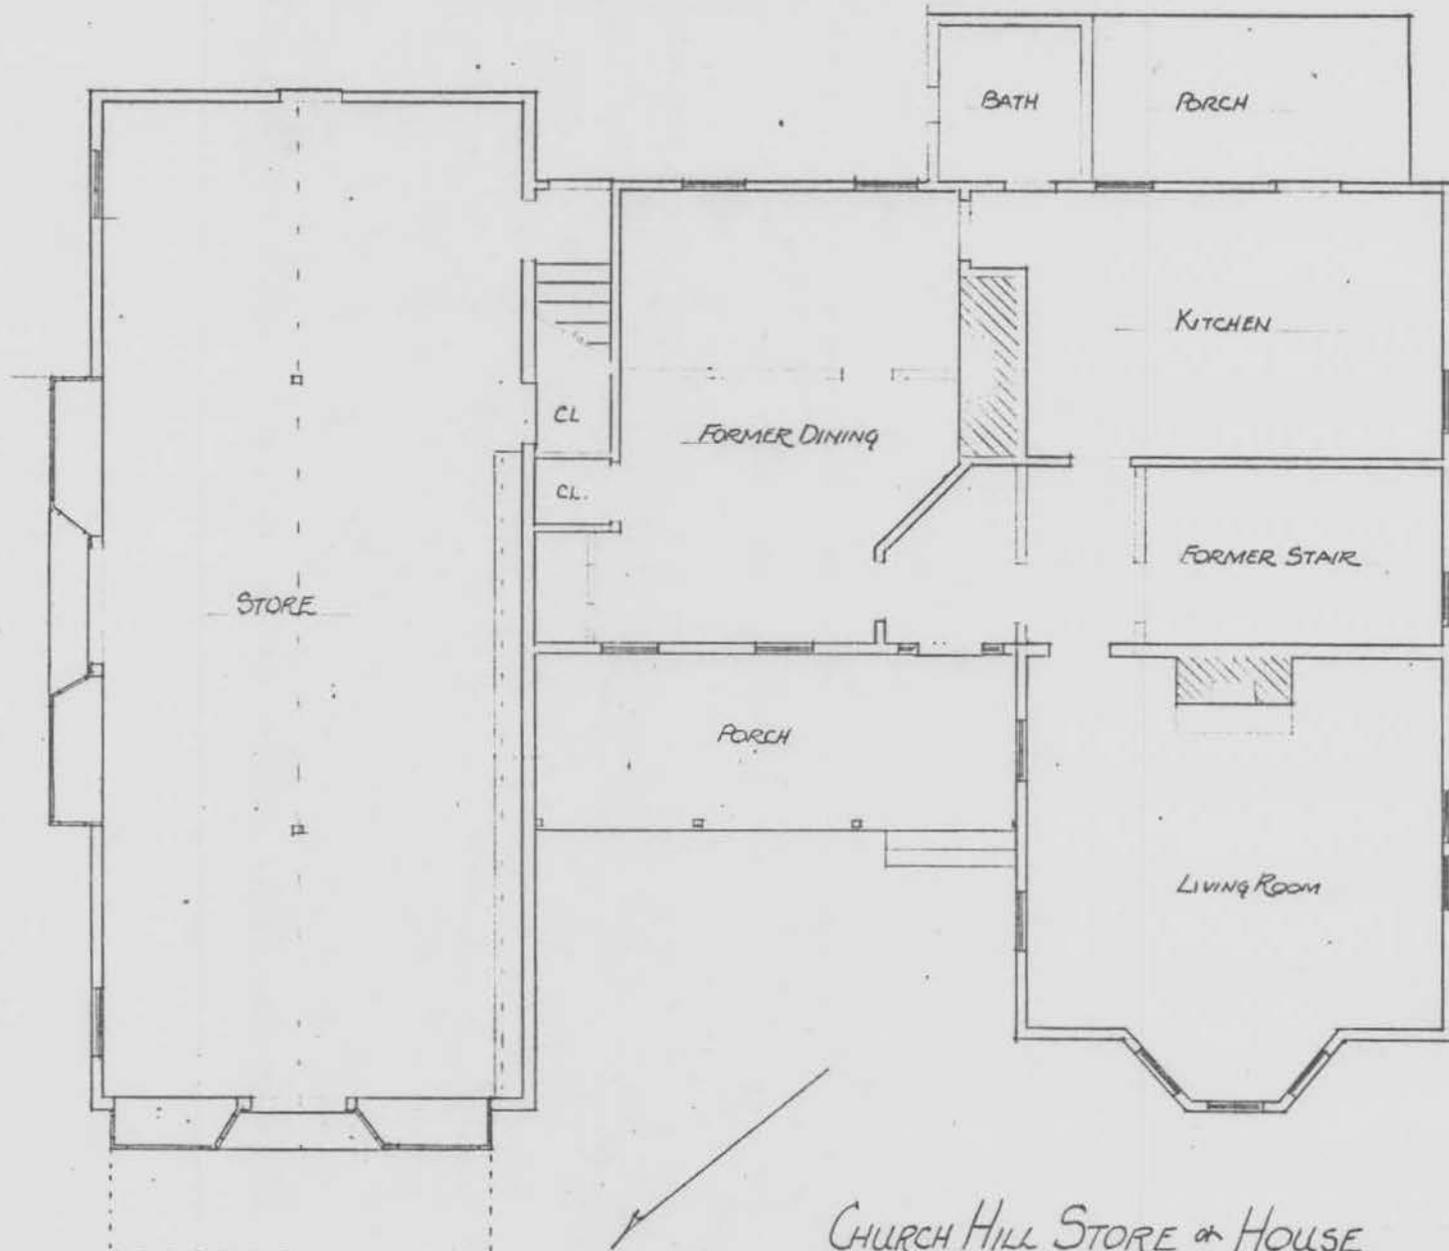
FIRST FLOOR PLAN - SCALE - 1/8" = 1'-0"

CHURCH HILL STORE & HOUSE

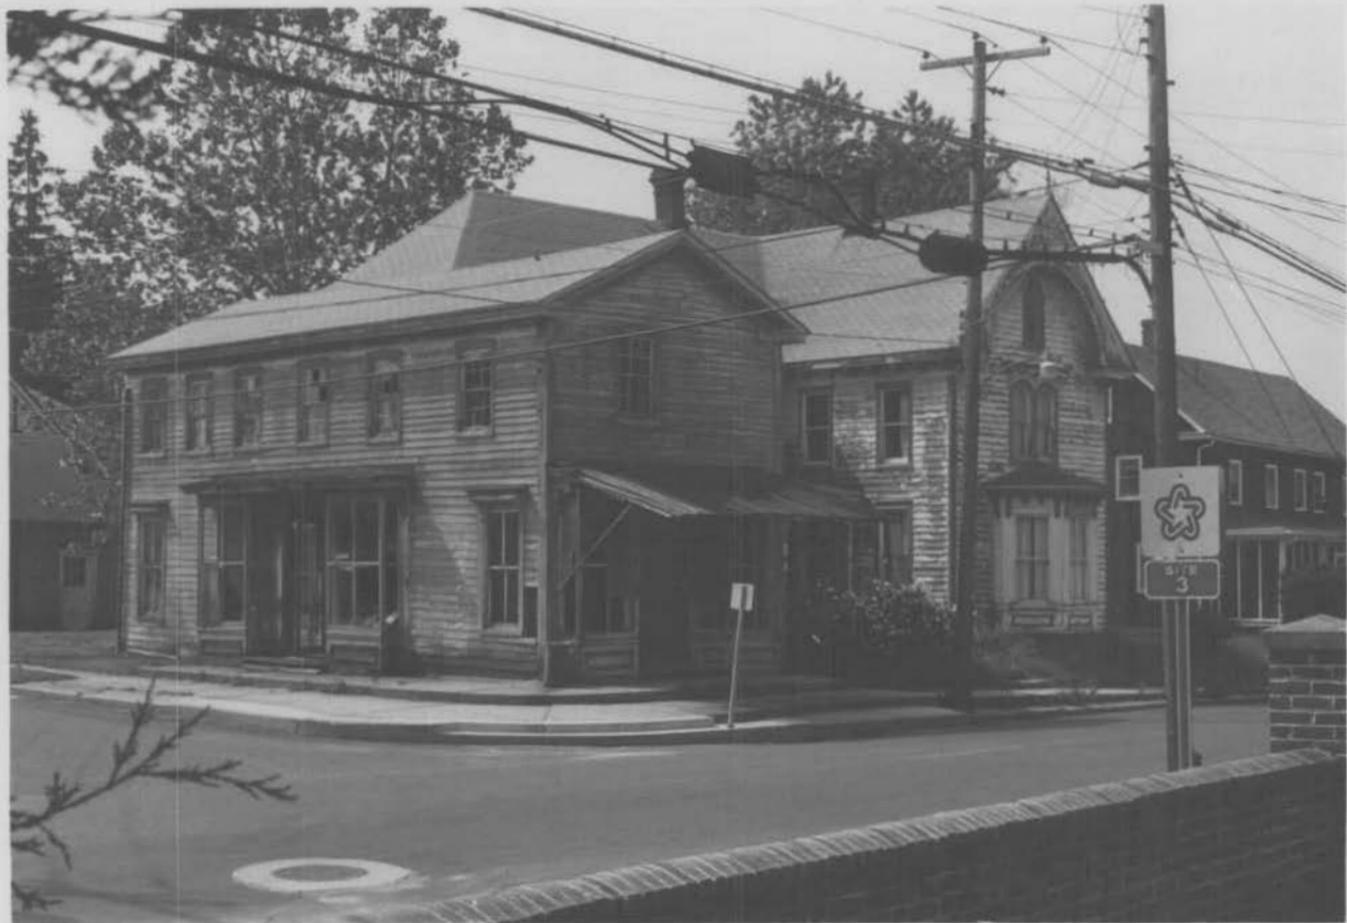
QA-372 House and Store
Church Hill
Northwest

The northwest facade has only a store window on the first story which is identical to the other window in every detail, only narrower. The original awning has chamfered structural members and exposed beaded dado or decking. Between the cornice and the diagonal pipe support is a row of the same type squiggly scallop as found on the northeast windows. There is one window, off-center, on the second story.
