QA-373
Rolph-Bowen Farm
Church Hill
Private

INVENTORY FORM FOR STATE HISTORIC SITES SURVEY

The Rolph - Bowen Farm

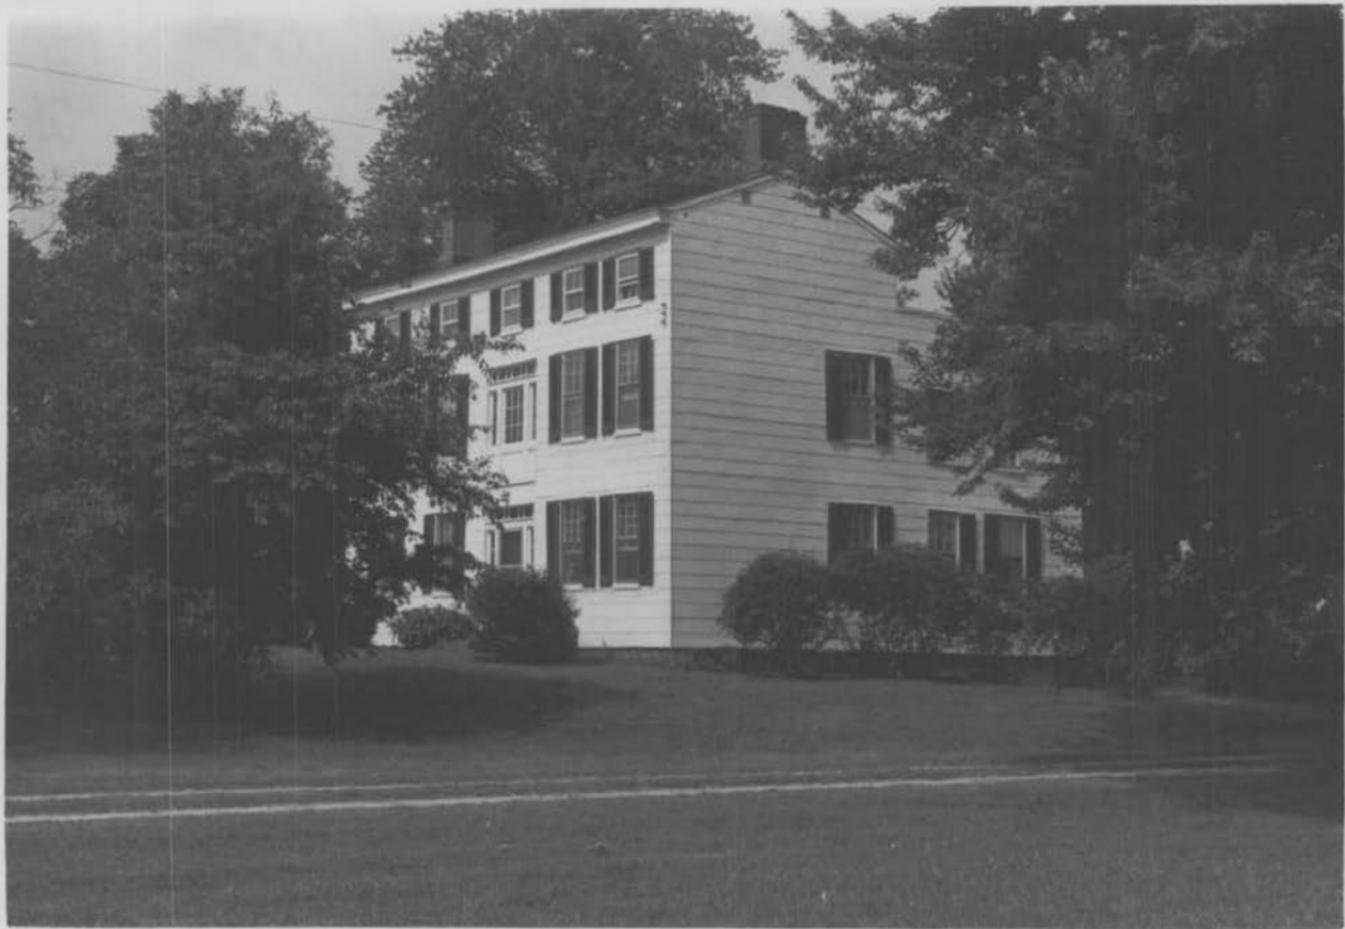
QA-~~012~~ Rolph-Bowen Farm
Northeast

Two brick chimneys rise within the gables of the house. The northeast gable has a window on the right side of the chimney on the first and second story, whereas, there are windows flanking the chimney on the southwest gable.

A unique feature of the house is the fact that the wing on the northwest side of the building has a single pitch roof. There are two windows on both stories of the northeast. A leanto screened porch across the southwest facade of the wing hides the door and window on the first story. The second story has only one window on its facade beside a protruding bathroom addition in the corner of the 'L', atop the screened porch. The northwest side of the house has one window on each story lighting the rooms on the right and one in the hall and room on the left on the third story. There is only one small window on the northwest wall of the wing.
