QA-43  
Slaughterton  
Sudlersville vicinity  
Private

c. 1820  
c. 1850, 1900

INVENTORY FORM FOR STATE HISTORIC SITES SURVEY

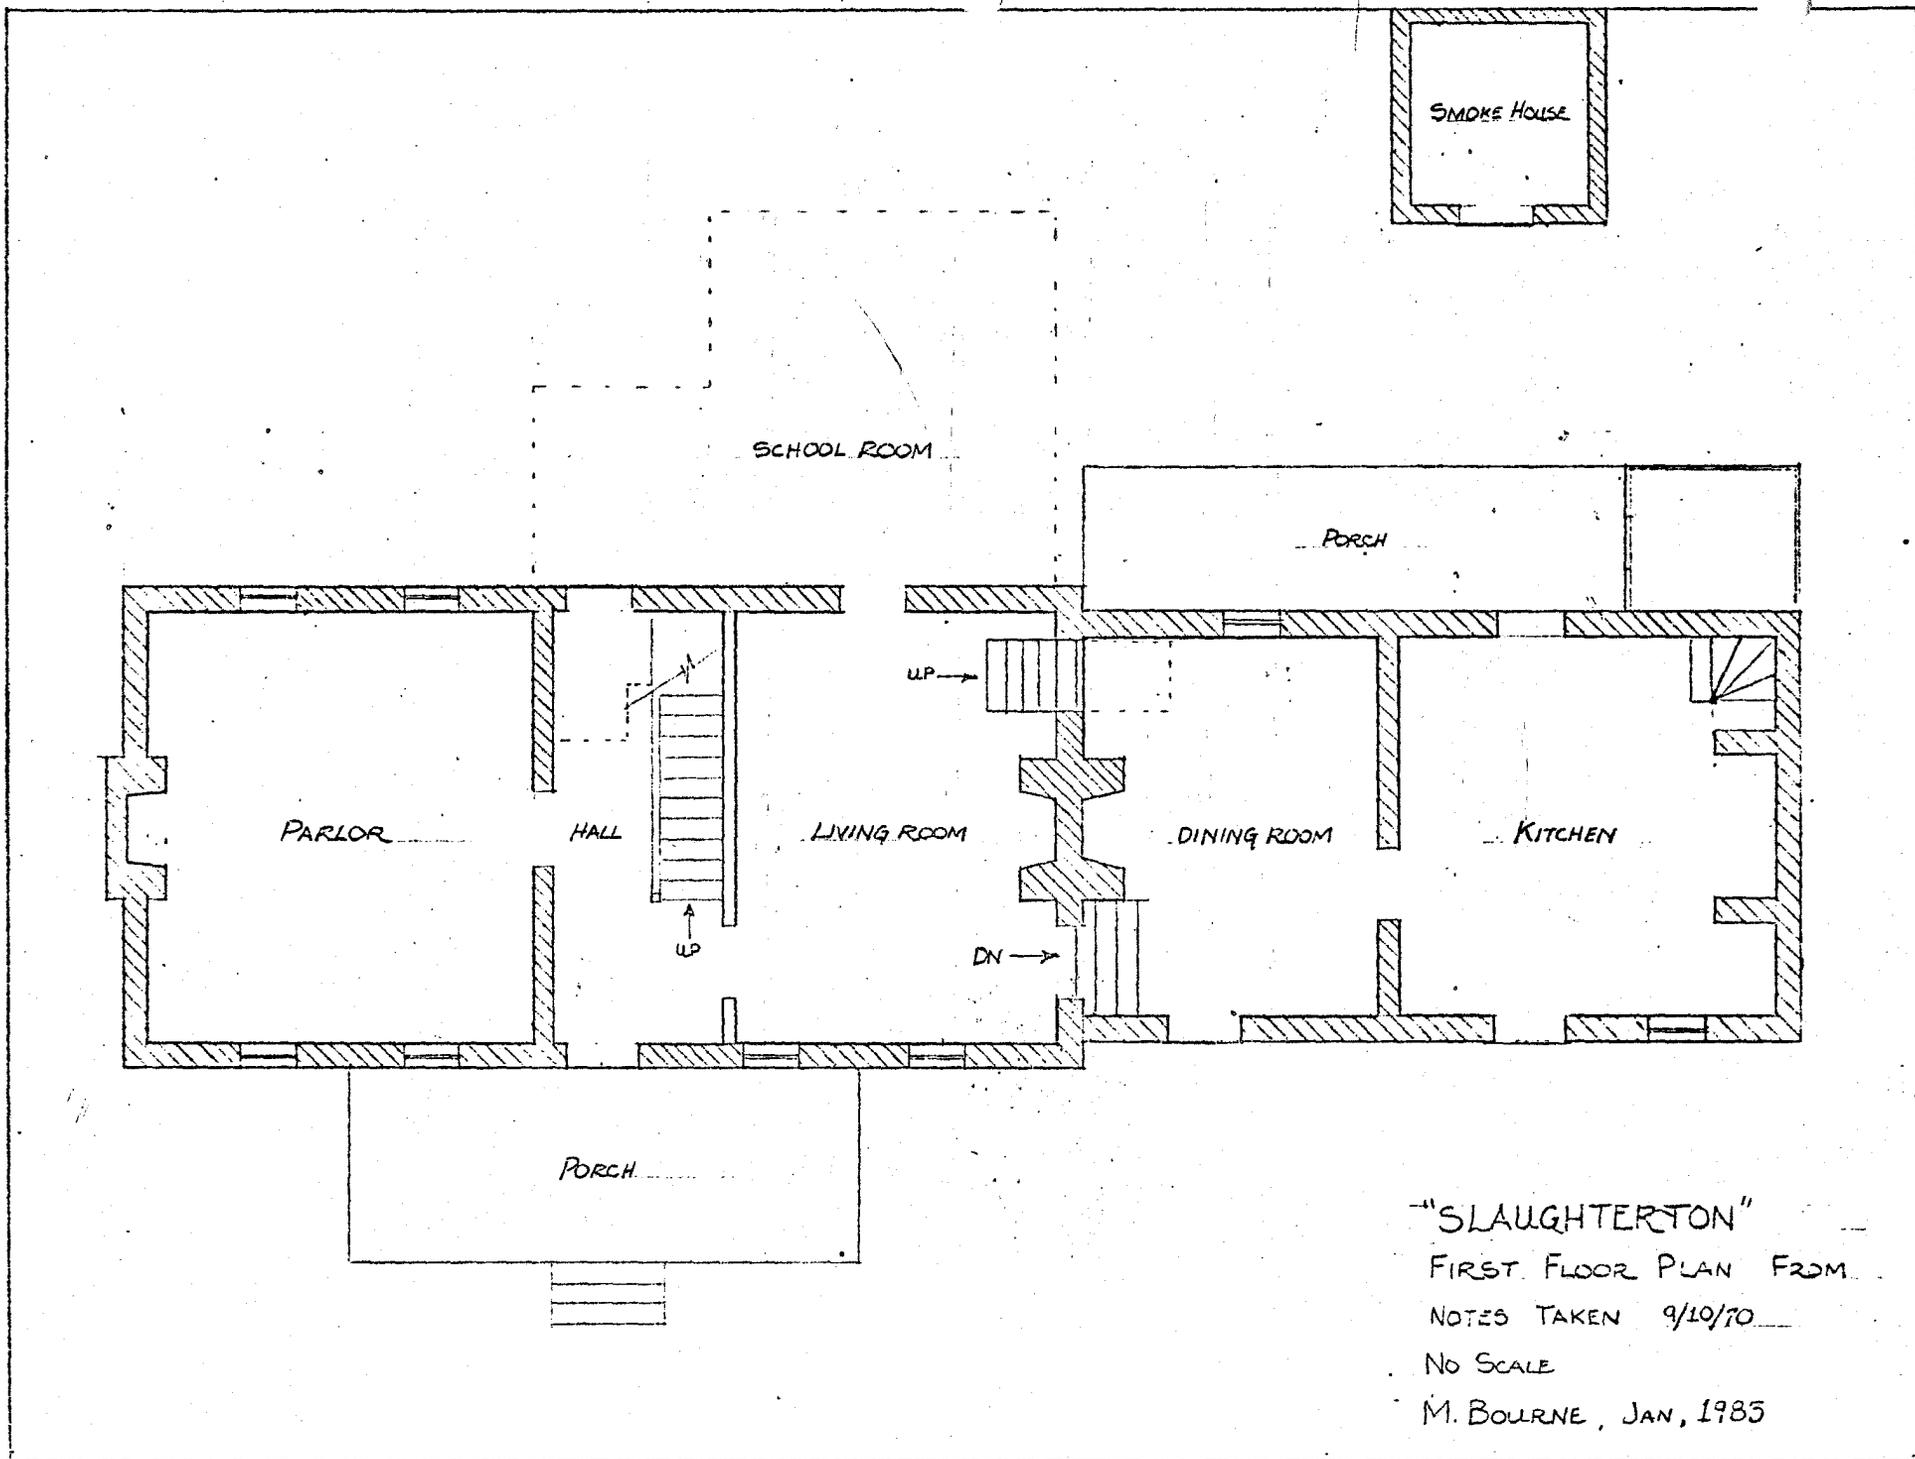
"SLAUGHTERTON"  
FIRST FLOOR PLAN FROM  
NOTES TAKEN 9/10/70  
NO SCALE  
M. BOURNE, JAN, 1985

The floor plan consists of two rooms with central stair hall in the larger part and two rooms, several steps lower, in the kitchen wing. Beginning from the west, the parlor has a fireplace protruding into the room. It has no chair rail or cornice and the window trim has been replaced. The stair is an open string stair with two rectangular balusters per step. The living room also has a fireplace projecting into the room. On the right side is the door to the kitchen wing; on the left side are five steps up to the 2nd story of the kitchen. On the north wall is one door to the "School Room".

The school room is a plain plastered room, now partly used for a bath.

Both rooms in the kitchen wing, the dining room and kitchen, are paneled with sheet paneling. In the north-east corner of the kitchen is a winder stair to the room above.

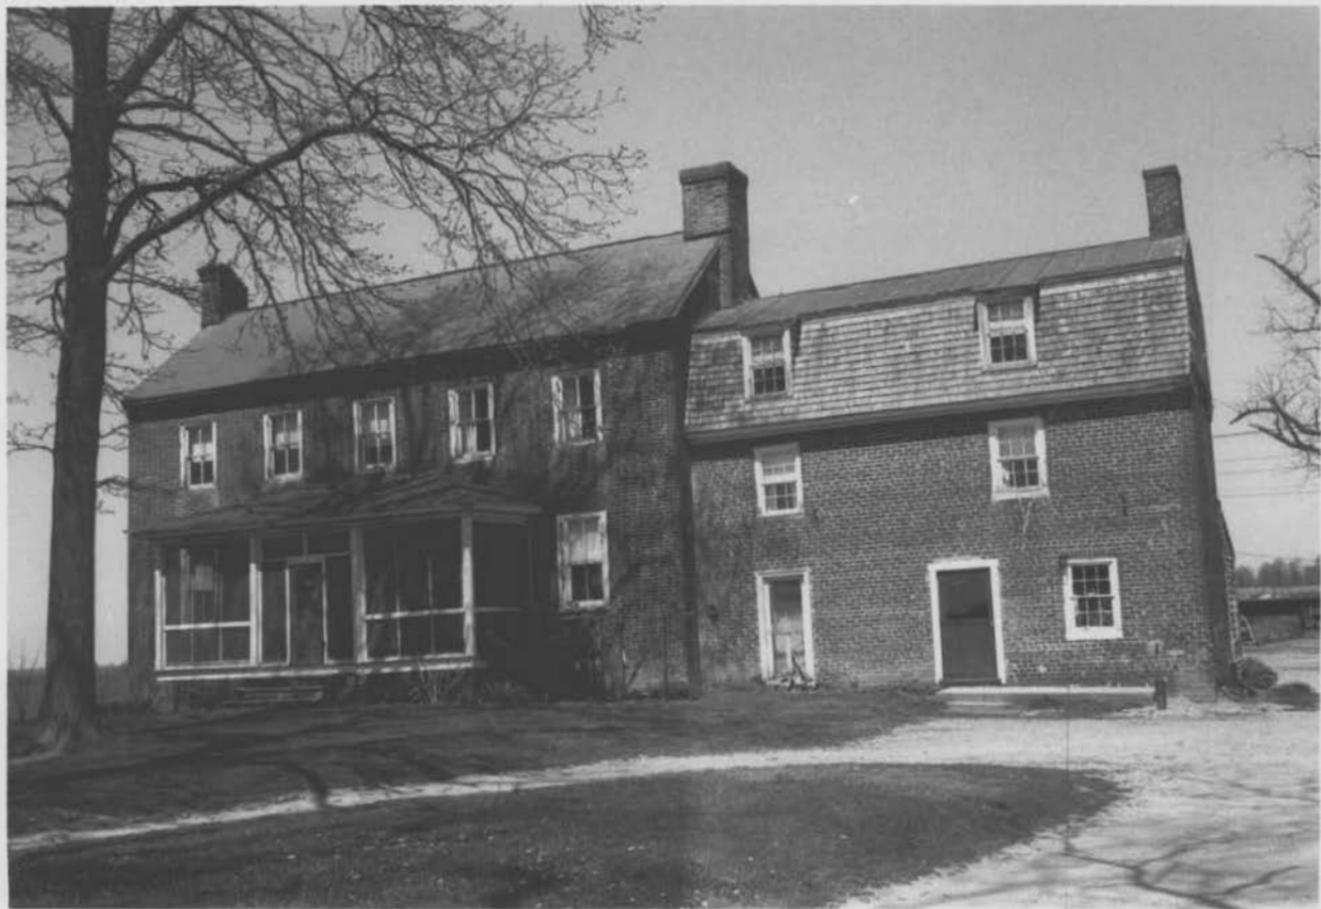
The main section of the house is five bays long, two stories and attic tall and one room deep. The south entrance occupies the central bay and retains its original six raised panel door with transom. The frames and sash of this section of the house were replaced around the turn of the century, probably when the porch was installed across three of the five bays. (Proportions of the windows suggest 9/6 sash for the first story and 6/6 sash for the second--the present ones are 2/2 on both stories). Jack arches over the openings are composed of alternating 2 headers and stretcher. There is no water table, but the cornice is composed of five courses of corbeled brick, the middle one set on an angle to create a dentil effect. The 'A' roof is covered with tin. The basement windows have five iron bars set into the masonry. The south facade of this portion of the house is the only part laid in Flemish bond; the remainder of the building, including

Slaughterton  
Sudlersville vicinity  
James W. Valliant, April 1974  
South facade
