INVENTORY FORM FOR STATE HISTORIC SITES SURVEY

Hogg Harbor

Vachel Downes Farm

QA-431

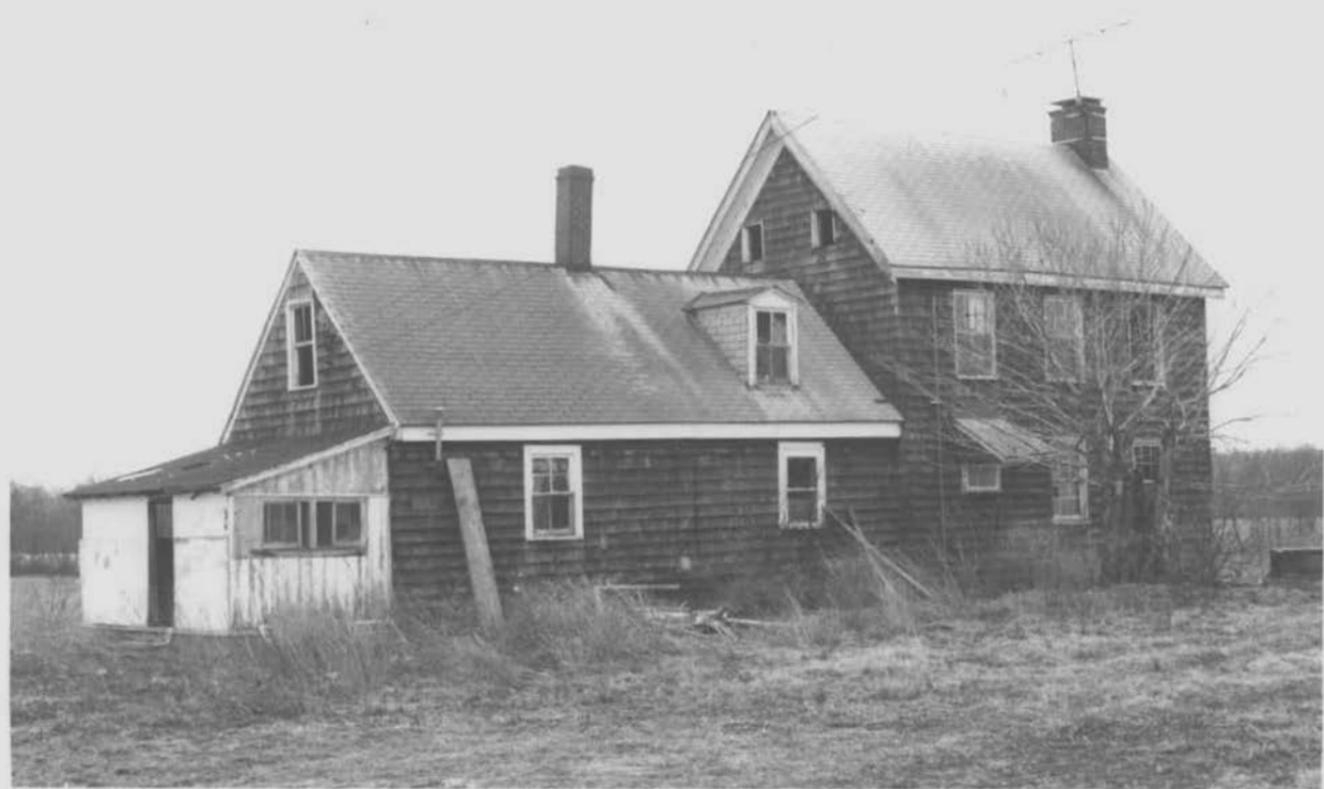
On the north facade, a door in the east bay of the first floor has been blocked and replaced with a small 6-light window. There are two 6/6 windows to the west and three 6/6 windows on the second story.

The north facade is virtually identical to the south facade, with two 2/2 windows on the first floor and one mid-19th century pitched roof dormer in the west bay of the second story.

QA-431 Vachel Downes Farm
Starr vicinity
Orlando Ridout V, 1981
View from North

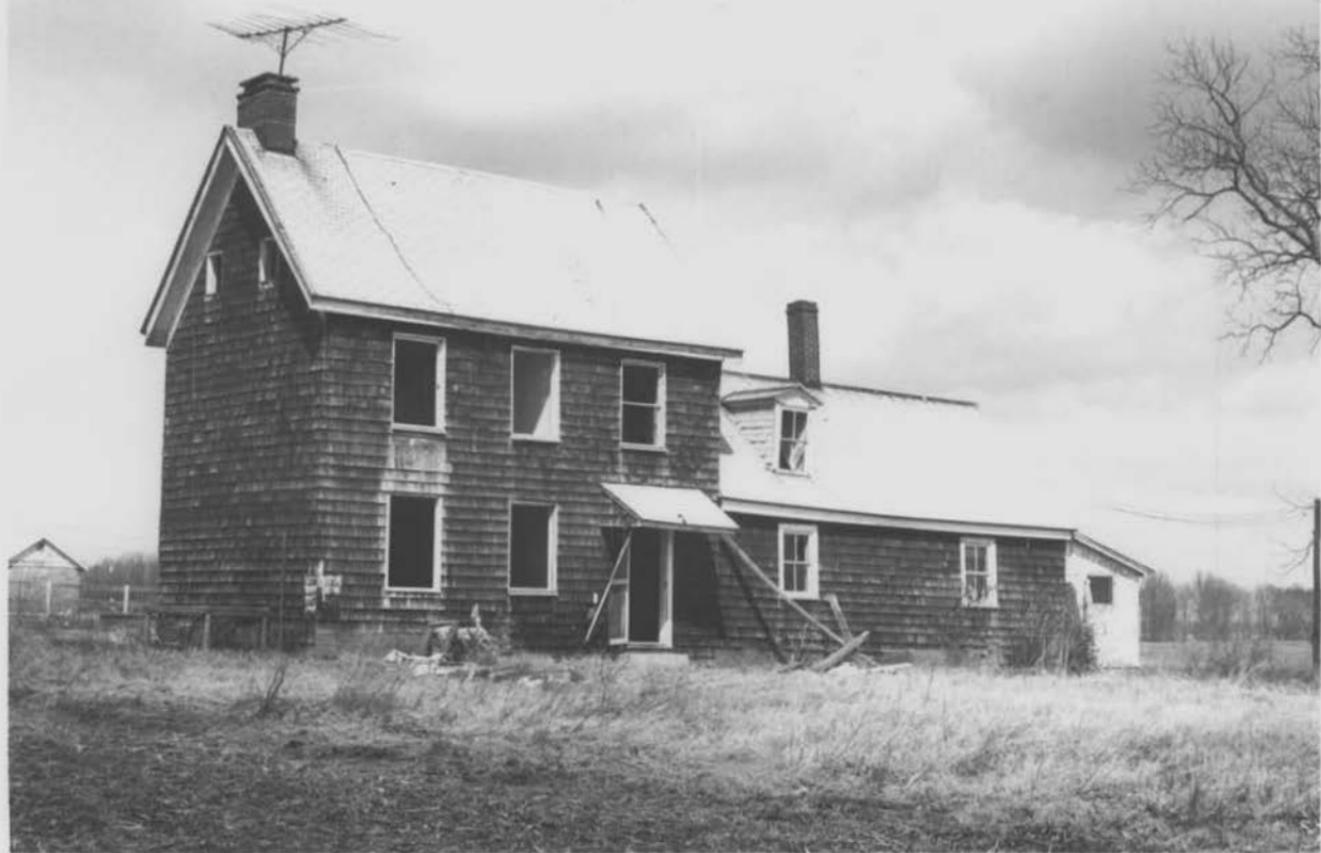
The principal facade of the main house faces south, away from the road. There is a door in the east bay, with two 6/6 windows to the west on the first floor and three 6/6 windows ranged across the second floor. There are no dormer windows on the third story. The building rests on a low, continuous brick foundation and is covered with horizontal weatherboards nailed with machine nails and a later covering of wood shingles. The roof

On the south wall of the wing, there are two 2/2 windows on the first story and a pitched roof dormer window in the west bay of the second story. This dormer has mid-19th century detailing and later 2/2 sash.

QA-431 Vachel Downes Farm
Starr vicinity
Orlando Ridout V, 1981
View from South
