QA-445
Merrick Farm, Barclay
Barclay vicinity
private

INVENTORY FORM FOR STATE HISTORIC SITES SURVEY

AND/OR COMMON
Merrick Farm, Barclay

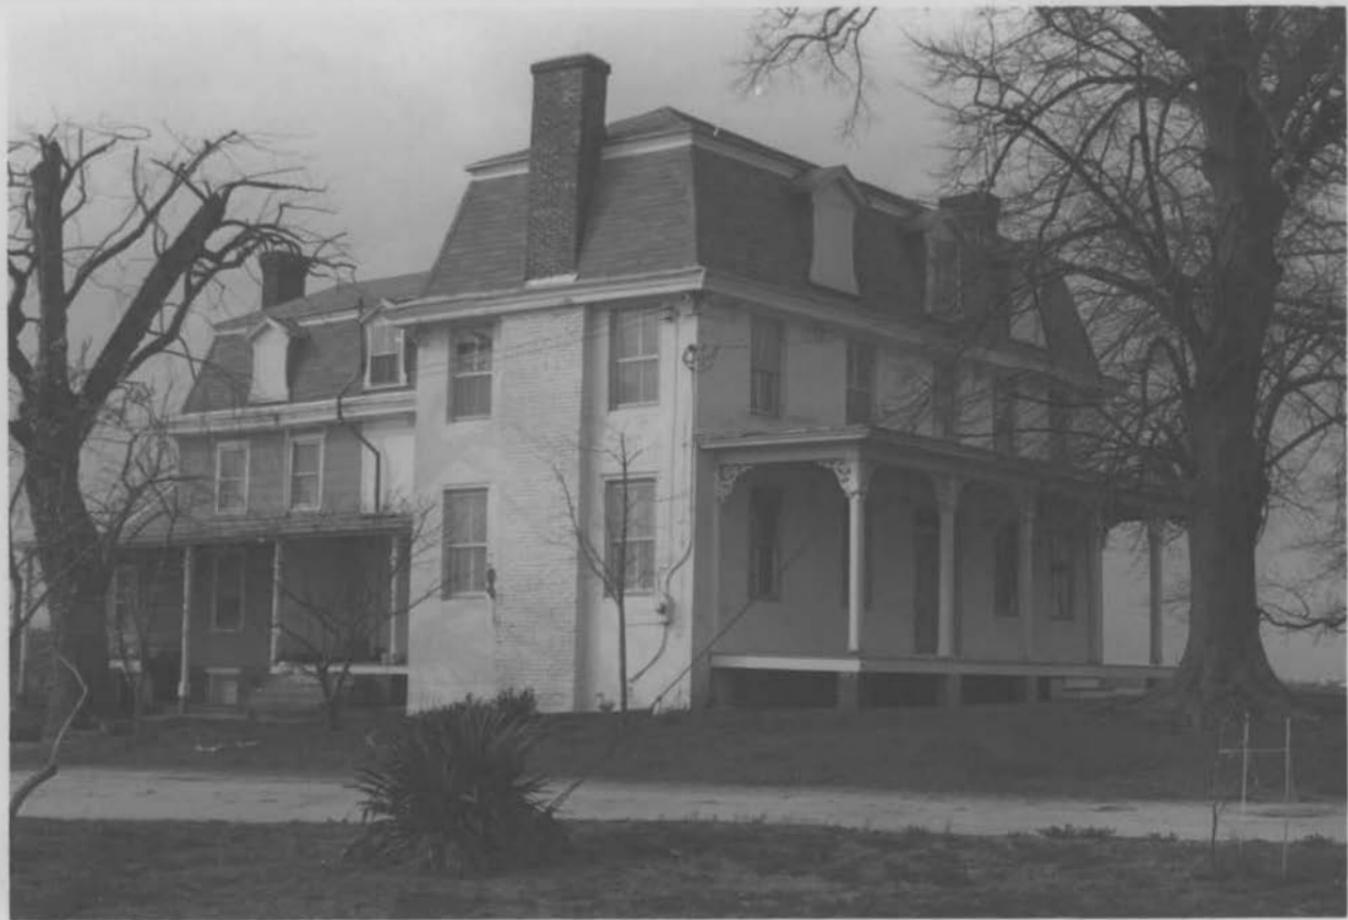
Southeast

The Merrick Farm, Barclay, located on the west side of Rt. 313 south of Barclay is a large brick five bay long mansard roof house with large back wing, nearly equal in size to the front. The east facade has five bays, with a porch across the entire facade. The central door with its sidelights and transom is slightly off-center and the windows above and to the north are closer than those to the south. All have 2/2 sash and originally had shutters. The porch is quite plain, with champhered posts and scrolled brackets. There are three dormers on the mansard roof, each with scrollwork at top and bottom and each having overhanging 'A' roofs. At the break in the two pitches of the roof is a crown molding. At each end of the house rises a large brick chimney, the north chimney within the gable, the south partly protruding.
