# Maryland Historical Trust

## State Historic Sites Inventory Form

historic SUBERS FARM or LEACH FARM

Survey No. QA-496

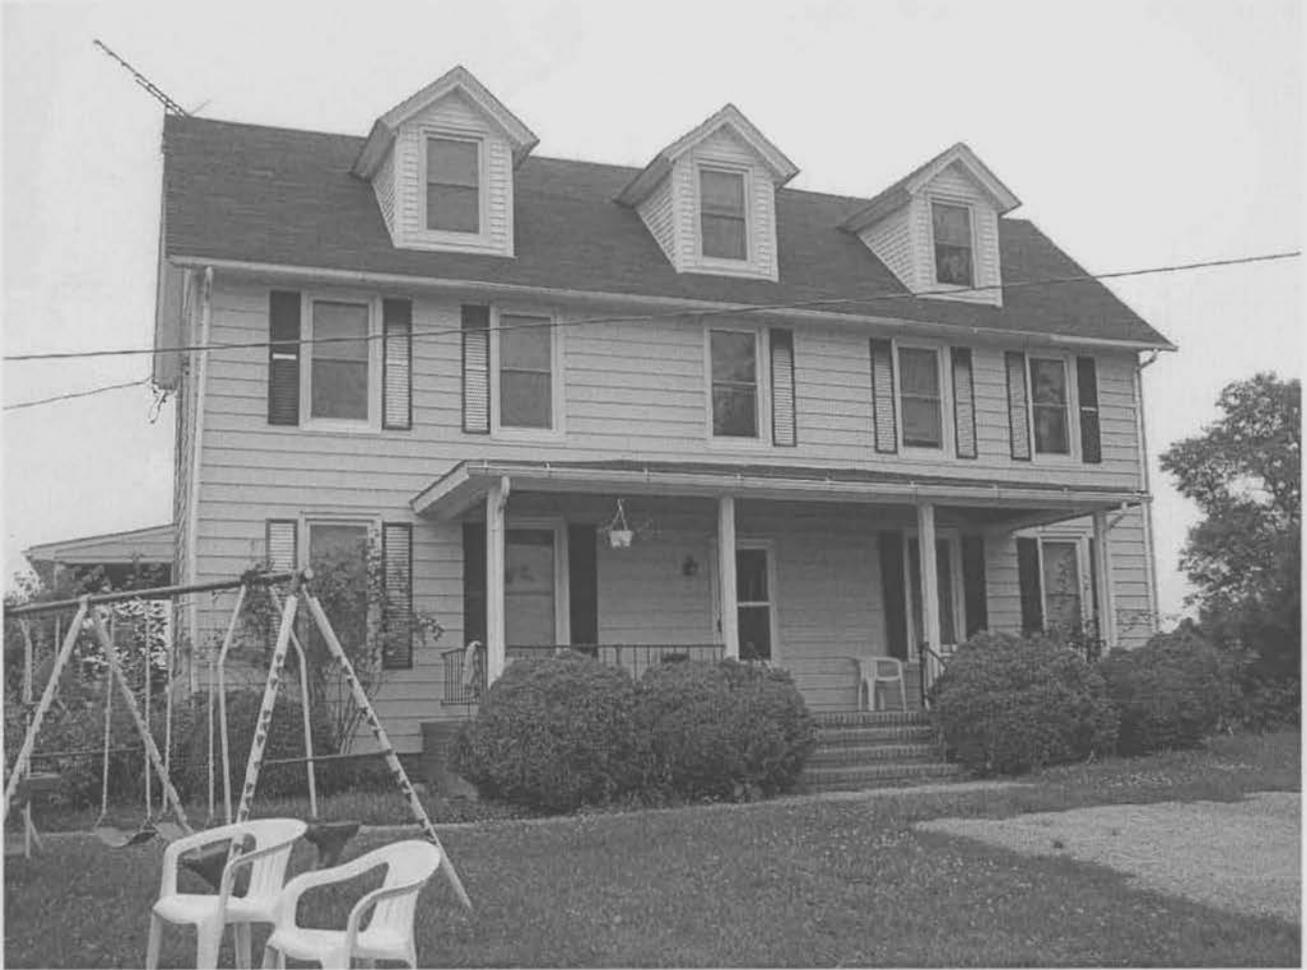
QA-496  
Subers Farm

The house is a five-bay long frame dwelling standing on a brick foundation. It is two-and-one-half stories tall and is covered with aluminum siding. There is an 'L' addition behind the south end of the house which is two stories tall and two-bays long. A one story family room was built in the corner of the 'L' in recent years. On both the east side of the main house and the south side of the kitchen 'L' there are covered porches with concrete floors and late 20th century iron balustrades. The windows have 1/1 sash and originally had shutters but do not at present. There are three "A" roof dormer windows on the east slope of the roof.
