**NATIONAL REGISTER OF HISTORIC PLACES
INVENTORY -- NOMINATION FORM**

THOMAS HOUSE

Thomas House
Queen Anne's County

QA-8
Thomas House
Ruthsburg vicinity
Private

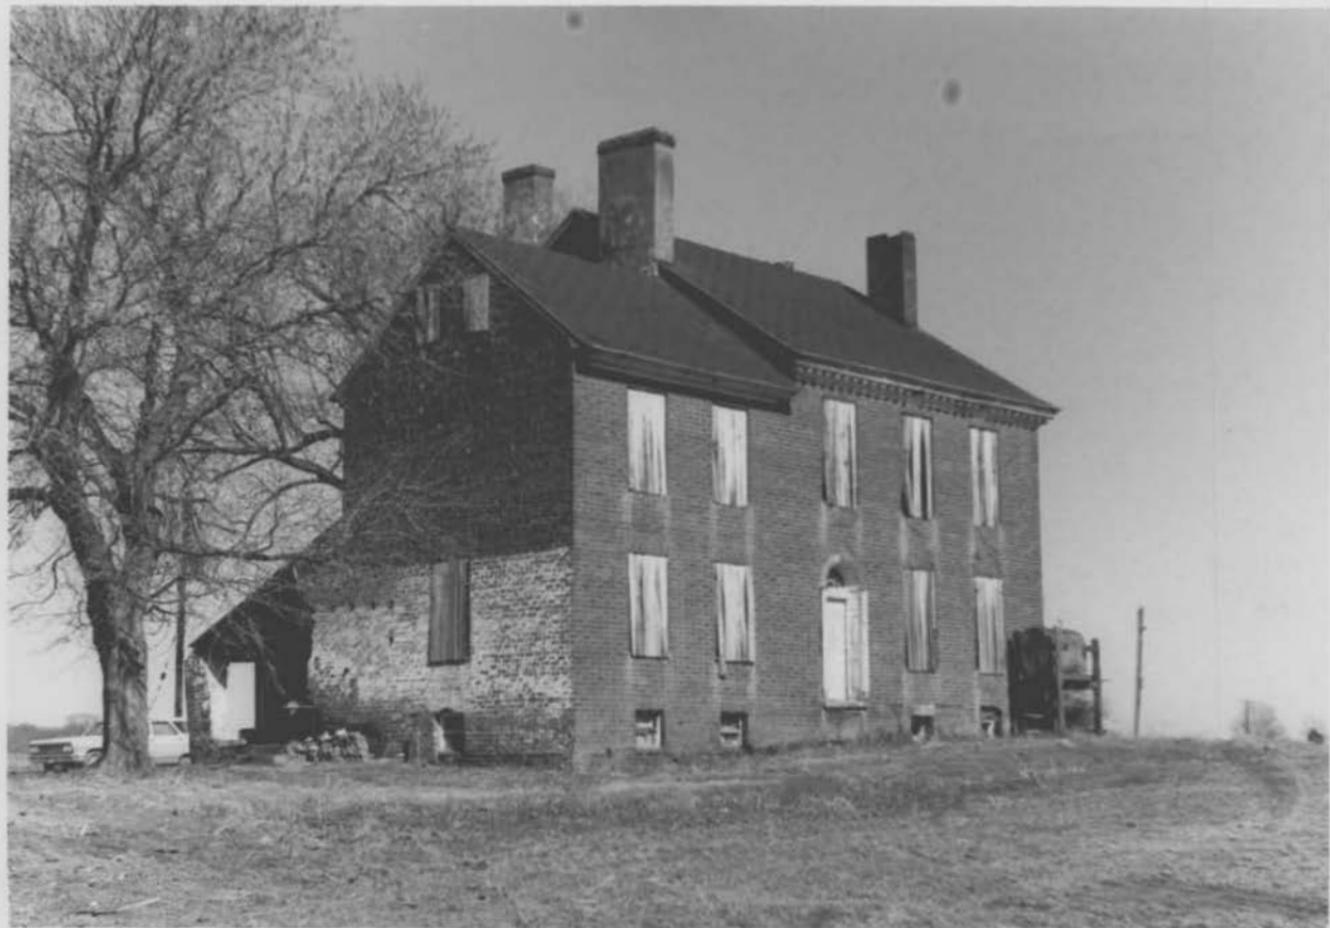
THOMAS HOUSE, QUEEN ANNE'S COUNTY

QA-8
Thomas House
Michael O. Bourne 3/1968
South elevation

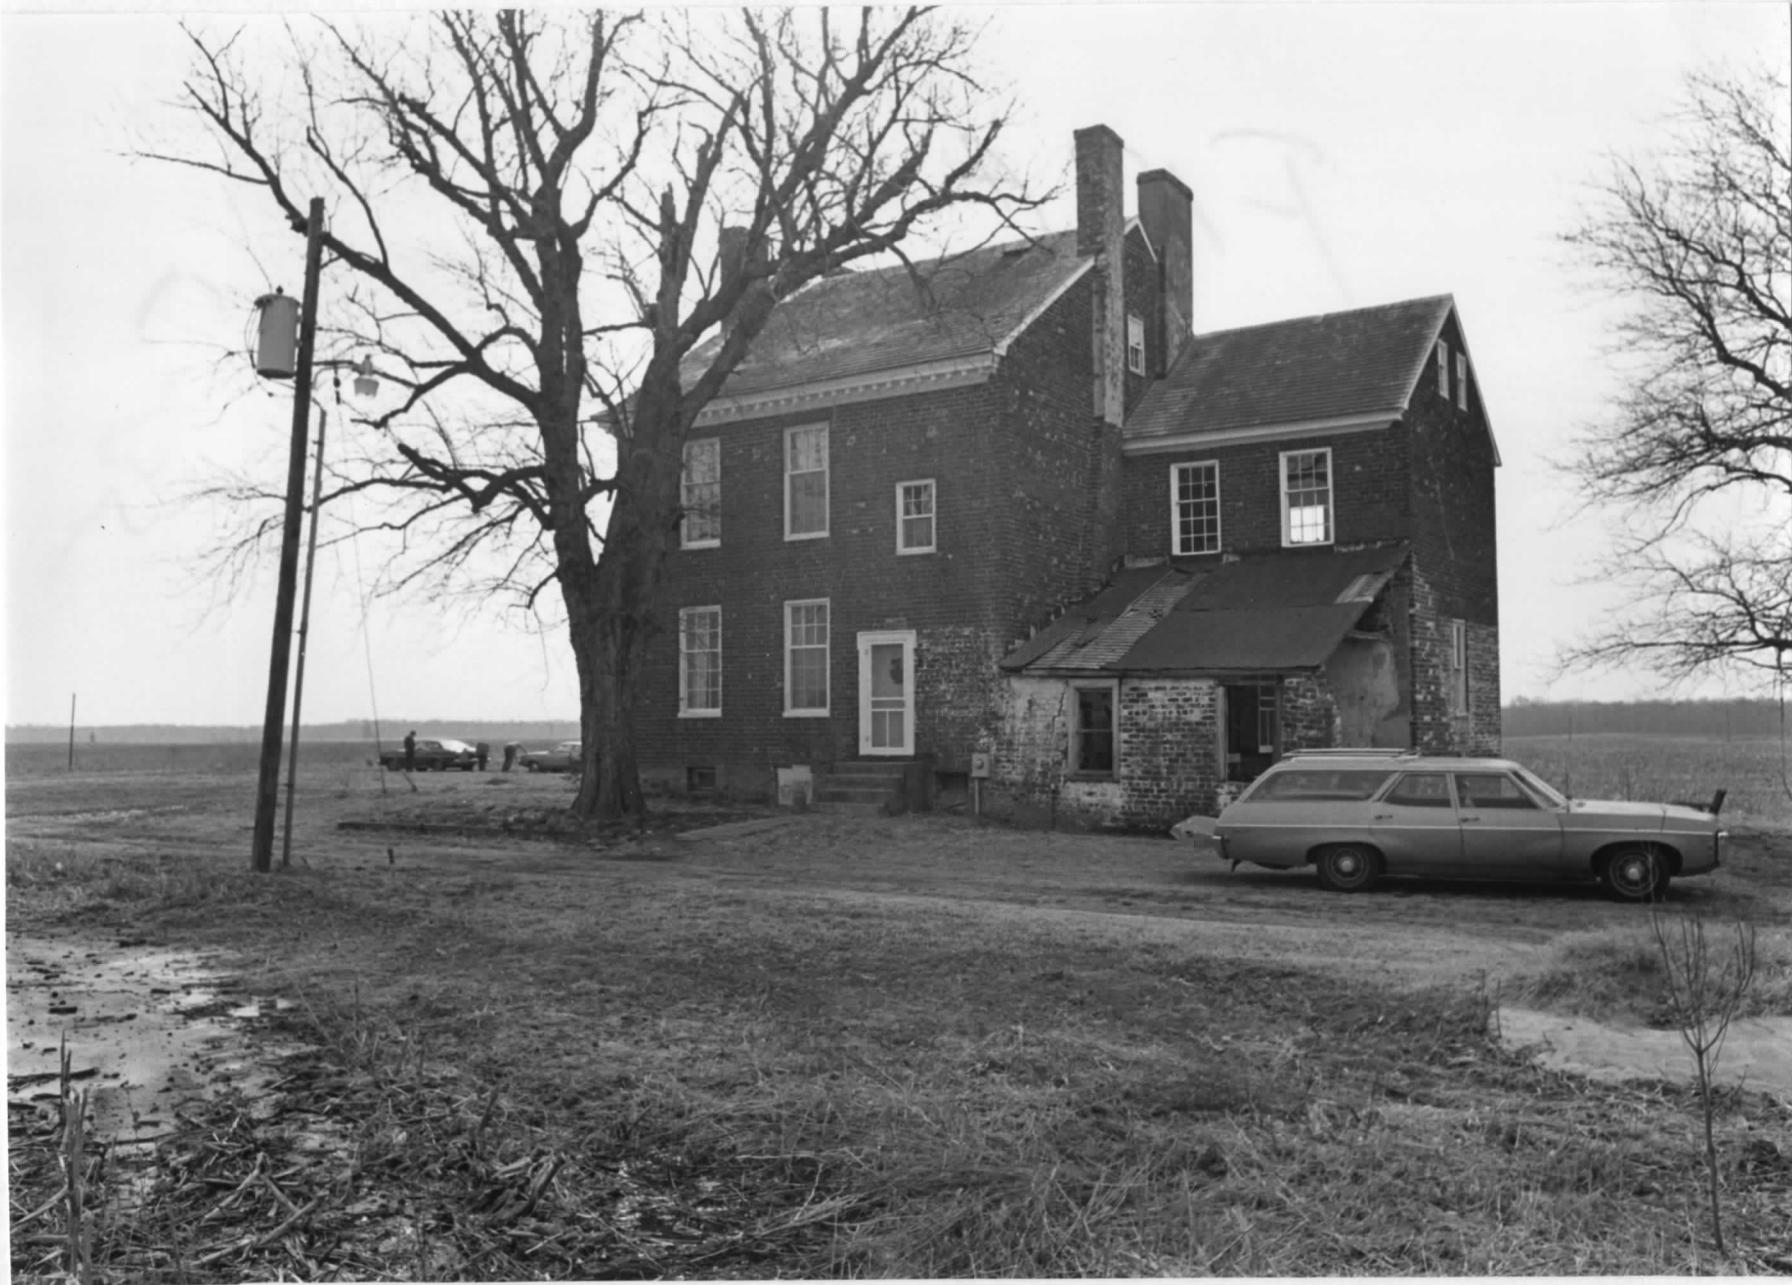
MAIN HOUSE - NORTHEAST FACADE
SCALE: *Simes A. Cartwright 1/77*
PREPARED: 3/77
MARYLAND HISTORICAL TRUST
JAC

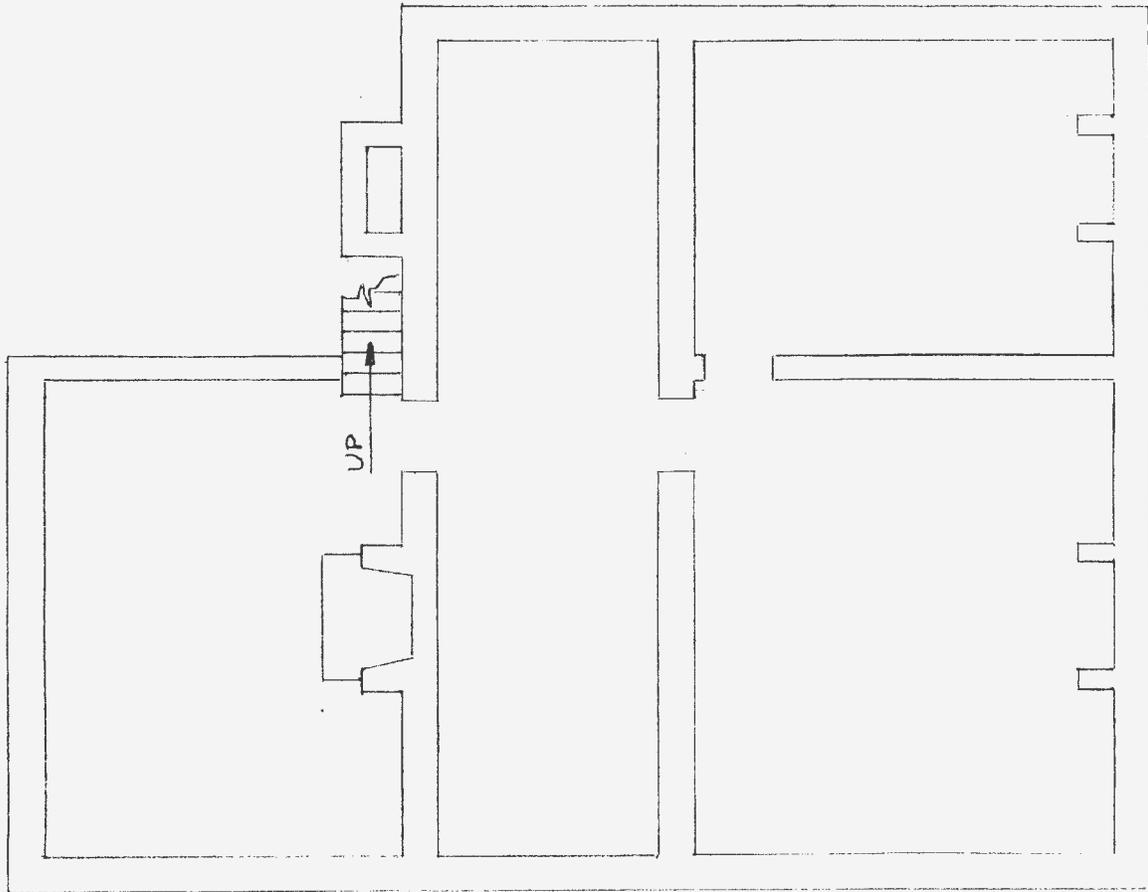
BASEMENT PLAN

The basement of the Thomas House has four rooms. That part of the basement beneath the main block follows the same room configuration as the first floor and has brick floors and recessed arches in the chimney bases. The basement area beneath the first floor southeast room originally housed the winter kitchen and has an expansive fireplace opening.

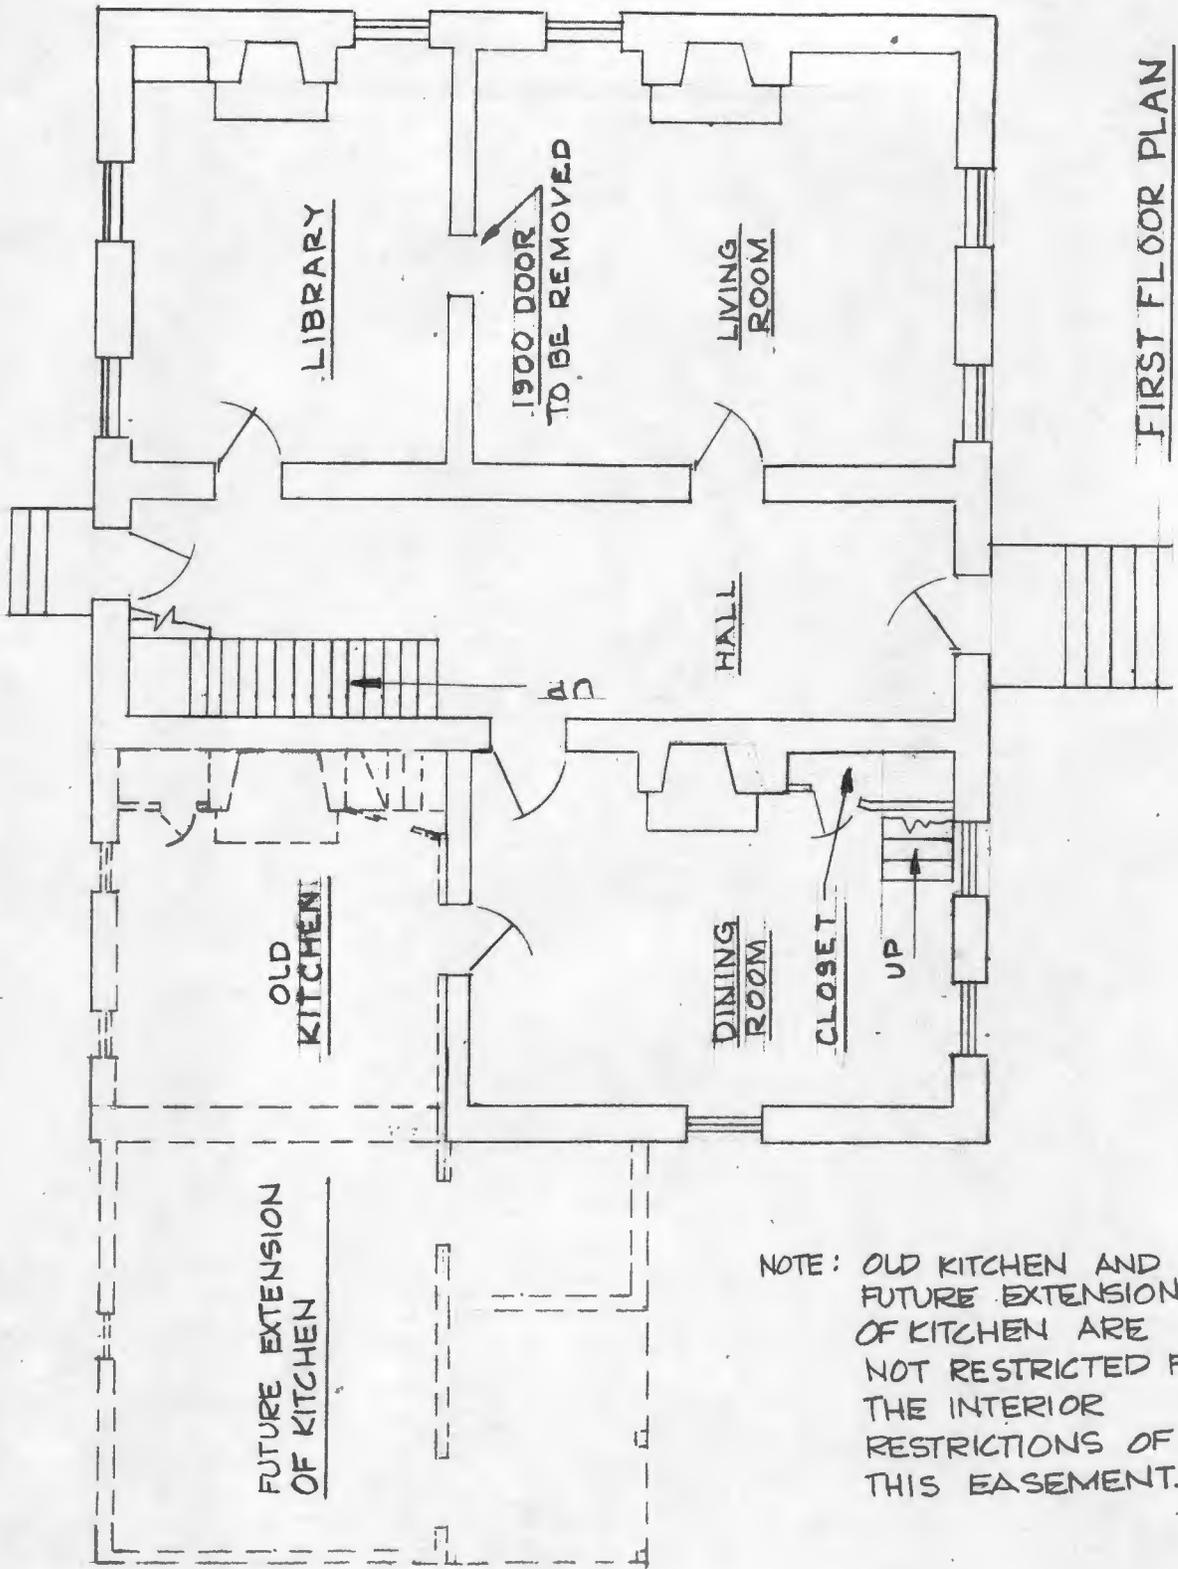
NOTE: OLD KITCHEN AND FUTURE EXTENSION OF KITCHEN ARE NOT RESTRICTED BY THE INTERIOR RESTRICTIONS OF THIS EASEMENT.

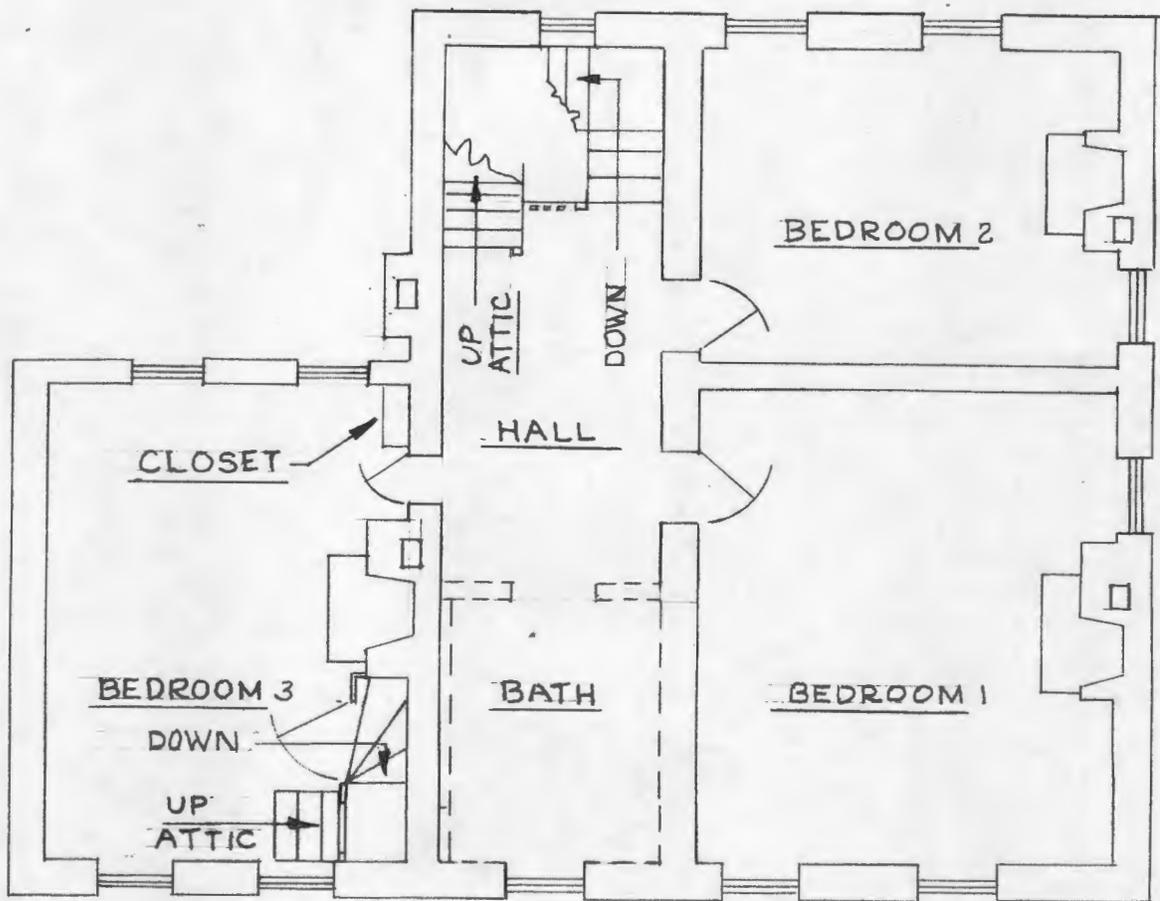
SECOND FLOOR PLAN

NOTE: BATHROOM IS NOT RESTRICTED
BY INTERIOR RESTRICTIONS OF
THIS EASEMENT

On the second floor of the house there are three bedchambers, one over each of the principal first floor rooms. The head of the stair hall is partitioned off to provide for a small fourth room. The woodwork in these rooms is similar in profile to that of the first floor but much simpler in its manner of execution. Two interesting features, however, exist. One is the window lighting the stair landing between the first and second floor levels. Its sill is "supported" by two ogee-shaped brackets with drops. Another is the use of a paneled gate and rail framing the stairwell in the northwest bedchamber.
