QA-81  
Plain Dealing  
Centreville vicinity  
Private

INVENTORY FORM FOR STATE HISTORIC SITES SURVEY

HISTORIC  
**Plain Dealing**  
AND/OR COMMON

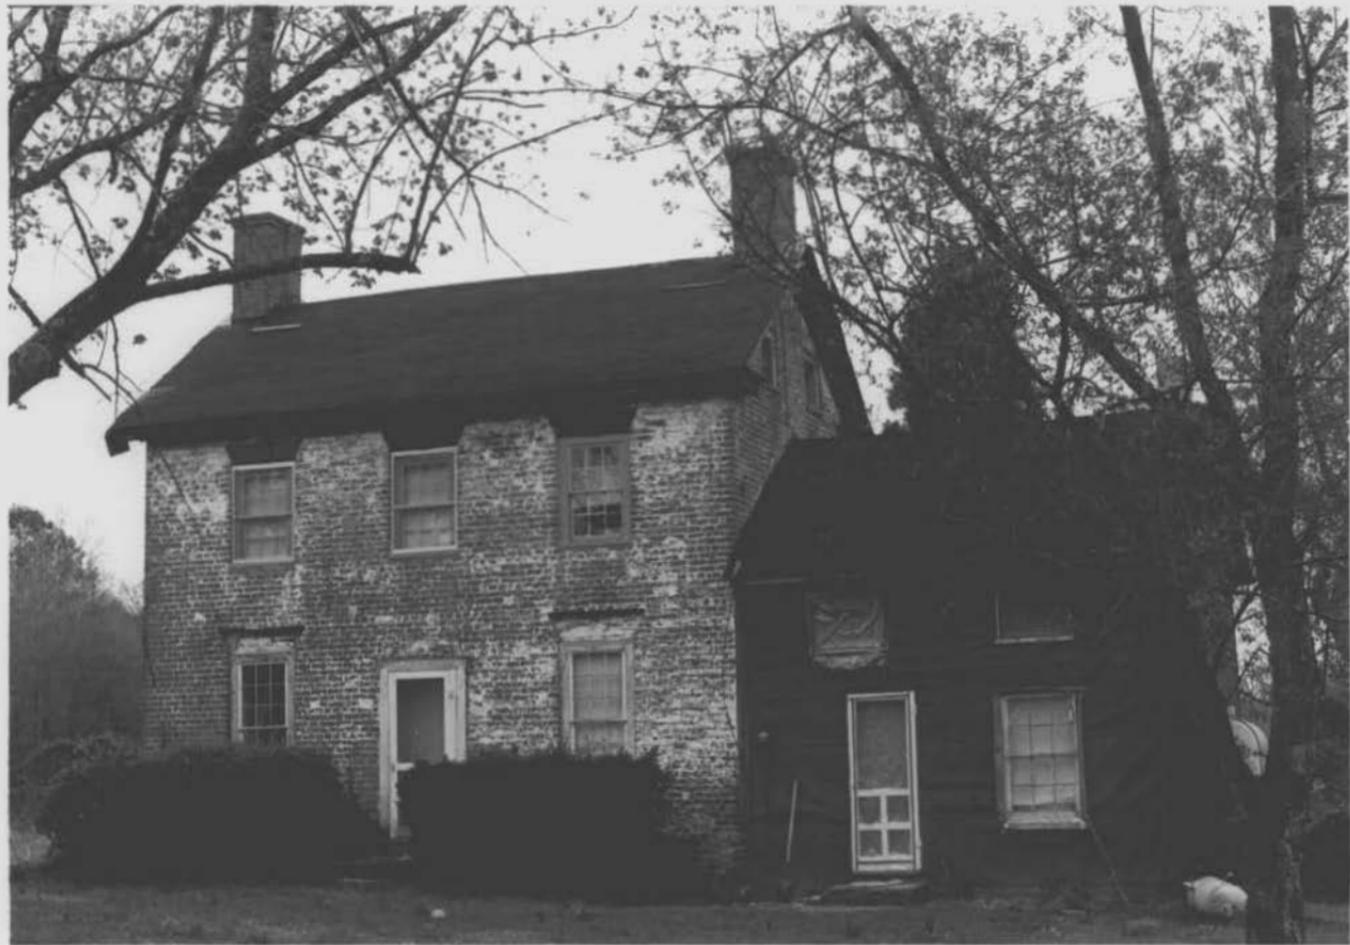
QA-81

The rear or north facade is similar to the front facade, with a center door flanked by 9/6 windows and three 6/6 windows on the second floor. The brickwork is three-course bond above a plain watertable. The wood lintels are also gone from the openings on this facade.

Plain Dealing  
Centreville vicinity  
Orlando Ridout V 1980  
North facade

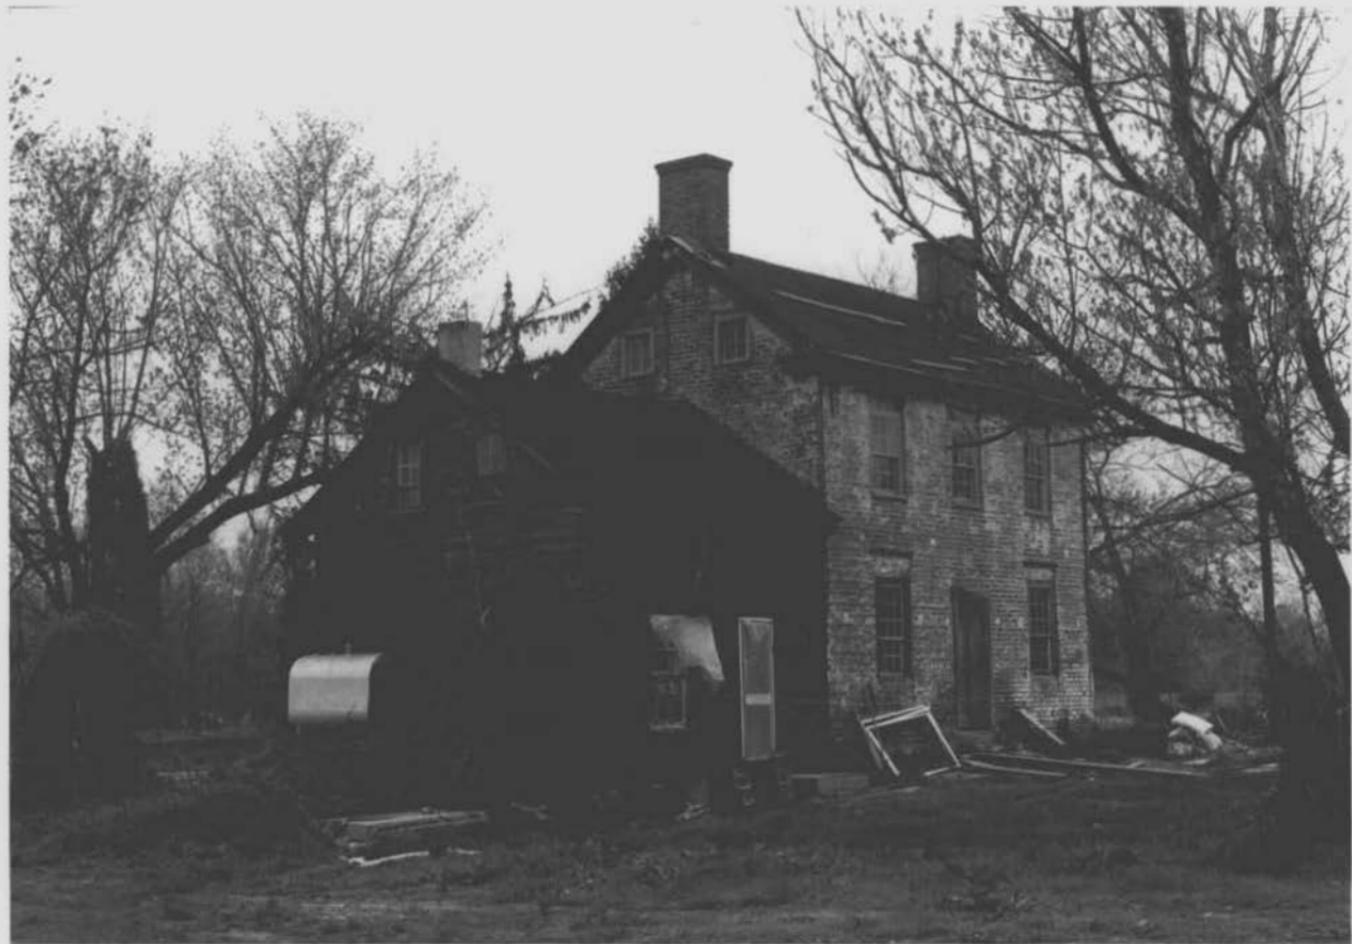
QA-81

Plain Dealing  
Centreville vicinity  
Orlando Ridout V 1980  
View from Southwest

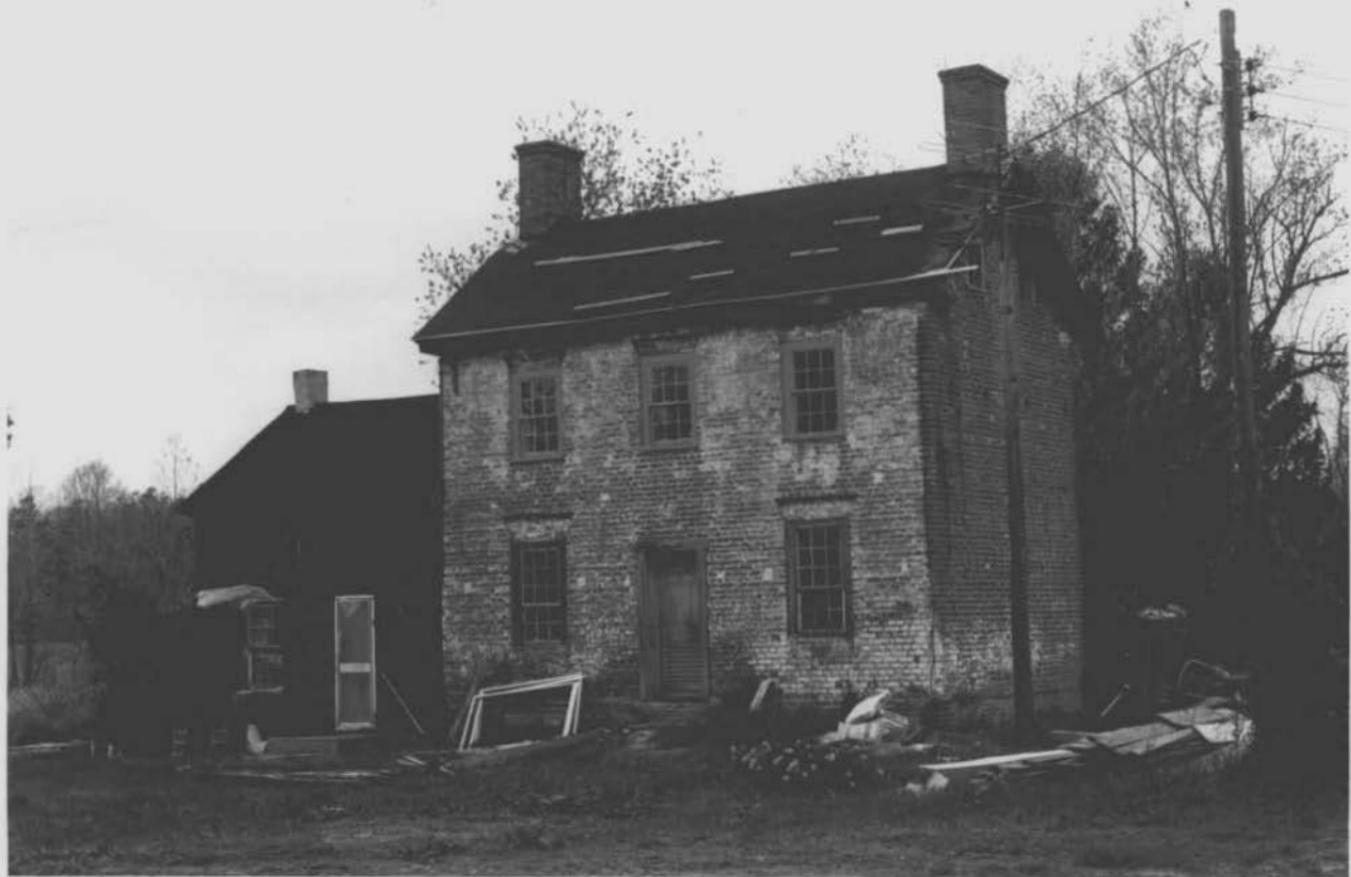
QA-81

The front facade of the original house faces south. The center door is flanked by one 9/6 window on each side; there are three 6/6 windows on the second floor. The jambs and soffit of the doorway are paneled with mid-19th century fielded panels, the 6-panel door appears to be original. Each opening was originally embellished with splayed wood lintels (presumably rusticated), but these are now gone, leaving shallow splayed recesses. The facade brickwork is laid in five-course bond above a plain watertable and three-course bond foundation. The eaves are finished

Plain Dealing  
Centreville vicinity  
Orlando Ridout V 1980  
South facade
